Study of the Technology Preventing the deformation area of the Hot -Dip Zn -Al Galvanizing steel Blackening

Abstract. In order to prevent the deformation area of the hot -dip Zn -Al Galvanizing extra deep drawing steel blackening during the drawing process, the microstructure and composition of the blackening area was researched by SEM and EDS. The blackening during the drawing process was caused by Zn -Al coating corrosion after the damage of passive film. And the effective measures that the surface passive film on Zn -Al coating had self-lubrication and the friction factor of the surface below 0.2 to prevent the blackened was determined. Then a self-lubricating hot -dip Zn -Al Galvanizing extra deep drawing steel was developed. After the application of Technology about the self-lubricating hot -dip Zn -Al Galvanizing, the blackening did not appear again.

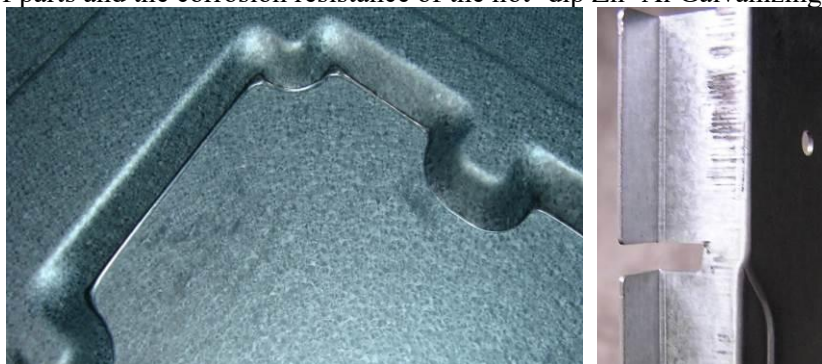
Fig. 1 The blackening phenomenon during the drawing process

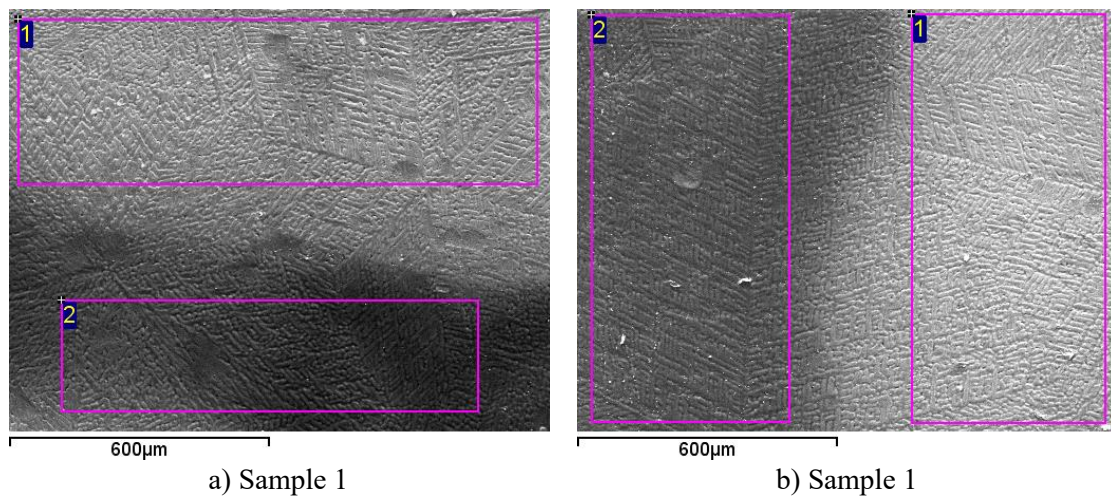
The surface morphology and composition of the black area on the hot -dip Zn -Al Galvanizing extra deep drawing steel after the deep drawing are shown in Fig.2 and Table 1. Thus, the morphology of normal area was dark and the black area was more clearly. The Si in the black area (the Si content in the Al-Zn coating was only about 1.6%, so Si was mainly from the passive film) was significantly lower than that in the normal area, so the passive film was serious damage occurred in the drawing process. And the O content should also be reduced with the passive film damage, but there is no significant difference about the content of O, so the Al-Zn coating occurred oxidation.

Fig.2 The surface morphology of the black area

- (1) In the drawing and forming process, the passive film was severely damaged due to the serious friction between the hot -dip Zn -Al Galvanizing extra deep drawing steel and the mould;
- (2) The heat produced in the friction process promote the Al-Zn coating to react with oxygen in the air and produce oxidation, then the surface blackening.

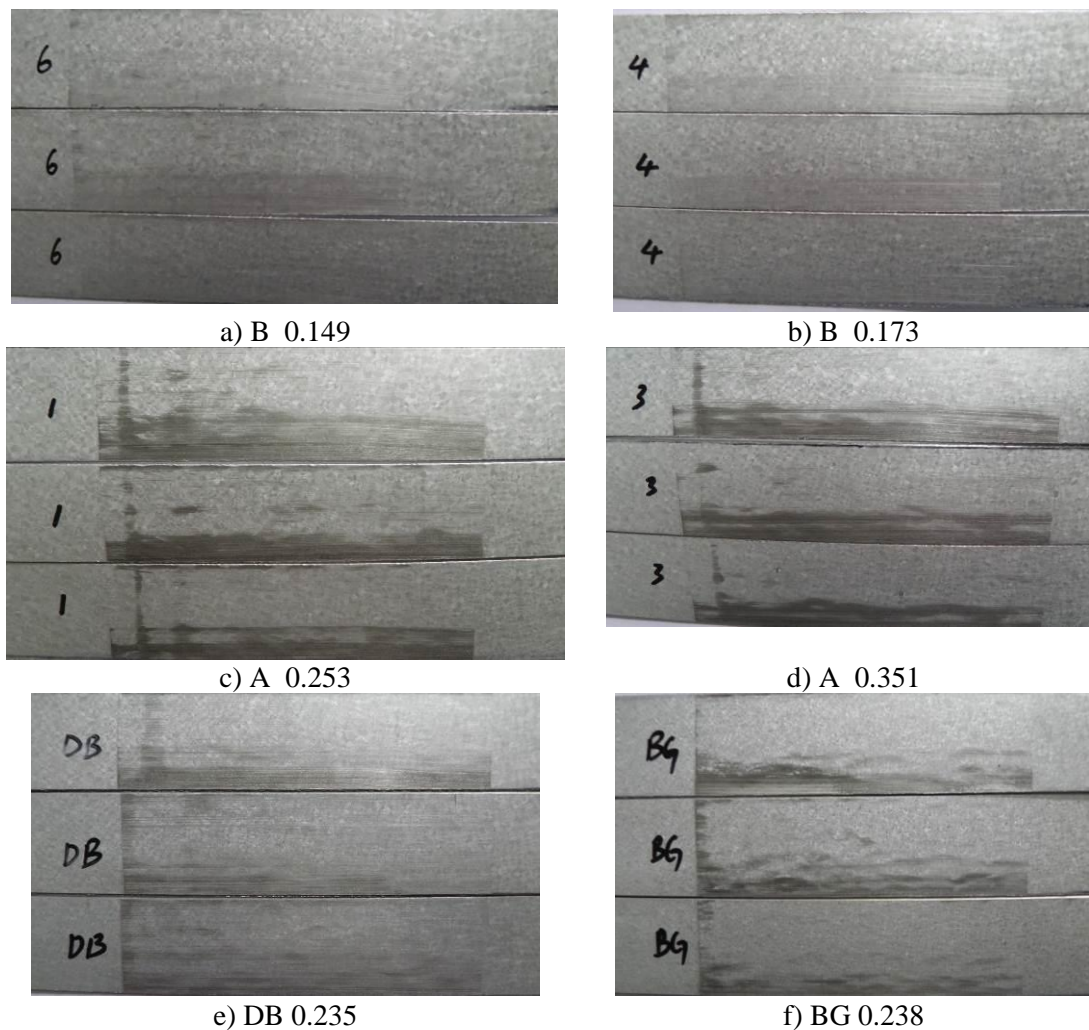
Fig.3 The surface state after testing

After deep drawing in the series production line, the passivated hot-dip Zn -Al Galvanizing extra deep drawing steel A appeared obviously blacken, B did not appear blacken, the DB and BG appeared slightly blacken. These results after deep drawing were consistent with the results of the friction factor test. Therefore, the friction factor of A (0.253~0.351) was a little bigger, the A appeared obviously blacken. The friction factor of DB and BG (0.235, 0.238) was in middle, DB and BG appeared slightly blacken. The friction factor of B (0.149~0.174) was a little smaller, B appear no blacken. When the friction factor was less than 0.2, the sample does not appear blacken, and the severity degree about blacken increased gradually as the friction factor of the hot-dip Zn -Al Galvanizing steel increased gradually. So the preventive measure that could effectively prevent the hot-dip Zn -Al Galvanizing steel blackening after deep drawing were that the surface passive film on Zn -Al coating had self-lubrication property and the friction factor of the surface below 0.2.

The blackening after drawing was caused by the friction, so it was necessary to improve the self-lubricating property and reduce the surface friction factor of the hot -dip Zn -Al Galvanizing extra deep drawing steel. The friction factor of different samples are shown in Table 2, and the surface state after testing was shown in Fig.3.
