Primary causes and treatment countermeasures of damages of pavement in Wuhan: A field investigation

Hu Chunhua¹, Xie wentao¹, Zhang shoucheng²

¹ HuBei University of technology, School of Civil Engineering, Architecture and Environment.

Abstract: At present, pavement in Wuhan is experiencing higher than anticipated rates of damages. Inspection of appearance evaluation, drilling core, deflection, flatness, rutting and tectonic depth is investigated to find the primary causes and treatment countermeasures of damages of asphalt pavement in Wuhan. It is found that vehicle overloading, maintenance period, insufficient compaction, increase of traffic load and differences in material properties of manhole cause the damages of asphalt pavement in Wuhan. The countermeasures include continuous reinforced pavement, double-surface layer and the use of black steel fiber.

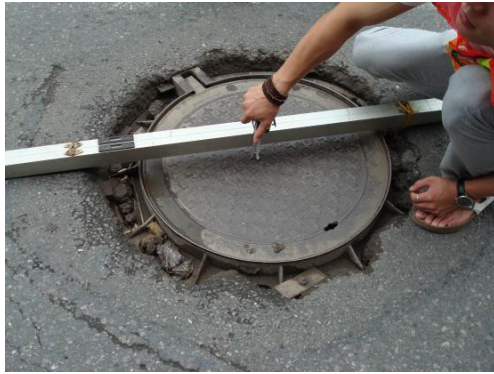
Figure 1. Inspection well subsidence

The survey statistics of typical roads in Wuhan can be seen in Table 6. The analysis finds that the problem of inspection well subsidence is a major problem in inspection wells in various industries of motor vehicle lanes and non-motor vehicle lanes. Among them, the damage caused by subsidence problems is the most prominent. The problems of damage and subsidence in wells do not occur separately, but interact and concomitantly occur. In the vast majority of cases, the occurrence of well damage is caused by the sinking problems of the inspection well itself [3-4]. At present, most of the problems of the inspection well damage are insufficient strength of the brick wellhead, insufficient backfill compaction at the inspection well, poor bearing capacity of the foundation, increased traffic load and traffic flow, unreasonable position of the inspection well, etc.

- Well covers should be selected to meet the requirements for load carrying capacity and deformation. Cast iron inspection wells are superior to other materials in terms of bearing capacity and deformation resistance, so cast iron inspection cover is recommended [8-9].
- The inspection cover should be fixed on the prefabricated well beam to prevent the cover from sliding and sinking.
- Black fiber-reinforced concrete could be used as a filling material around the well to balance strength and color.

- Aimed at inspection well subsidence damage, the first solution is to use qualified manhole covers that meet the requirements for carrying capacity and deformation. The other is to fix inspection manhole covers on prefabricated well beams to prevent sliding and sinking of manhole covers. Third, it is recommended that black steel fiber concrete be used as the filling material around the well.

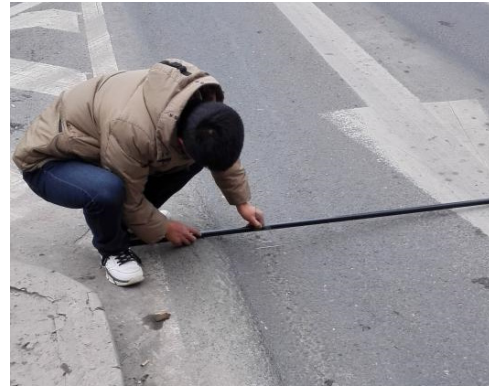
Figure 2. Intersection Rutting

Rut is a common disease of asphalt pavement. The rut is a groove-shaped permanent deformation caused by the repeated action of the vehicle load under certain environmental conditions, especially in the hot season [2].

Wuhan is hot and rainy in the summer and lasts for a long period of time. This is a period of high incidence of rutting and pit problems. The study found that the intersections in Wuhan are mainly mobile vehicles due to the influence of high temperatures in summer. Under high temperature conditions, the wheel rolling acts repeatedly, as a result, the load stress exceeds the stability limit of the asphalt mixture and the flow deformation accumulates to form a rut. On the one hand, this type of rut is recessed, on the other hand, the sides of the lane where the wheels are less active raise up. In addition, there is a noticeable outward push at the bend, and the lane line or stop line may therefore be a deformed curve. Once the rut depth exceeds 15mm, it will not only lead to pavement water, structure thinning, cracking, directly affecting driving comfort and safety, but also affect the durability of the pavement structure.

Considering that the maximum shear stress on asphalt pavement generally occurs at 4~10cm below the road surface, it is recommended to use double-layer modified asphalt anti-rutting pavement structure on the road surface and middle surface layer, it could improve the anti-rutting performance of the road surface. For existing roads, when the intersection rut depth is greater than or equal to 25mm, it should firstly mill the upper and middle surface of the original pavement, and then add anti-rutting pavement structure, the grass-roots level and soil base are processed separately according to actual conditions. Prior to the implementation of the road reconstruction project, the road condition investigation and core drilling sampling shall be performed on the rutting road section in order to analyze the cause of rutting disease and delineate the scope of the intersection [7].

For newly-built roads, the pavement structure in a certain area of the intersection should be raised to meet a higher standard than the ordinary road section, and two-layer modified asphalt anti-rutting pavement structure should be adopted on road surface and middle surface layer.
