Detection of reinforcement in the non-traditional building structures - historical statues

O Anton, L Vitek, V Hermankova, T Komarkova and P Cikrle

Department of Building Testing, Faculty of Civil Engineering, BUT in Brno, Veveri 95, Brno, Czech Republic

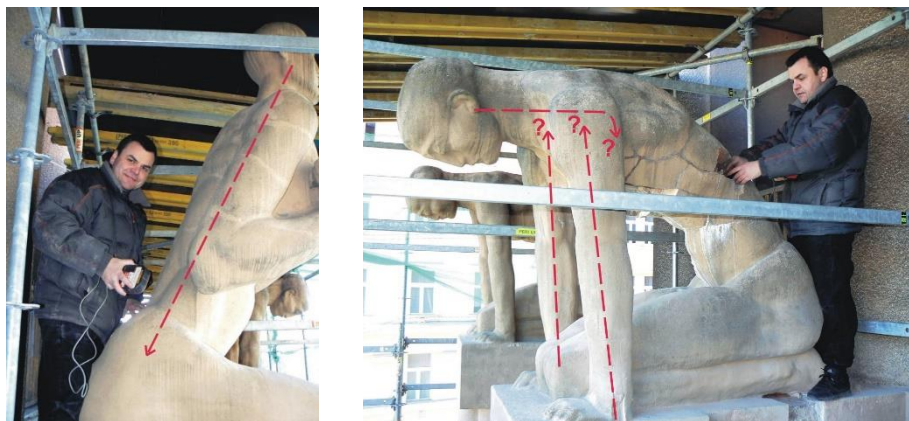
11 in Brno. It is the building of a former Regional Sickness Fund from 1925, and the author of the sculptures was Myslbek's pupil, academic sculptor Václav Hynek Mach. In the sculptures made from artificial stone, we detected only sporadic reinforcement with several smooth reinforcing bars with a circular cross-section of 20 mm, which are insufficient in terms of statics, as is apparent in figure 1.

Figure 1. Measurement of the position of reinforcement in individual sculptures from artificial stone in the sculptural group called Health. The detection of reinforcement was relatively precise, considering the low number of reinforcing bars. Nevertheless, it was not possible to precisely determine the location and method of anchoring of individual reinforcing bars [3].

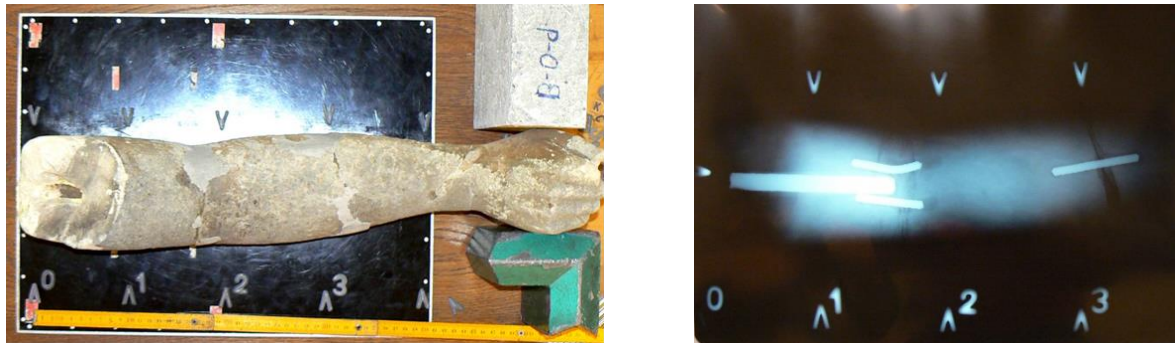
The radiology revealed that the original reinforcement consists of one, probably forged, rod-like element with a diameter of approximately 13 mm. This element originally linked the arm with the corpus of the statue and ended at the elbow level, in the plane of the first repaired fracture. The image of this reinforcing element is well apparent in figure 3 and also in figure 5. The reinforcement is located in the cavity with a diameter of approximately 20 mm which is sealed with sulphur. An additional reinforcement was detected at the point of the repaired fracture in the elbow. The reinforcement consists of two steel reinforcing bars with a diameter of approximately 6 mm and a length of approx. 53 and 55 mm. According to the surface finish of the reinforcement apparent on the radiogram, it is probably a cut piece of the Kari net for concrete.

It is well apparent on the radiograms that reinforcements were inserted into the holes pre-drilled in both fragments, and the holes exceed the inserted reinforcement by approx. 11 - 17 mm. From the image of the pre-drilled holes it is possible to assume that they are either not filled at all, or that they are filled with a material with a substantially lower density than the volume mass of the arm's sandstone. The image of these reinforcing elements is well apparent in figure 3 and 4.

Another additional reinforcement was detected at the point of the repaired fracture in the middle of the forearm. The reinforcement consists of one steel reinforcing bar with a diameter of 6 mm and a length of 70 mm. According to the surface finish of the reinforcement apparent on the radiogram, it is probably a cut piece of the Kari net for concrete.

It is well apparent on the radiograms that reinforcement was inserted into the hole pre-drilled in both fragments, similarly to the additional reinforcement 1. The image of this reinforcing element is well apparent in figure 3 and 4.

Figure 3. Radiography of the sandstone arm from shoulder to wrist in geometry 1, view from the x-ray tube (from the focus of irradiation), right picture: the resulting radiogram, well apparent metal connecting elements in both parts of the fracture (in the elbow and in the middle of the forearm) as well as the reinforcement ending in the elbow. The picture clearly shows also the pre-drilled holes for inserting the connecting elements in the fracture points. Also apparent is the hole in which the original reinforcement is placed, filled with sulphur.

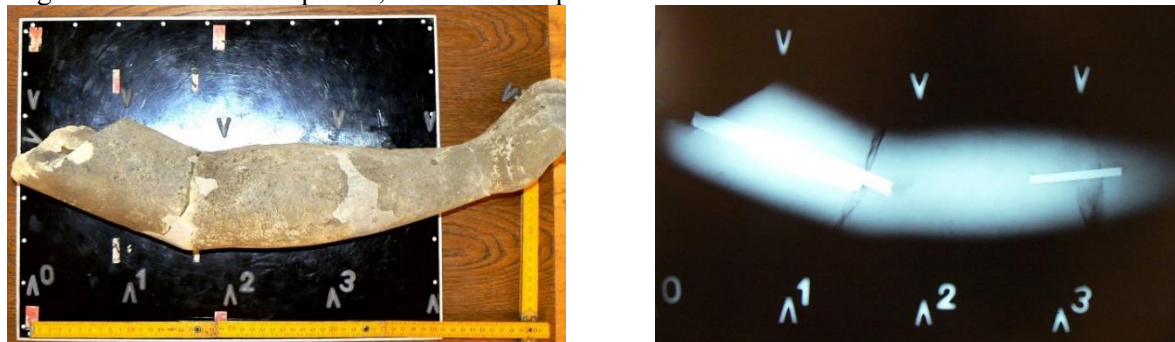
Figure 4. Radiography of the sandstone arm from shoulder to wrist in the control geometry 2, view from x-ray tube (from the focus of irradiation).

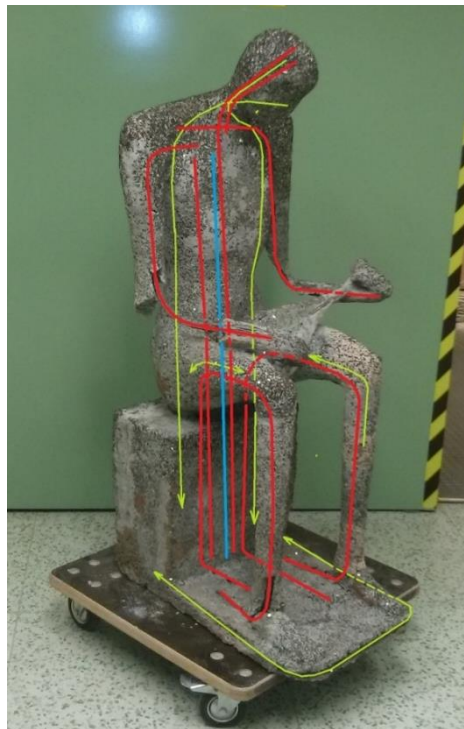
Figure 7. The anticipated pathways of the detected reinforcement in the sculpture. Red – rectangular cross-section of 10 x 10 mm, green – circular cross-section of Ø 6 mm, blue – reinforcement with an unknown cross-section with a width (diameter) of min. 15 mm. Reinforcement of the mandolin and fingers with reinforcing bars of Ø 6 mm is not captured in the picture.
