# Assessment of damp and salinity of historical building in Markušovce

**E Terpakova and A Estokova**

Institute of Environmental Engineering, Faculty of Civil Engineering, Technical University of Kosice, Vysokoskolska 4, 042 00 Kosice, Slovakia

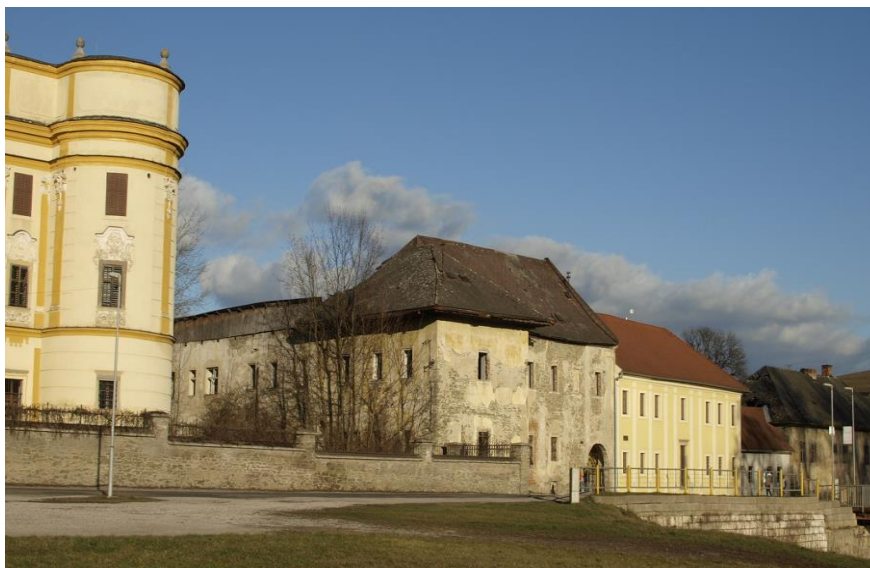
There is also a historical building in the grounds of the manor house, but is without making public visits available. This damaged historical building (see figure 1 - in middle part of photo), is at present time registered in the list of Monuments Board as Technical Building. The assessed building dates from the 18<sup>th</sup> century and was built in the Baroque style [1].

The biggest problem was the partially destruction of roof of building, which is source of negative influence of the water towards the walls, mortars, plasters and reason of foundations disrepair. The neighboring building was renovated approximately 5 years ago (see figure 1 - right side in the photo).

**Figure 1.** Manor house Markušovce in region Spiš (Slovakia) and assessed building (*owner photo*).

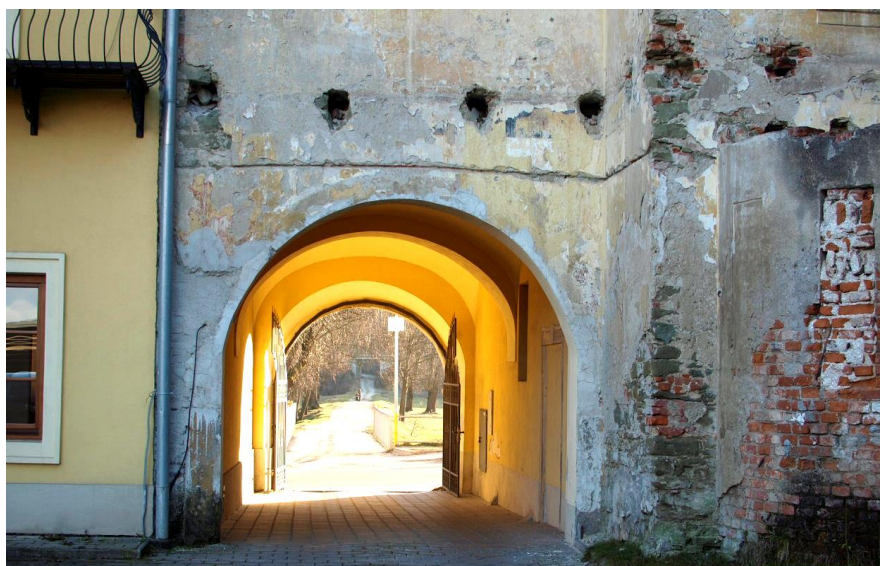
During the visual survey of object it was found that damp content of the internal masonry pillars reaches up to the height at around 1700 – 1900 mm. The situation was the worst at the north and west side of the technical building. On the inner surface of the plasters there were visible efflorescence and mildew occurrences especially in the higher parts of the plinth. On the outside of the walls there are still visible lichens, mosses and algae.

**Figure 2.** Damaged part of east side of façade, damp, salinity and biocorrosion (*owner photo*).

The results of diagnostics tests show, that the samples from damaged parts of façade have a higher degree of salinity, this fact confirms the need for a reconstruction. The samples taken from the stone-redominantly porous sandstone are able to absorb humidity and consequently salts are deposited into wall of pores. The presence of salts has also been observed at the surface of the sampling points as white efflorescences. Increased salt concentrations are related to the location of historical building, as

we can see from figure 1 and figure 2, the building is located in the immediate vicinity of local communication where salt is used for winter maintenance.

The results of diagnostic assays show, that the samples from damaged parts of façade have a higher degree of salinity, this fact confirms the need for a reconstruction. Determinations of humidity and salinity of construction parts are very important aspects from durability and reliability building. Damaged parts necessarily require urgent reconstruction because the object is in several parts of statically disturbed. When choosing technologies and materials, it must also be taken into account that it is a historic building, each other step should be in accordance with the requirements of the monumental authority under which the object belongs.

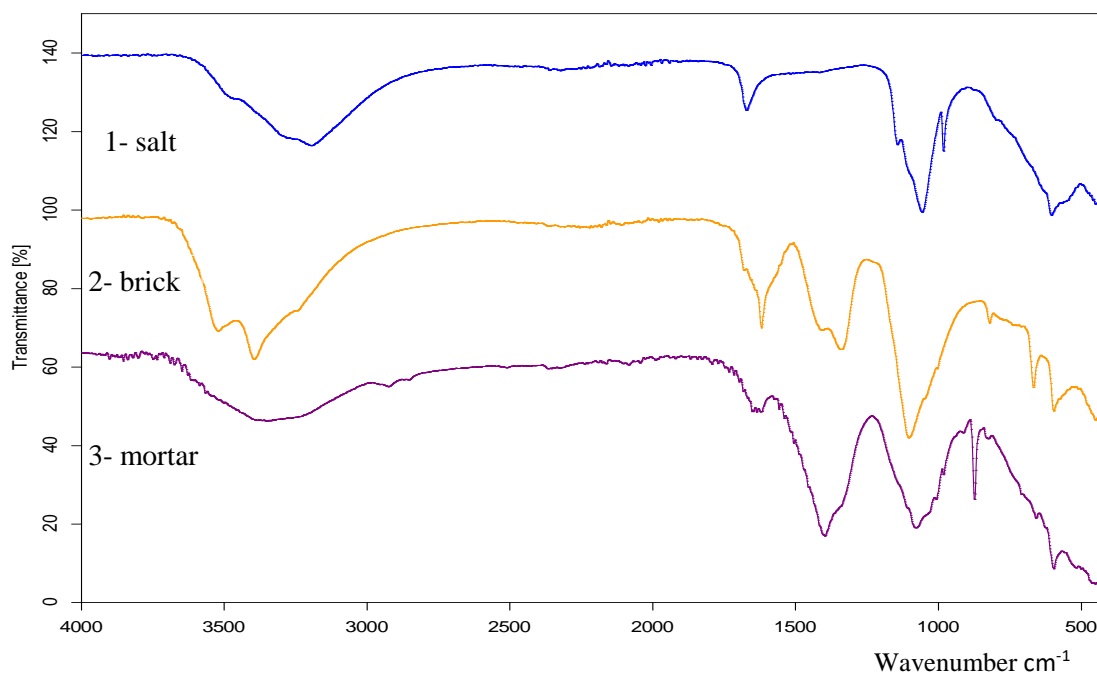
Except to chlorides, higher sulphate concentrations were also detected in the samples using semiquantitative analysis by  $\text{BaCl}_2$  precipitation of sulfate anions. In addition to above mentioned method was made FTIR spectral analysis of sample by ATR FTIR spectrometer Alpha Brucker, in range  $4000\text{--}360\text{ cm}^{-1}$ , with 24 scans. The results of white salts sample taken from the east part of the facade is shown in figure 3.

In figure 3 three characteristic FTIR transmittance spectra samples obtained from east facade are presented. The spectra from sample brick (2) and sample mortar (3) have dominated the characteristic peaks of calcite ( $1400\text{ cm}^{-1}$  and  $880\text{ cm}^{-1}$ ) while a weak broad band of approximately  $1100\text{ cm}^{-1}$  is an indication of silicate ( $-\text{Si-O}$ ) vibrations, which are overlapped the peak of the anion  $-\text{SO}_4^{2-}$  in both cases.

Finally the spectrum obtained from sample salt (1) has dominated the characteristic peaks about  $1650\text{ cm}^{-1}$ ,  $1064\text{ cm}^{-1}$  respectively at  $620\text{ cm}^{-1}$  which are an indication of sulphates [5], guiding us to conclude that the sample contains products of bio-corrosion processes, because on the historical masonry cement was not used as a binder.

**Figure 3.** FTIR spectra of samples.
