Fracture Analysis of Escalator Step and Comb Plate

Abstract. The escalator step fractured during applications. The causes for the fracture of escalator step and comb plate were investigated by means of macroscopic fractography, optical microscope and scanning electron microscope. The analysis results indicate that some porosity defects with different size distributed in the escalator step support. The fracture mode of escalator step is overload fracture.

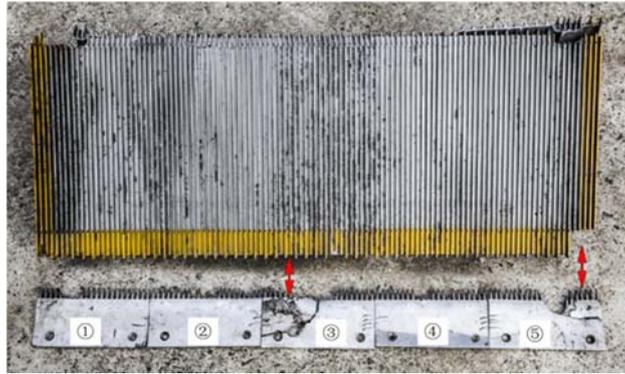
Figure 1. Escalator step and comb plate.

The fractured escalator step and comb plate are shown in Fig. 1. The width and length of the escalator step are 400mm and 1000mm, respectively. It can be seen that the escalator step has obvious squeeze deformation and crack. The comb plates (No. 1-No. 5) have varying degrees of deformation and damage. The comb plate of No. 5 has serious fracture phenomenon. One part of the escalator step, which is corresponded to the No. 5 comb plate, has a defect.

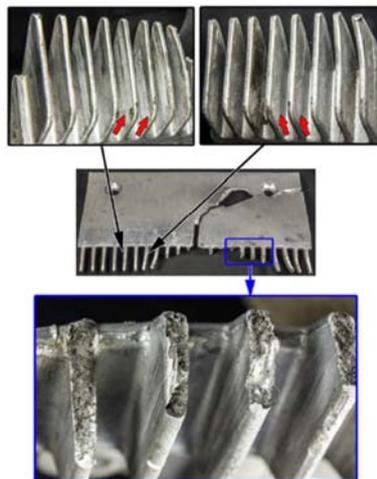
Figure 2. Macroscopic fractography of the escalator comb plate (No. 3#).

Macroscopic fractography of the escalator comb plate (No. 3#) is shown in Fig. 2. Ten combs have been fractured, which are related with the squeeze. The fracture surfaces are relatively rough and have the overload fracture characteristic. Local fracture surface has squeeze scratching phenomenon. Through further observation, two sides of the comb have unilateral wear phenomenon.

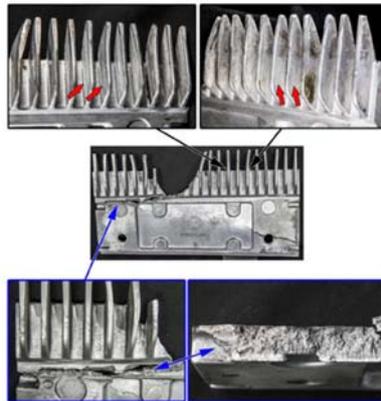
Figure 3. Macroscopic fractography of the escalator comb plate (No. 5#).

Macroscopic fractography of the escalator comb plate (No. 5#) is shown in Fig. 3. There are obvious bending deformation and comb broken phenomenon. The root zones of fractured comb plates have obvious squeeze and friction trace. It can be seen that the comb plate fracture surface has the bottom-up overload fracture characteristic. The two sides of comb plate also have the unilateral wear phenomenon.

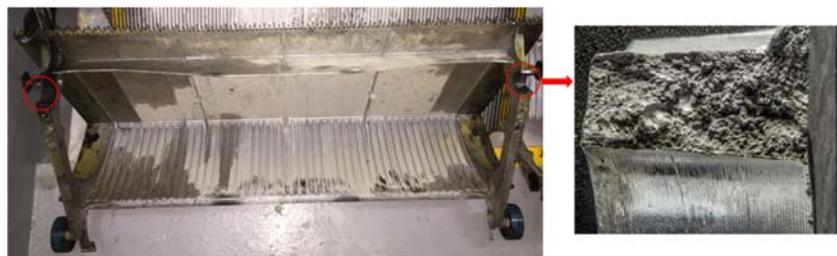
Figure 4. Macroscopic fractography of the escalator step support.

Macroscopic fractography of the escalator step support is shown in Fig. 4. It can be seen that both sides of step supports have fractured. The fracture surface is relatively rough. Owing to squeeze, the support close to the auxiliary wheel fractured and both sides were almost the same. On the upper side of the fracture, there was a herringbone pattern. Lots of pit defects can be seen on the fracture surface of both sides.

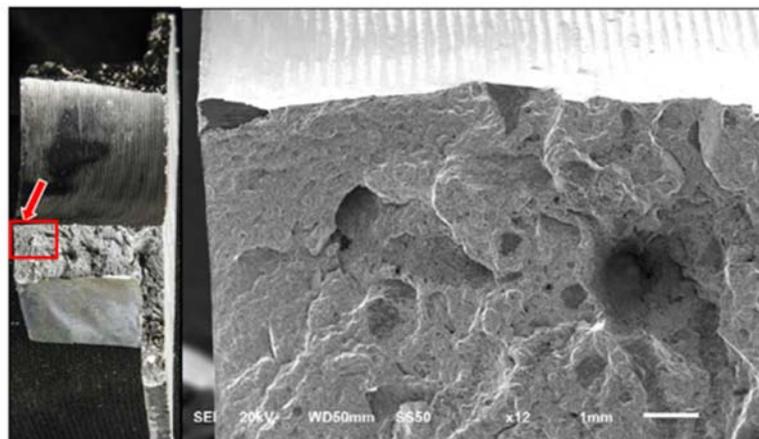
Figure 5. Fractography of the fracture initiation region.

The fractography of the fracture initiation region observed using scanning electron microscope under low magnification is shown in Fig. 5. It can be seen that some deeper pits distributed in local region. In the fracture initiation region, some flat regions with different size were found and the largest length is about 1.7mm. It can be inferred that the flat regions belong to cold lap defect.

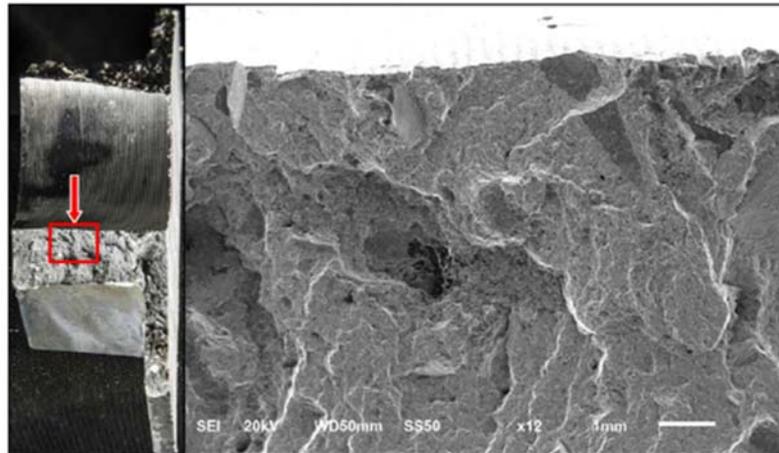
Figure 6. Fractography of the fracture propagation region.

The fractography of the fracture propagation region observed using scanning electron microscope under low magnification is shown in Fig. 6. Compared with the fracture initiation region, more porosity defects distributed in this region. The size of largest porosity defect is measured and the length and width of are about 5.5mm and 1.8mm, respectively.

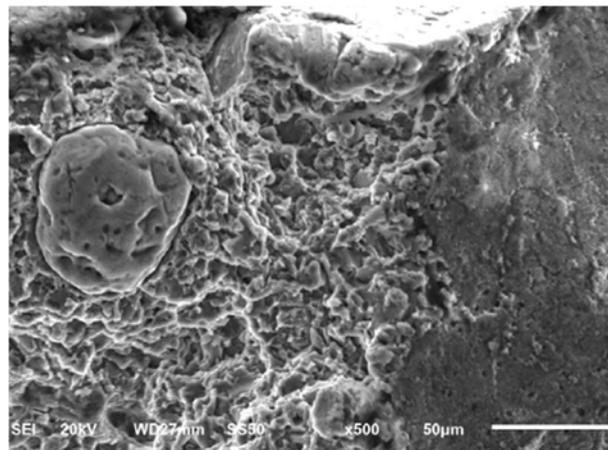
Figure 7. Fractography of the porosity defect of fracture initiation region.

The fractography of some porosity defects of the fracture initiation region under high magnification are shown in Fig. 7. It can be seen that the surface shows the free surface characteristic.
