# Fracture analysis on fasten bolt of a shaft sleeve of escalator stave

**Abstract.** The fasten bolt of a shaft sleeve of escalator stave fractured during applications. The cause for fasten bolt fracture was investigated by means of macroscopic fractography, optical microscope and scanning electron microscope. The results indicate that superficial decarbonization occurred on the bolt screw thread and the depth overstepped the requirements of relevant standards. The fracture mode of fasten bolt of a shaft sleeve is clockwise torsion overload fracture.

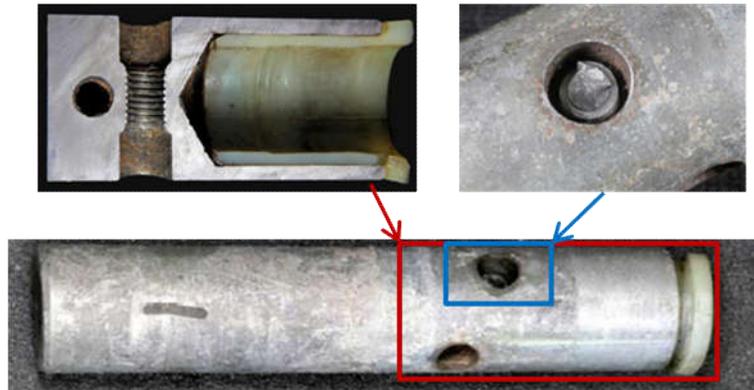
The failure shaft sleeve of escalator is shown in Fig. 1. The shaft sleeve, which is fixed to support arm of stave by fasten bolt, is assembled with driving chain pin. The length and outer diameter of the shaft sleeve are 160mm and 30mm, respectively. The depth and diameter of the axis hole are 37mm and 24.5mm, respectively. The shaft lining is nylon sleeve with the diameter about 20mm. There are two orthogonal fixing screw holes in the shaft lining back-end, which are 50mm and 60mm distant from the end. It can be seen that the fasten bolt of shaft sleeve has been fractured. The fracture surface sunk inside. The axis hole of shaft sleeve has no obviously plastic deformation.

**Fig. 1** Shaft sleeve and the damage morphology of fasten bolt.

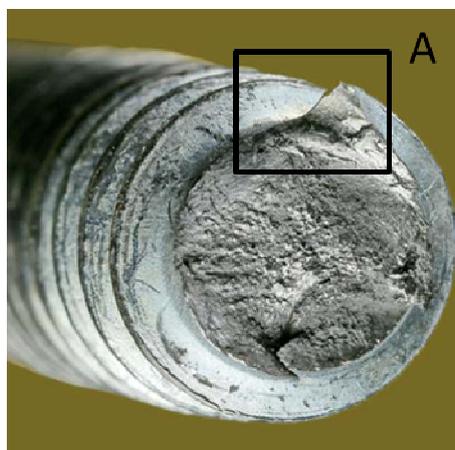
Macroscopic fractography of the fasten bolt of a shaft sleeve of escalator stave is shown in Fig. 2. It can be seen that the fracture surface developed along the screw thread root. The fracture is much rougher in zone 'A' which has a step. The fracture of edge is relatively smooth. It is obvious that the pattern is leaning and spinning, which indicates that the fracture mode is torsion overload fracture.

**Fig. 2** Macroscopic fractography of the fasten bolt

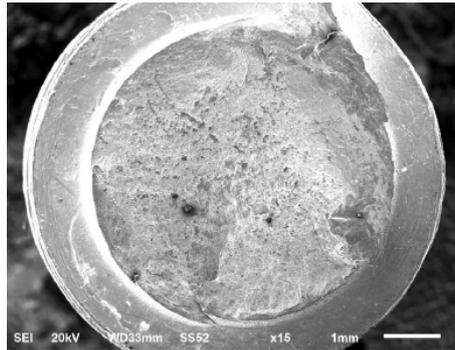
The fractography of fractured bolt under low magnification is shown in Fig. 3. It can be seen that all the fracture edge located at the screw thread root. There is downward sliding bruise at the 3 o'clock position edge. It's still visible that the subsurface is downward. The 6 o'clock position exhibits outside-in oblique fracture shape and has oblique crack step. There is bruise at the 9 o'clock position edge. The fracture surface exhibits bottom-up development. The central zone of fracture presents dimple pattern, which indicates forward overload tension crack type.

**Fig. 3** Fractography of the fasten bolt

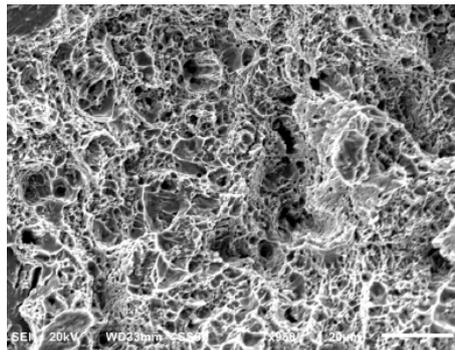
**Fig. 4** Dimple morphology of the fracture central zone

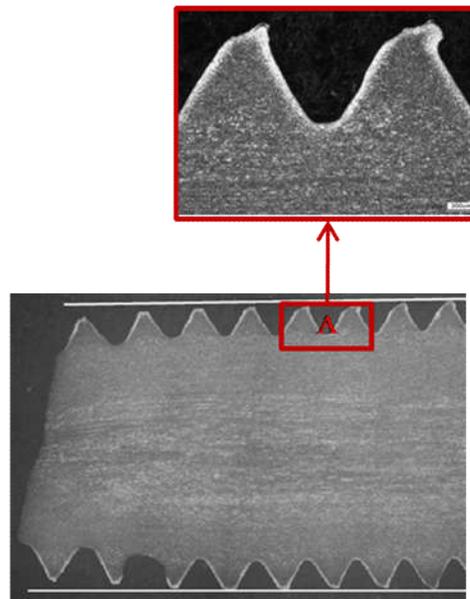
The optical microstructure of the longitudinal section near the bolt fracture is shown in Fig. 5. It can be seen that the left fracture tends towards diagonal distribution. The diameter of fracture has relatively contract phenomenon which is caused by the deformation before fracture. The edge of the screw thread appears bright white which is related to decarbonisation. The screw thread has obviously deformation phenomenon. It can be seen from the optical microstructure of part A that the surface microstructure of screw thread is ferrite and only tiny amounts of sorbite. There is decarbonization phenomenon and the maximum depth is about 0.08mm. It also can be seen that there is diagonal zigzag micro-crack distributed on the screw thread and the length is about 0.2mm. The matrixes are sorbite and a few ferrite.

**Fig. 5** Microstructure of longitudinal section near the bolt fracture

The bolt screw thread has the phenomenon of superficial decarbonisation and the maximum depth is about 0.08mm, which has overstepped the standard requirement ( $\leq 0.015\text{mm}$ ) of GB/T 3098.1-2010 <Mechanical properties of fasteners-Bolts, screws and studs>. The fracture mode of fasten bolt investigated in this paper is clockwise torsion overload fracture.

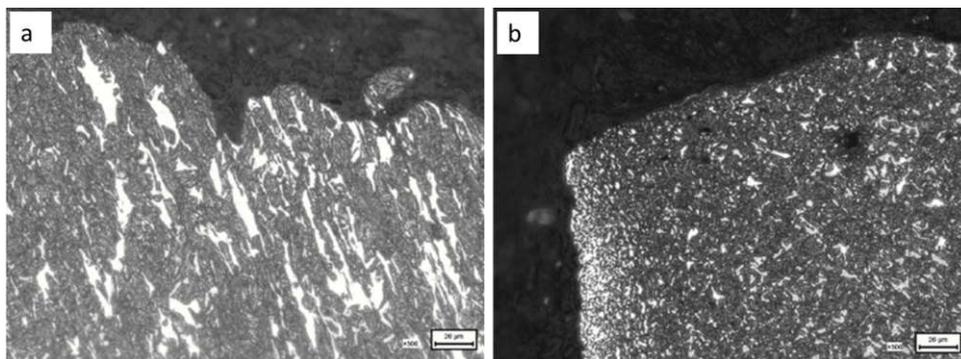
The microstructure of fracture central zone of the fasten bolt is shown in Fig. 6(a). It can be seen that there is no oxidation phenomenon on the fracture surface. The microstructures of the central zone of fracture are sorbite and undissolved massive ferrite. The microstructure of fracture boundary part of the fasten bolt is shown in Fig. 6(b). The left side is the screw root surface and the upside is the fracture surface. It can be seen that the surface microstructure of screw root is ferrite. There is no oxidation and decarbonization phenomenon on the fracture surface. The microstructures of the boundary part of fracture are sorbite and a few ferrite.

**Fig. 6** Microstructure of (a) central zone and (b) edge zone of the bolt fracture
