Trim Die Damage and “Self-Reconditioning” Effect on Trimmed Edge of Sheet Metal Blanks

Ameer Al-Shawk^{1,3}, Xin Wu¹, and Qingyu Yang²

¹Department of Mechanical Engineering, Wayne State University, Detroit, MI 48202

Abstract. Tooling durability for advance high-strength steels has been investigated by Auto/Steel Partnership at an industrial site using AISI D2 die for trimming DP980 up to 100,000 hits. The topological characterization of the trimmed workpiece edges were measured by a laser confocal microscope that provided 3D surface geometries, and further analysed. It was found that, despite of initial portion of edge roughening and edge quality deterioration from the new trim die, in the majority portion of the trimming operation up to 100,000 hits the edge quality of the trimmed sheet metal edges show combined roughening and smoothing cycles, or called a “self-reconditioning” effect, with the edge quality to be within a stable roughness window. The non-even wear between two pieces of trim die pair and along the die cutting edge is observed and analysed. This finding leads to the need of better redefinition of trim die failure or trim die reconditioning criterion.

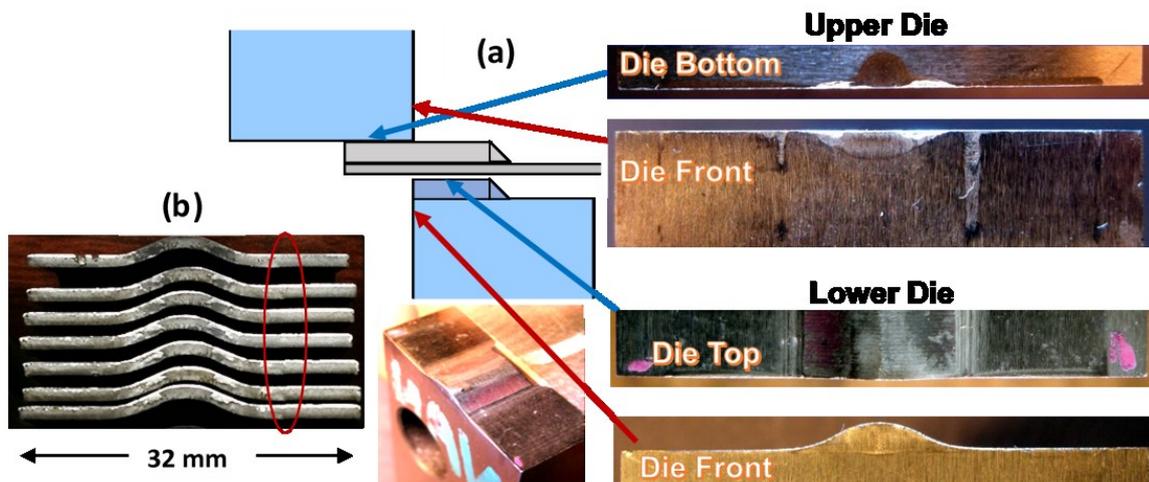
Figure 1. (a) Schematic view of trim die configuration along with the images of upper and lower die inserts after 100k hits; (b) the sheared surface of the trimmed parts.

Without direct measurement of die wear by laser confocal microscope, one set of high-resolution photo images were taken, and the top view and front view of the die inserts have been shown in Figure 1(a). Image processing was performed to trace the boundaries of the damaged areas consisting a more severely damaged zone and two lightly damaged outside zones. For the upper die viewed from two planes, the bottom (horizontal) plane) was wear-out at the central portion (that has heavy contact with the bumper portion) and the more severe wear-out area in the two down-hill area (in red), and its front (vertical) cutting plane has been severely worn in two bumper end portions of severely damaged zones (uneven wear out occurred with the right side worn much more severe than left side). For the lower die, the top surface worn more severely on top-right side of the waved bumper, and the cutting edge worn zone is narrow but deep.

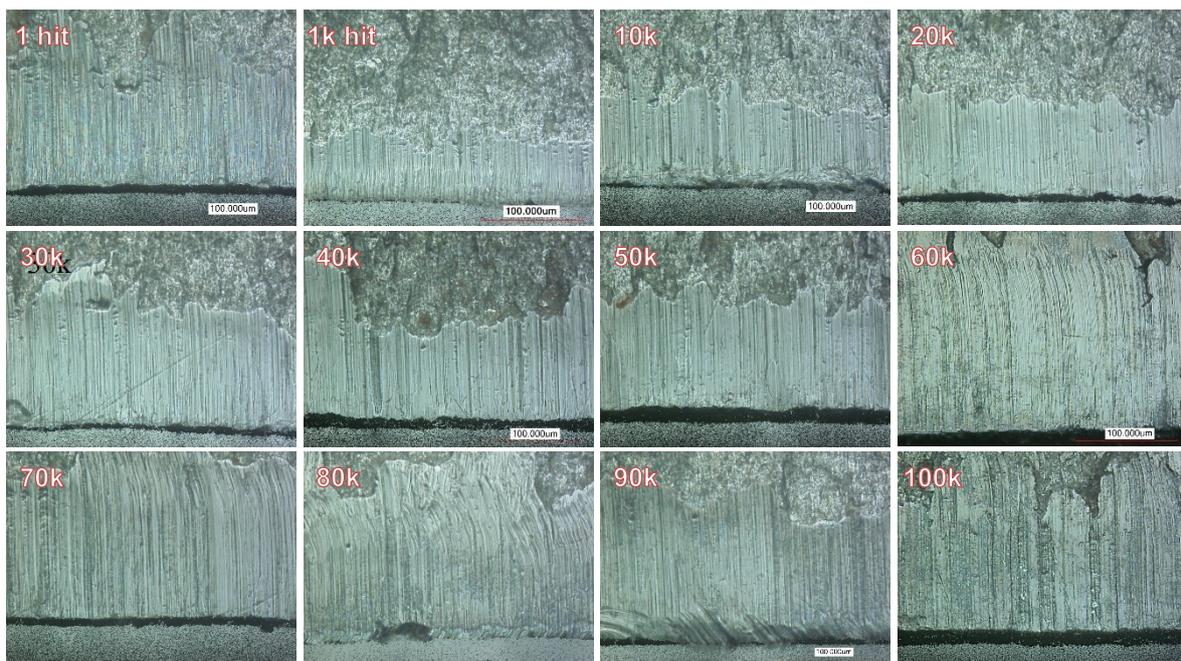
Figure 2. Burnish zones of selected samples from different numbers of hits at 1, 1k, 10k, 20k, 30k, 40k, ..., 100k, form of laser confocal microscope.

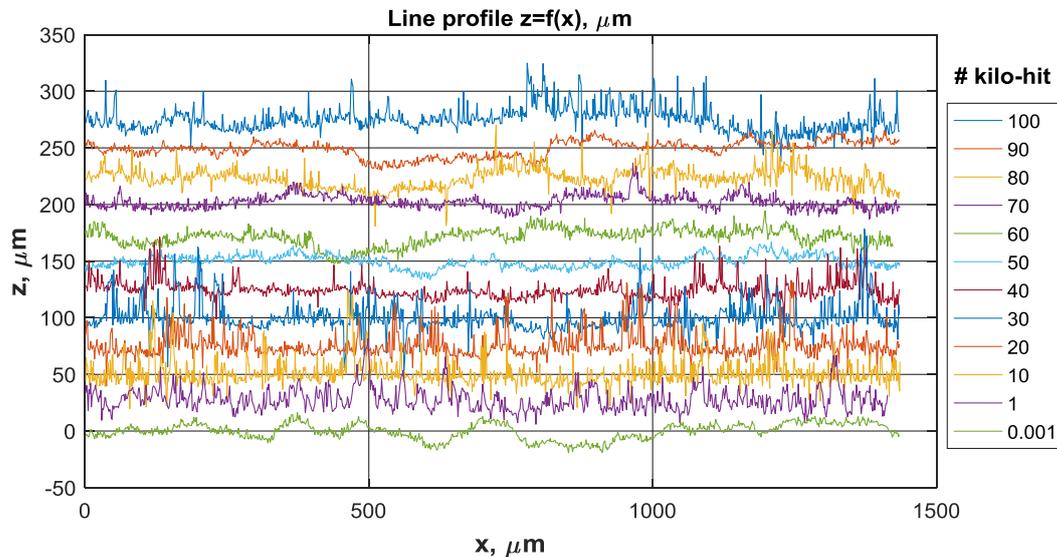
Figure 3. Line profile $z=f(x)$ at section $y=20\mu\text{m}$ of the burnish surface data for different number of hits (in kilo hits), with the mean of z value offset by $25\mu\text{m}$ for each consecutive line in order to see more clearly the profile evolution. The data were measured under identical settings of from laser scanning confocal microscope.

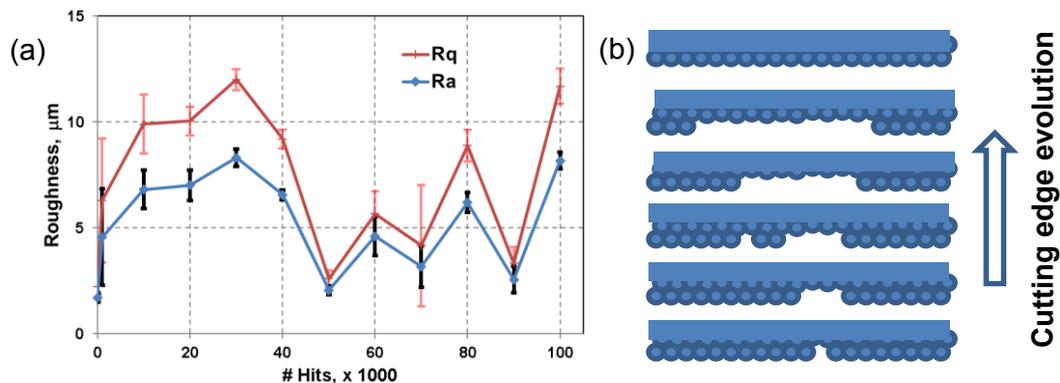
The roughness of the samples measured from three y sections are shown in Figure 4, with the mean of z -values off-set to zero for each measured profile, where R_a is the arithmetic mean and R_q is the squared root mean (and with zero off-set it is the same as standard deviation). The edge initial roughness

Figure 4. (a) R_a and R_q vs. number of hits, with the error bar representing the 1σ deviation from three y -section lines of 1.4mm length on the burnish zone; (b) The schematic demonstration of “self-reconditioning” process with cutting edge in top-view.

is low, then it quickly increases, but after 40k hits it turned out to be smoother over quite high number of hits, and gradually increases till the end of this experiment at 100k hits. More roughness parameters can be generated but all follow the same trend. From Figure 4, there exists a roughening/smoothing cyclic process without artificial die reconditioning. This “self-reconditioning” process is explained as follows, see Figure 4(b). The D2 material has the microstructure of martensite particles surround by continuous primary carbide network. When cutting ultra-high-strength steels (here DP980) the tool damage often takes the form of chipping along the carbide boundaries, resulting in sharp boundaries of missing metals (holes or grooves), which inversely generates peaks on burnish zone profile in Figure 3. These die sharp edges would bear higher contact pressure to support concaved missing metals, so with increased local wearing, that blunt or smooth-out the chipped edge. Statistically there exist two

completing processes of roughening and smoothing at both die and workpiece cutting edges, with roughening dominate in initial stage of die use, and then under cyclic alternation of smoothing and roughening in competition. This finding suggests that the trim die failure or reconditioning criterion needs to be better defined.

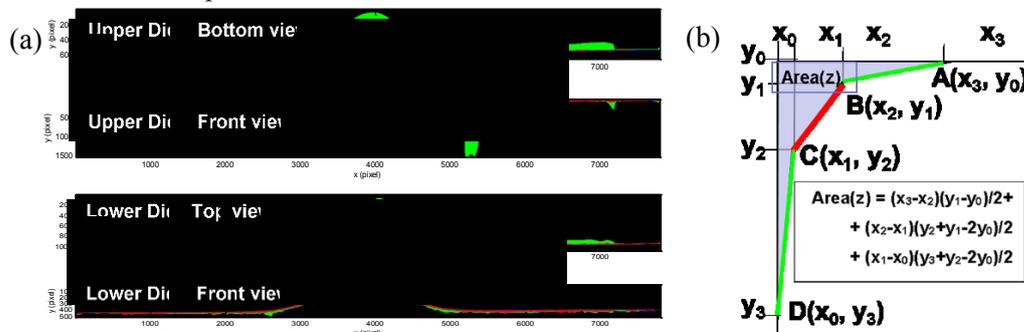
Figure 5. (a) The measured edge zone areas of missing metal for the upper die and lower die cutting edges, with red area to be severely damaged and green area lightly damaged based on the light reflection; (b) the simplified method to calculate cross-sectional area of missing metal at the cutting edge, based on the images of two orthogonal cutting surfaces.

A simplified method is used to estimate the missing metal volume at the trim die cutting edge: see Figure 5(a), on the projected images from top view and front view the edge damage zone was traced and divided into three zones: the central severe-damaged zone and two less-damaged zones on the cross-section of the cutting edge. The curved (generally convective) damage area boundary is simplified by three straight segments, see Figure 5(b). From the image processing the coordinate of the die edge and the coordinates of point A, B, C, D are obtained. The total volume of the missing metals along the cutting line is the integration of the sectioned area over edge line. As the result for the upper and lower dies after 100k hits, the missing metal volumes are 5.399 mm³ and 0.385 mm³, respectively. Surprisingly the upper die damaged so much more than the lower die, probably due to the fact that only the upper die but not lower die was scratched by the stationary sheet metal sheared section that stayed on the top of the lower die. Interestingly, under such a severe wear out of the upper die edge it was still able to produce acceptable sheared edge quality of workpieces, based on the burnish zone roughness evolution results.

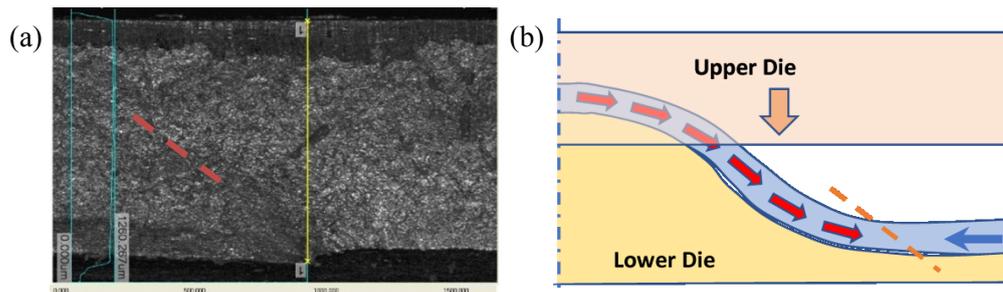
To explore the root cause of the non-uniform distribution of the wearing shown in Figure 5(a), Figure 9 shows a representative sample at the heavily worn area at the end portion of the waved bumper, which has a severely sheared band zone, and at the end of the band a step of burr height with discontinuous edge. Two factors contribute to the severe wearing at the end of the bumper region: In the two sides of the waved bumper the cutting penetration depth or effective cutting thickness increases from the flat cutting thickness t to the side cutting thickness of $t/\cos\phi$, where ϕ is the angle of sheet normal relative

to the vertical direction, with the maximum thickness at 45° to be 44% thicker. The second contributor is that during this down-hill cutting the sheet metal flows from the bumper area to the flat area, compressive width stress will develop due to two reasons: the side metal flow sees the resistance from the constraint of the front/back ends of the sheet metal outside the cutting plane, similar to a plane strain deformation condition. In addition, the friction of the tool also generates resistance of the down-hill metal flow that contributes to the compressive stress. As a result, the superimposed compressive width stress will increase the cutting resistance. This explains the uneven die wear. This oblique shearing process is more general in sheet metal trimming production, and further analysis will be given elsewhere.

Figure 6. (a) The shear band at the end of the waved bumper zone, and a discontinuous burr step appeared at the end of the shear bands, (sample is from 40k hit sample and the cutting is in top-down position); (b) The schematic of compressive in-plane stress development from side metal flow, the inward friction during cutting, and the constraints of width deformation from metals outside the cutting planes (not shown).
