Fracture Failure Analysis on Main Wheel Hole of Escalator Step

Abstract. The escalator steps used in a building fractured during applications. The cause for escalator step fracture has been investigated systemically. The supporting rod main wheel hole of escalator step was studied by means of chemical composition analysis, scanning electron microscope and optical microscope. The results indicate that there are some porosity defects in the support rod of escalator step. The fracture mode of main wheel hole is overload brittle fracture.

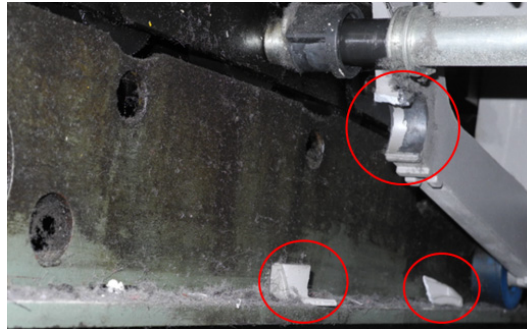
The accident scene of escalator is shown in Fig. 1. It can be seen that the main hole of escalator step fractured. Some parts of the main wheel hole scattered on the fixed frame. The supporting rod with main wheel hole of escalator step is shown in Fig. 2. It can be seen that both supporting rod A and supporting rod B have no obviously plastic deformation.

Figure 1. The accident scene.

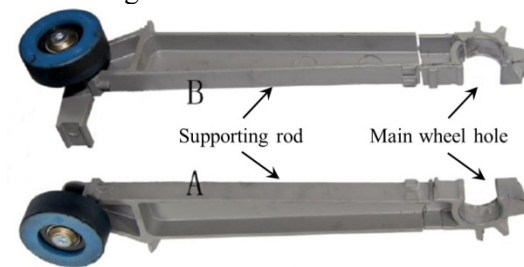
Figure 2. The supporting rod of escalator step.

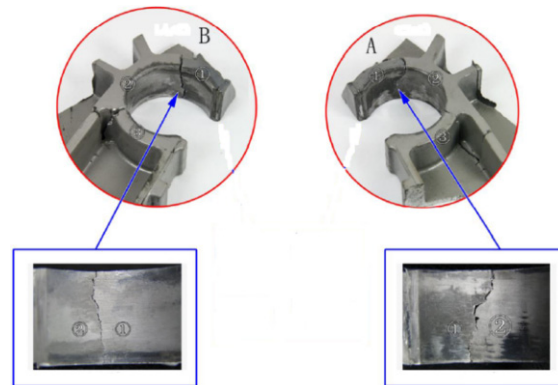
Macro morphology of both main wheel holes of escalator step is shown in Fig. 3. It can be seen that the main wheel holes of supporting rod A and supporting rod B have fractured into three parts. The shape of fracture part of two supporting rod is almost the same. It can be inferred that the two main wheel holes have the same fracture mechanism. The fracture morphology of the two main wheel holes is basically similar. During the occurrence of crack, there is plastic deformation phenomenon. The crack lengths of main wheel hole A and B are 4.9mm and 6.5mm, respectively.

Figure 3. Macro morphology of the main wheel hole.

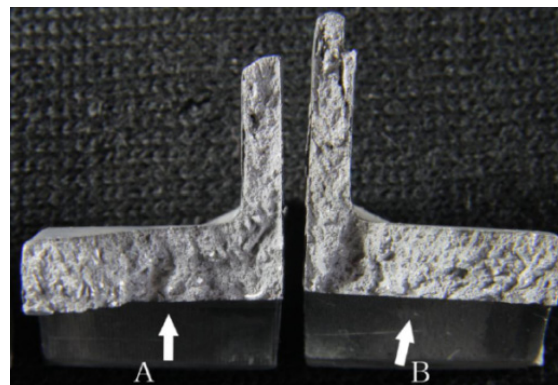
Macroscopic fractography between the part ① and part ② of main wheel hole is shown in Fig. 4. Fracture started from this crack based on the analysis of fracture surface. There is no obvious plastic deformation on the fracture. The fracture surface is silver gray and rough. There are radiation stripes on the fracture surface from the inside to the outside.

Figure 4. Macroscopic fractography of the main wheel hole.

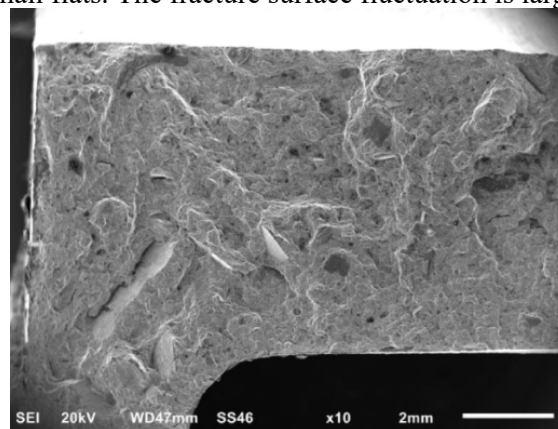
The low multiple SEM image of zone ① in part A is shown in Fig. 5. It can be seen that there are top-down stripes and tearing small flats. The fracture surface fluctuation is large.

Figure 5. Macroscopic fractography of the main wheel hole.

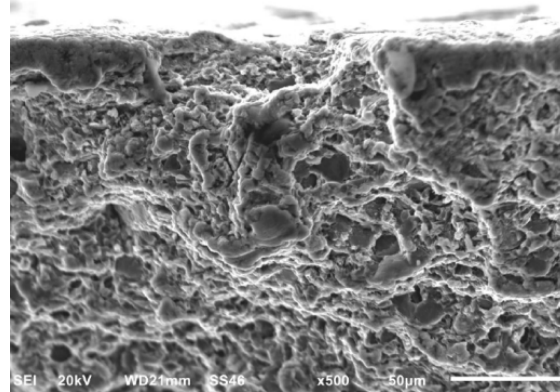
The fracture initiation region SEM image of zone ① in part A is shown in Fig. 6. It can be seen that the fracture surface shows quasi cleavage pattern and there are some scratches on the edge. There is no flat zone related to the fatigue initiation.

Figure 6. Fracture initiation region SEM image of zone ① in part A.

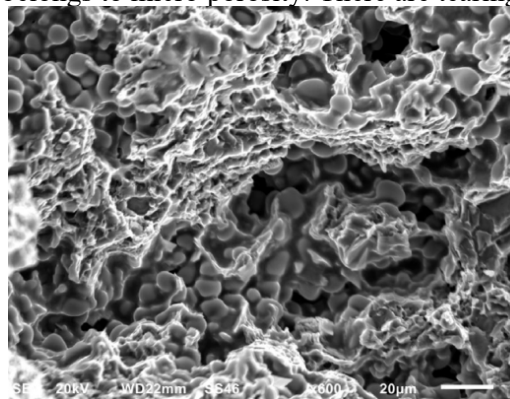
The fracture propagation region SEM image of zone ① in part A is shown in Fig. 7. It can be seen that there are tearing ridge and small pit defects on the quasi cleavage pattern. Based on further analysis, the small pit defect belongs to micro porosity. There are tearing secondary crack in local area.

Figure 7. Fracture propagation region SEM image of zone ① in part A.

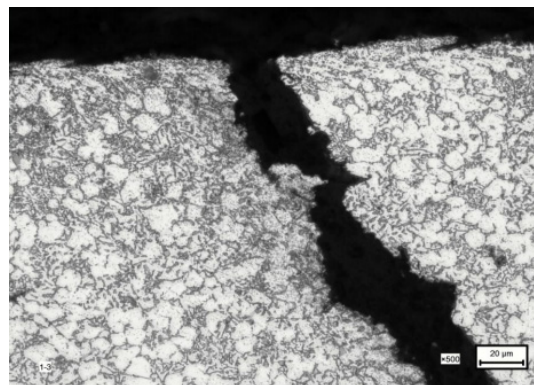
The optical microstructure of the crack region is shown in Fig. 8. It can be seen that the crack width is not alike, which is related to the original porosity defect. The matrixes are $\alpha(\text{Al})$ phase and eutectic silicon phase.

Figure 8. Optical microstructure of the crack region.

The supporting rods of escalator step have some porosity defects, which can reduce the strength of main wheel hole and influence the path of fracture process. The fracture mode of escalator step investigated in this study is overload brittle fracture.

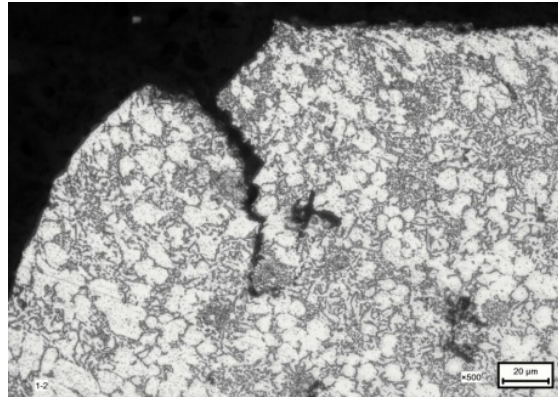
The distribution morphology of crack close to the edge is shown in Fig. 9. It can be seen that the crack length is about 0.08mm. The crack opening is relatively bigger, which indicates that it is related to tensile fracture.

Figure 9. Crack distribution morphology.
