Failure Analysis of Escalator Step

Facai Ren¹, Yu Song¹ and Xiao Liang¹

¹Shanghai Institute of Special Equipment Inspection and Technical Research,
Shanghai 200062, China

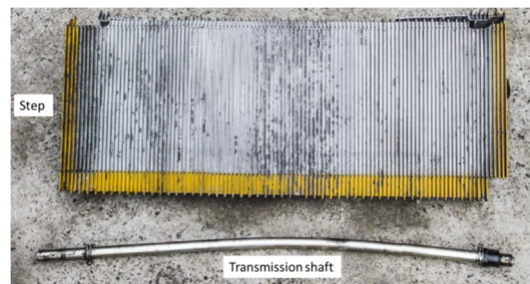
The failure escalator step is shown in Fig. 1. The length and width of the escalator step are 1000mm and 400mm, respectively. It can be seen that the support draft holes and part of the step have been fractured. The transmission shaft, which is assembled to the support draft hole of escalator step, has serious plastic deformation.

Figure 1. Step and transmission shaft.

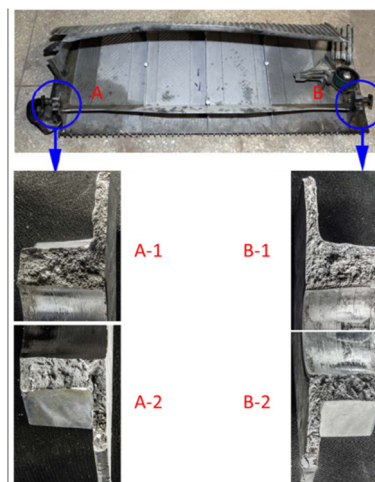
Macroscopic fractography of the escalator step is shown in Fig. 2. It can be seen that the step supports of both sides have fractured. Judged from the step deformation situation, the fracture of support close to the auxiliary wheel was caused by squeeze. The fractures of both sides are almost the same. It can be seen there is a herringbone pattern in the upper side of the fracture. There are lots of pit defects on the fracture surface of both sides. Referring to the drive direction of axis hole and transmission shaft, the bottom side fractured due to the squeeze with transmission shaft and the upper side fractured due to the squeeze with step.

Figure 2. Macroscopic fractography of the escalator step support.

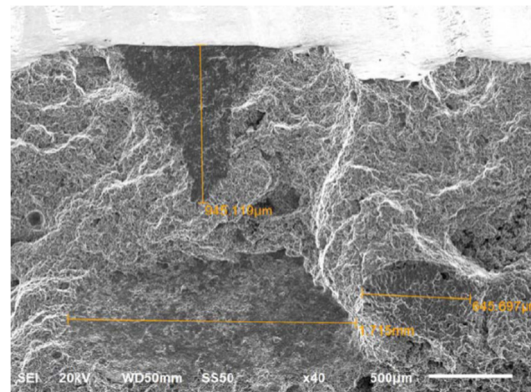
The fractography of the fracture initiation region under low magnification is shown in Fig. 3. It can be seen that the fracture surface is relatively rough. Some deeper pits distributed in local region. After further observation, some flat regions with different size were found in the fracture initiation region. The largest length is about 1.7mm. The flat regions belong to cold lap defect.

Figure 3. Fractography of the fracture initiation region.

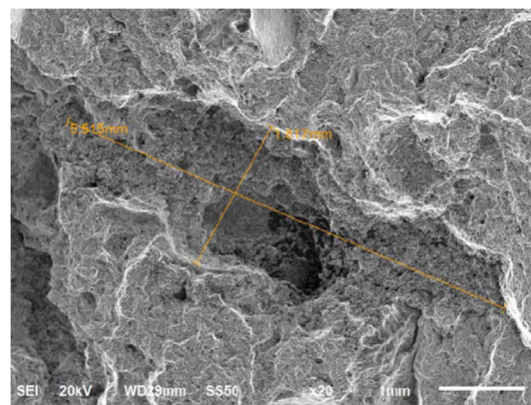
The fractography of the fracture propagation region under low magnification is shown in Fig. 4. It can be seen that more porosity defects distributed in this region. The length and width of the largest porosity defect are about 5.5mm and 1.8mm, respectively. The fractography of the porosity defect under high magnification is shown in Fig. 5. The surface shows the free surface character.

Figure 4. Fractography of the fracture propagation region.

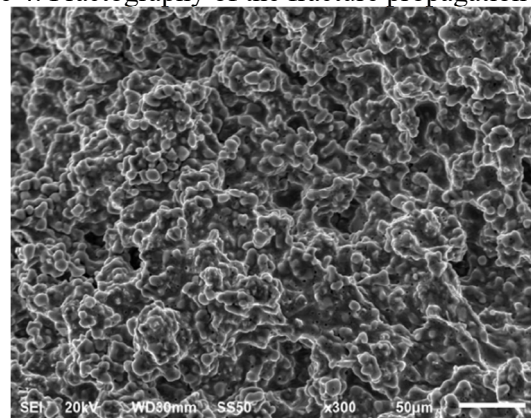
Figure 5. Fractography of the porosity defect.

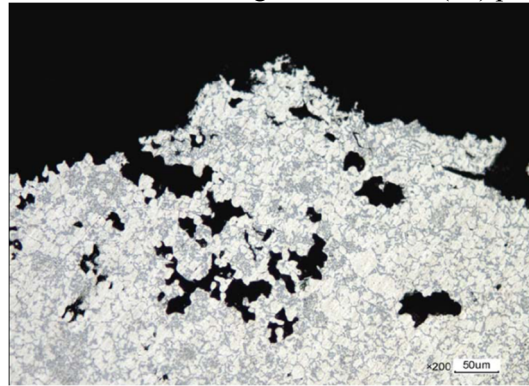
The optical microstructure of the fracture surface region is shown in Fig. 6. It can be seen that there is no obvious plastic deformation and the surface is not very smooth. There are lots of porosity defects distributed in the fracture region. The matrixes are α (Al) phase and eutectic silicon phase. The optical

Figure 6. Macroscopic fractography of the escalator step and comb plate.

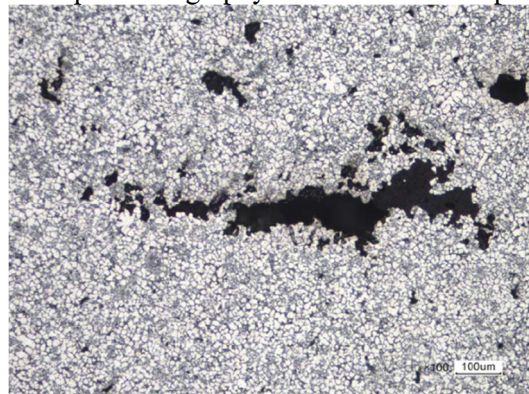
microstructure of the region away from fracture is shown in Fig. 7. There are also some porosity defects with different size. The matrixes of this region are also α (Al) phase and eutectic silicon phase.

Figure 7. Macroscopic fractography of the escalator step and comb plate.
