# Failure analysis of S50C carbon steel applied for fine boring transmission system

L Anggraini<sup>1</sup>

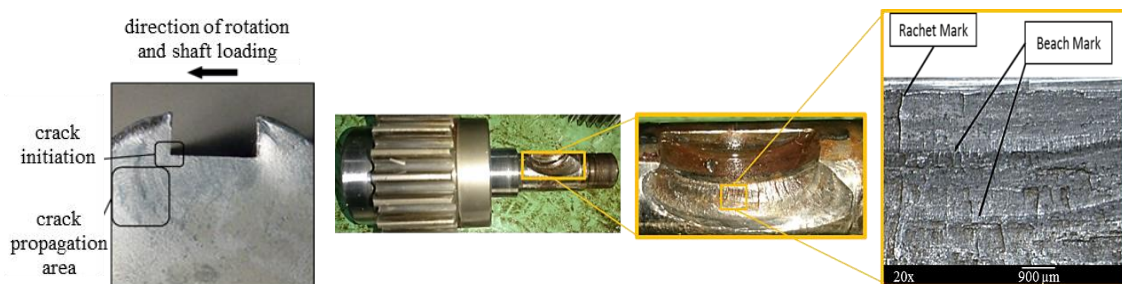
**Figure 2.** Direction of shaft loading.

In the stake home area, the shaft was flowed with a certain depth so that the shaft part which holds the load from the initial spin that occur less than half the diameter of the shaft. Then the next step was to observe on the part of the shaft that has broken failure to analyze the initial part of the crack that causes the fracture, the pattern of the fracture propagation and the final area of the fault. In Figure 2, some formation that occurs due to fracture can be seen, that is: Sign machine on the post groove, cracking origin, fatigue propagation zone, plastic deformation in the zone of final fracture, and longitudinal sign. An observation by using scanning electron microscope was done on the surface fracture pattern from the beginning of crack initiation, propagation from crack and final rupture to surface of the broken shaft can be seen. The observations were performed with an enlargement of less than 20× in order to obtain an overall breaking surface. The beginning of the crack was affected in the machining process signals. In asddition, the longitudinal marks on the post-plot that exist prior to the occurrence of the fracture were caused by the events occurring when the peg was inserted into the stake groove, thus leaving small scratches on the stake. In addition, there was also a ratchet mark and beach mark that showed high stress at the angle of the stake groove.

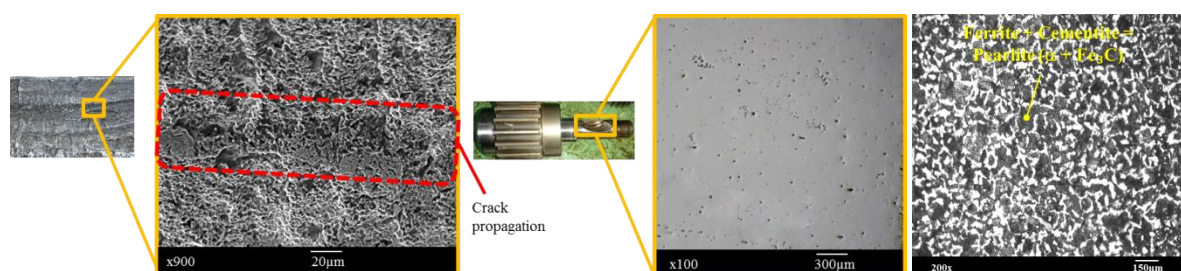
**Figure 3.** Direction of shaft loading and its microstructure.

The microstructure testing evaluated conformity with the material standard JIS G 4051 S50C also the initial formation process of the material whether the material gets heat treatment during the manufacturing process can be also be known. This test was conducted to obtain an overview of the material structure using etchants of 5 g  $\text{CuCl}_2$ , 40 ml  $\text{HCl}$ , 30 ml ethanol, and 30 ml of aquadest. Examination of samples on microstructure observation is found in three parts of the specimens which can be in broken transmission porous material with  $200\times$  phase enlargement of the material in the form of pearlite which is a combination of two ferrite ( $\alpha$ ) and cementite ( $\text{Fe}_3\text{C}$ ) phases. The pearlite phase was formed by the heating process of the material followed by slow cooling to the room temperature.

From the microstructure evaluation, the formation of pearlite structure shown, consisting of two phases consists of ferrite ( $\alpha$ ) and cementite ( $\text{Fe}_3\text{C}$ ), was obtained. This explains the fact that the occurrence of heat treatment at the stage of material formation by heating and then gradually cooling at room temperature so that carbon bonds form pearlite structure. In the test results of the chemical composition of the transmission, shaft material meets the standards of the JIS G 4051 S50C material. With the resultant chemical composition of the three tests being within the limits of the percentage composition tolerance standard are C (0.47 – 0.53), Si (0.15 – 0.35), Mn (0.6 – 0.9), P (0.03 max), S (0.035 max) and Cr (0.2 max). All material compositions fall within the standard range of JIS G 4051 S50C material.

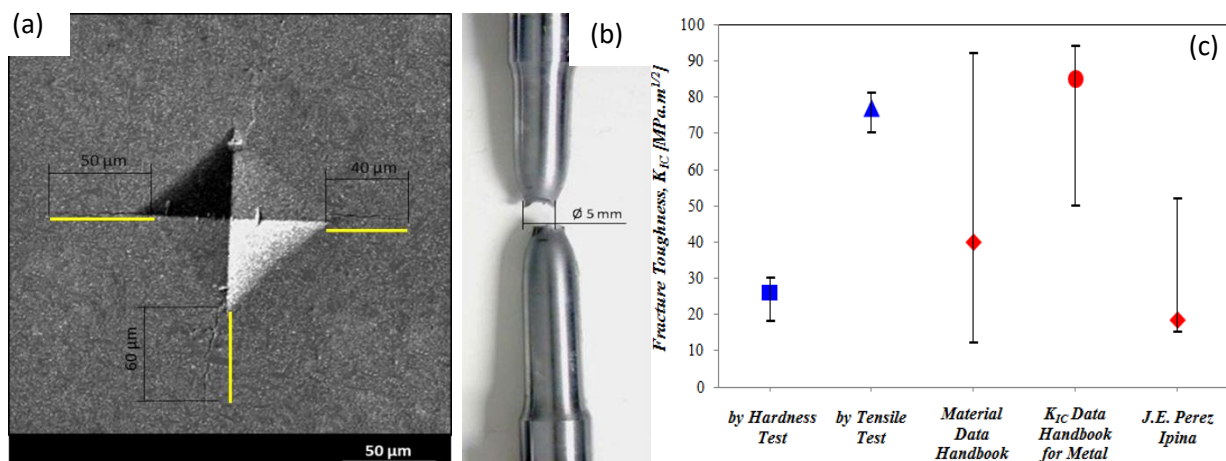
**Figure 4.** Crack length obtained by (a) hardness indentation and (b) tensile test (c) graph of fracture toughness obtained from calculation compared by some references [14–20].

The average of fracture toughness obtained by hardness and tensile crack are 26 and 77  $\text{MPa}\cdot\text{m}^{1/2}$ , respectively, as shown in Figure 4. The error bars indicate the minimum and maximum for both  $K_{Ic}$  obtained by hardness and tensile test, which are 18 – 30  $\text{MPa}\cdot\text{m}^{1/2}$  and 70 – 81  $\text{MPa}\cdot\text{m}^{1/2}$ , respectively. The differences of fracture toughness obtained by hardness and tensile test are considerable because of the crack length. Based on the macrostructure, it was found that the failure that occurred was a fatigue
