# Sustainable structural rehabilitation and strengthening of the “Ponte delle Grazie” bridge in Faenza, Italy

**M Micheloni<sup>1</sup>, M La Monica<sup>1</sup>, D Parmeggiani<sup>2</sup>, P Barchi<sup>2</sup>**

**Abstract.** The “Ponte delle Grazie” is a three span bridge, with a total length of 72 meters, built between 1948 and 1952 in Faenza, Italy. The reinforced concrete main beams of the deck have undergone a strong deterioration over the years. In detail atmospheric agents and chemical aggressions caused a strong deterioration of the concrete, up to the point of making the structure not accessible and at risk of collapse. In fact, the five main beams were heavily damaged, as well as the concrete bearings were strongly compromised. So, an urgent intervention was necessary to save the structure of this historic bridge. A delicate restoration has allowed to remove the deteriorated concrete and to restore the resistant sections with new materials compatible with the old remaining structures. In particular, a specific rehabilitation procedure was studied using fiber-reinforced cement mortar with low elastic modulus, that is shrinkage compensated, in combination with composite m

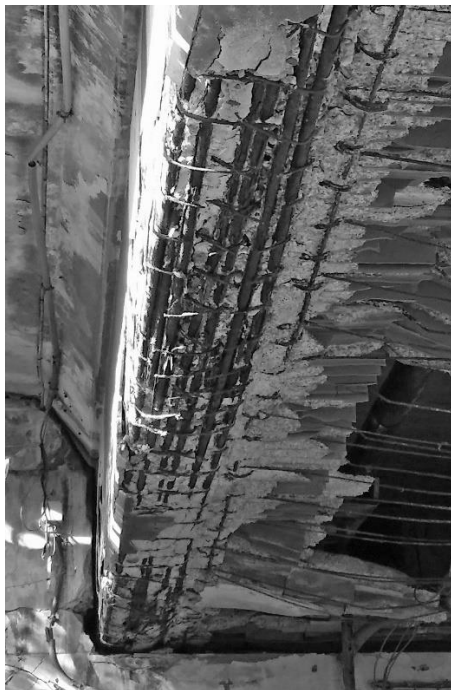
**Figure 5.** Beams deterioration on the side span

The dangerous state of the main beams in the area near to the abutments was evident. In fact not only the concrete is strongly damaged, but also the steel bars are deeply corroded and the stirrups are exploded.

The main beams of the side spans are repaired with a deep cleaning and restoration of concrete and reinforced with a wrapping of carbon fiber textiles. The bearing strengthening in this way is verified considering the loading scheme n. 3 described in the previous section 5.

- Deep cleaning of concrete surfaces with high pressure hydro-scarification (2000 bar)
- Reconstruction of the concrete section with a two-component thixotropic, fiber-reinforced cement mortar with low elastic modulus that is shrinkage compensated.
- Wrapping with carbon fiber textiles.

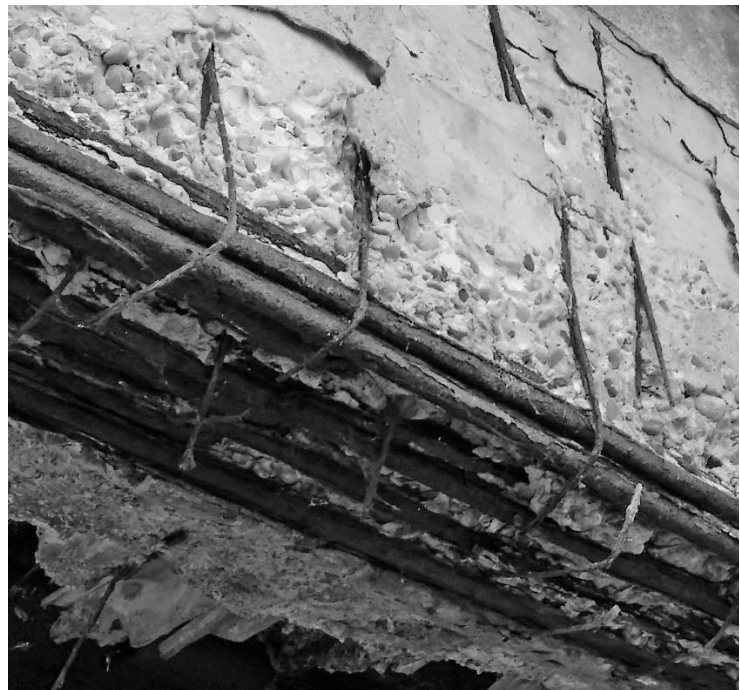
**Figure 6.** Beams deterioration on the side span

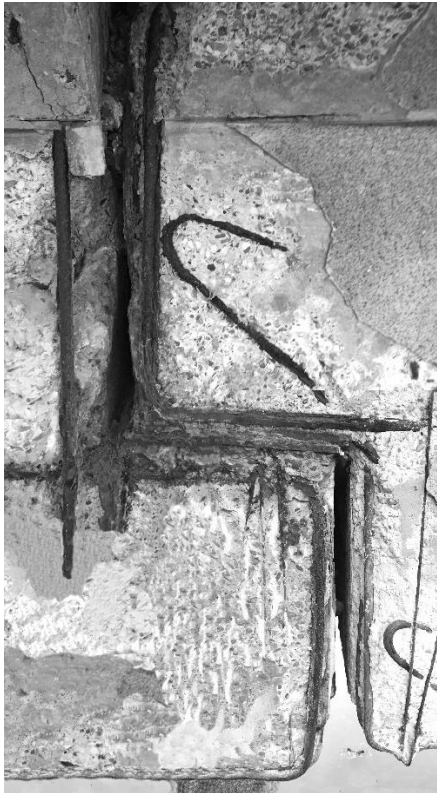
A disadvantage inherent in “Gerber bridge” type of construction is that there are problems associated with leakage through the half joint. This enables moisture to accumulate at the beam seats thereby increasing the propensity for the deterioration of the concrete and reinforcement steel.

Furthermore, together with water leakage and moisture, there is also an accumulation of chlorides, dangerous for concrete and steel bars.

The situation is adversely compounded by limited access to the bearing seat joint, which leads to both inspection and maintenance issues.

**Figure 7.** Gerber half joint at actual state

For these reasons a protective metal structure, that comes into operation only in case of collapse of the half joint and prevents the collapse of the bridge central span, was considered.

The steel structure works with a strut and tie scheme, where an upper strut is placed under asphalt and a tie rod tilted through the existing structure up to the lower face of the beam. This steel structure does not modify the working scheme of half joint, but it sustains the central span in case of half joint collapse.

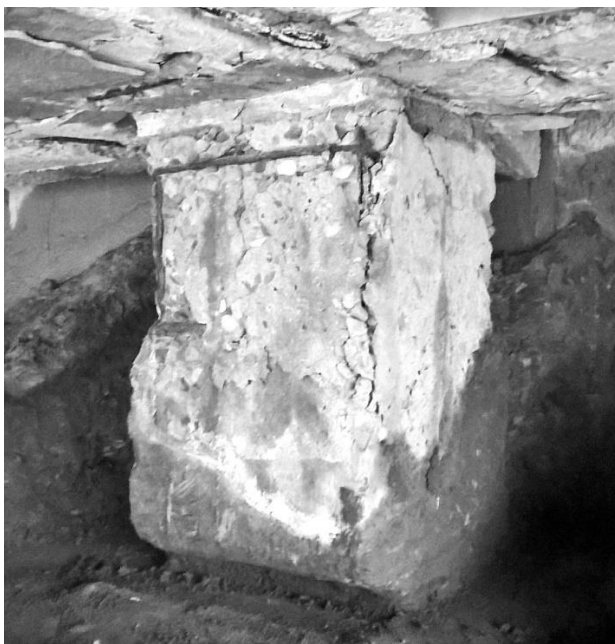
**Figure 9.** Deterioration and cracks on the concrete pendulum bearing

In detail this concrete bearings exhibit a strong degradation phenomena, with evident breaking lesions in place, as evidenced by the following images.

The dangerous state of the supports is evident and it has become necessary to take urgent action.

The reinforced concrete pendulum bearings are repaired with a soft cleaning and restoration of concrete and reinforced with a wrapping of carbon fiber textiles. In this way the bearing strengthening is verified considering the loading scheme n. 1 described in the previous paragraph 5. However, it is important to consider the particularity and delicacy of this kind of bearing. So there is no guarantee that the actual situation can get worse without the possibility of intervention.

For these reasons some steel columns are put in place as a structure of defense, that comes into operation only in case of collapse of the concrete bearings.

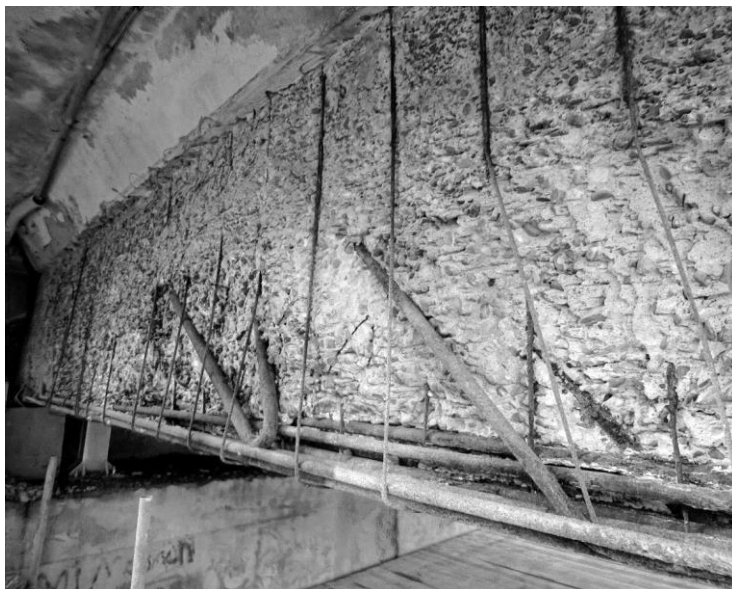
In the areas where the cognitive tests on the concrete had given the lowest results, a large quantity of deteriorated concrete was removed. In these points the 40cm wide beam has been reduced to only 18cm.

**Figure 11.** The main beams after the cleaning with hydro-scarification.

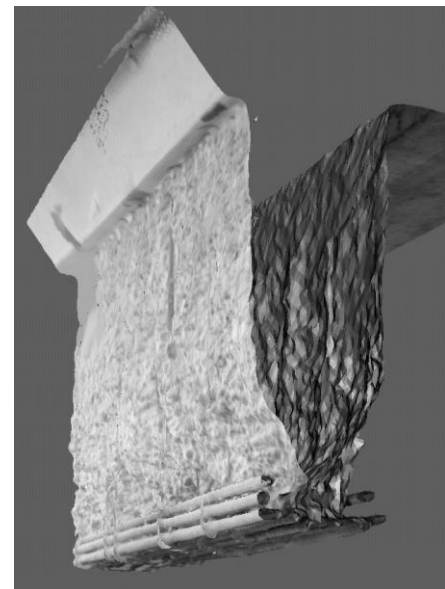
**Figure 12.** 3D laser scanner of the main beams after hydro-scarification
