Analysis on Reason of Generator Set Complete Power Outage of a Hydropower Plant

Yue Yang, Zhan Shu, Yan Zhang, Xin Xie, Bei Cao, Simeng Chang

State Grid Jiangxi Electric Power Co, Ltd. Electric Power Research Institute;
Nanchang 330096, China

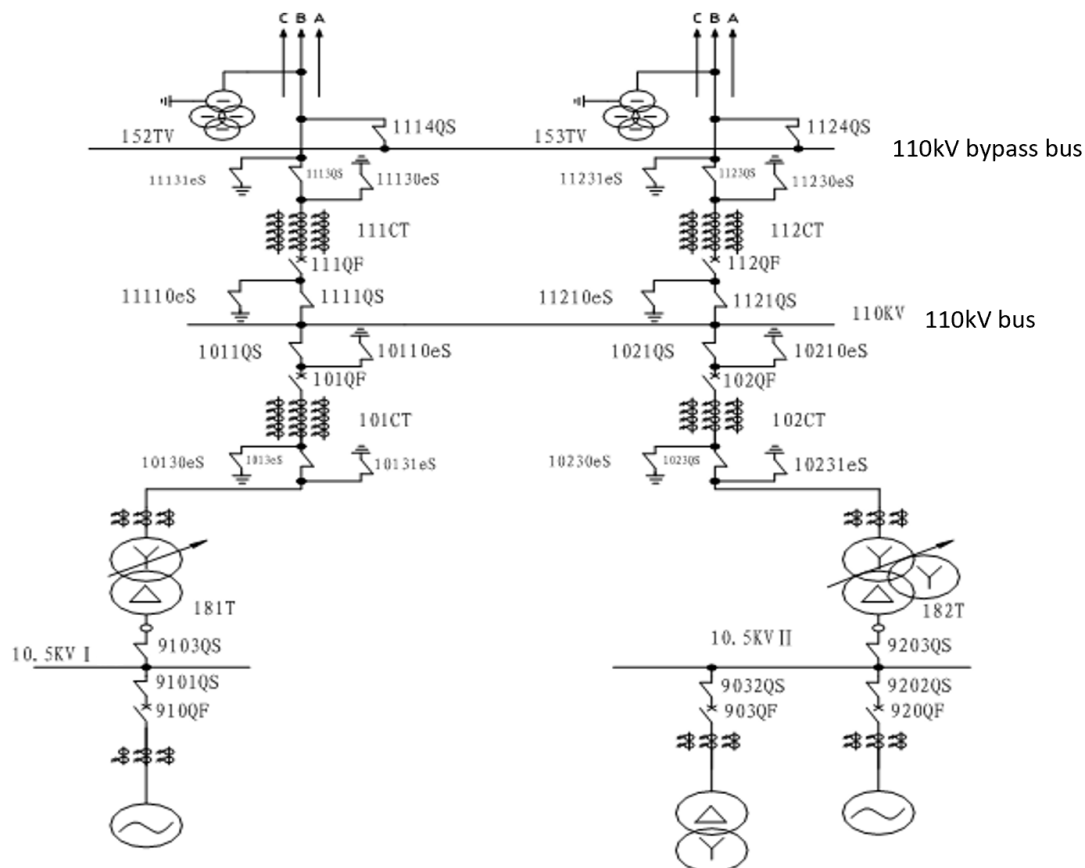
Fig. 1 Main connection diagram of the power plant

NO.1 main transformer and 110kV line 1 connects to 110kV busbar; 110kV bypass bus and 110kV line 2 work as cold spares. The main connection of the power plant is shown in Figure 1.

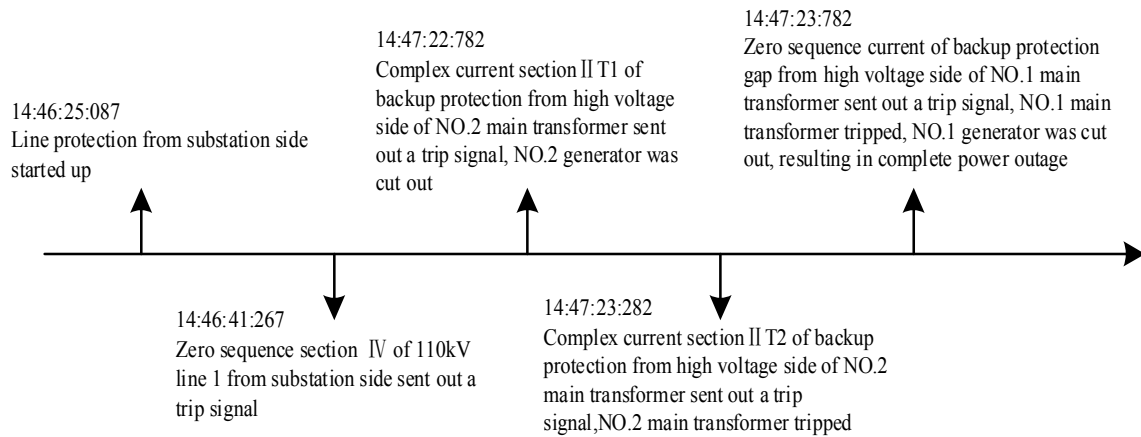
Fig. 2 Time sequence diagram of the fault

As the time setting of protection devices GPS from both sides was inaccurate and duration of this fault was long, it is difficult to analyze the whole development of the fault directly through protection actions messages and fault wave-record charts. The action time and starting time of all the protections and fault wave recorders must be converted to a unified time coordinate point on the standard of starting time of protection of 110kV line 1 from the substation side. The following time points have been converted from which we could deduce the time sequence diagram of the fault (as shown in Figure 2).

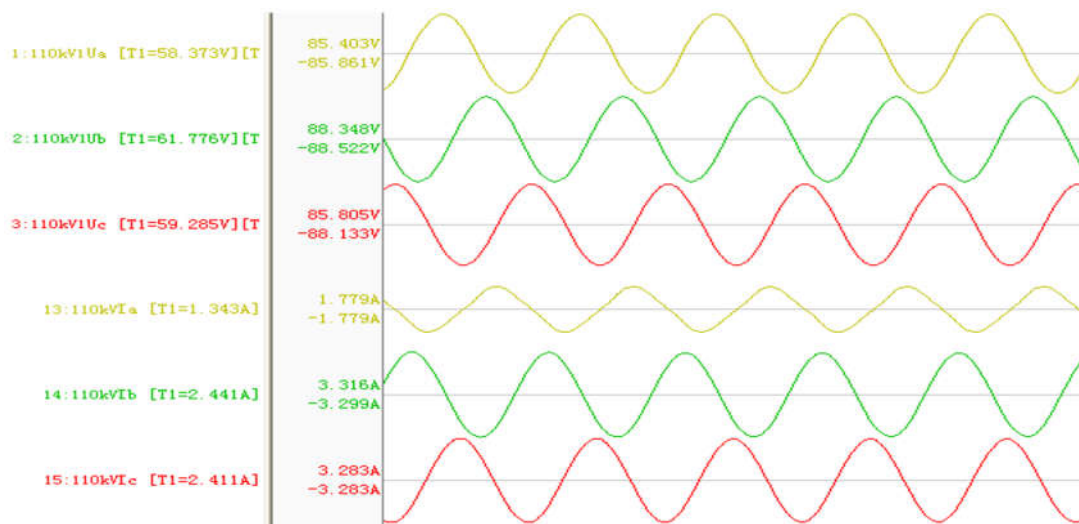
Fig. 3 Fault wave-record chart from the substation side

Actions messages of the protection of line 1 from the substation side said that there was a fault at phase A of the line, the protection from the power plant side started up and did not send a trip signal. As for normal single-phase grounding fault, voltage decreasing and current increasing are the fault characteristics of current and voltage waveforms. However, through the analysis on the current and voltage waveforms from the both sides of the line fault, fault waveforms from the substation side in Figure 3, current from phase A of the line was less than that from phase B and phase C, the bus voltage almost kept invariant; in Figure 4, fault waveforms from the power plant side, current from phase A of the line was larger than that from phase B and phase C, the bus voltage was also almost invariant.

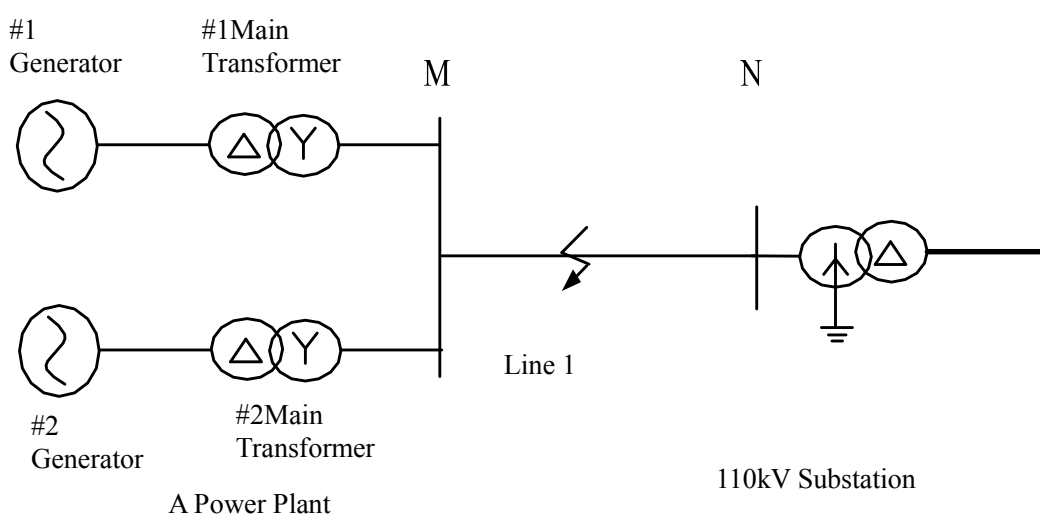
Fig. 5 Main wiring diagram

The main wiring between the power plant and substation is shown in Figure 5. As for the complex current section II of NO.2 main transformer, this fault was an external fault, so the action of complex current section II was a misoperation.

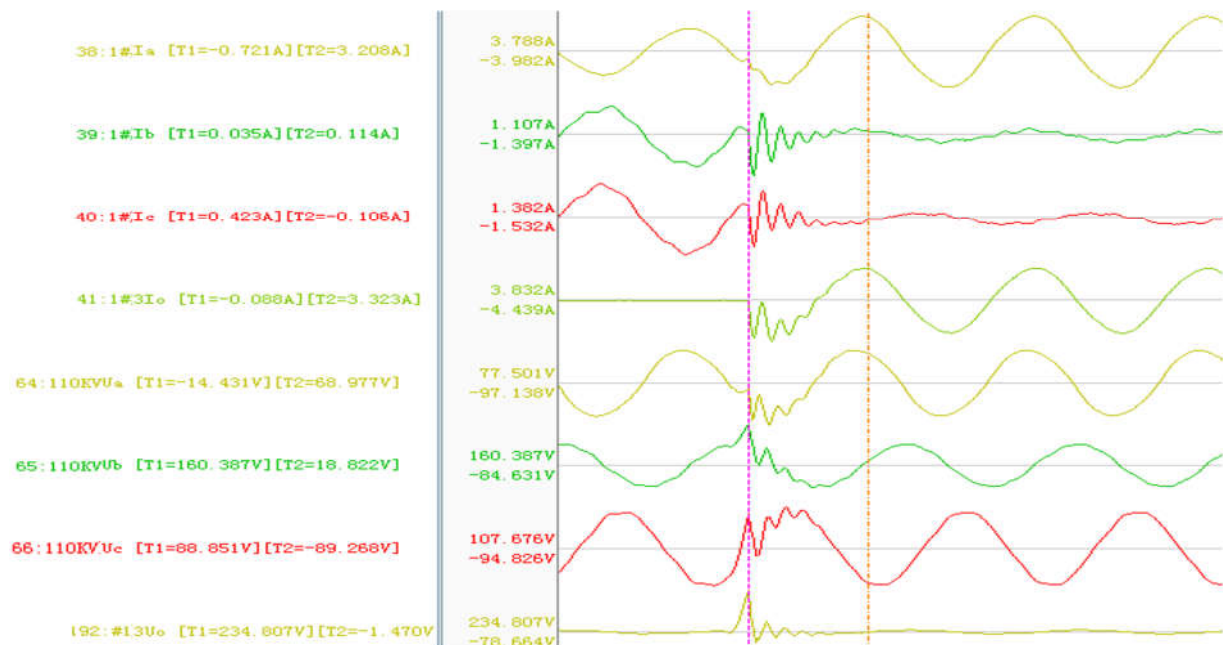
Fig. 6 Current and voltage waveforms of the high voltage side before NO.1 main transformer sent out the trip signal

When NO.2 main transformer tripped, NO.1 main transformer turned to have gap protection. The gap voltages are shown in Figure 6, the maximum instantaneous voltage was 234V, the gap was broken down. The zero sequence current RMS passing through the gap was 3.32A, larger than setting value 2.5 A. After 0.5s, gap zero sequence current protection started up, NO.1 main transformer tripped, NO.1 generator was cut out, the protection actions were correct.

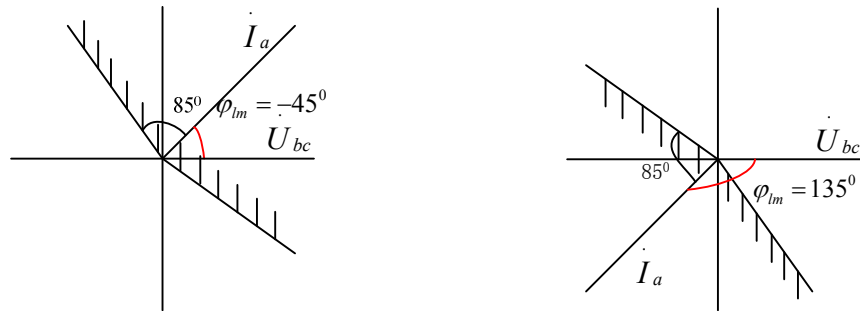
Fig. 7 Operation characteristics of interphase directional components

High resistance grounding fault happened on phase A of line 1. Misoperation happened outside of complex voltage overcurrent section II of NO.2 main transformer backup protection from high voltage side, which could be related with the power directional components of complex voltage overcurrent section II. According to the principle of complex voltage locking overcurrent protection of CSC-326GH protection device [4], operation characteristics of interphase directional components in Figure 7 and Figure 8 were based on the conditions that the primary positive polarity end of main transformer CT was on the busbar side, the direction of directional components could be ordered to point to the busbar or transformers by control words.

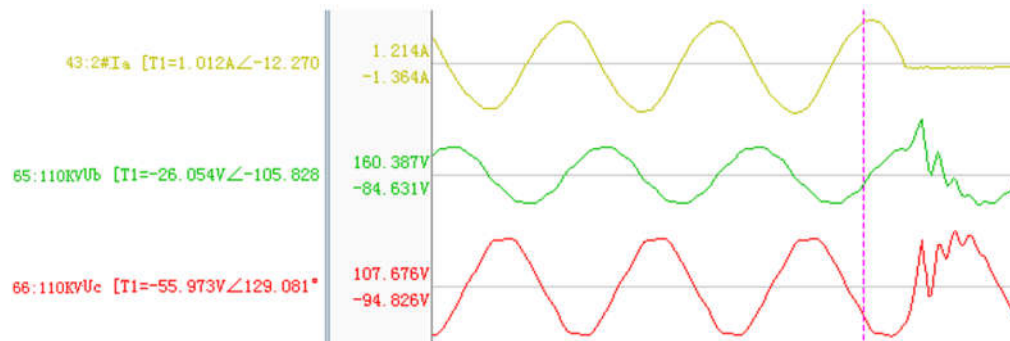
Fig. 8 Current and voltage waveforms of the high voltage side before NO.2 main transformer sent out the trip signal

Through the onsite verification and on-load tests of NO.2 main transformer backup protection from high voltage side, it was proved that the primary positive polarity end of NO.2 main transformer CT from the power plant side was on the high voltage side of the main transformer, which was contrary to the standard that primary positive polarity end of TA was on the busbar side as backup protection from high voltage side requested. Since the direction of fixed complex current section II pointed to the main transformer, the operation characteristics of directional components were the same as the specification said. According to the current and voltage waveforms, we could calculate the vector of power directional component of phase A as shown in Figure 9, which was consistent with the operation characteristics in the principle.

The fixed value of current of complex current section II of NO.2 main transformer backup protection from high voltage side was 0.2A, the fixed voltage of negative sequence was 8V. When the

fault happened, the fault current RMS was 0.75A. When the negative sequence voltage of busbar was larger than 8V (the negative sequence voltage was 10.234V when the complex current section II sent out the trip signal), the complex current section II sent out the trip signal, which was a misoperation caused by setting.

Suggestions upon the rectification of the power plant: 1) If the outdoor space allows, add a set of CT and protection devices on the branch side of the neighborhood transformer as the protection configuration of the neighborhood transformer. 2) Add a protection device for the neighborhood transformer as its protection, sharing the original protection winding of the neighborhood transformer.
