Discharge Analysis of 1100kV GIS Equipment in Lightning Impulse and Power Frequency Withstand Voltage

State Grid Heilongjiang Electric Power Co., Ltd. Electric Power Research Institute, Heilongjiang Province, China

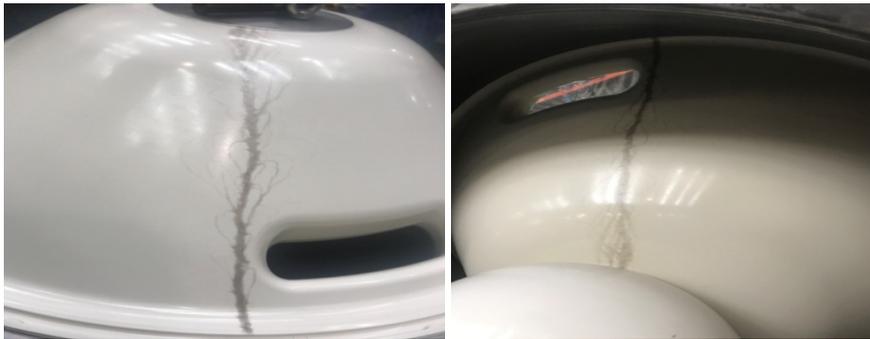
Figure 2. Basin insulator discharge trace

When the power frequency voltage rose to 1066 kV, a discharge phenomenon of basin insulator was occurred. After disintegration on site, it was found that one of the insulating basins had discharge marks and burrs on the surface (**Figure.2**). According to the disintegration inspection, the reason for this discharge is that the burr is not cleaned after the bump at the R angle of the tooling cylinder during the assembly of the test piece, which causes the electric field distortion result in the surface of the basin to climb.

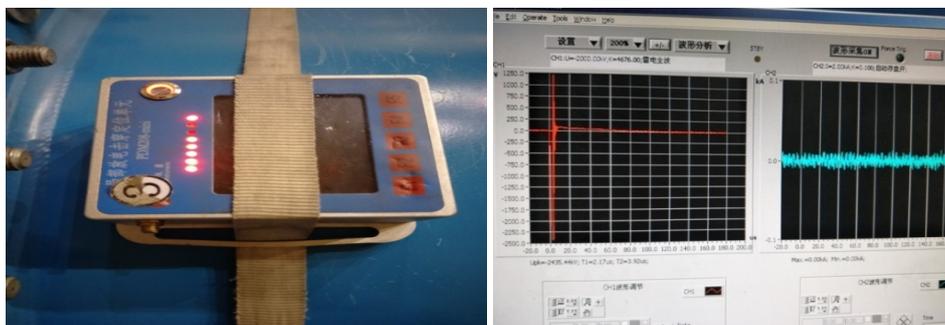
Fig.3 Discharge indicator and cutoff diagram

When the isolation switch form and the circuit breaker shape are subjected to the lightning impulse test in the closed state, the first negative polarity is cut at 2435 kV. The discharge indicator of the circuit breaker form interface is fully illuminated, and the indicator switch interface indicator of the test is not illuminated (**Figure.3**). Then disassemble the device to find the reason. First, the circuit breaker is detached from the fixture and check the interface. No discharge point is found. The inside of the circuit breaker was then inspected and no discharge point was found. Finally, the discharge trace was found in the ES moving contact and the static side shield inside the tool housing (**Figure.4**). Through inspection and analysis, it is concluded that the discharge position is located in the disassemble fixture, and the air chamber is mainly composed of a three-way spherical shell and a grounding switch. After analyzing the discharge position and the appearance of the discharge trace, it is judged that the discharge is caused by foreign matter. Because of the tooling chamber is used for a long time, the pressure reduction and inflation operations are required for each use, and the effective maintenance is not performed during use. In the charge and discharge operation, foreign matter may be blown onto the ES static side shield, resulting in a lightning impulse test cutoff.

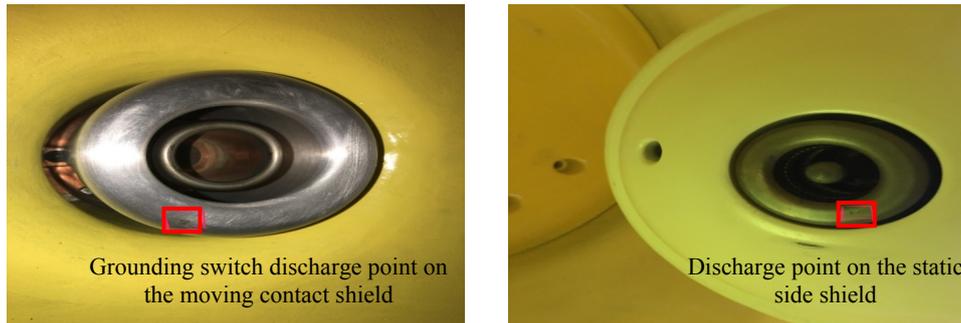
Fig.4 ES moving contacts inside the tool housing and static side shields found discharge marks

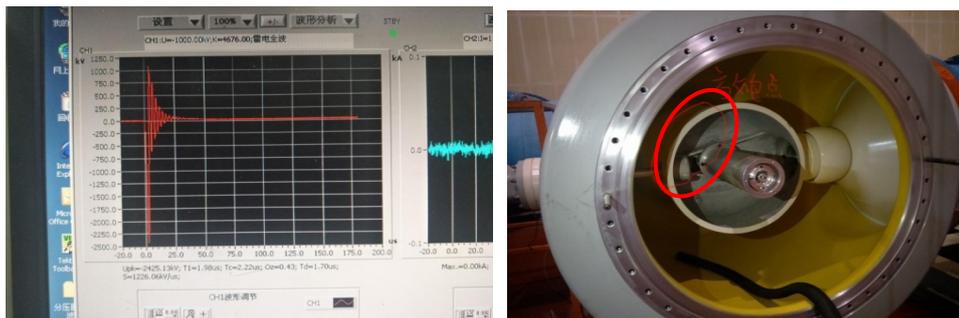
The lightning impulse withstand voltage test was performed on the composite bushing and the discharge was occurred at the first negative polarity pressurization test (the peak value of the cutoff was 2425 kV), and the discharge indicator light was all bright. After disintegration, it was found that there was obvious discharge trace on the shield inside the casing interface tooling isolating switch (**Figure.5**). Through inspection, a trace of discharge was found in the tooling disconnecter. After inspection and analysis, it is judged that the lightning impulse cut-off is caused by the foreign object at the moving side shield and the support connection of the isolating switch.

Fig.5 Lightning shock chopping pattern and equipment discharge point

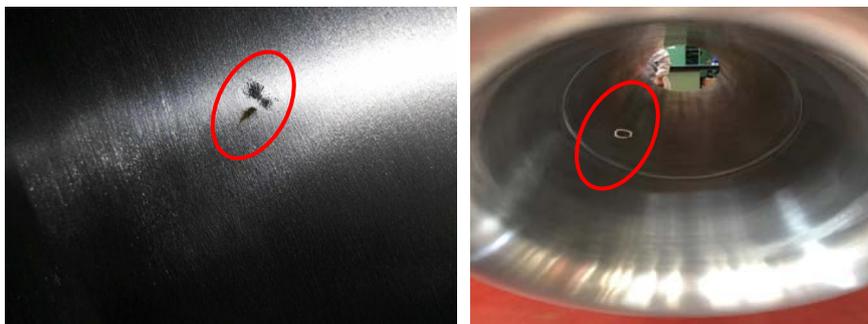
The lightning impulse withstand voltage test was performed on the bushing and the discharge occurred again at the first negative polarity pressurization test (the peak value of the cutoff was 2,504 kV). After disintegration, it was found that there was a significant discharge trace on the inner shield surface of the sleeve center conductor (**Figure.6**).

Fig.6 Shielding center conductor inner shield discharge photo

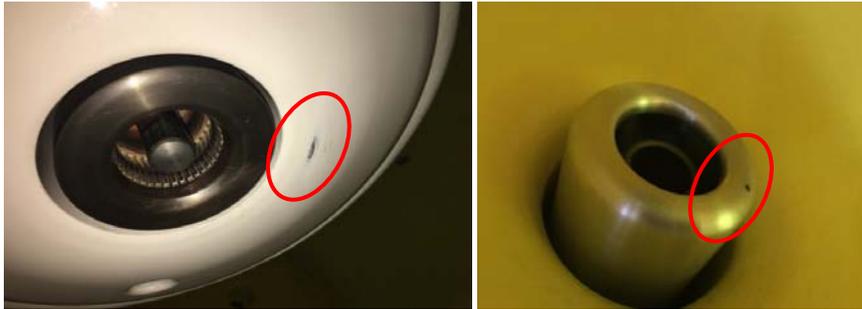
In the closing state of the lightning impulse test on the circuit breaker, the discharge occurs at the first test of the negative polarity (the peak value of the cutoff is -2435 kV), and the discharge positioning indicator placed at the interface of the circuit breaker is fully illuminated. After disintegration, it was found that the grounding switch moving contact shield at the end of the circuit breaker discharges the conductor shield, and the conclusion is that the tool discharges.

Fig.7 Grounding switch moving contact shield discharges the conductor shield
