Proceedings of PVP:
PVP 2001
22-26 July 2001

Digital Radiography of a Drop Tested 9975 Radioactive Materials Packaging

Glenn Abramczyk
Westinghouse Savannah River Co.
Aiken, South Carolina, 29808
(803) 725-8701, glenn.abramczyk@srs.gov

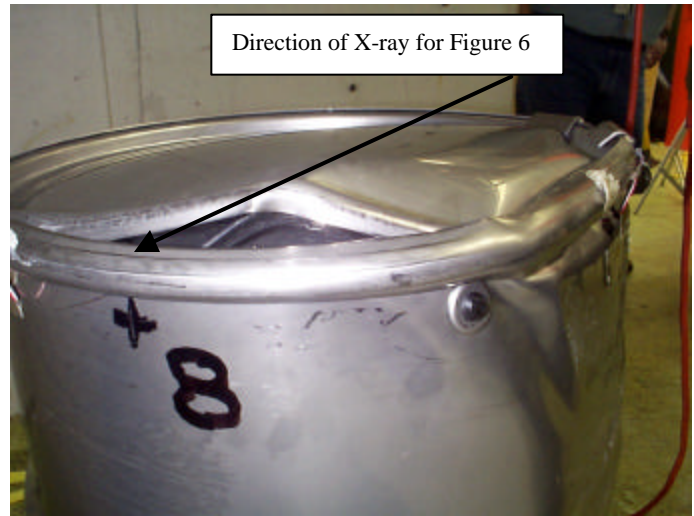
Figure 3. 9975 Package Drop Damage

The 9975 package design as depicted in Figure 1 was dropped from a NCT drop height of 4-feet followed by the HAC 30-foot drop and 40-inch puncture pin drop, Reference 2. The purpose of the preconditioning NCT drop was to maximize weakening of the closure system so that the effects of the subsequent HAC drops would be maximized. In each drop the axis of the package was oriented 17.5° from horizontal. The shallow drop angle and impact positions were selected to maximize damage to the drum closure. The test sequence, the dual 17.5° drops, resulted in a partial separation of the lid from the drum rim, as shown in Figure 3. The puncture drop did not appreciably increase drum damage, rather the opening between the drum lid and drum wall were found to close slightly.

After examining the damage to the package closure it was determined that the pass/fail criteria that had been established for the test had been exceeded. Though the physical gap criteria established for the test was exceeded, evidence existed that indicated the package would survive the regulatory thermal test. With this information and the strategy that a CoC could most easily be obtained by completing the regulatory HAC test sequence, the damaged package shown in Figure 3 was prepared for a regulatory thermal test.

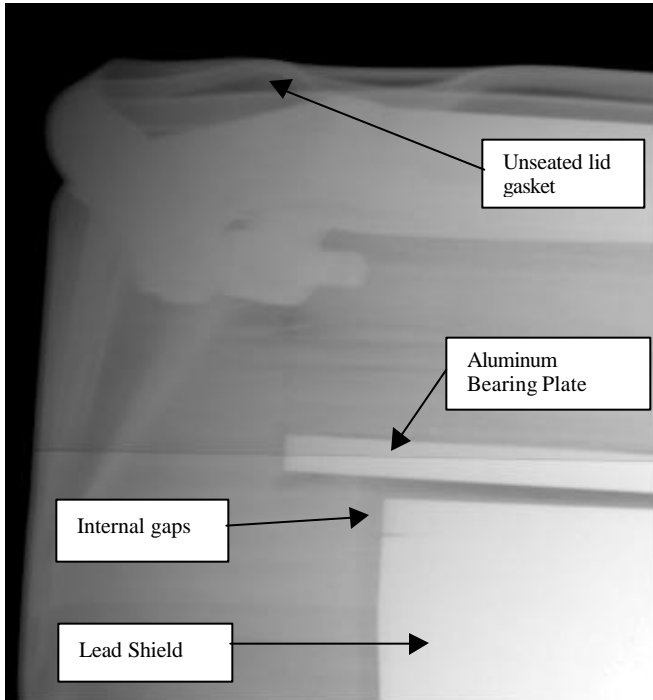
Figure 7. Drum Lid Closure

Figure 7 depicts a digital shot of the 9975 lid closure. The X-ray was shot looking from the rear of the drum and pointed to the “#8” as shown in Figure 3. The drum was in an upright position. From the X-ray the dislodged lid gasket that serpentine across the gapped lid can be readily distinguished. The engineered gap between the lead shield

and top bearing plate is also observable and is seen as a light shaded area which is representative of the gap. This gap also extends along the lead shielding. This gap beside the lead shield is a result of the Celotex being crushed during the side drop. A slight bulge in the lead shield due to the impact of SCV can be evident.

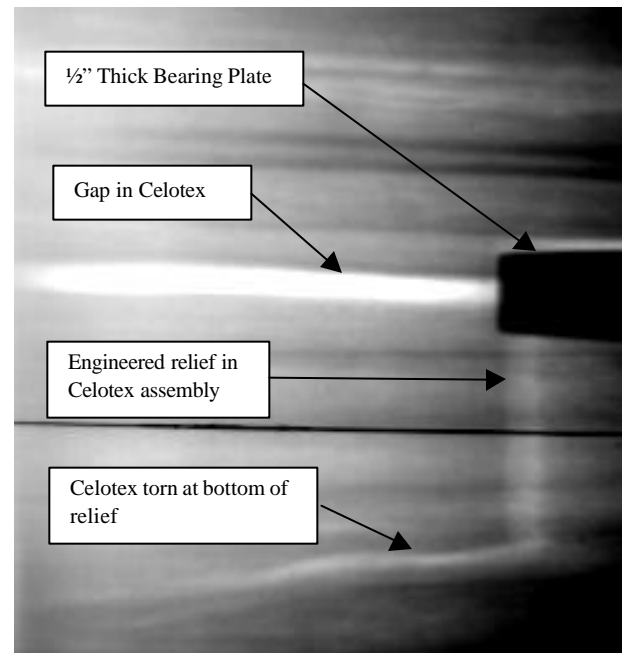
Figure 9. Damaged Celotex Adjacent to the Bottom Bearing Plate

Figures 9 and 10 illustrate specific package damage from the drop test. Figure 9 blows up a section of Figure 8 slightly rotated that shows a fairly large gap just adjacent to the bearing plate and a what appears to be a tear in the Celotex extending from the engineered relief below the bearing plate. When Figure 9 is viewed dynamically, the gap extends radially from the plate's edge for the most part the full circumference of the drum. However, the gap does not stay as nearly as pronounced (wide or long) as observed in the Figure. The tear at the bottom of the designed relief demonstrates that the relief performs as expected by translating damage away from the edge of the bearing plate thereby reducing Celotex separation adjacent to the bearing plate.

Indications of gaps in the Celotex (black lines in Figure 6 and 10 and light colored lines in Figures 8 and 9) that were discovered in the radiographic examinations of the damaged package resulted in package thermal analysis. Thermal analyses were performed for the 9975 with the assumption of a bounding 1.38 inch circumferential radial gap through the Celotex insulation to determine the effect of such a large gap in the hypothetical fire test, Reference 4. Results from the analysis showed that the 9975 package safety basis was not effected.

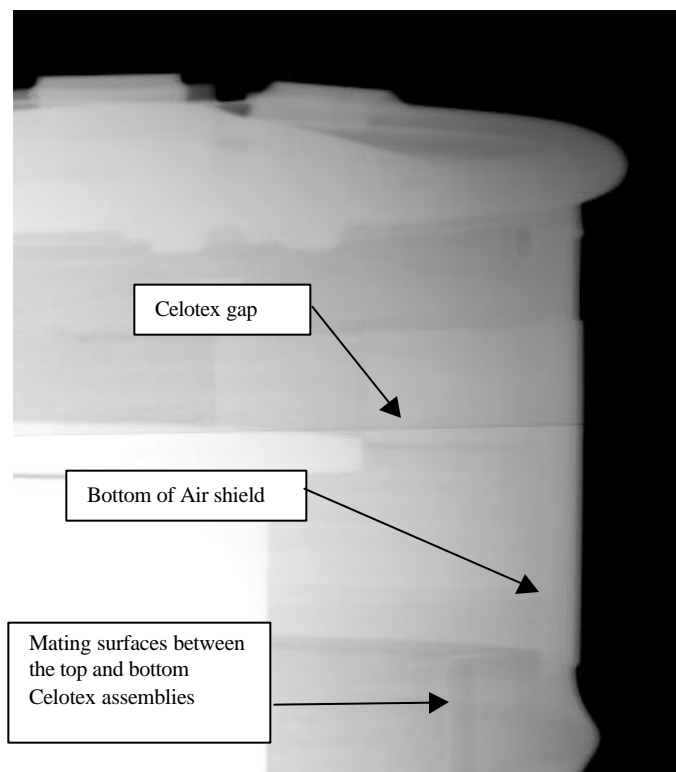
Figure 10. Top Section of Drum

Figure 10 illustrates an additional separation area in the Celotex. There is a slight gap in the Celotex adjacent to the top bearing plate, similar to the one shown in Figure 9. The gaps appear to form along the glue plane. Figure 10 is interesting in that the gap formed by the mating top and bottom Celotex assemblies is evident. The combination of the offset between the Celotex assemblies, the design relief above the bearing plate and the top Celotex assembly air shield minimizes Celotex damage at the top of the package.
