# **IMPROVEMENT OF WEAR COMPONENT'S PERFORMANCE BY UTILIZING ADVANCED MATERIALS AND NEW MANUFACTURING TECHNOLOGIES: CASTCON PROCESS FOR MINING APPLICATIONS**

Quarterly Technical Progress Report

For the period starting April 1, 2003, ending June 30, 2003

## **DE-FC26-01NT41055**

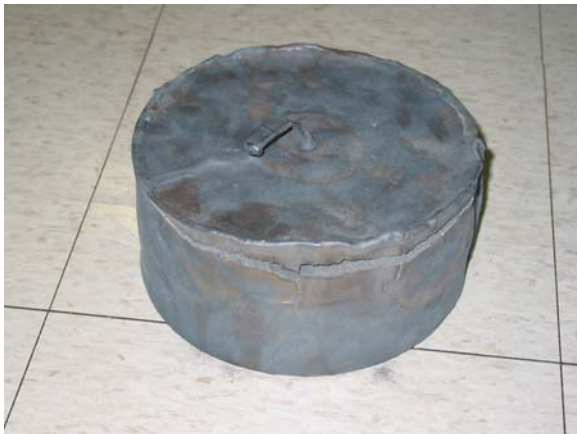
Both cans expanded slightly after high temperature off-gassing although a much slower heating rate was used. After HIPping, one can cracked and another blew, as seen in Figures 1 and 2. From our past experience, the cracked can resulted from free movement of the graphite sand inside the can. A portion of the graphite sand moved over an insulation layer to contact directly with the steel can and reacted with the steel. The reaction formed a brittle iron carbide and this carbide cracked during cooling. The can blowing was due to a small vacuum leak. High-pressure gas penetrated the can during HIPping, and expanded the can upon a quick discharge of HIPping gas.

Figure 1. H13 only disc can with a big crack

Off-gassing a larger volume and thin wall container in a vacuum furnace at an elevated temperature over softening point of the container material is not recommended. An alternative debinding and off-gassing method needs to be developed for the large, thin walled HIPping can.

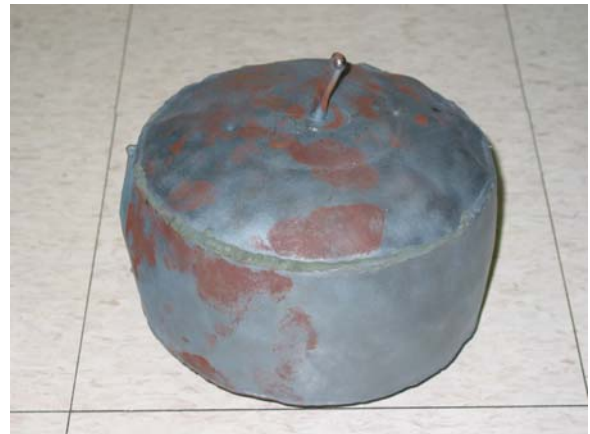
Figure 2. Blown H13/WC disc can

Vacuum leak must be prevented.

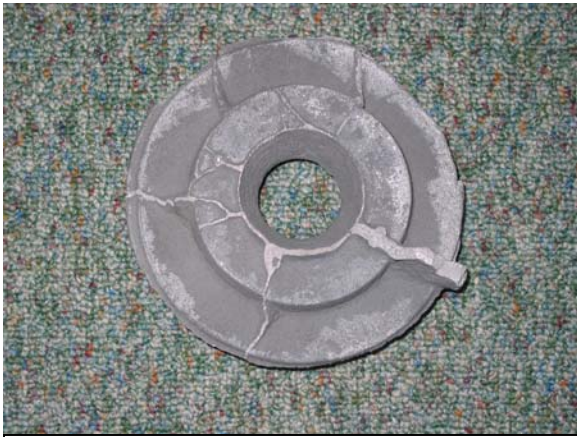
After being removed from the cans, both discs showed severe defects as seen in Figures 3 through 6. It was obvious that both sand molds cracked and the metal powder flowed into the big, thick cracks and formed the "ribs".

**Figure 3.** H13 only disc, back, note 'ribs' where the sand mold cracked

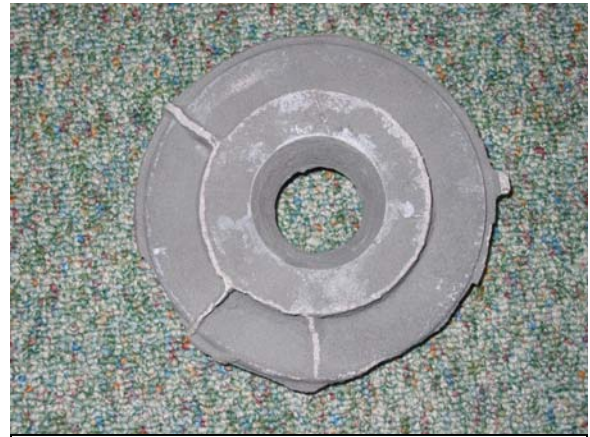
**Figure 4.** H13 only disc, front, note 'ribs' where the sand mold cracked

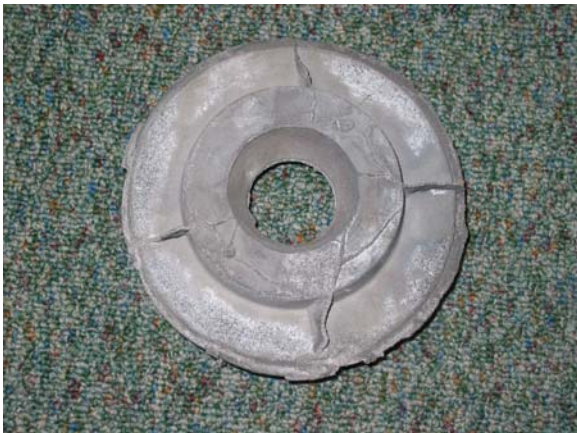
**Figure 5.** H13/WC disc, front, note 'ribs' where the sand mold cracked

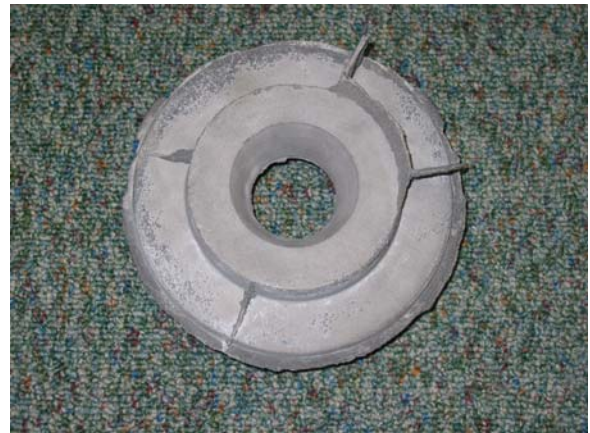
**Figure 6.** H13/WC disc, back, note 'ribs' where the sand mold cracked
