Report 40850R24 Revision 1

Final Technical Report

Demonstration of Black Liquor Gasification at Big Island

Submitted By: **Georgia-Pacific LLC¹**
133 Peachtree Street, N.E.
Atlanta, Georgia 30303

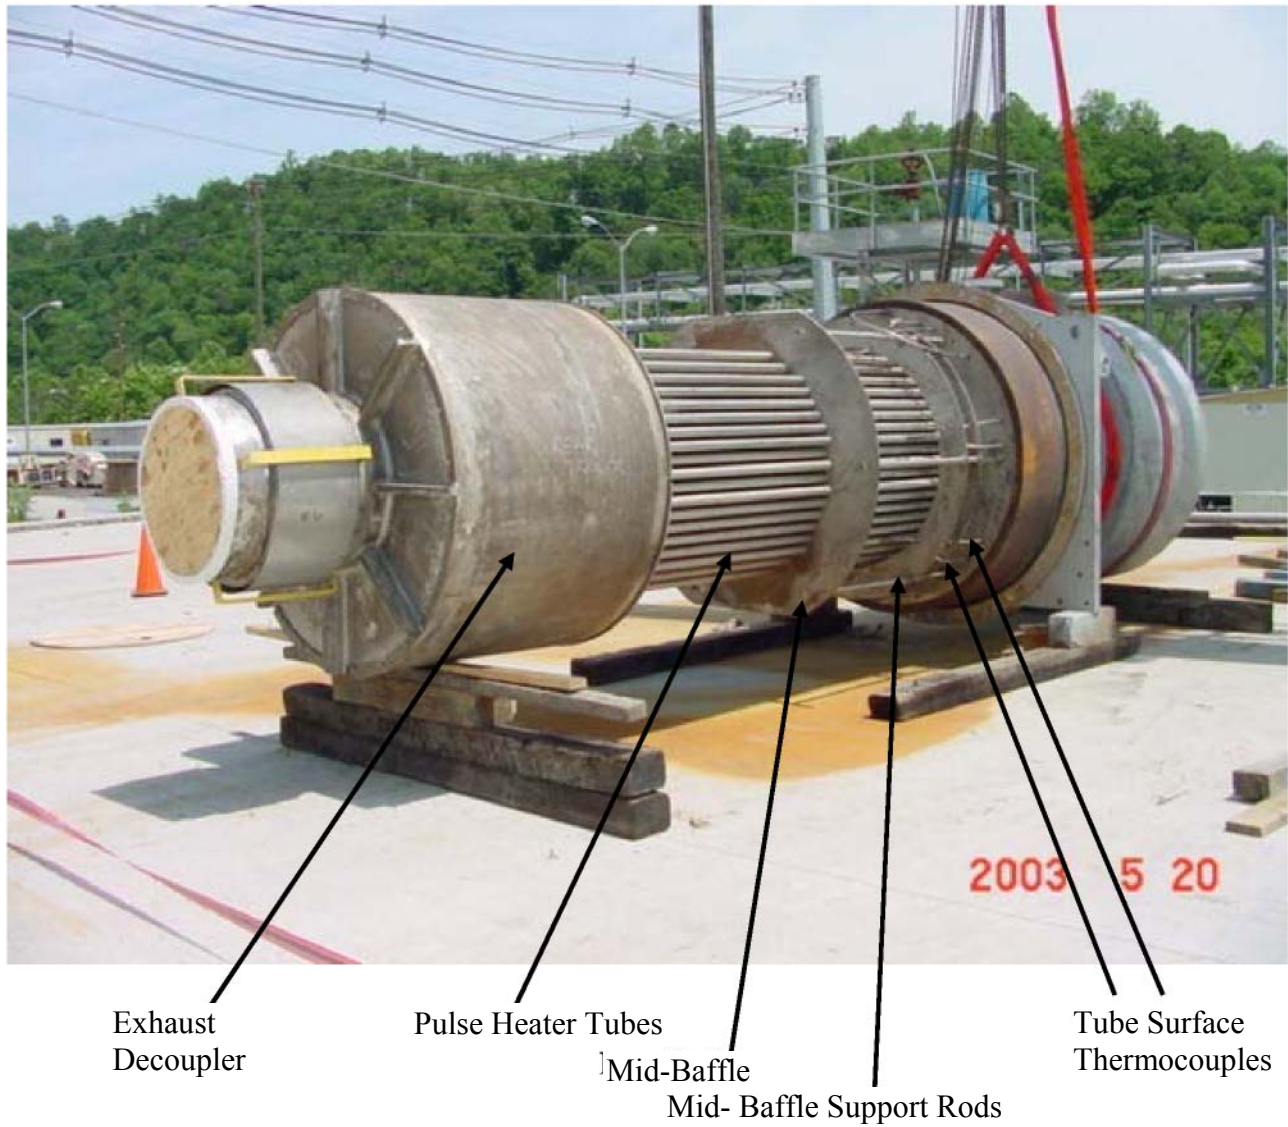
Pulse Heater

During the project, GP experienced failure of the in-bed pulse heater thermocouples used to control the firing rate of the heaters. The action of the fluidized bed would damage the thermocouples and cause the heaters to trip off line. By the end of the project, these thermocouples could no longer be used and control of the pulse heater firing rate was based on combustion chamber temperature and the readings of the dummy tube thermocouples installed to detect bed side plugging of the heater bundles. The action of the bed also damaged the upper heater in both reformers. GP modified the heaters in this position to eliminate the mid-point baffle support rods and supported the baffle from the tube bundle. All of the mid-point baffles were trimmed to eliminate excess surface area and minimize the problems. A picture of a pulse heater is shown in Appendix 5.

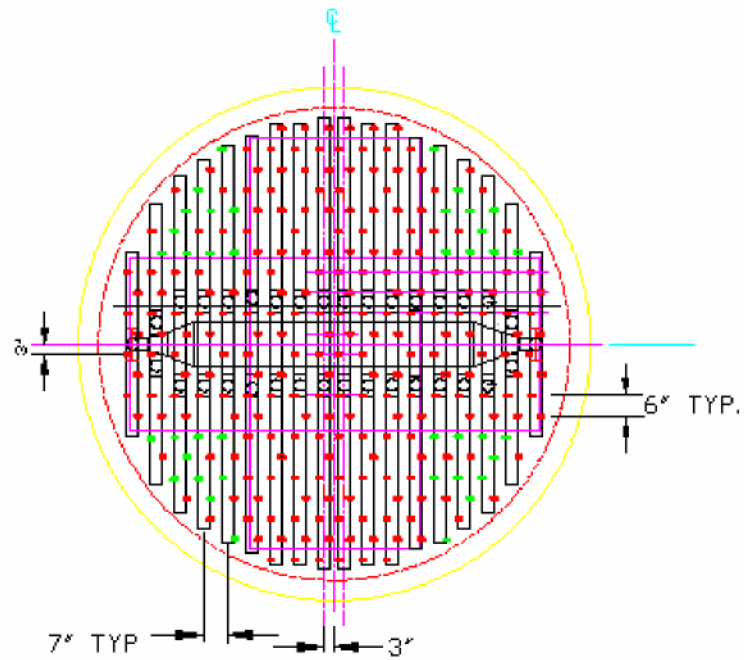
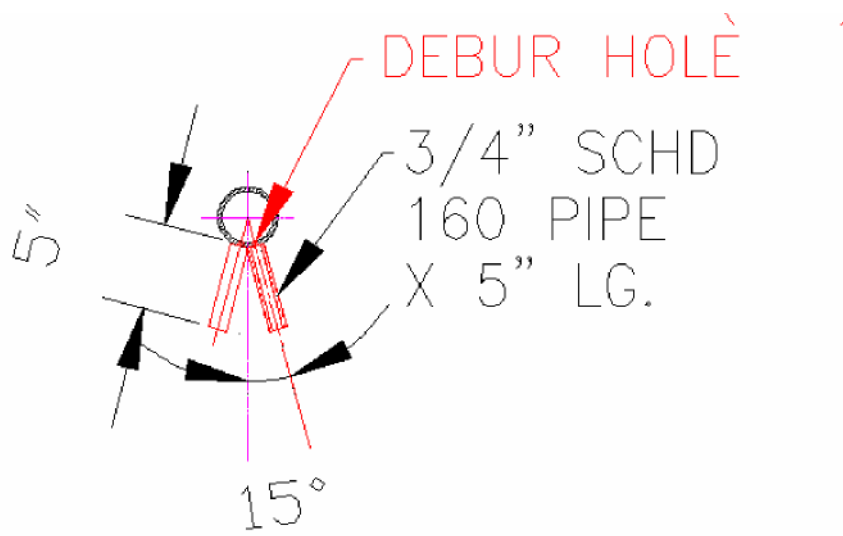
GRID GP-4

At the end of last period, run 11 was completed. At the end of run 11 a steam-out trial was conducted and data was collected and analyzed. During this reporting period, three trials were conducted using Reformer 2. During all three trials, the reformer was operated with only 3 heaters in service. The fourth heater had been removed and shipped to Mitternacht for tubing replacement. The fluidizing grid in Reformer 2 was modified to the configuration of Grid GP-4.
