## Application of Material Characterization Techniques to Electrical Forensic Analysis

**Abstract** – The application of forensic science techniques to electrical equipment failure investigation has not been widely documented in the engineering world. This paper is intended to share an example of using material characterization techniques to support an initial cause determination of an electrical component “failure” event. The resulting conclusion supported the initial cause determination and ruled out the possibility of design deficiencies. Thus, the qualification testing of the equipment was allowed to continue to successful completion.

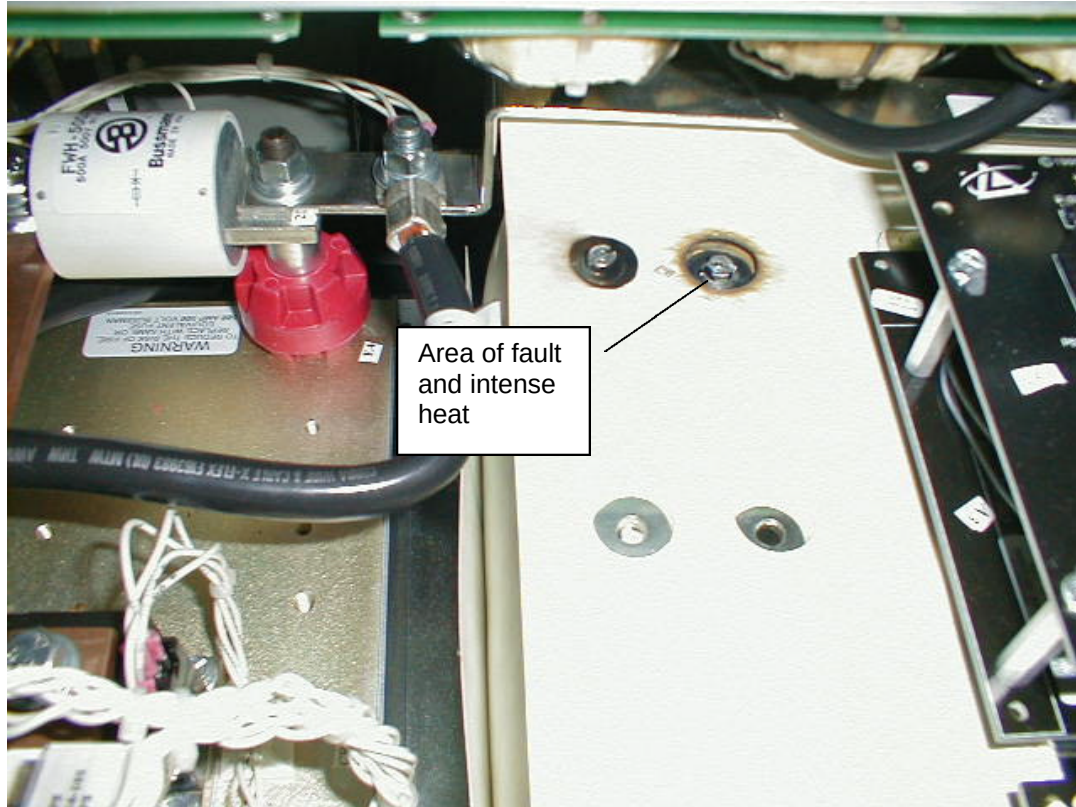
found. The terminal screw and the bus bar assembly at the location shown in Fig. 1 were burnt with metal melting where the capacitor had discharged. There were no other obvious indications of damage at any other location. Due to the narrow confines of the damage, it was proposed that some small piece of debris fell into the terminal area of the capacitor causing it to discharge. Due to the intense heat, no loose remains of the item of debris could be found. No loose or missing fasteners were observed upon inspection of them.

Fig. 1 Initial view of arc flash area

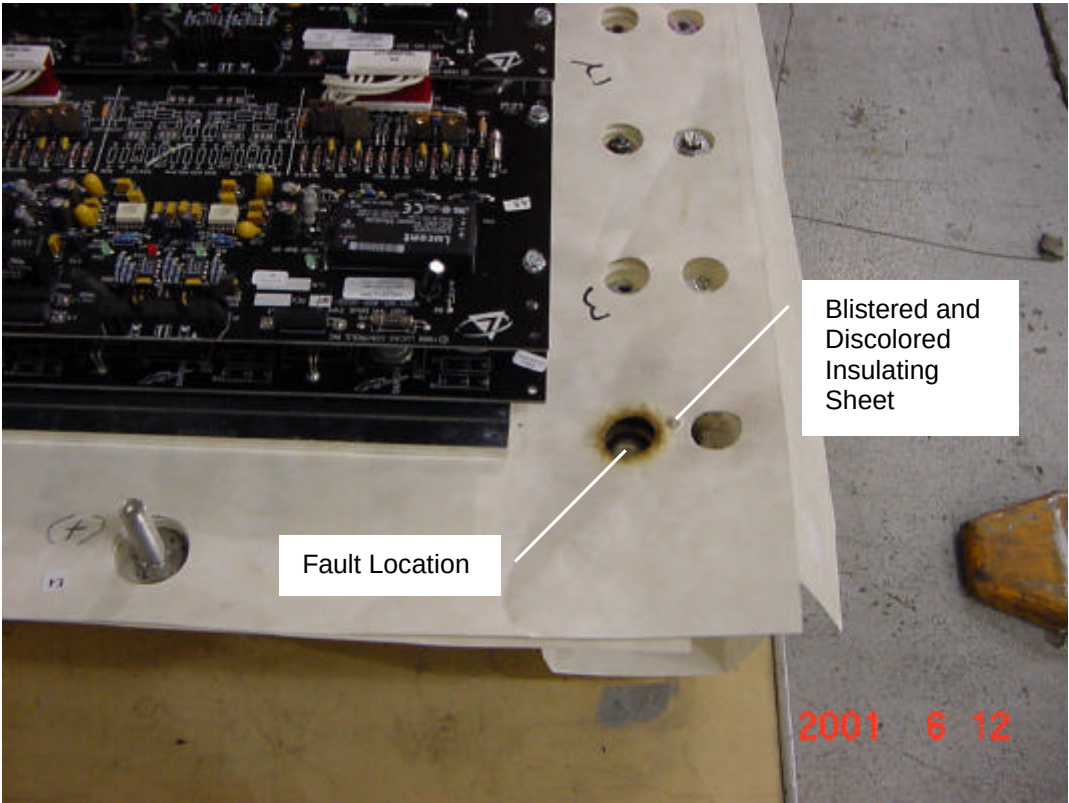
Fig. 2, Unit removed from cabinet

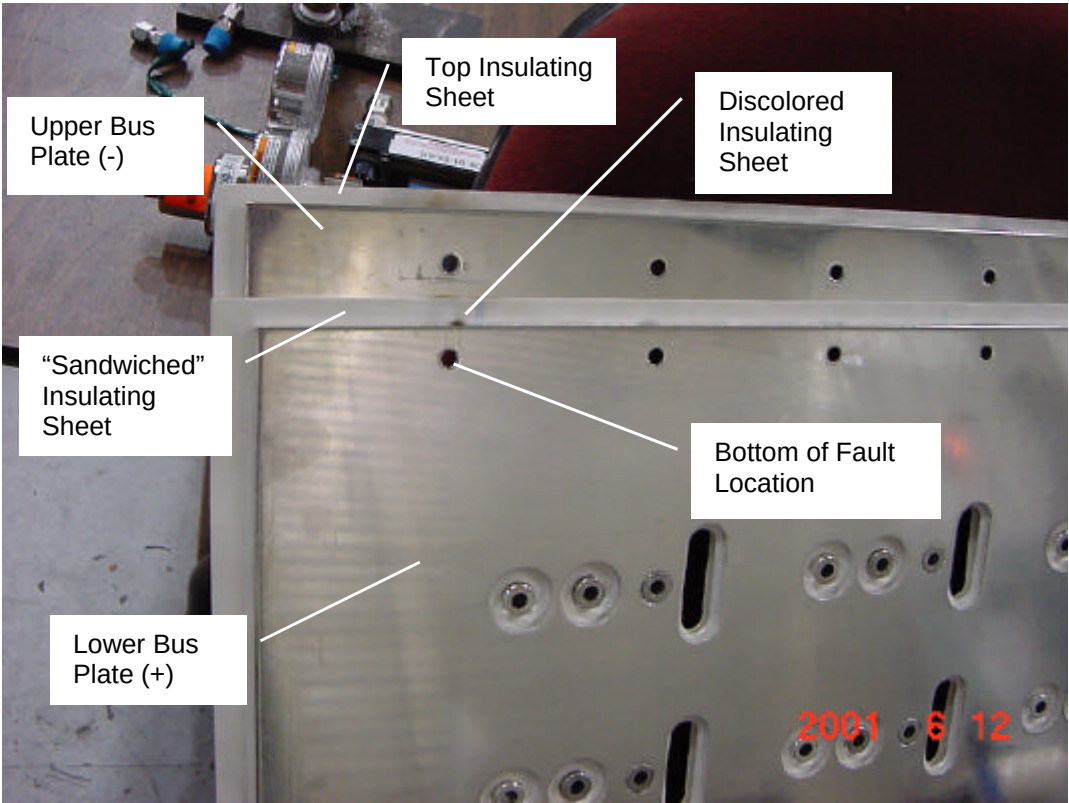
Fig. 3, Disassembled capacitor plate

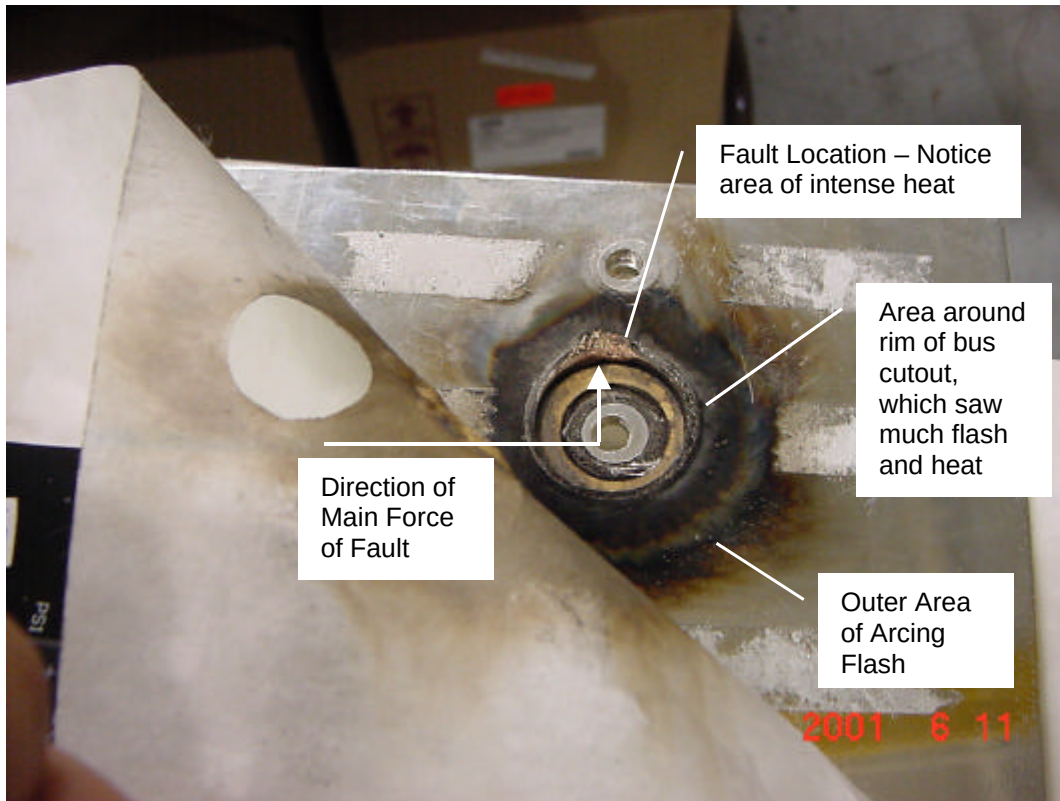
Fig. 4, Fault area uncovered

As an interim measure, we determined that a remote possibility existed that some other “foreign” material could make its way into the capacitor/plate connection area and fashioned a insulating cover from the same material used in the fabrication of the plate assembly. This “fix” worked well as there were no additional mishaps or setbacks to the testing program.

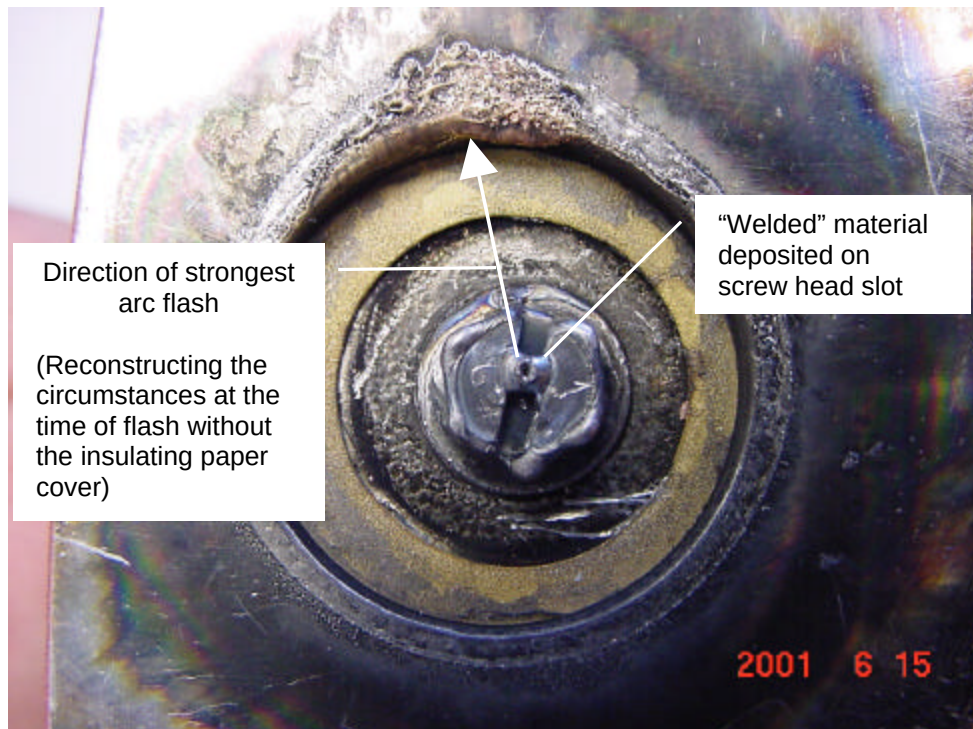
The University of Cincinnati laboratory technician ran several tests on samples of bus, insulation paper, and screws to determine if any foreign material residues were present. We were looking for anything that might indicate that the fault was caused by a piece of debris, which was shaken down into the terminal location. It was found that material deposited on the screw head involved in the flash was something other than the screw material and different than any bus material present. The material had been “welded” by the DC arc and a puddle was left attached to the screw head in the slot area. Fig. 6 shows a simulated reconstruction of the screw and bus assembly, as it would have been at the time of the arc.

Fig. 6, Reconstructed view of screw head and plate assembly

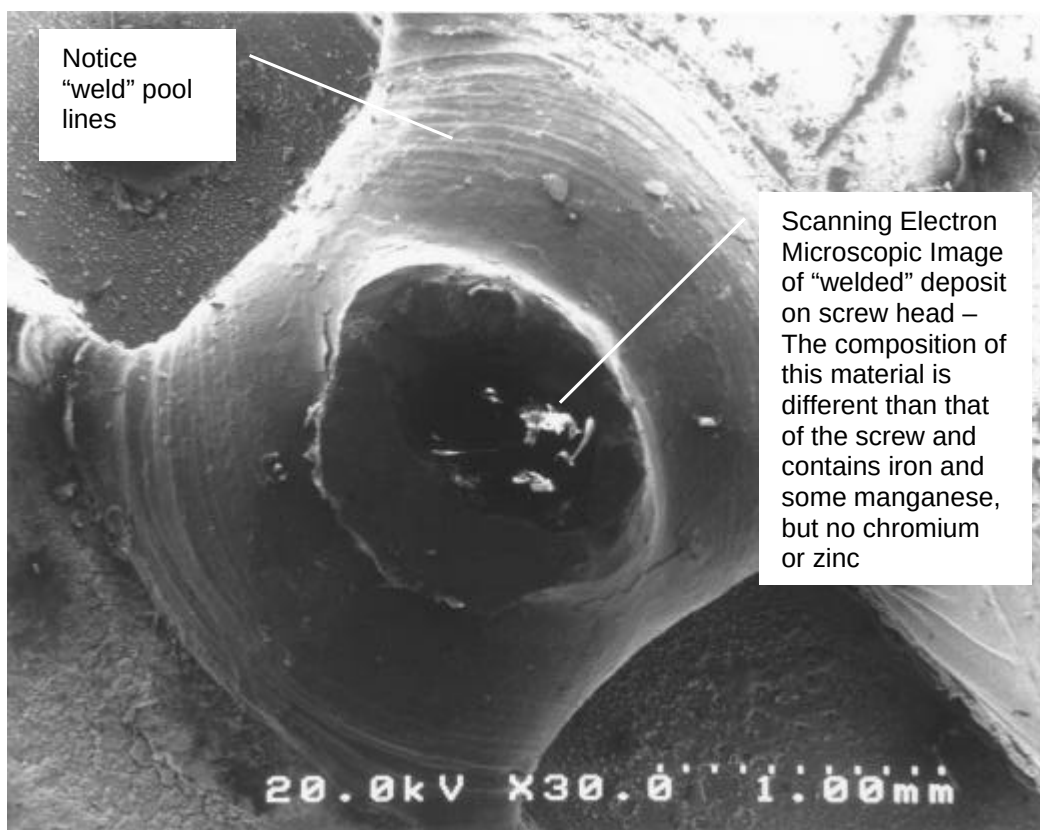
Fig. 7 shows the scanning electron microscopy photo of the screw head involved in the flash. The material in the “pool” was characterized as an iron with some trace of manganese, but differed from the chromium/zinc/steel of the screw itself. Fig. 8 and Fig. 9 indicate the differences of the two materials.

Fig. 7, Scanning Electron Microscope photo of screw head

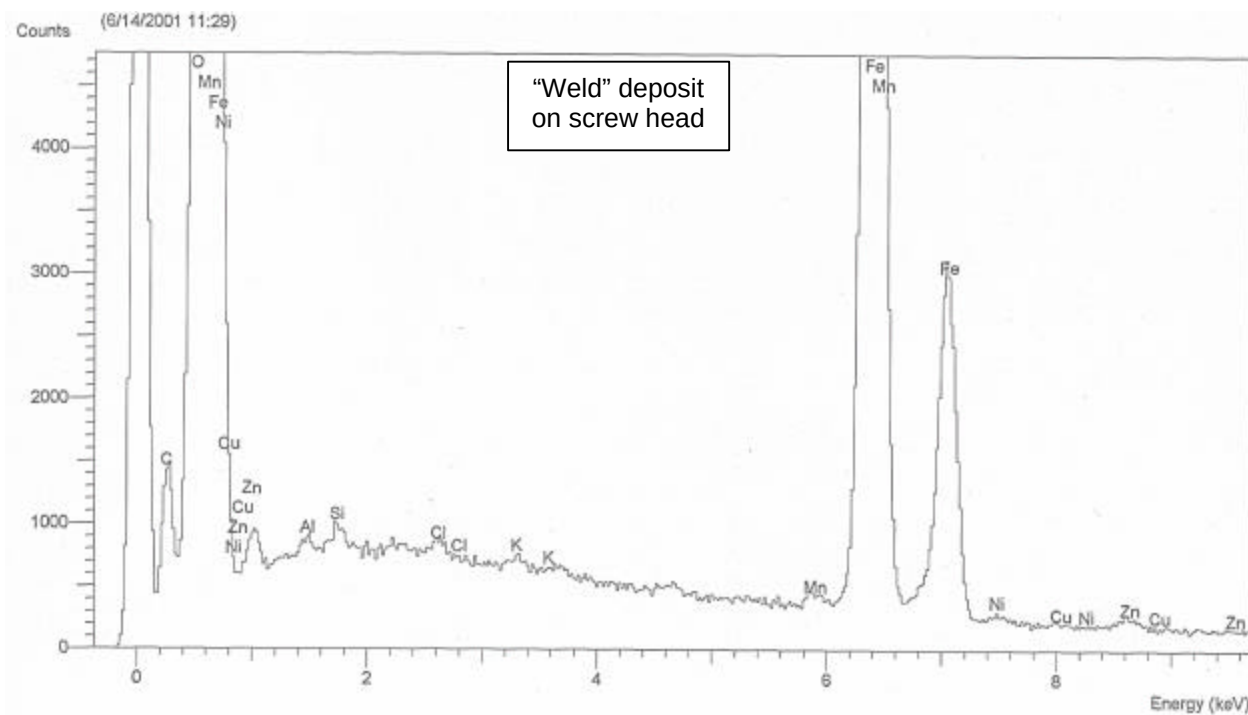
Fig. 8, SEM printout of screw head with "foreign" material

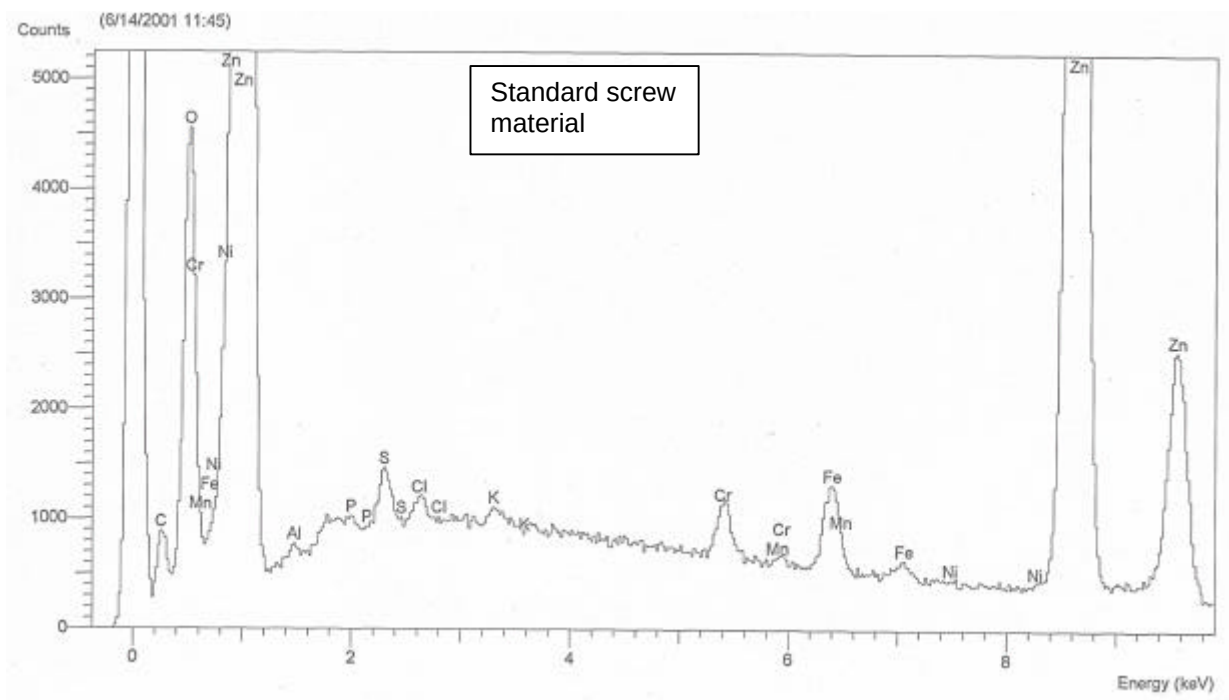
Fig. 9, SEM printout of standard screw head
