A Structural Impact Assessment of Flaws Detected During Ultrasonic Examination of Tank 15

**B. J. Wiersma
J. B. Elder**

Savannah River National Laboratory
Materials Science and Technology Directorate

Publication Date: August 2008

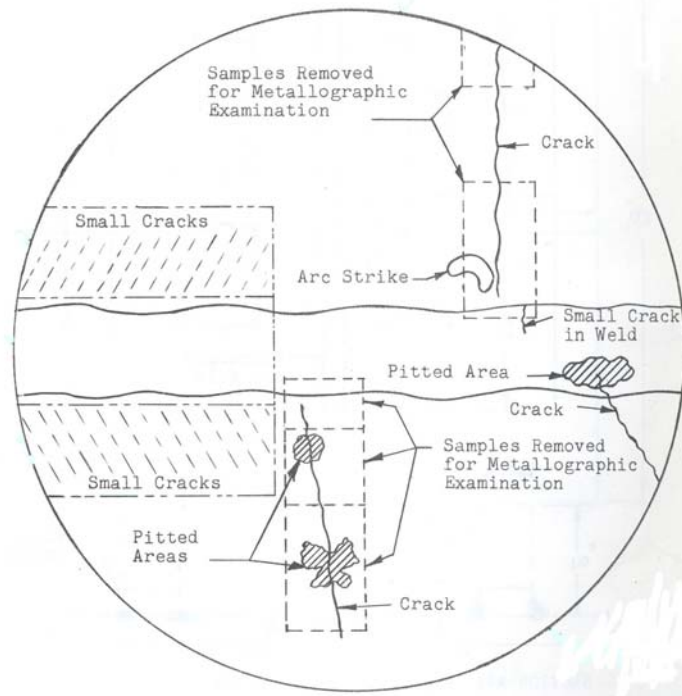
- Three cracks were visibly observed on one of the samples (see Figure 2), with two of the cracks being through-wall. The cracks were intergranular and essentially perpendicular to the horizontal weld.

Figure 2. Drawing of interior surface of sample removed from Tank 16H.

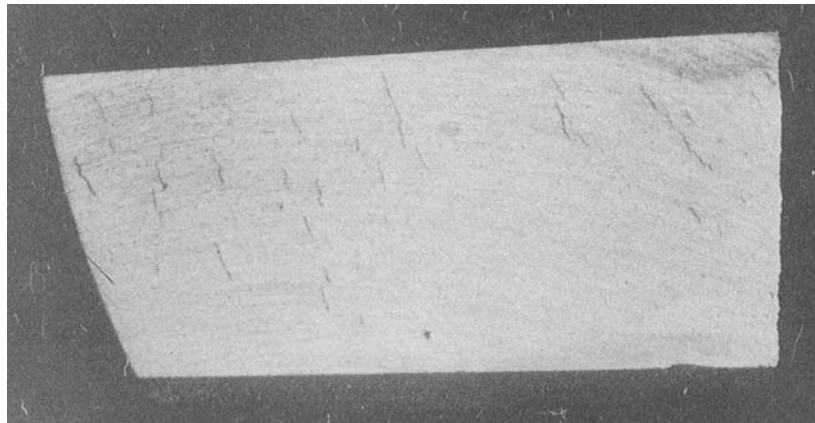
- Numerous small cracks were observed on the inner surface (see Figure 3). These cracks were located in both the knuckle and primary shell plates in bands approximately 0.5 inch wide. The edge of these bands was located between 0.0625 and 0.125 inch from the edge of the weld. The cracks ranged from 0.0625 to 0.5 inch in length and were 0.031 inch deep.

Figure 3. Shallow cracks on interior surface of Tank 16 sample.

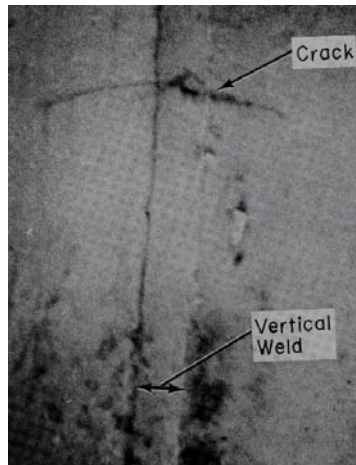
In June 1962, the vertical weld in the upper primary shell beneath inspection port 151 was sandblasted and then inspected with dye penetrant [12]. Ten large cracks were visible without magnification. The cracks were essentially perpendicular to the weld bead (see Figure 4). Four of the cracks were estimated to be between 4 to 6 inches long. The radiograph of the vertical weld and the photographs revealed exterior surface imperfections as well as internal weld beads. Although three of the cracks appeared to be associated with weld beads, most of the cracks showed no correlation with known fabrication blemishes. One crack appeared to be slightly curved, however, this crack was located next to a repair weld at the intersection of the vertical weld and the middle horizontal weld. All of the cracks appeared to be in a 3-inch zone next to the weld and therefore likely affected by fabrication residual stresses. One crack was observed near a repair weld at the intersection of the vertical and horizontal weld. The crack had an arc like appearance (see Figure 5).

Figure 4. Dye-penetrant testing of stress corrosion crack on vertical weld in Tank 16 [12].

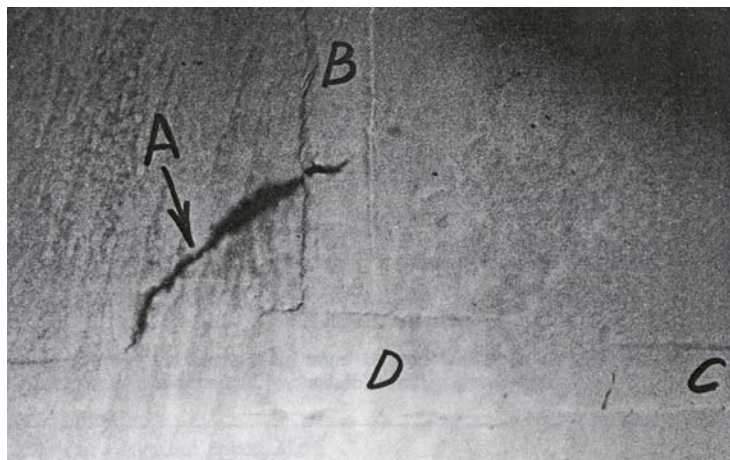
Figure 5. Dye-Penetrant testing at the intersection of vertical and middle horizontal weld in Tank 16: A) crack, B) vertical weld, C) middle horizontal weld, D) repair weld [12].

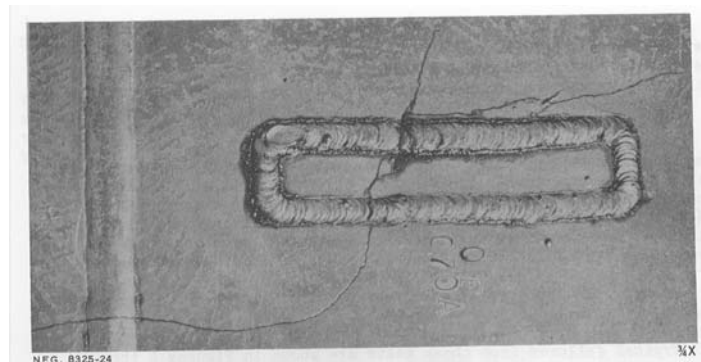
Figure 6 shows the crack pattern associated with a weld attachment. Weld attachments are typically fillet welds rather than full penetration welds. An arc-like crack that curves through the center of the attachment was observed. It is also interesting to note that the attachment redistributes the residual stresses so that the crack that is roughly perpendicular to the seam weld begins to arc. It is difficult to distinguish whether the crack initiated from the seam or the attachment.

Figure 6. Stress corrosion cracking in area near weld attachment [15].

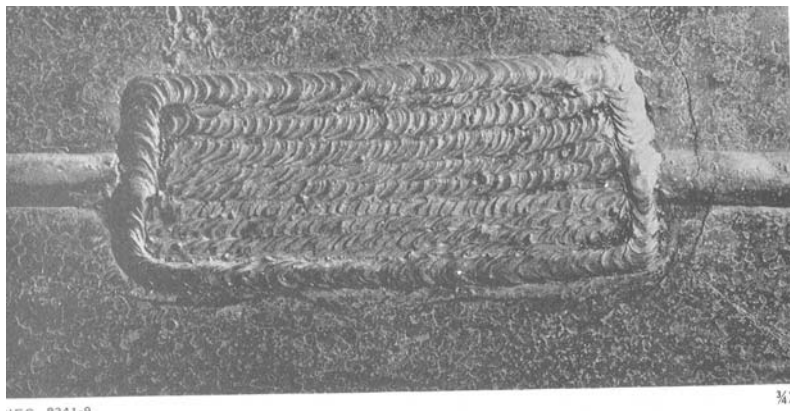
Figure 7 shows the crack pattern associated with a weld repair. A repair weld is performed to remove defects found in weld beads and the base material during pre-service radiography inspections. During repair, a groove is prepared by grinding out the original weld metal. The repair groove is then filled with new metal. The actual repair length, width and depth may vary depending on the defect size. Cracks were observed proceeding both through and around a repair weld, although the latter was more frequently observed. Typically the crack traces an arc-like path around the repair and then tends to radiate from the corners.

Figure 7. Crack pattern near a weld repair [15].

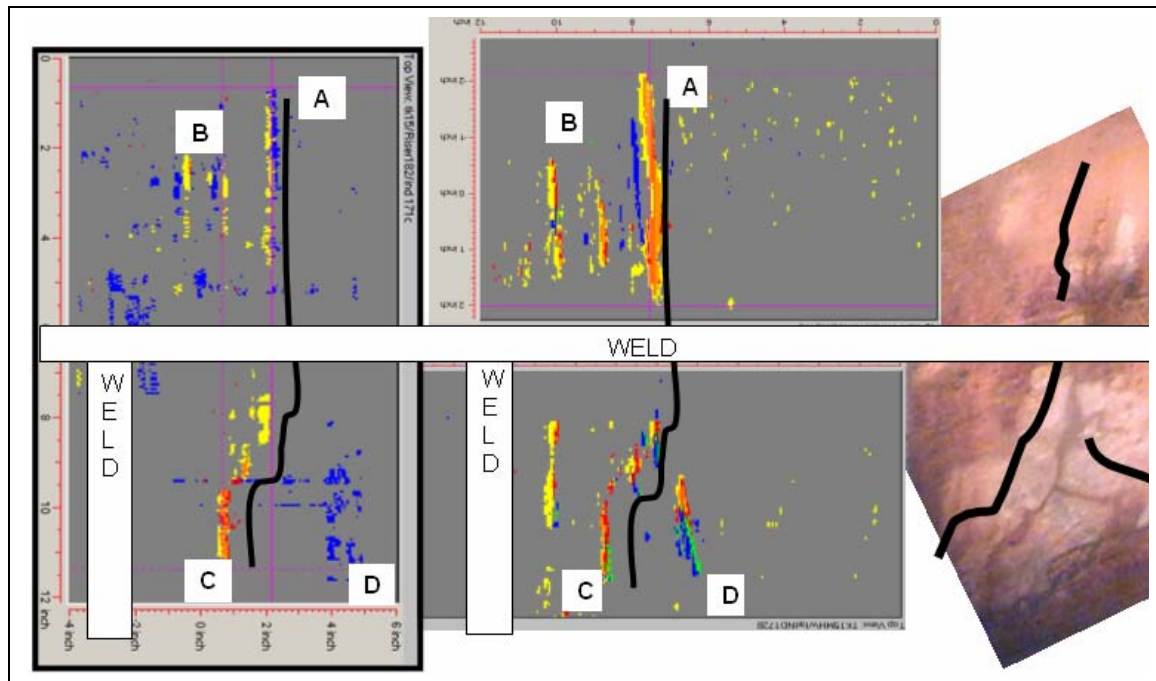
To determine whether growth had occurred in this situation, the edge of the weld bead on the interior surface of the tank was used as a reference point. A comparison was then made between the distance between this reference point and the tip of the crack in 2002 and 2007. From this comparison it was determined that the tip of the crack had extended by 0.25". Crack growth in the other three cases was determined similarly by comparing to reference points that were clearly observed in both 2002 and 2007. All available scan data was utilized to look for landmarks and determine if growth had occurred. Typically there were at least two sets of data for each indication from each examination period.

Figure 17. Images from crack # 3 2002 (left) and 2007 (center and right)

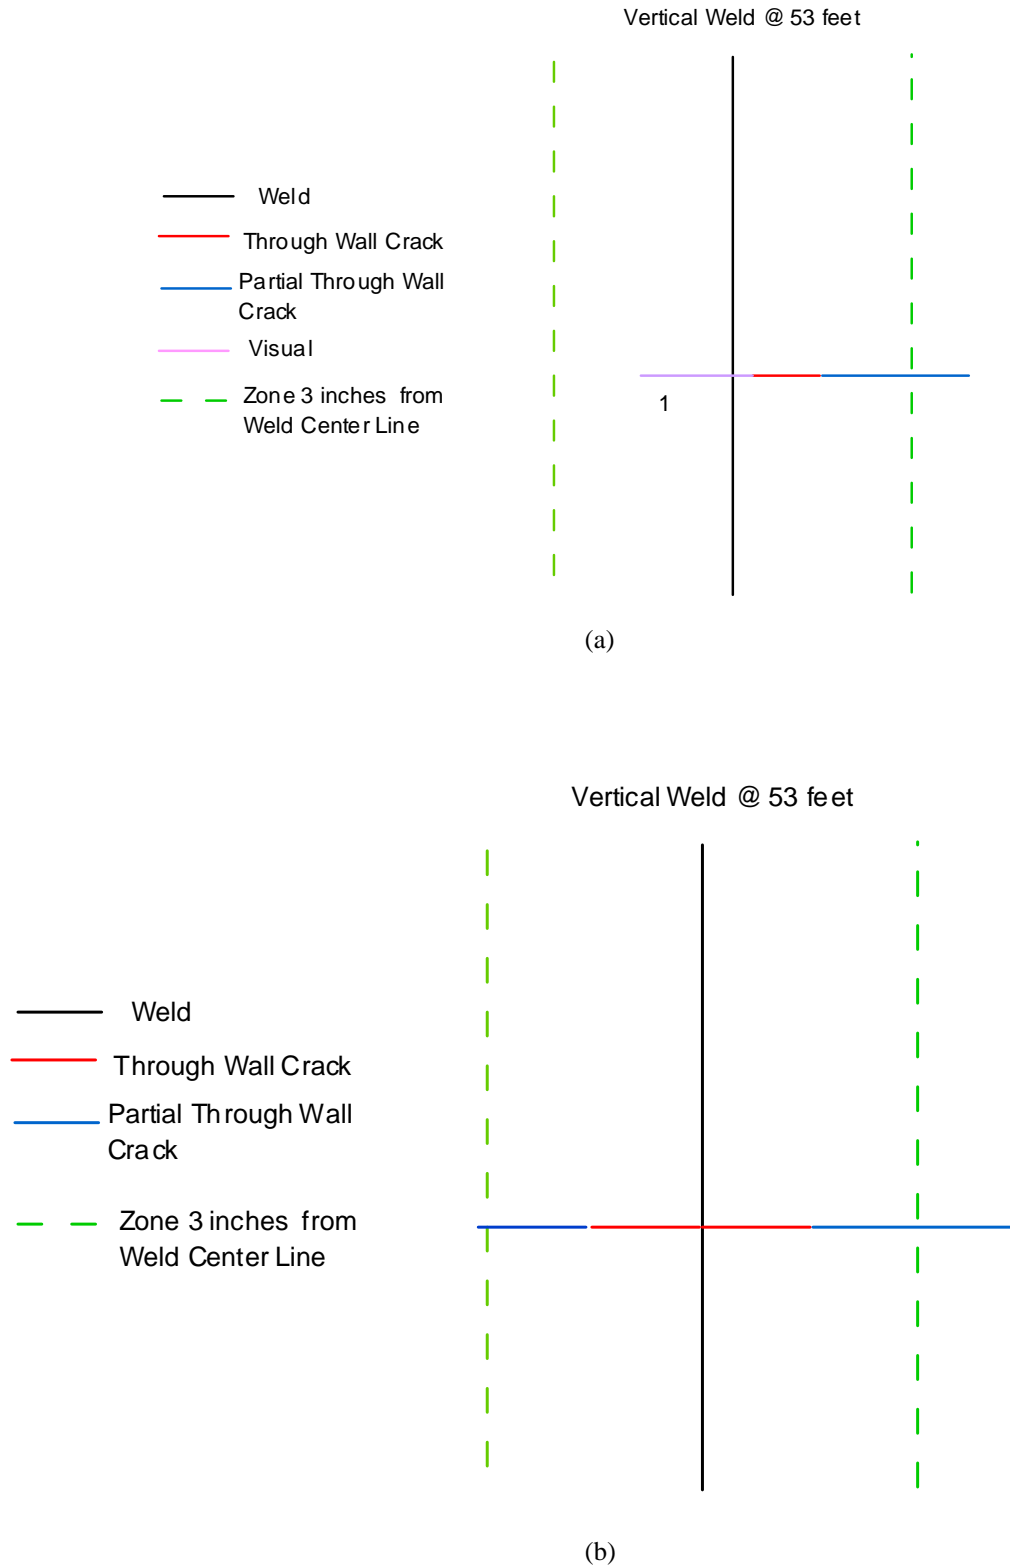
Figure 18. Rudimentary drawing showing crack # 1 (a) 2002 and (b) 2007.

The rudimentary drawing of crack #1 is shown in Figure 18. The crack was first visually observed in 1998 due to moisture leaching from the interior to the exterior and had no associated leakage. UT inspections of this crack were performed in 2002 and 2007. During the first 21 years of service the crack was exposed to supernate, while for the past 25 years it has been in the vapor space. Though the exact date is unknown, visual inspection results and the limited amount of leakage appear to indicate that through-wall penetration occurred during the past 25 years of vapor exposure. Initiation of the crack may have occurred during the exposure to supernate.

The UT inspection in 2002 was performed on the portion of the crack to the right of a vertical weld. Visual inspections at the time indicated that the crack extends through the weld to the other side. The through-wall portion of the crack extends approximately 1.4 inches from the weld center-line and is roughly perpendicular to the vertical weld (i.e., horizontal). However, the UT inspection revealed that the crack extends an additional 2.9 inches part through-wall. The crack length of 4.3 inches to the right of the weld extends slightly beyond the assumed 3-inch residual stress zone around the weld. The data from the UT scan are portrayed in Figure 19. In 2002 (top image in Figure 19), only the right side of the crack was scanned. The images in Figure 19 are from the right side of the indication, from 2002 (top) and 2007 (bottom). The images would need to be flipped to coincide with the photograph of the indication. The growth is evident on the left side of the image.

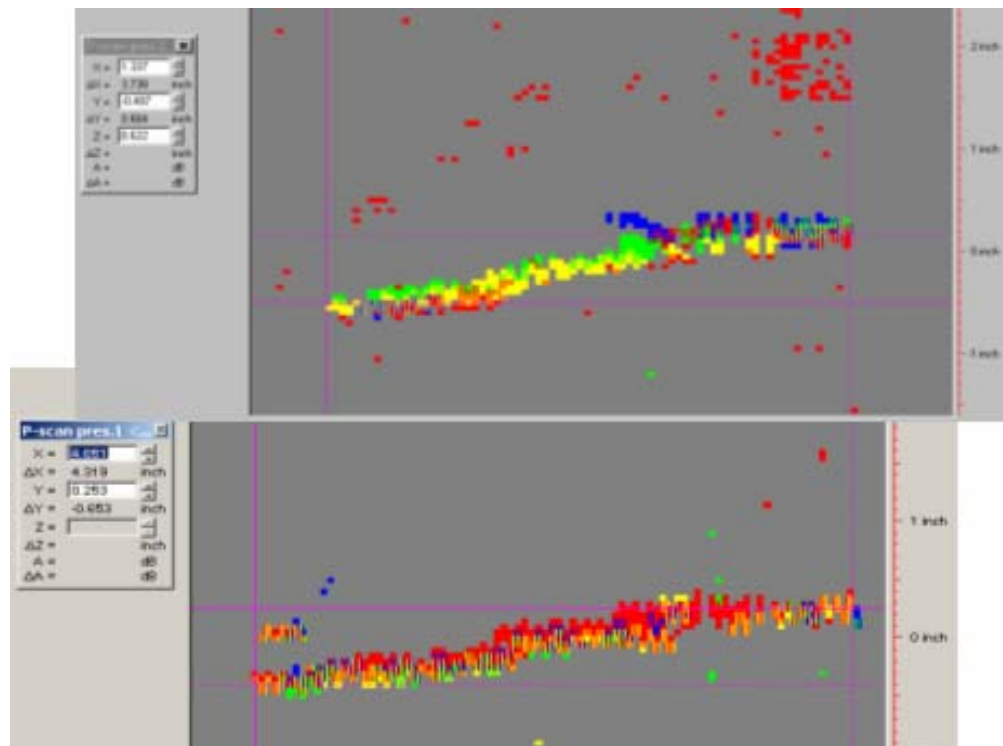
Figure 19. UT data from Crack #1 demonstrating crack growth measurement.

The measured growth was 0.46 inches. The UT scan indicates that this crack extension is approximately 20% through-wall. The fact that the crack did not proceed through-wall indicates that the residual stresses, and hence the driving force for crack growth, has decreased.

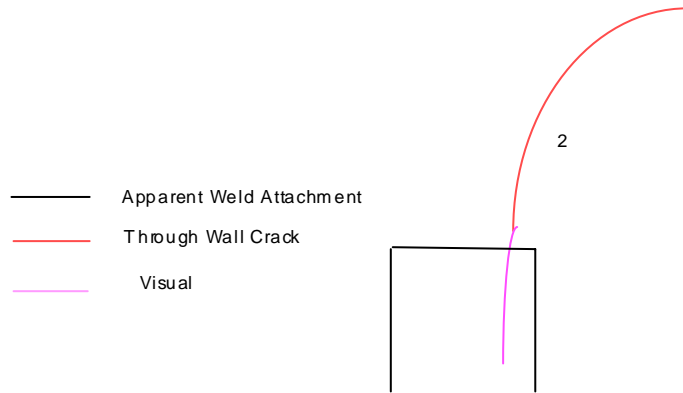
Figure 20. Rudimentary drawing showing crack #2.

The crack was located in the center of the lower shell plate far removed from seam welds. There is visual evidence that the crack is associated with a weld attachment. Previously, mid-plate leak sites were also correlated with weld attachments (see Tank 16 and Tank 6). The arc-like nature of the crack is also consistent with results observed during laboratory testing [15]. The visually observed portion of the crack is parallel to a weld fusion line. The portion that was inspected with UT shows the influence of the intersection of two fillet welds on the residual stress distribution. Curvature is generally the result of a region of large compressive stresses that exist at the end of these regions. The total length of the crack could not be measured due to the weld attachment obstruction. In 2002, the portion of the crack that was measured was approximately 3.7 inches in the vertical direction and 2.3 inches in the horizontal direction. No mention was made as to whether the crack was longer on the interior or exterior of the tank. If the visually observed portion of the crack were estimated to be approximately 2 inches longer, the total length of the crack would be approximately 6 inches. The UT examination performed in 2007 indicated no changes in the crack length.

Due to a lack of significant driving forces, either hydrostatic or residual stresses, the crack currently does not impact either the structural stability or the leak tightness of the tank. At this time the level the tank will be at during waste removal is not known, however, this site is close enough to the sludge level that it is very likely that waste will be above the crack during waste removal. The primarily vertical characteristics of the crack would be subject to hydrostatic stresses in the hoop direction. The hydrostatic stresses are potentially higher at this site than for Crack #1, however, it is anticipated that the sludge slurry during waste removal would have a relatively low specific gravity of the sludge slurry. Therefore, from a structural stability perspective the crack is not anticipated to be significant. If the waste is raised above this level, leakage may occur. Procedures to handle the leakage are in place.

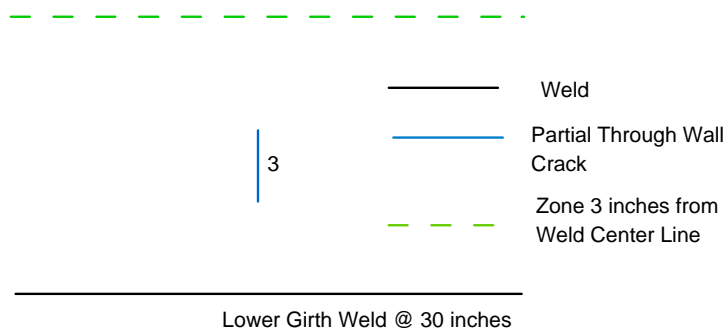
Figure 21. Rudimentary drawing of crack # 3.

The rudimentary drawing of crack #3 is shown in Figure 21. Since this crack is part through-wall, there was no previous indication of a crack. Between 1961 to 1965 the site was exposed primarily to supernate. The site has been completely immersed in the sludge since that time. The exact date of crack initiation is unknown, however, it is apparent that it occurred either during exposure to the supernate or the sludge layer.

The crack is vertical and was located approximately 0.8" above the bottom horizontal weld. In 2007, the crack was approximately 25% through-wall and 0.6 inches long. Although, the length was slightly longer than that measured in 2002 (i.e., 0.55 inches), comparison of the two UT scans did not provide sufficient evidence to suggest that any crack growth had occurred. Due to a lack of significant driving forces, either hydrostatic or residual stresses, and the fact that the crack is part through-wall the crack currently does not impact either the structural stability or the leak tightness of the tank. Since the crack is within the 3-inch reference zone around the weld, future crack growth is possible. However, maintaining the waste within the corrosion control limits during any future waste removal operations would minimize this possibility.

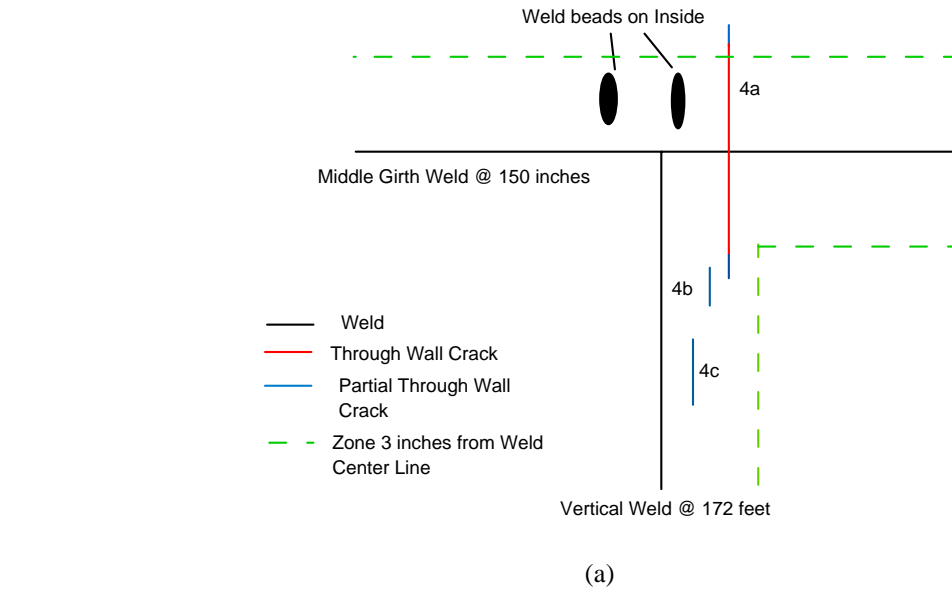
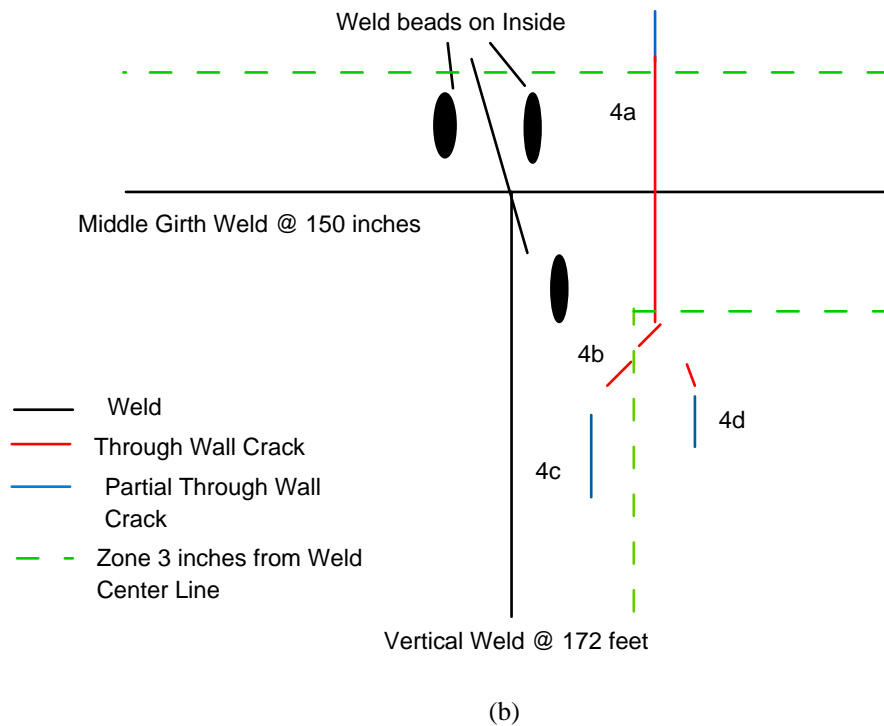
Figure 22. Rudimentary drawing of crack #4 (a) 2002 and (b) 2007.

The crack is located near the intersection of a vertical weld and the middle horizontal weld, and is roughly perpendicular to the horizontal weld. In 2007, the UT examination revealed that this vertical crack appears to consist of four segments, one through-wall crack (4a) and three smaller partial through-wall cracks (4b, 4c, and 4d). If segments 4a-4c are considered a single crack, the crack length would be approximately 10.5 inches. This crack is the longest vertical crack ever observed. The through-wall portion of crack 4a was approximately 7 inches, although on the interior the crack was approximately 7.9 inches. In 2007, it was determined that the segment of crack 4a in the upper plate had extended approximately 0.25 inches in the direction away from the weld, and therefore just outside the residual stress zone. The portion of the crack that extended was partial through-wall. The three other sections of the crack were approximately 50% through-wall and were 1.0 (4b) and 1.8 (4c), and 1.4 (4d) inches long. No extension was observed for cracks 4b and 4c. Crack segment 4d was not observed in 2002. Due to the improvements in the probe fixtures it is not known whether this crack segment was actually present in 2002. In addition to the intersection of the vertical and horizontal seam welds, weld beads in the vicinity of the crack may have influenced the residual stress distribution. However, assuming they are cracks, both were outside the 3 inch zone around the horizontal weld, but within the 3 inch zone of the vertical weld. Residual stress modeling of a region near a horizontal and vertical weld indicates that a "pocket" of tensile stress in the direction transverse to the vertical weld is present approximately at the location of Cracks 4b, 4c, and 4d (see Figure 10). Thus, the cracks would tend to grow parallel to the vertical weld rather than perpendicular. The modeling also suggests that this tensile stress has a relatively short range and therefore the crack driving force in that direction decreases. After this short distance, the primary tensile stress becomes longitudinal to the vertical weld.

Due to a lack of significant driving forces, either hydrostatic or residual stresses, the crack currently does not impact either the structural stability or the leak tightness of the tank. At this time the level the tank will be at during waste removal is not known. However, if the waste level were to exceed the middle horizontal weld, the primarily vertical characteristics of the crack would be subject to hydrostatic stresses in the hoop direction. The hydrostatic stresses are potentially higher at this site than for Crack #1, however, it is anticipated that the sludge slurry during waste removal would have a relatively low specific gravity of the sludge slurry. The instability length for a vertical crack at the middle girth weld of a Type I tank, with a solution with specific gravity of 1.1, was estimated to be 111 inches for normal operating conditions and 64 inches for seismic conditions [22]. Although, this is a Type II tank rather than a Type I, there are enough similarities between the two tank styles that one may assume that the instability crack length would be similar. Therefore, from a structural stability perspective the crack is not anticipated to be significant. If the waste is raised above this level, leakage may occur. Procedures to handle the leakage are in place.

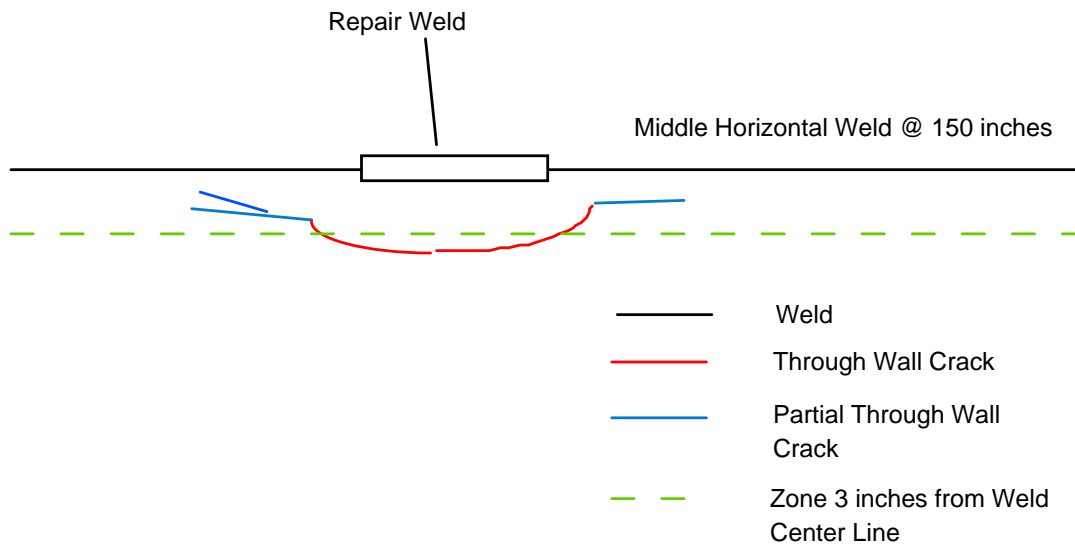
Figure 23. Rudimentary drawing of Crack #5.

The crack is located near a repair weld in the middle horizontal weld. The crack arcs slightly around the repair weld, however it is primarily oriented in the horizontal direction. In 2007, the length of the crack was determined to be approximately 20 inches. In 2002, the crack was reported to be approximately 18 inches. However, comparison of the two scans indicated that there was actually no further growth. The through-wall portion of Crack 5 is approximately 10 inches and is in the section of the crack that is adjacent to the repair weld. At each end of the through-wall section of the crack are part through-wall sections. The crack to the left of the repair is approximately 6 inches and appears to branch, while the portion of the crack to the right is approximately 4 inches. The arc-like pattern of the crack adjacent to the weld repair is consistent with laboratory results [15]. The behavior also agrees with the residual stress model for a narrow weld repair in that the crack is located a short distance from the weld repair fusion line. The simulated weld repairs in the laboratory were much wider than this repair in the tank. This crack is the longest ever observed.

Due to a lack of significant driving forces, either hydrostatic or residual stresses, the crack currently does not impact either the structural stability or the leak tightness of the tank. The fact that the crack is oriented primarily in the horizontal direction means that hydrostatic stresses in the hoop direction will not have a significant impact on further growth of this crack. Therefore, from a structural stability perspective the crack is not anticipated to be significant. If the waste is raised above this level, leakage may occur. Procedures to handle the leakage are in place.

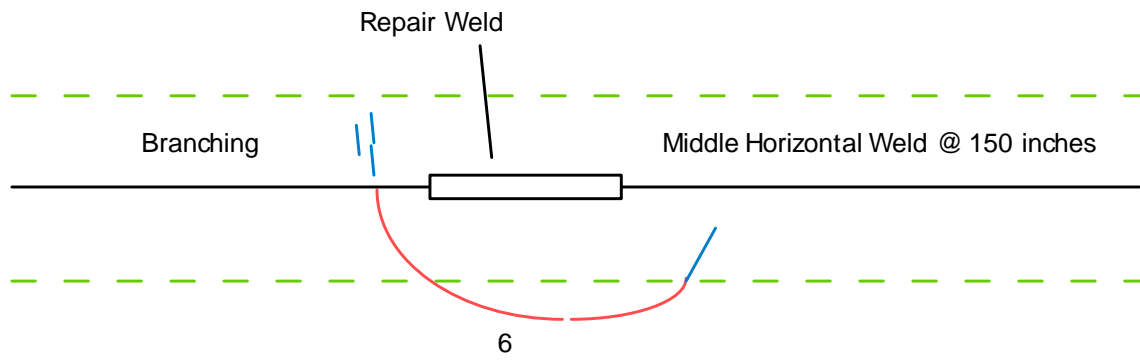
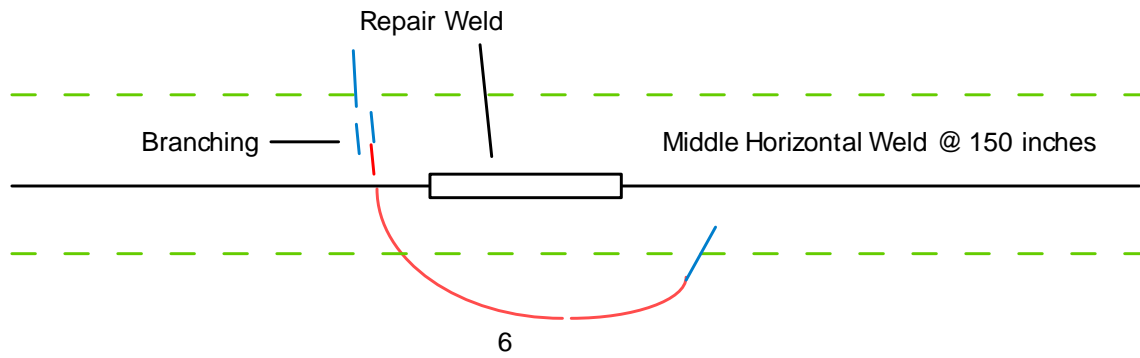
Figure 24. Rudimentary drawing showing crack # 6 (a) 2002 and (b) 2007.

Due to a lack of significant driving forces, either hydrostatic or residual stresses, the crack currently does not impact either the structural stability or the leak tightness of the tank. This statement is confirmed by the finite element fracture analysis previously performed on the crack (assuming that it was 15 inches) [21]. The analysis showed that the hydrostatic stresses were not sufficient to drive the crack to instability. The horizontal orientation of the crack means that hydrostatic stresses in the hoop direction will not have a significant impact on further crack growth. Therefore, from a structural stability perspective the crack is not anticipated to be significant during waste removal. If the waste is raised above this level, leakage may occur. Procedures to handle the leakage are in place.

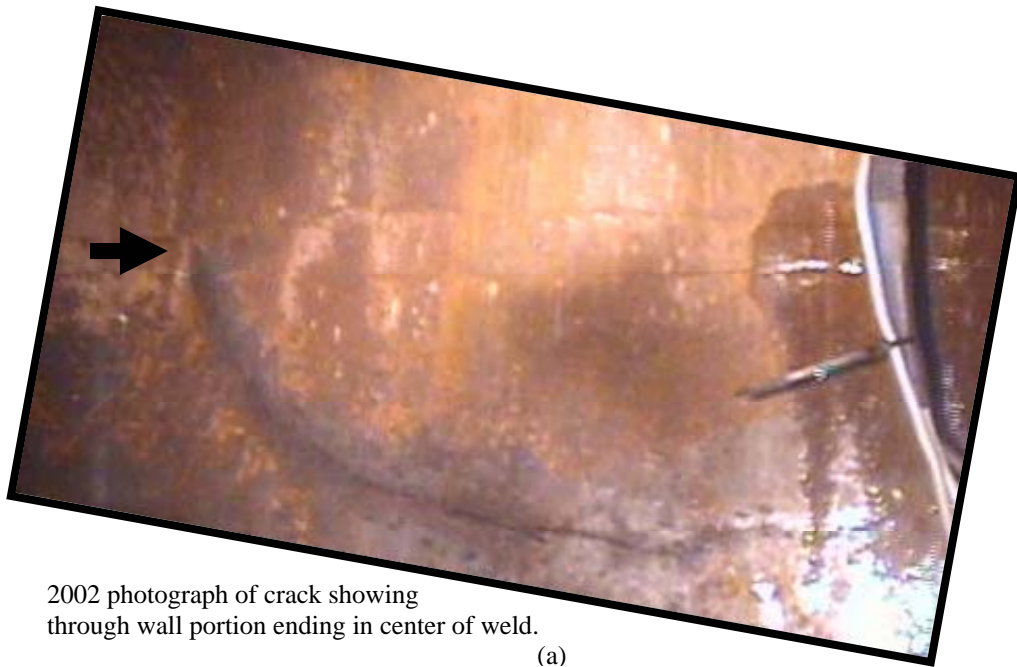
(a)

2002 photograph of crack showing
through wall portion ending in center of weld.

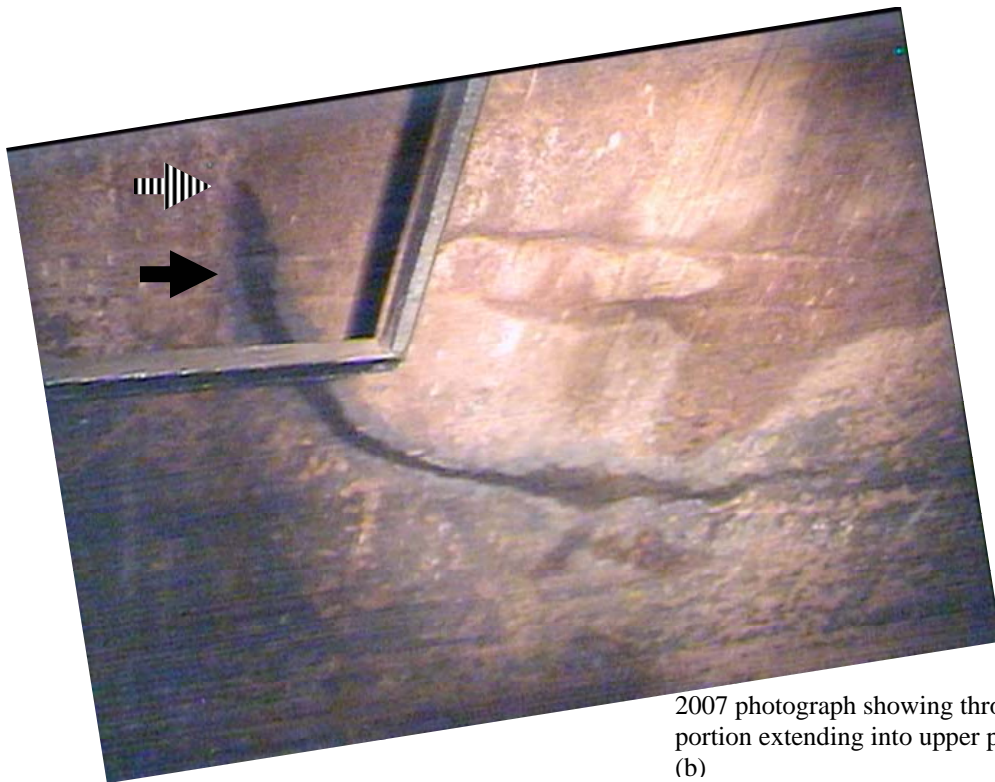
2007 photograph showing through wall
portion extending into upper plate
(b)

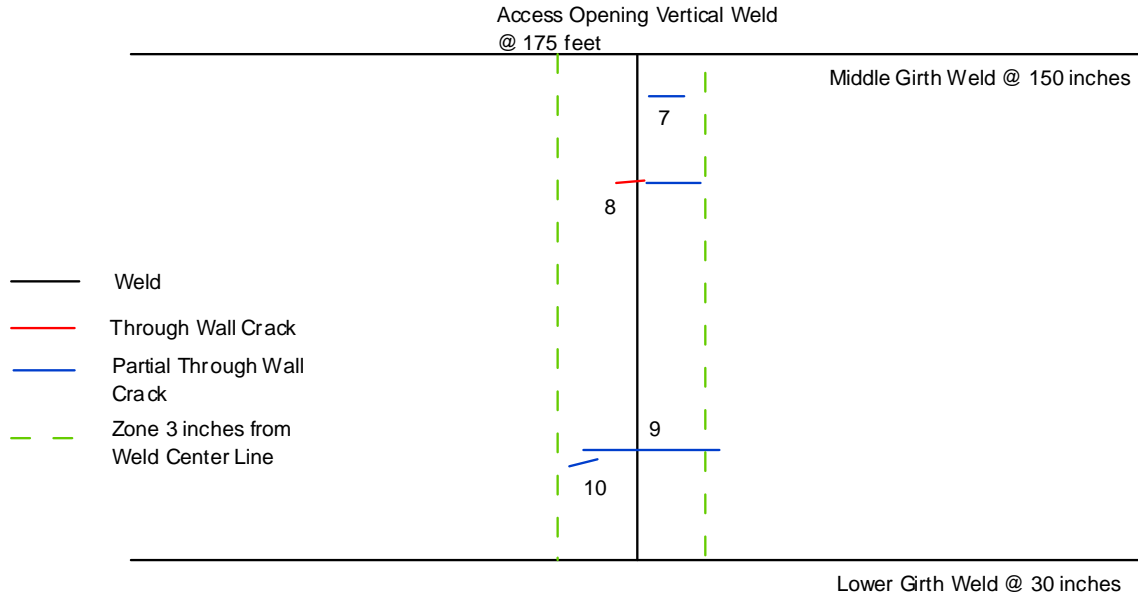
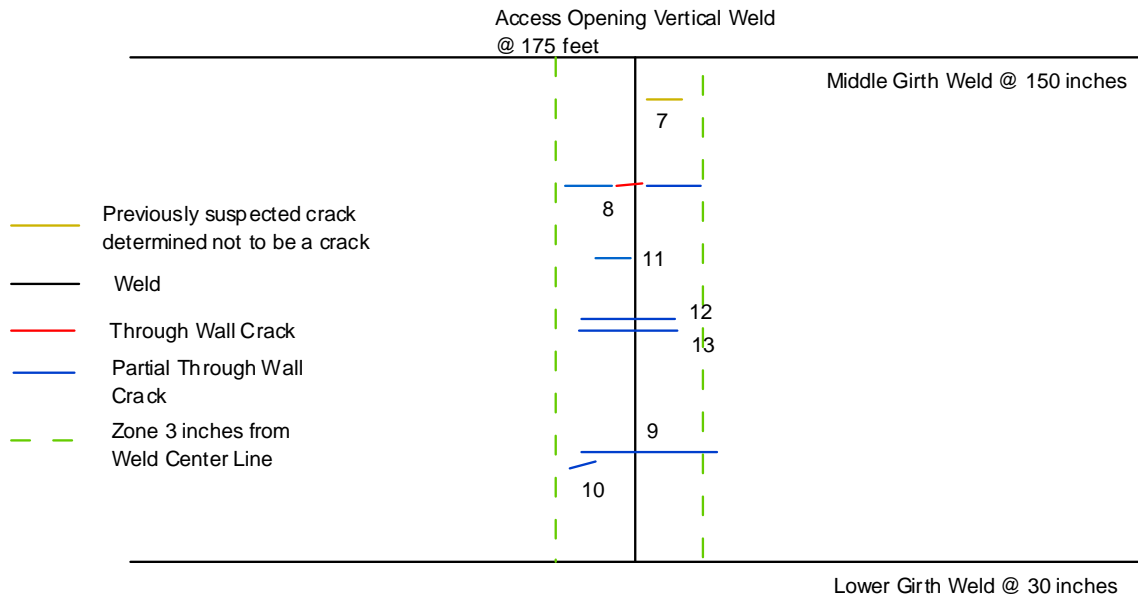
Figure 26. Rudimentary drawing of cracks #7-13 (a) 2002 and (b) 2007.

Due to a lack of significant driving forces, either hydrostatic or residual stresses, the crack currently does not impact either the structural stability or the leak tightness of the tank. The horizontal orientation of the crack means that hydrostatic stresses in the hoop direction will not have a significant impact on further crack growth as well. Therefore, from a structural stability perspective the crack is not anticipated to be significant. If the waste is raised above this level during waste removal, leakage may occur. Procedures to handle the leakage are in place.
