WSRC-TR-2003-00426
Revision 0

DWPF AIR LIFT PUMP LIFE CYCLE EVALUATION (U)

SAVANNAH RIVER TECHNOLOGY CENTER

Publication Date: February 2, 2004

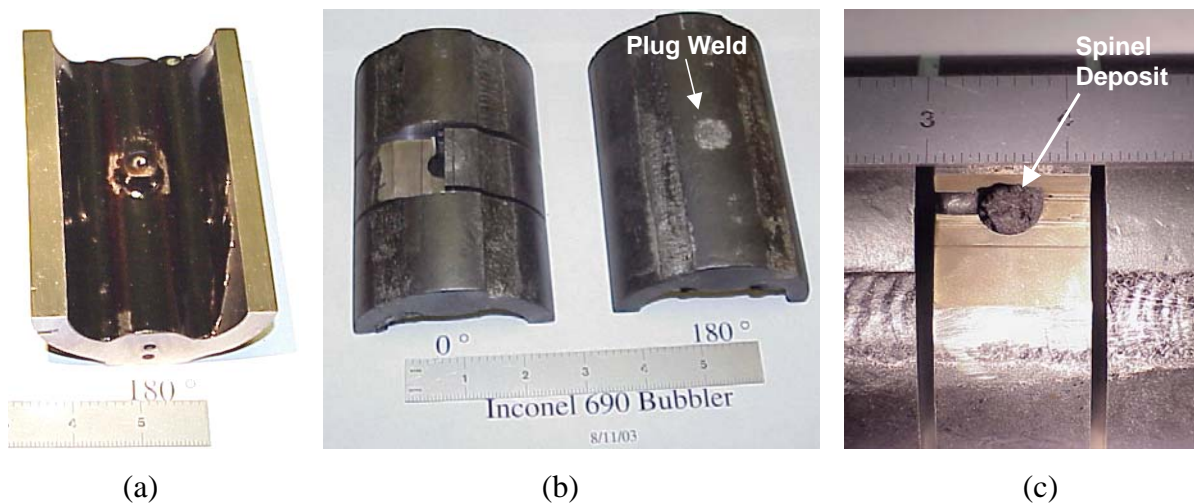
After completing the UT and visual examinations, the lower portion of the pump was cut off approximately 3 inches above the nozzles. This segment was then cut longitudinally between the nozzles (Figure 4). The halves were further sectioned approximately 0.5" above and below the nozzles exposing the air supply passage. The air supply on the side labeled 180 ° was completely blocked with glass. This probably resulted when the air supply from this side was cut off during removal from the molten glass. The other air supply passage from the side labeled 0 ° was free of any glass or other obstructions, i.e. oxide build up. Glass was fractured on the platinum nozzles using a vibra tool with light pressure. The pump segments containing the nozzles were then placed in boiling sodium hydroxide over the weekend to facilitate glass removal. Visual examination of the nozzles confirmed that no significant degradation had occurred. Shoulders used to screw the platinum nozzle into the 690 tube were distinct. Some minor roughening of the platinum had occurred.

Figure 4. Photographs showing sectioning of the lower half of the pump. a) Thick coating of glass on inner diameter, b) Outer diameter showing longitudinal and seal welds, and c) Spinel deposit at inlet of nozzle.

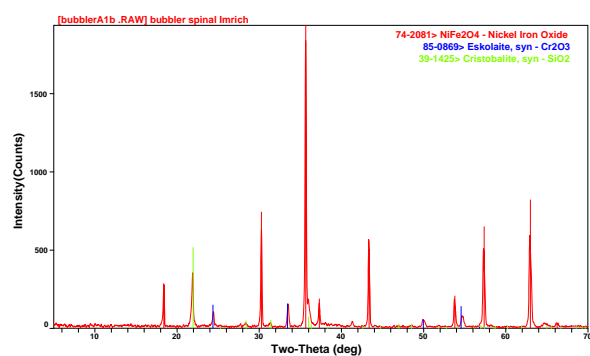
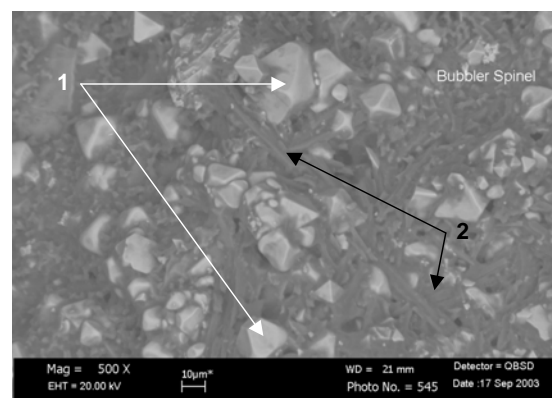
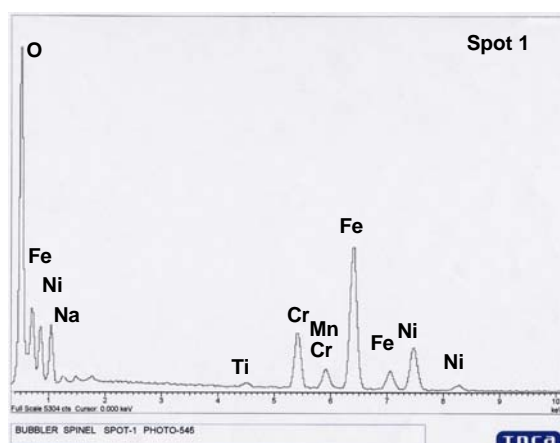
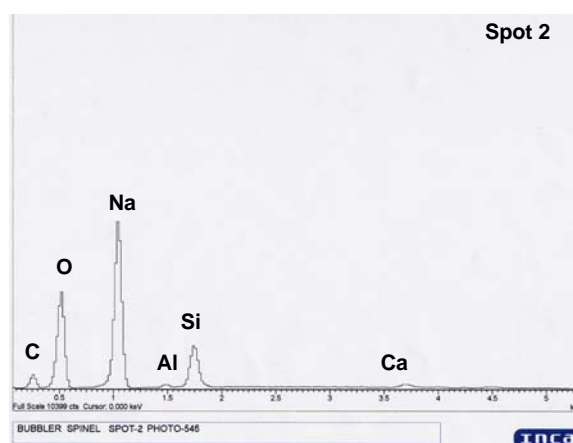
Figure 5. Analysis of deposit at inlet of the platinum nozzle. a) XRD spectrum of spinel deposit, b) SEM photograph of spinel deposit, c) EDS spectrum of spinel crystal, and d) EDS spectrum of a second phase in the deposit.

Spinel formation was noted at the inlet of each nozzle. The deposits were large enough to completely cover the air passage at the inlet of the nozzle. Although the deposits were extensive, they were porous and did not impede the air flow for the duration of the test. The propensity of the glass to form various spinel phases during the test at Clemson may have been increased because the melter pot was made entirely from 690. Even minimal corrosion of the 690 in this system may have increased the concentration of transition metals in the glass because of the large surface (690) to volume (glass) ratio. However, to minimize spinel formation during the operation of the DWPF production air lift pump, argon should be used rather than air to minimize oxidation of the 690 air passage. Disruptions in gas flow should also be avoided in order to minimize glass intrusion into the air passage. These operational controls should minimize the formation of spinel deposit and extend the life of the pump. The use of platinum or a platinum/rhodium alloy to line the air passage and as a nozzle should be further investigated in order to extend the operational life of the production pump.

- Argon gas should be used with the Inconel 690 pump to minimize oxidation and possible spinel formation.
- Recommendations for pump insertion, operation, and performance are as follows:

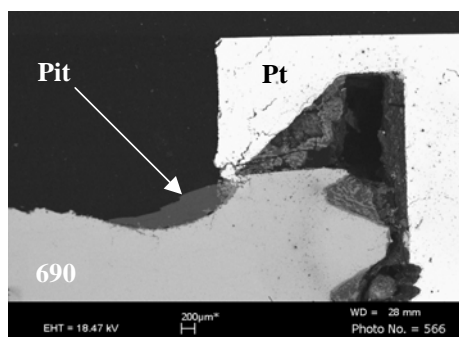
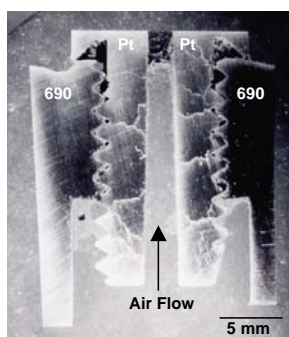
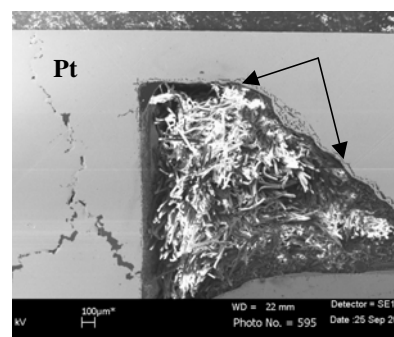
During metallographic preparation of the nozzle it became apparent that it had numerous cracks. Most were radially oriented between the threads to the air passageway but some were observed parallel to machined surfaces (Figure 6). Both the platinum and 690 threads showed evidence of degradation. A large pit was also observed in the 690 adjacent to glass sealing surface between the housing and the nozzle. This was observed on both nozzles. A thick chromium oxide layer had developed on the threads indicating that oxidation of the 690 had occurred (Figure 7). Glass was found in all of the radial cracks, however; it was depleted in iron. Small particles of chromium oxide were also found deep within the cracks. It most likely originated from oxidation of chromium in the 690 and was carried into the cracks by the molten glass. Microstructural examination revealed intergranular cracking of the platinum with cracks running generally in a

Figure 6. Photographs of Pt nozzle and Inconel 690 housing. a) SEM photograph of pit adjacent to Pt nozzle, b) As-ground metallurgical specimen showing numerous radial cracks in the platinum, and c) SEM photograph showing cracking parallel to machined surface (arrows).

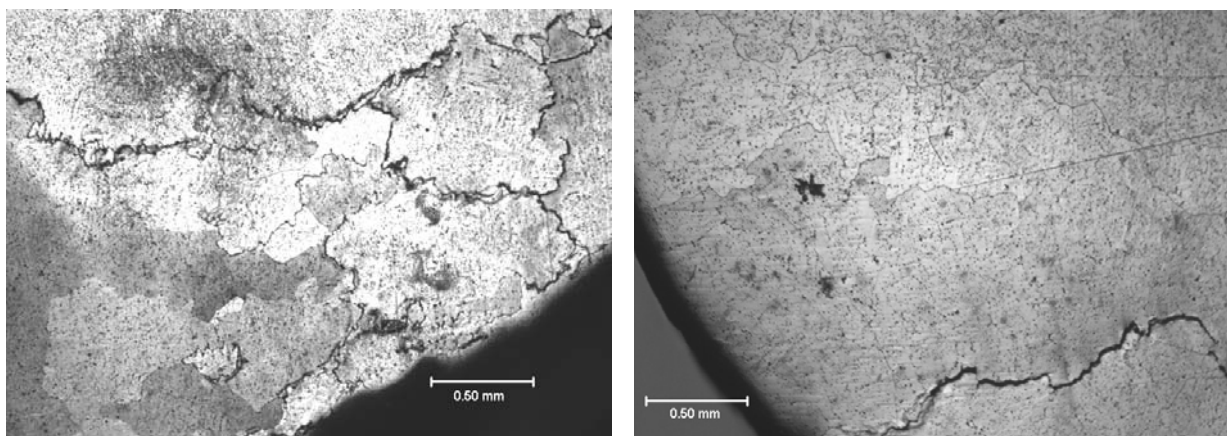
radial orientation. Grain size varied dramatically with some grains exceeding several millimeters in length (Figure 8).

Figure 8. Photomicrograph of the platinum nozzle. Cracks can be seen following grain boundaries. Some grains were as large as several millimeters in length. Etch, aqua regia, 60°C 20 to 40 minutes.

Severe intergranular cracking of the platinum/rhodium alloy had occurred. Several possibilities exist but the actual cause could not be conclusively determined. One possible explanation is that the melting practice and starting material may have embrittled the alloy. The starting material was old discarded crucibles, which were cleaned prior to processing, and were melted in an induction furnace using a graphite crucible as a susceptor. The reducing environment inside the crucible along with impurities in the crucibles may have reduced the contaminants and embrittled the alloy. Although this is plausible, no mention of cracking or unusual machining characteristics were observed during fabrication of the nozzles. A second explanation is that an interaction with the molten glass had occurred resulting in the observed intergranular attack. The pitting attack of 690 observed in the contact region between the Pt nozzle and the 690 housing most likely resulted from a galvanic attack (Figure 6a). Considering a galvanic couple between 690 and platinum, 690 would be more anodic and would therefore be expected to corrode preferentially. This galvanic interaction may have played a role in the initiation of the cracks. As-cast material was not saved; therefore, a direct comparison with the starting material was not performed. Generally the cracks were oriented in a radial direction which was perpendicular to the direction of the tensile force as the nozzle engaged the pump to form the glass seal. Cracks were also located around the nozzle outlet. This region should have been unaffected by the tightening of the threads, and therefore, in a low state of stress. It is possible that the peening operation may have induced some stress in this area but no gross deformation was visible. This may suggest that the applied stress did not play a significant role in the cracking of the nozzle and that chemical attack was the most likely cause. Further investigation

- Platinum or a platinum alloy should not be used on the production pump until the degradation mechanisms are fully understood. Immersion tests should be performed to evaluate the cause of the intergranular cracking, the extent of the galvanic potential between platinum and 690 under these conditions, and to optimize the design in order to increase performance and extend the pumps service life. The use of grain stabilized alloys should also be investigated.

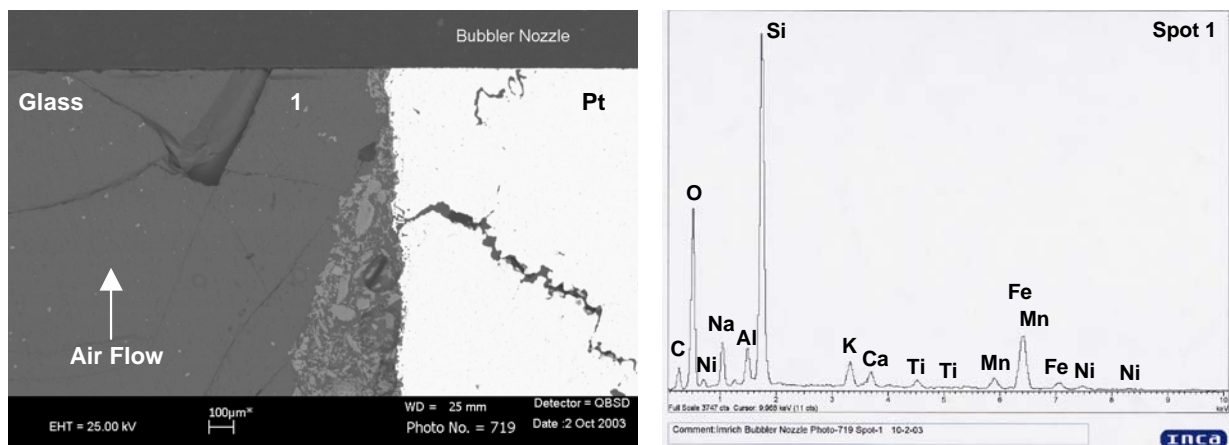
Figure 10. SEM photograph showing the air passage of the nozzle and a EDS spectra of the solidified glass. The glass is representative of the bulk chemistry and contains iron.
