Public Housing: A Tailored Approach to Energy Retrofits

Jordan Dentz, Francis Conlin, David Podorson,
and Kunal Alaigh

*Advanced Residential Integrated Energy
Solutions (ARIES) Collaborative*

June 2014

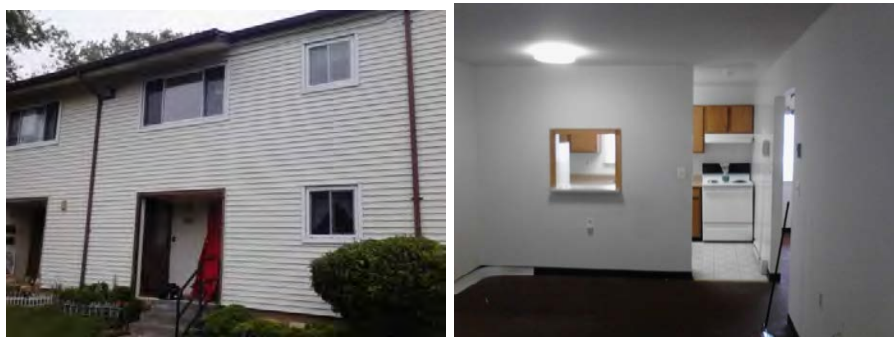
Figure 1. Typical IHA housing unit

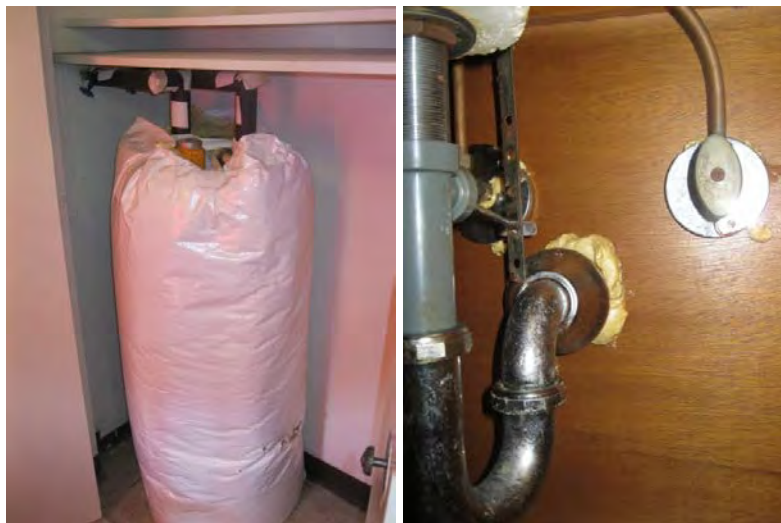
Figure 3. Electric storage water tank with insulation wrap (left) and foamed plumbing penetrations (right) at IHA

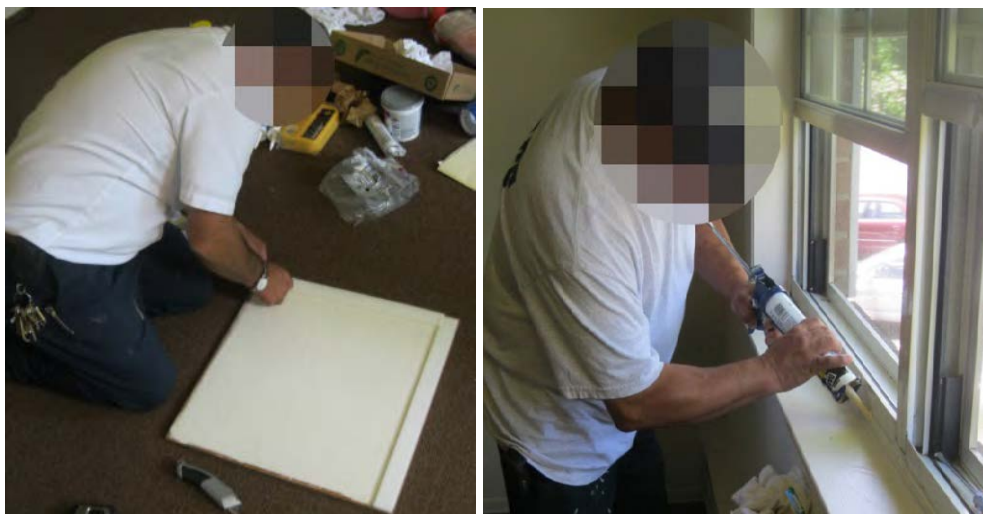
Figure 4. Installing gasket on attic hatch (left) and caulking gap around window (right) at IHA

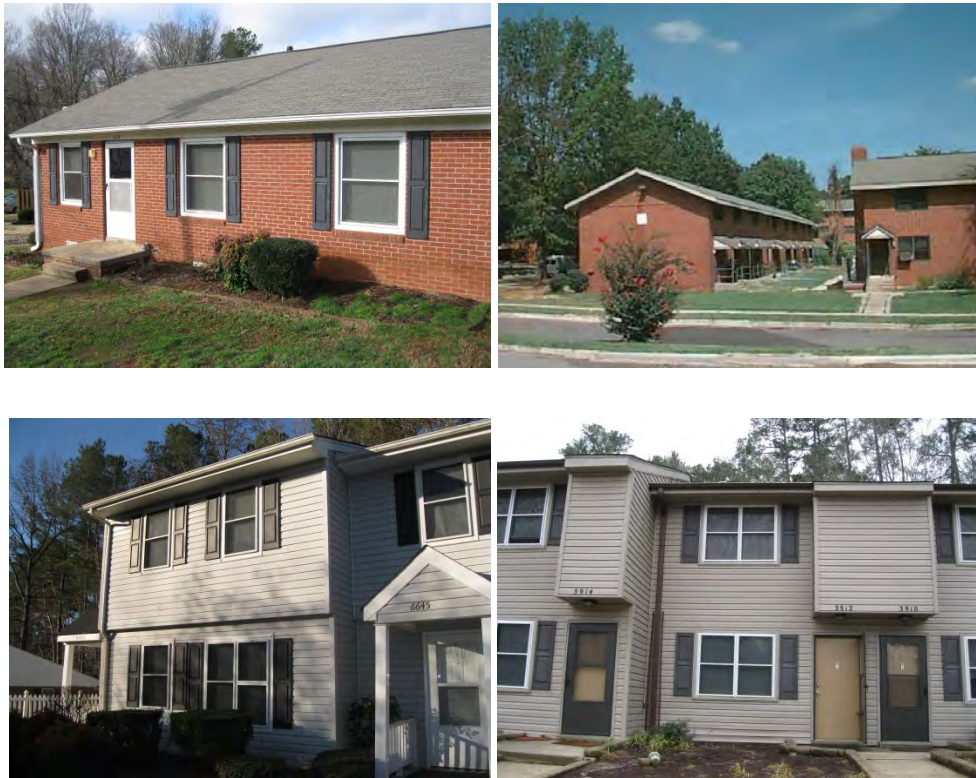
Figure 7. Typical RHA housing units

| Inspection Item | Findings |
|---|---|
| Envelope Leakage | Blower door test results (unguarded, ACH50): ranged from 17 to 25 with an average of 20.2 |
| Ducts | Average duct leakage to outside tested 29 CFM25/100 ft ² ; average total duct leakage 31 CFM25/100 ft ² ; ducts very dirty |

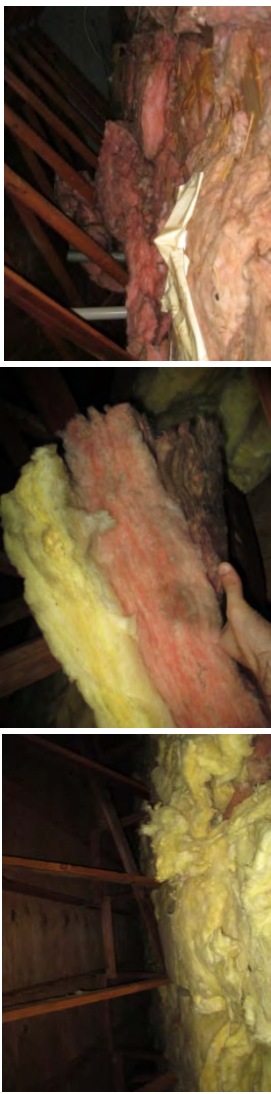
| | LOCATION | INSTRUCTIONS | MATERIALS | PHOTOS |
|---|--|--|---|--|
| ATTIC | 20. Attic insulation depth and distribution | Check that ceiling insulation is dispersed evenly without gaps, is free of water damage, and covers rafters and other framing members fully to the exterior walls. Re-arrange insulation or supplement if necessary. | Flashlight, attic insulation | <p>Poor insulation condition:</p> |
