# **Incident Analysis Report: B696 MOVER Event, August 19, 2004**

**Report Serial Number: 0514**

**November 11, 2004, Rev. 1**

Lawrence  
Livermore  
National  
Laboratory

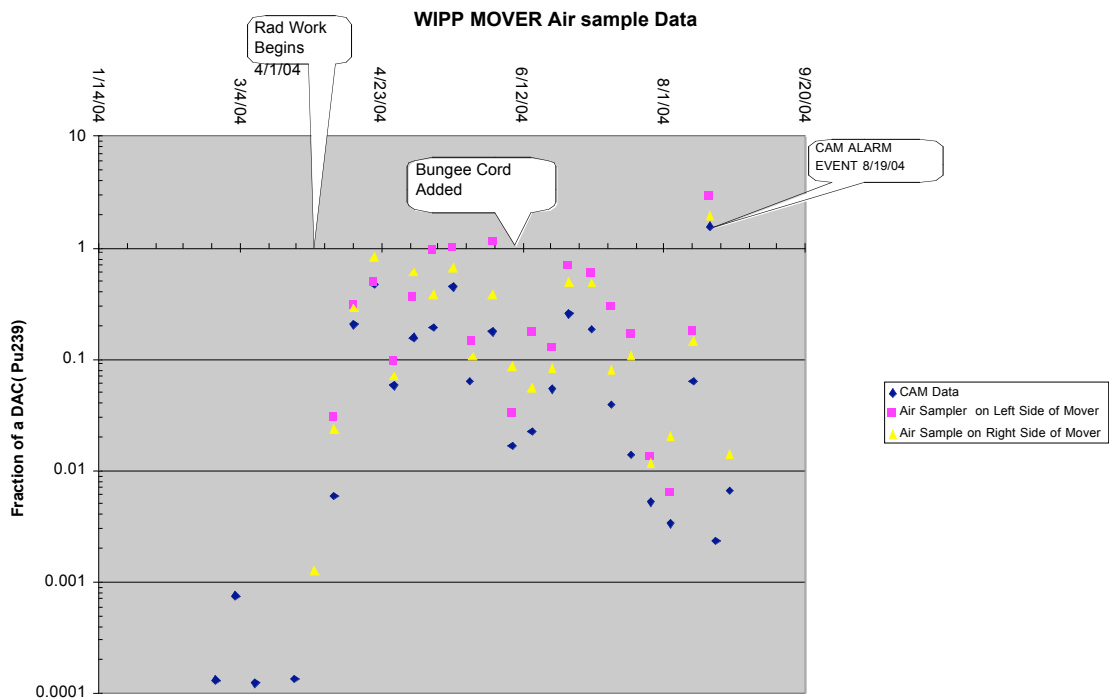
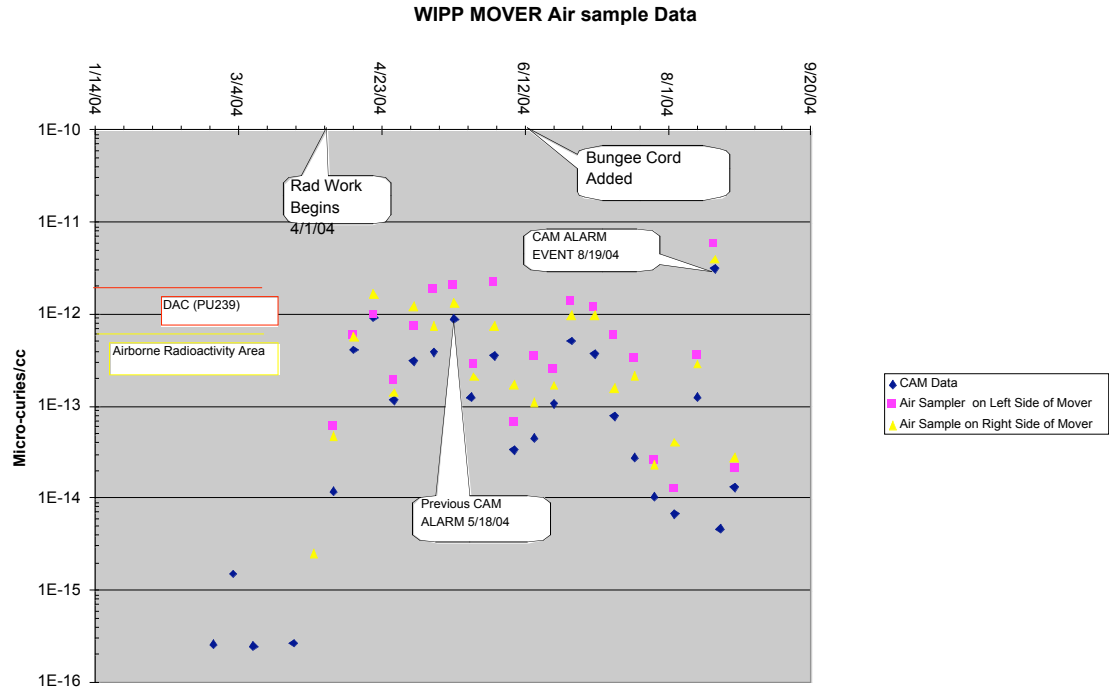
Figure 5. Air sample data show a chronic airborne radioactivity condition present in the MOVER from April 1, 2004, through August 19, 2004.

Most of the positive airborne radioactivity samples were less than the activity level that would have caused the CAM to alarm, and many were below the notification level employed by the Radiation Measurements Laboratory (RML) of  $10^{-13}$   $\mu\text{Ci/ml}$ . As a precaution, the HP placed MOVER workers on a monthly bioassay program versus the standard semi-annual sampling program. Radioactive contamination control swipes indicated that very little contamination was spread during the entire period of MOVER operation.

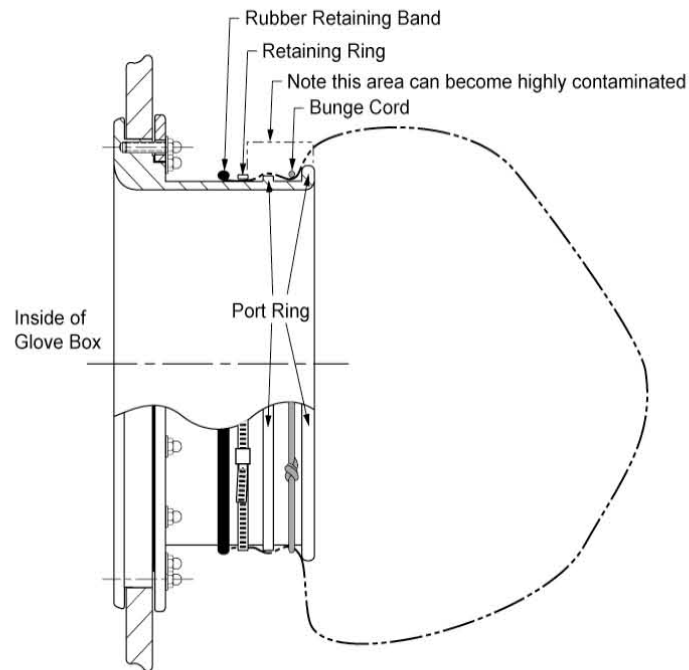
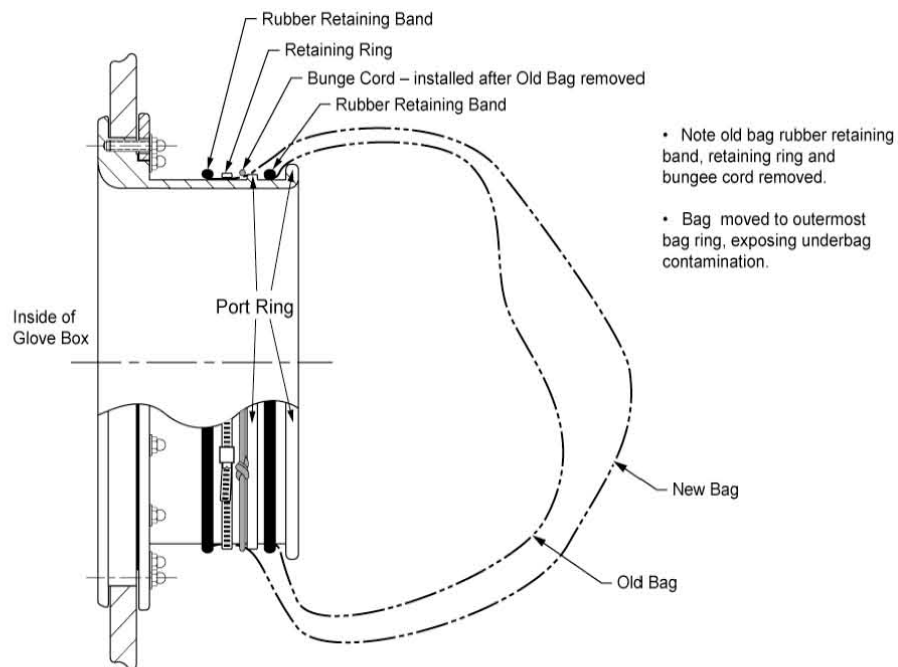
Figure 6. MOVER working configuration (top) and bag-change configuration (bottom).

During the August 19, 2004, event, MOVER operators observed that the retaining band was not tightened adequately. CCP personnel attributed the problem to a worn clamp-tightening screw, and the clamp was subsequently replaced. The IA Committee believes that the clamp mechanism was never completely effective even in its normal state, and its degraded condition would have allowed more contamination to make its way through the retaining clamp to the area up to the rubber retaining ring. A third mechanism for providing a contamination seal (installed in June as suggested by LLNL ES&H personnel) was a bungee cord installed around the bag on the outboard side of the hose clamp to attempt to seal the drum bag to the bag port. The bungee cord had several knots, and the end hooks were still attached. The presence of knots and hooks, and the absence of pressure adjacent to them, provided for channels that contamination could pass through. Although the bungee cord may have had some effect on reducing contamination on the glovebox bag port, it was not totally effective as a seal.

Thus, the three sealing methods discussed above each provided a tortuous pathway for material to enter the air in the MOVER. As a result, a small amount of material could easily escape through the three compression seals because each had a leak path to the next seal, and eventually through the bag port interface.

When bags at the MOVER are left on the innermost port ring (closest to the glovebox), contamination can migrate along the port ring. When a bag needs to be changed, personnel remove the retaining (hose) clamp and rely completely on the rubber retaining band and move it to the outermost port ring. This operation physically scrapes areas that were previously exposed to the glovebox environment and leaves them exposed. Contamination in excess of tens of thousands of counts was observed on the bag port. The area was then decontaminated before the bag-change process continued. The Incident Analysis Team believes that operating processes resulting in conditions that required routine decontamination are less than adequate. Moving the drum bag to the first port ring could eliminate this contamination area along with the need to continuously clean the area of contamination. The combination of bag design and bag-installation techniques resulted in leak paths for contamination to exit the MOVER glovebox and become airborne.

| <b>Topic</b> | <b>MOVER</b> | <b>LLNL Plutonium Facility</b> | <b>Comments</b> |
|---|---|---|---|
| Bag material and design | Bag is very stiff; extra bag material causes micro-channels past sealing area. Rubber retaining band appears to not provide a tight seal of bag to port. Retaining band uses ~1-in. metal clamp to join the two ends of material into a round ring. | Material for bag is pliable and has minimal extra material at O-ring to minimize micro-channels. Rubber O-ring (continuous piece of material) provides a relatively tight seal to bag port. | MOVER bag design does not provide an adequate seal during operations. |

| No. | Judgments of Need | Related causal factors |
|---|---|---|
| JON1 | LLNL needs to recommend to the Vendor that their design of the seal between the bag and drum port be redesigned to achieve an effective seal. This need includes, but is not limited to, recommending that the Vendor evaluate the current process against other, more-effective interface-seal processes used in gloveboxes to seal the drum port/bag interface; modifying their seal process based on their evaluation; and evaluating the current drum port bags against other drum port bags and providing an effective drum port/bag interface seal. | <b>RC1</b> , CC1 |

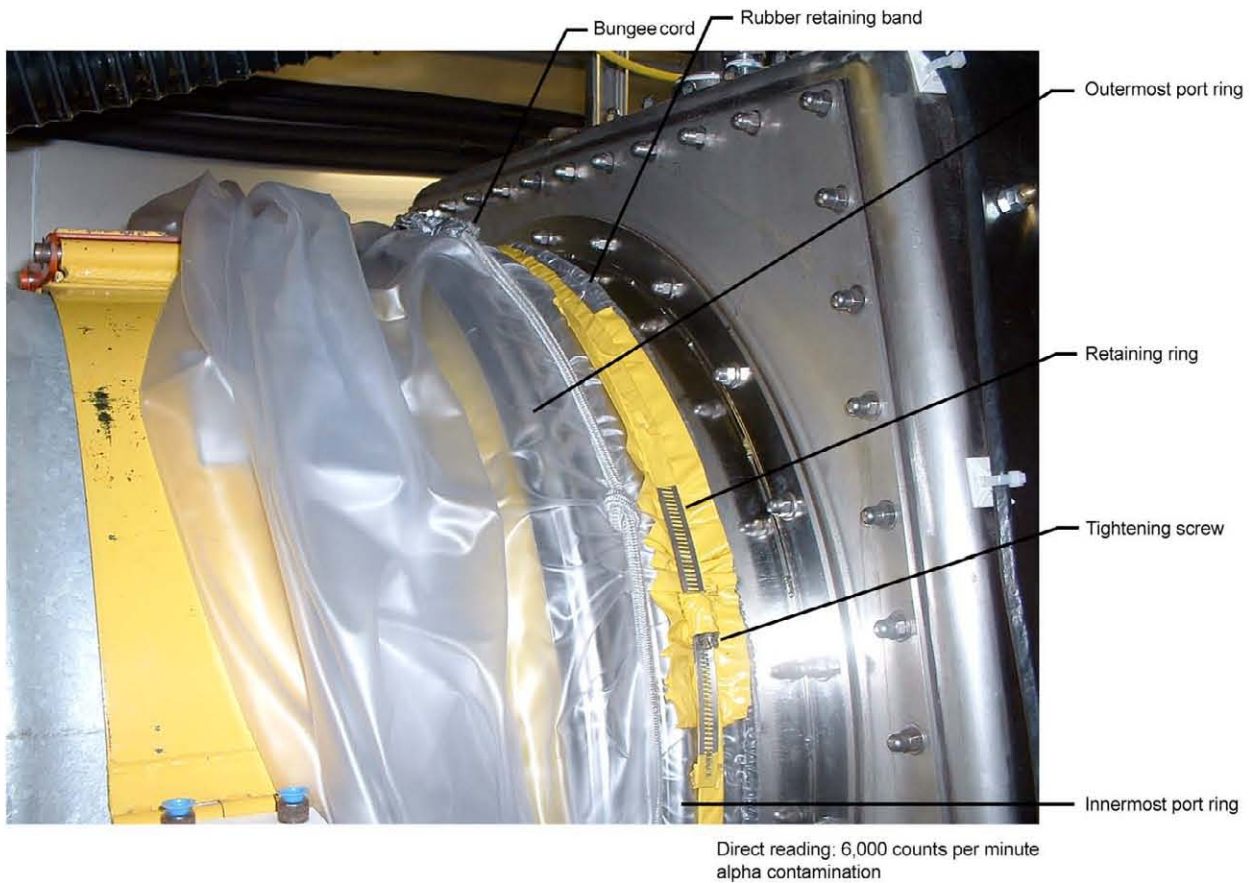
Figure 8. Photo of MOVER configuration, August 19, 2004, showing bungee cord, rubber retaining band, retaining ring, and tightening screw.

Whereas the CCP design used two contamination rings to provide a seal, neither was effective. HP 1 and the HP SME identified the potential for leakage at the bag/bag-port interface. Their recommendation for an additional bag seal (bungee cord) was also ineffective in correcting this leak path. A positive seal of bag to the bag port is needed. A demonstrated and effective way to accomplish such a critical seal is to use 2-in.-wide vinyl tape overlapping the bag to the port.
