# **Examination of the 1970 National Bureau of Standards Underground Corrosion Test Welded Stainless Steel Coupons from Site D**

January 2008

**Idaho National Laboratory  
Environmental Management Science Program  
Idaho Falls, Idaho 83415**

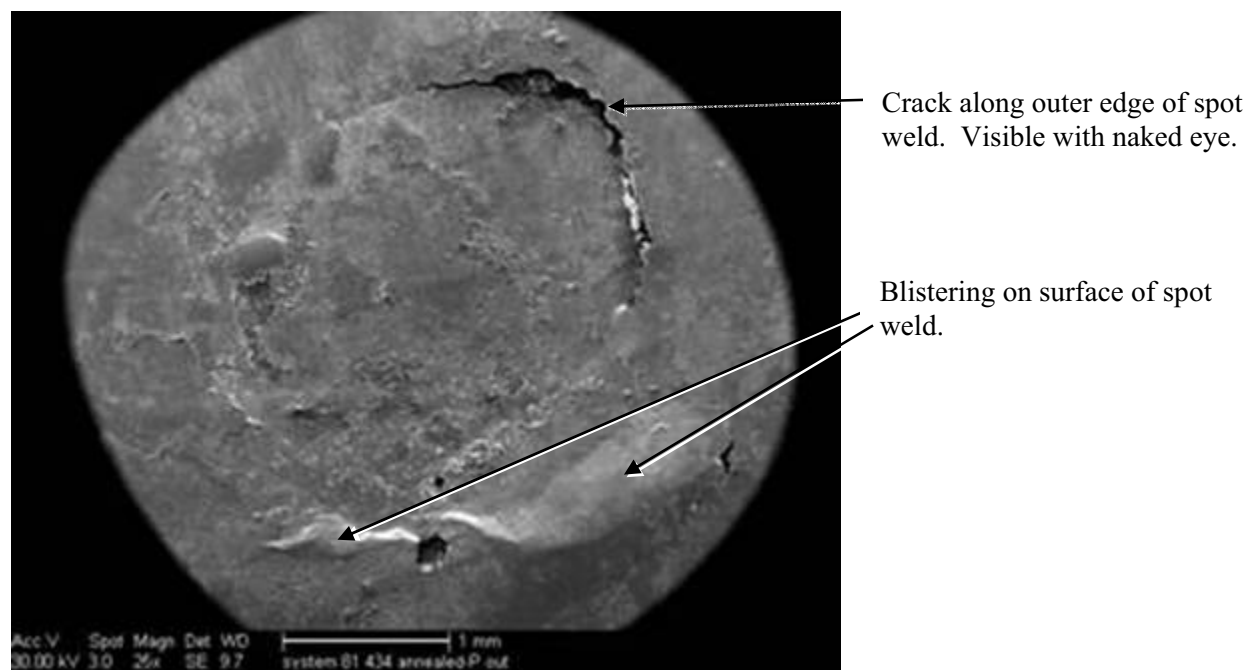
Figure 37. System 81 (Type 434) ESEM 25X photograph of spot weld.

System 81 (Type 434) shows a large amount of corrosion scale and build up of corrosion material in comparison to other system materials. The extent of the corrosion damage is further shown in Figure 38, a Back Scatter Electron (BSE) image of System 81. The BSE images have the advantage of showing the contrast of an image based on an element's Z number. The higher the Z number, weighted average of the element's Z numbers, the brighter an area will appear. This mode is ideal for finding grain boundaries and/or cracks running through sample material, and in System 81, the base material appears much brighter than the weld and corrosion areas. Within the weld are many varying shades, gray to black. These varying shades of darkening can be directly attributable to the amount of corrosion product and/or missing base metal. The spot weld appears porous using the BSE process. The EDS data correlates with the ESEM images (System 81 overlay) such that the corrosion product is chromium rich in comparison to the base metal.

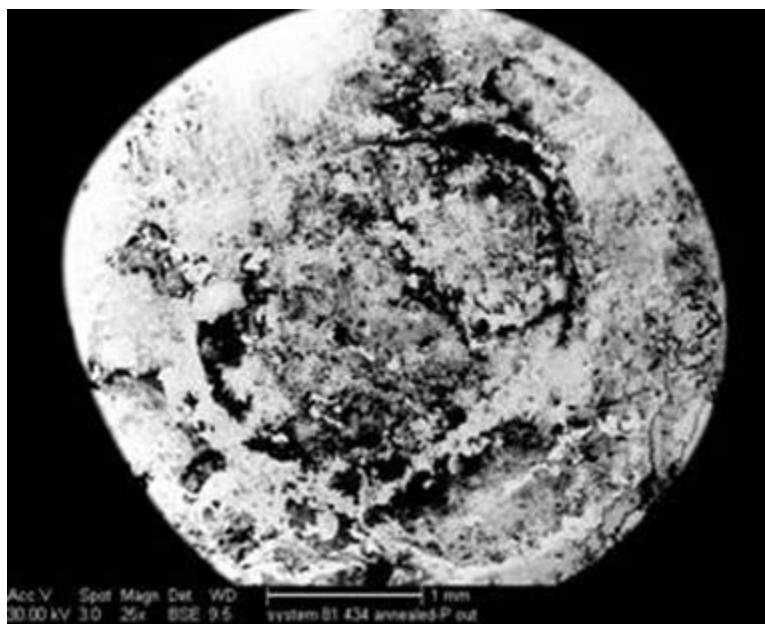
Figure 38. Back Scatter Electron image of System 81 (Type 434).

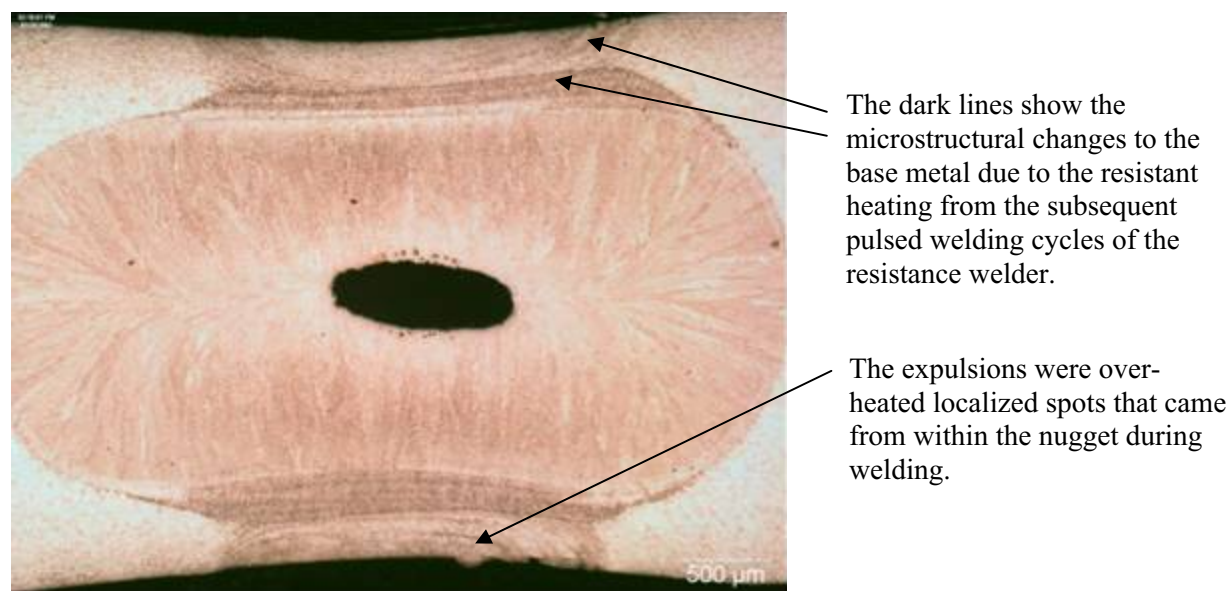
Figure 39. System 68 (Type 301) 25X photograph of cross section. No corrosion visible.

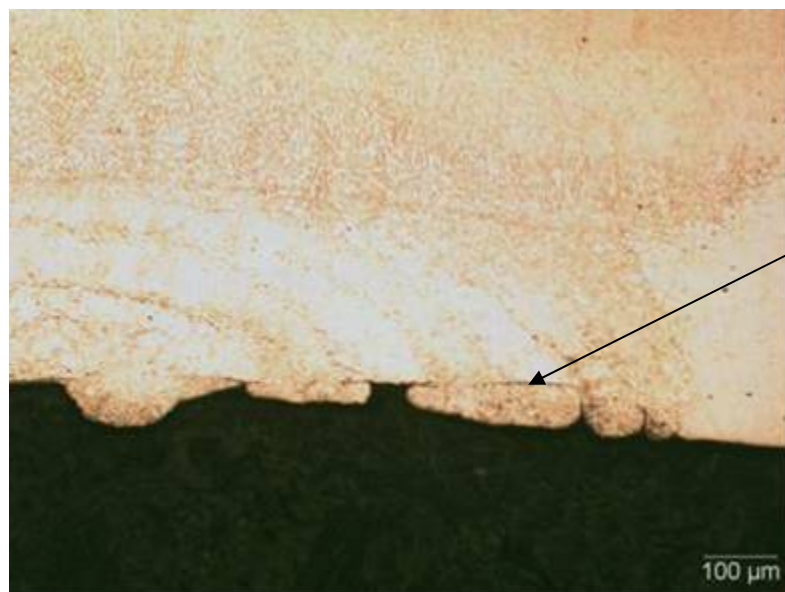
The expulsions erupted out from the base metal, re-solidified on the surface, and were flattened by the resistance welding electrodes while the metal was still hot. The expulsions were given a spectrographical analysis and the copper values were higher due to the contact with the copper electrodes during welding.

Figure 40. System 68 (Type 301) 100X photograph of expulsion.

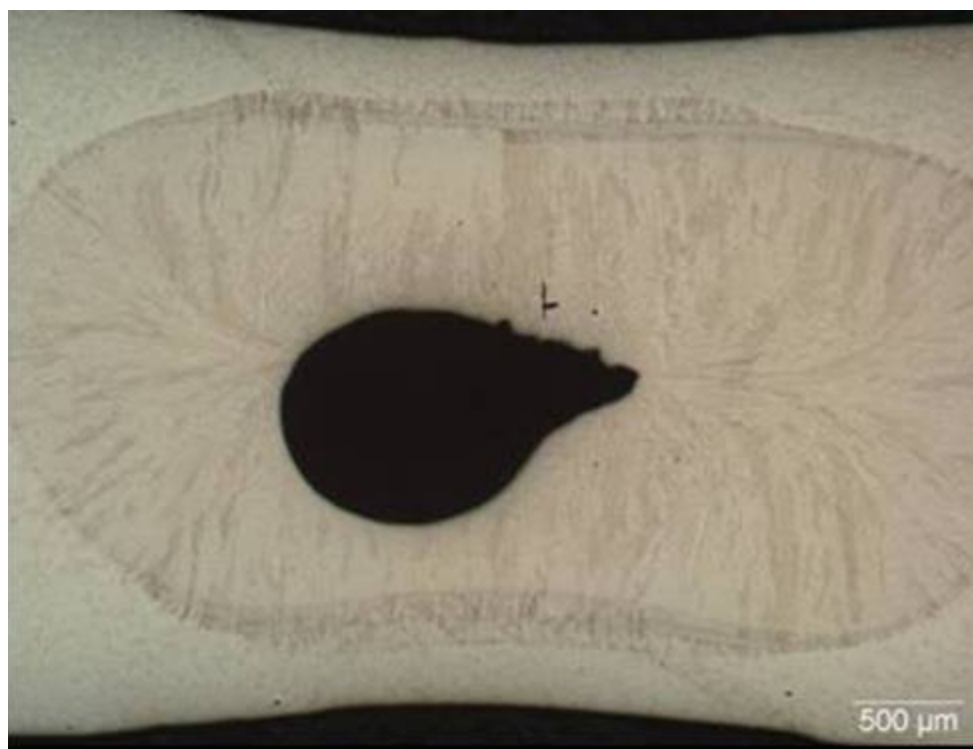
Figure 41. System 71 (Type 301) 25X photograph of cross section with large shrinkage void. No corrosion visible.

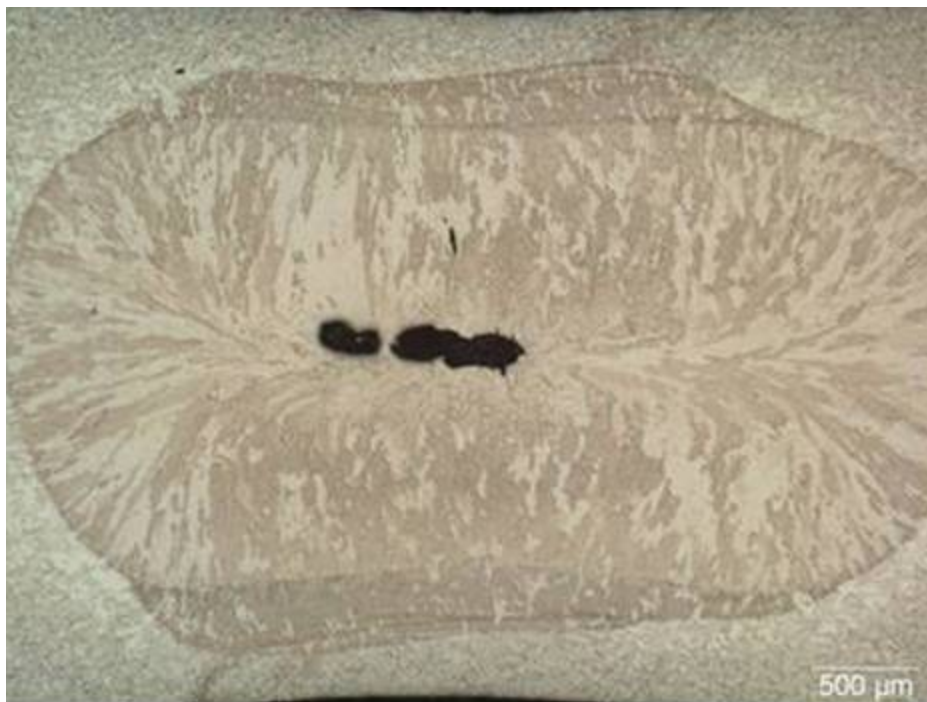
Figure 42. System 73 (Type 304) 25X photograph of cross section with small shrinkage voids. No corrosion visible.

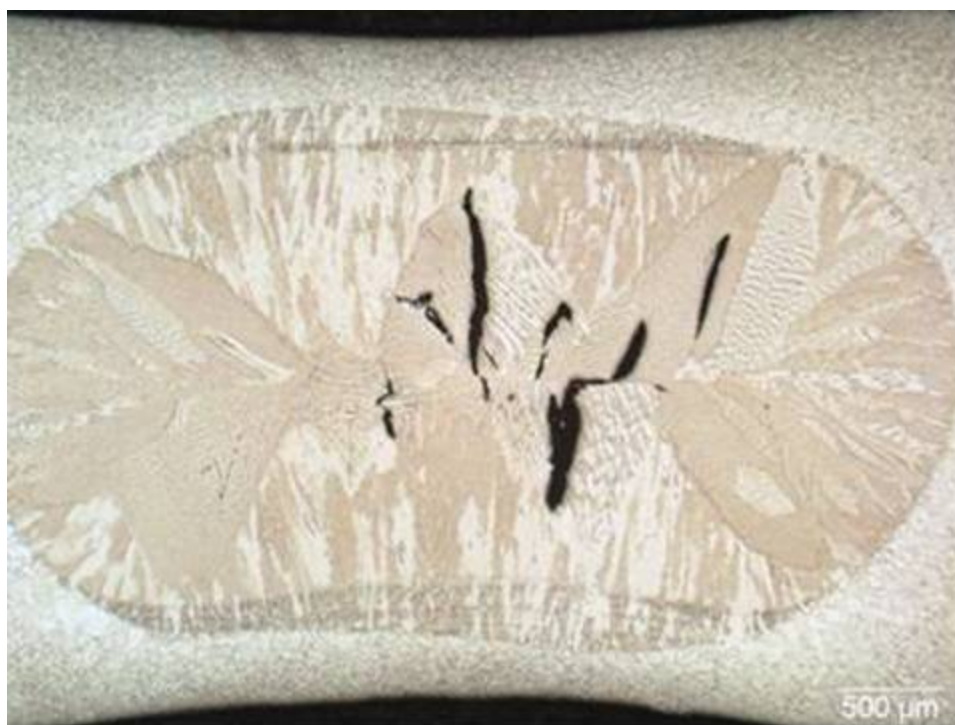
Figure 43. System 75 (Type 304) 25X photograph of cross section with small shrinkage voids. No corrosion visible.

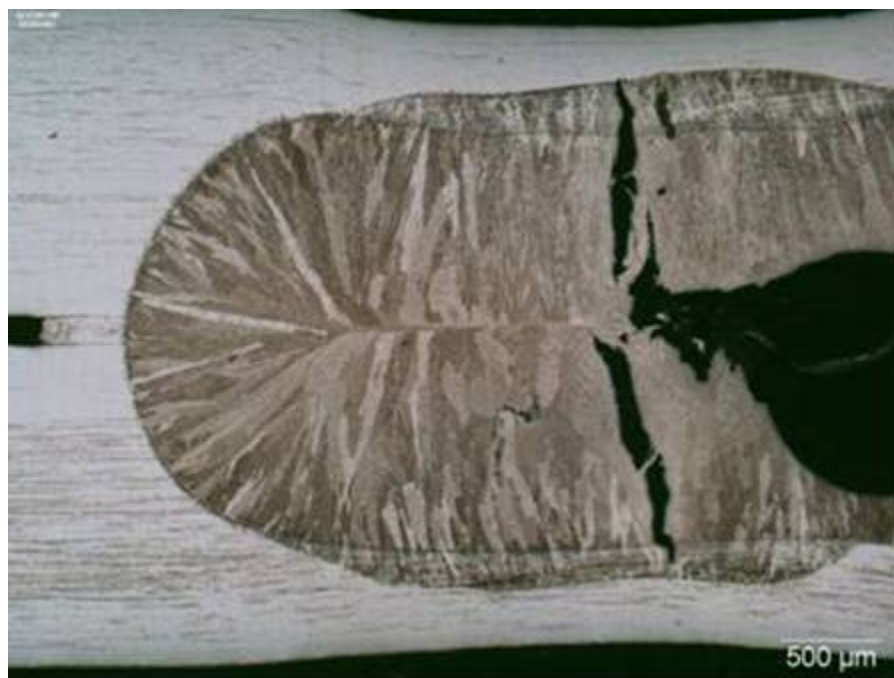
Figure 44. System 78 (Type 316) 25X photograph of cross section with large shrinkage voids. No corrosion visible.

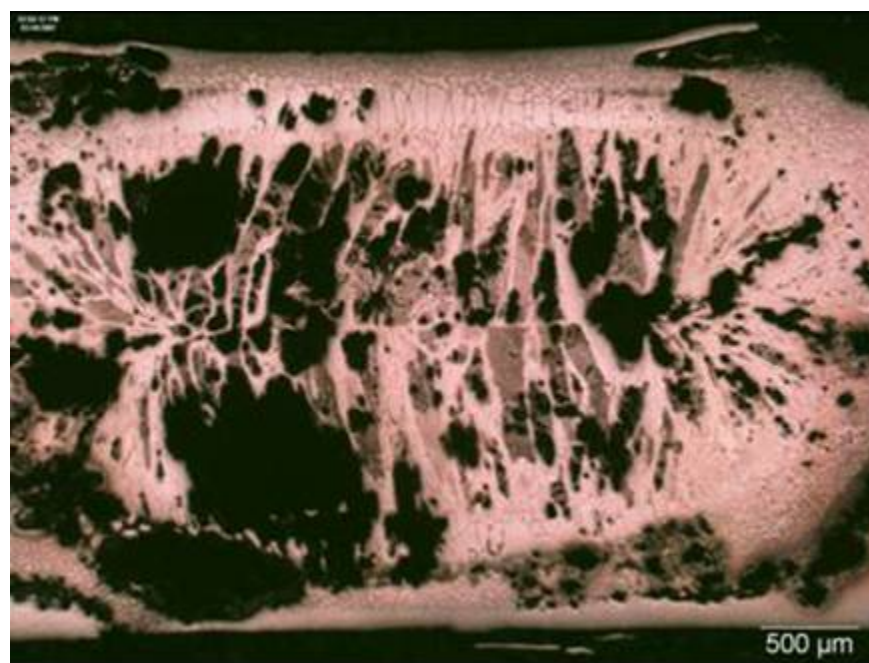
Figure 45. System 81 (Type 434) 25X photograph of cross section with severe corrosion.

Any shrinkage voids due to welding is not known, but the corrosion was extreme. The Lippold report in Appendix A details the corrosion of the Type 434 material more thoroughly.

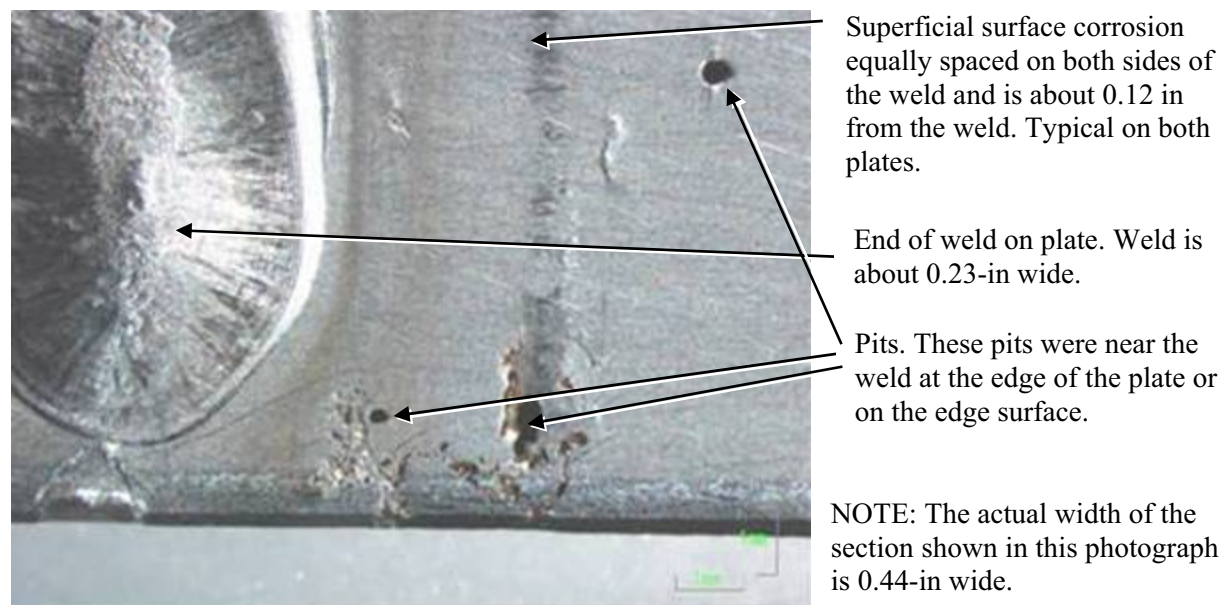
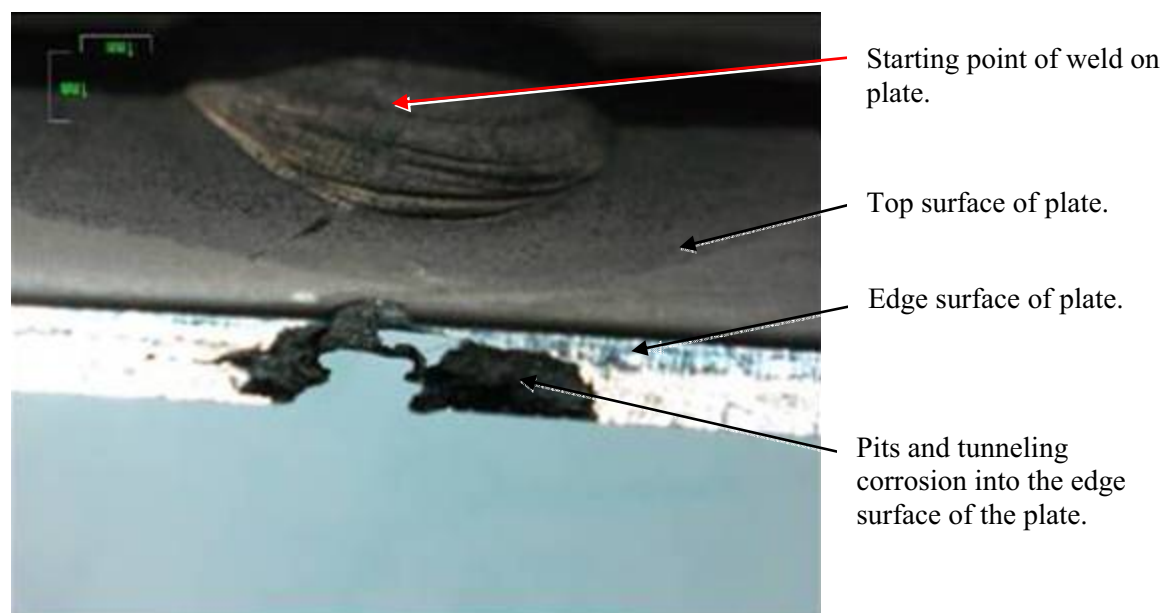
The two cross-bead plate coupons were essentially identical in outward appearance. (See Figures 15-18.) The surfaces had no general corrosion, just slight rust staining, but they looked remarkable for being buried for over 33 years. There was, however, several small pits found both at the edge near the end of the welds and on the edge surface of the plate of sample 54D20 (see Figure 46 and 47). Pits were also found on sample 54D19.

Figure 46. Close-up top view of end of weld at edge of plate on sample 54D20.

Figure 47. Close-up end view of plate at the beginning point of weld on sample 54D20.

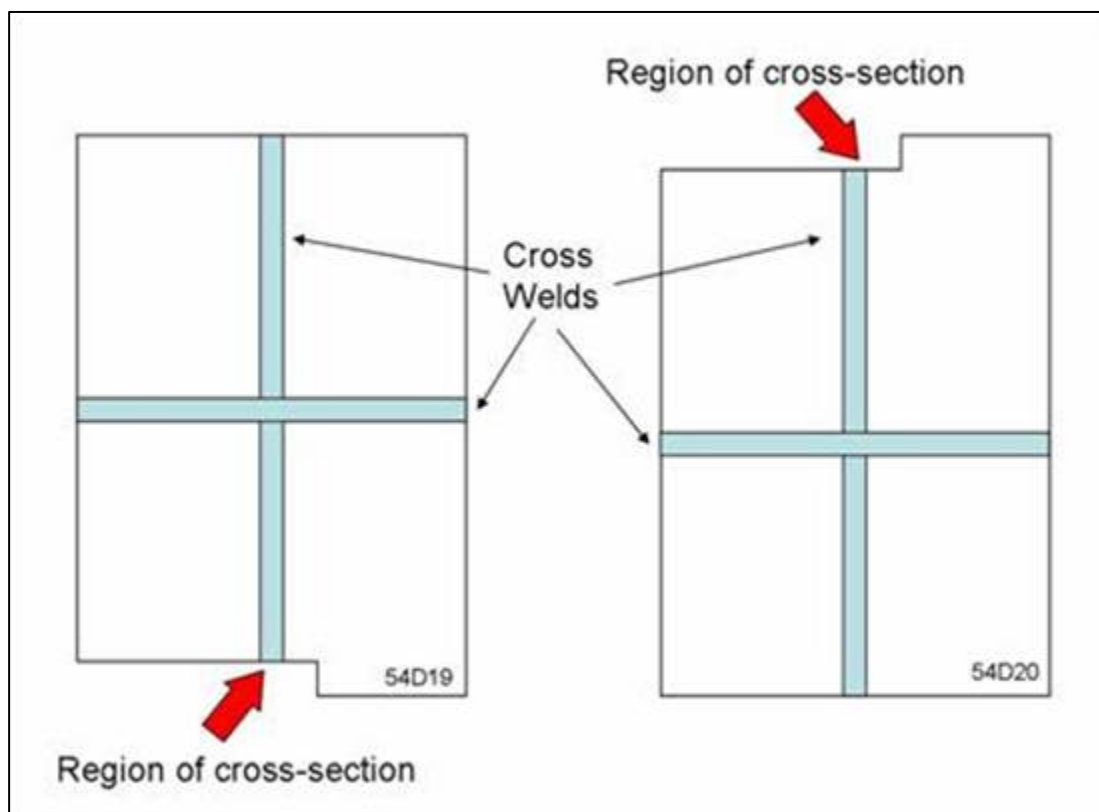
Figure 48. Locations on plates where pits were located and where sections were removed.

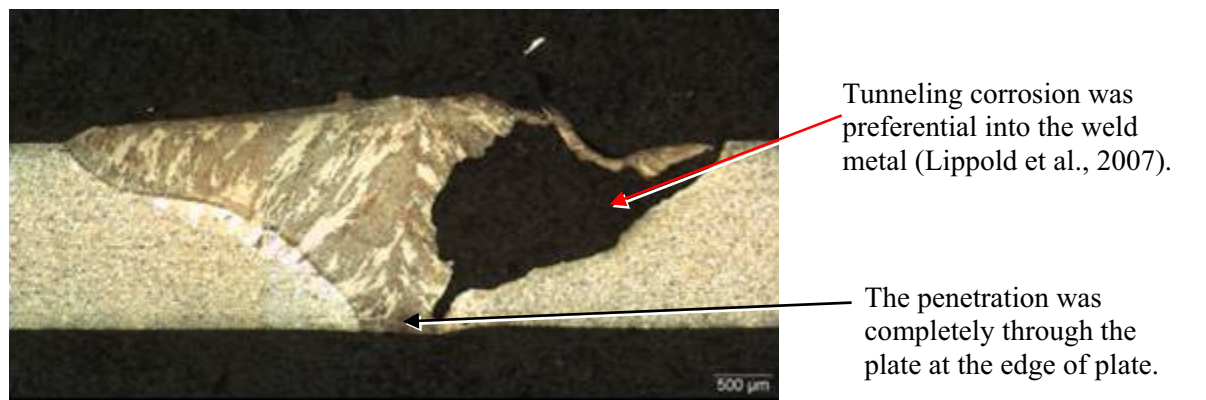
Figure 50. Tunneling corrosion in the weld metal.

The corrosion in these plates is identical to what was reported by the NBS in 1981 (Gerhold et al., 1981). In 1981, they reported the plates had pitting and tunneling along and adjacent to the weld and at the plate edge. In an informal discussion with Edward Escalante, one of the former NBS researchers, he stated that he believed that the tunneling corrosion may be accentuated by gravity. The plates were buried into the trenches with the long direction of the plate vertical. The tunneling observed in the cross-section sampled from the top and bottom edges of the welded plate was directed in the long direction of the plate along the weld. The cause of the tunneling corrosion will be further investigated in examinations of the non-welded samples.

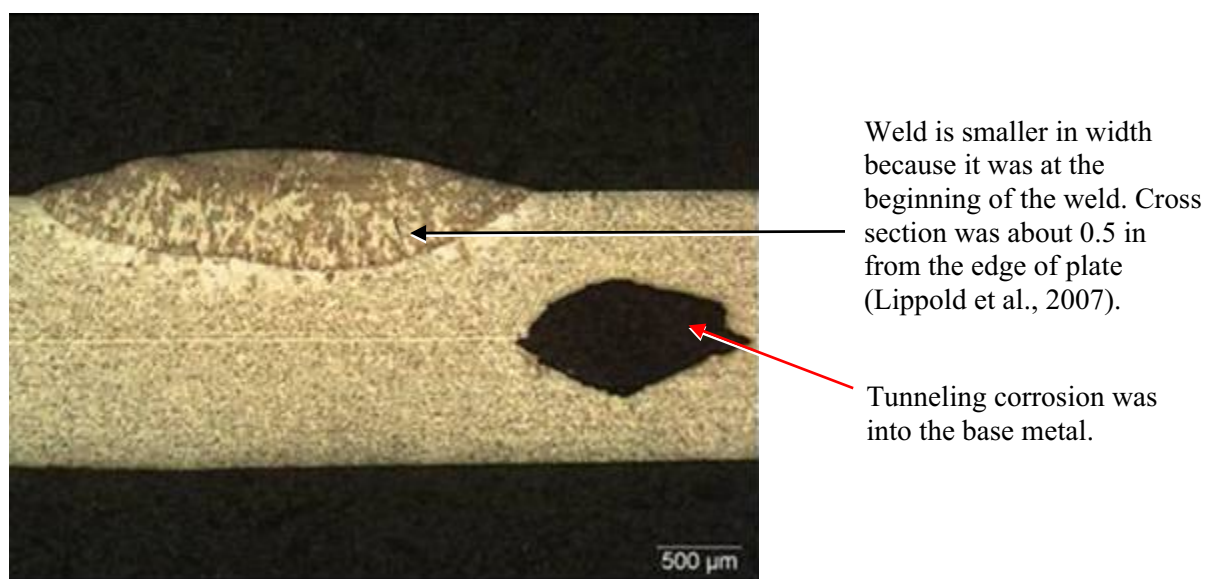
Figure 51. Tunneling corrosion was into the base metal.

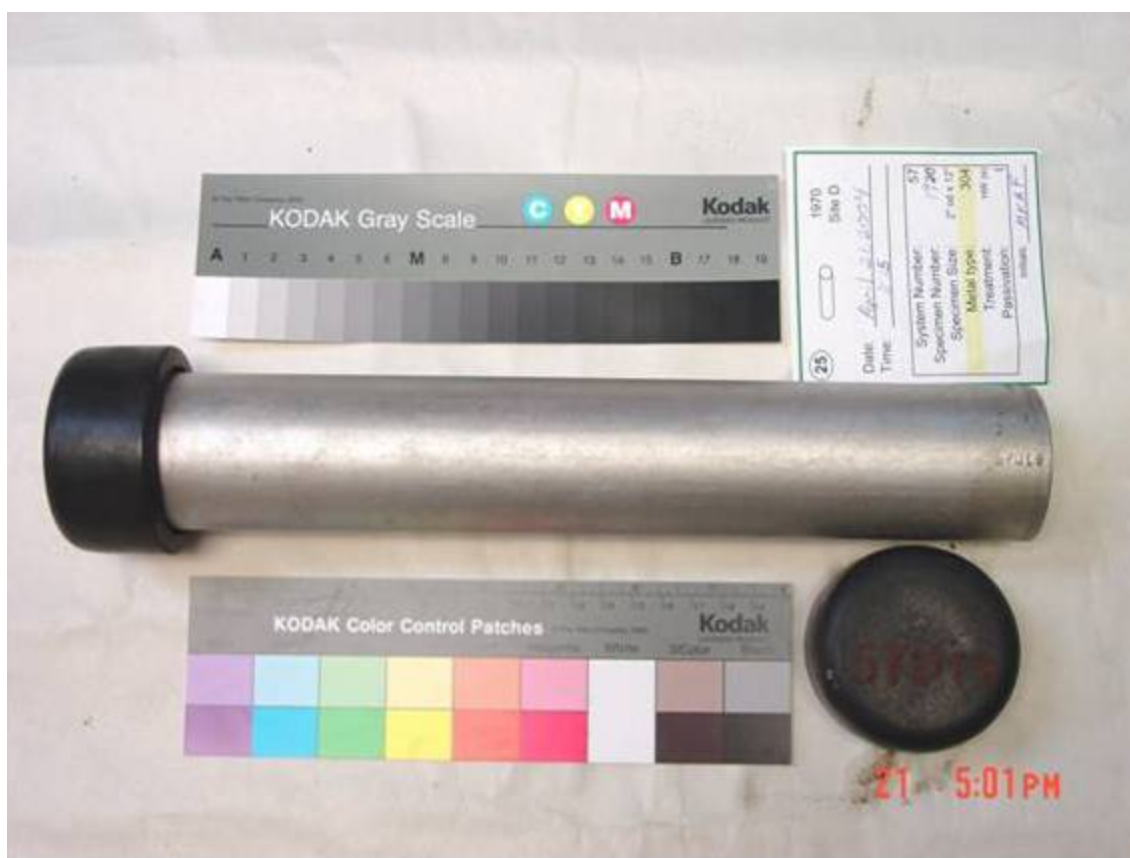
The two tubes were essentially identical with no observable general or surface corrosion. Upon examination, the surface showed an etched condition. The etched condition concurred with the results of the NBS report. The welded tubes, samples 57D19 and 57D20, were given a total anneal according to the specifications in ASTM A249. The welds were performed by GTAW, and upon examination, the tubes showed no internal/external general corrosion or attack. Aside from a few isolated surface localized pits under the rubber stopper, there was no obvious corrosion after 33 years. Figure 52 shows the lack of corrosion on sample 57D19 upon removal.

Figure 52. System 57, Type 304 GTAW welded coupon with removed rubber stopper.

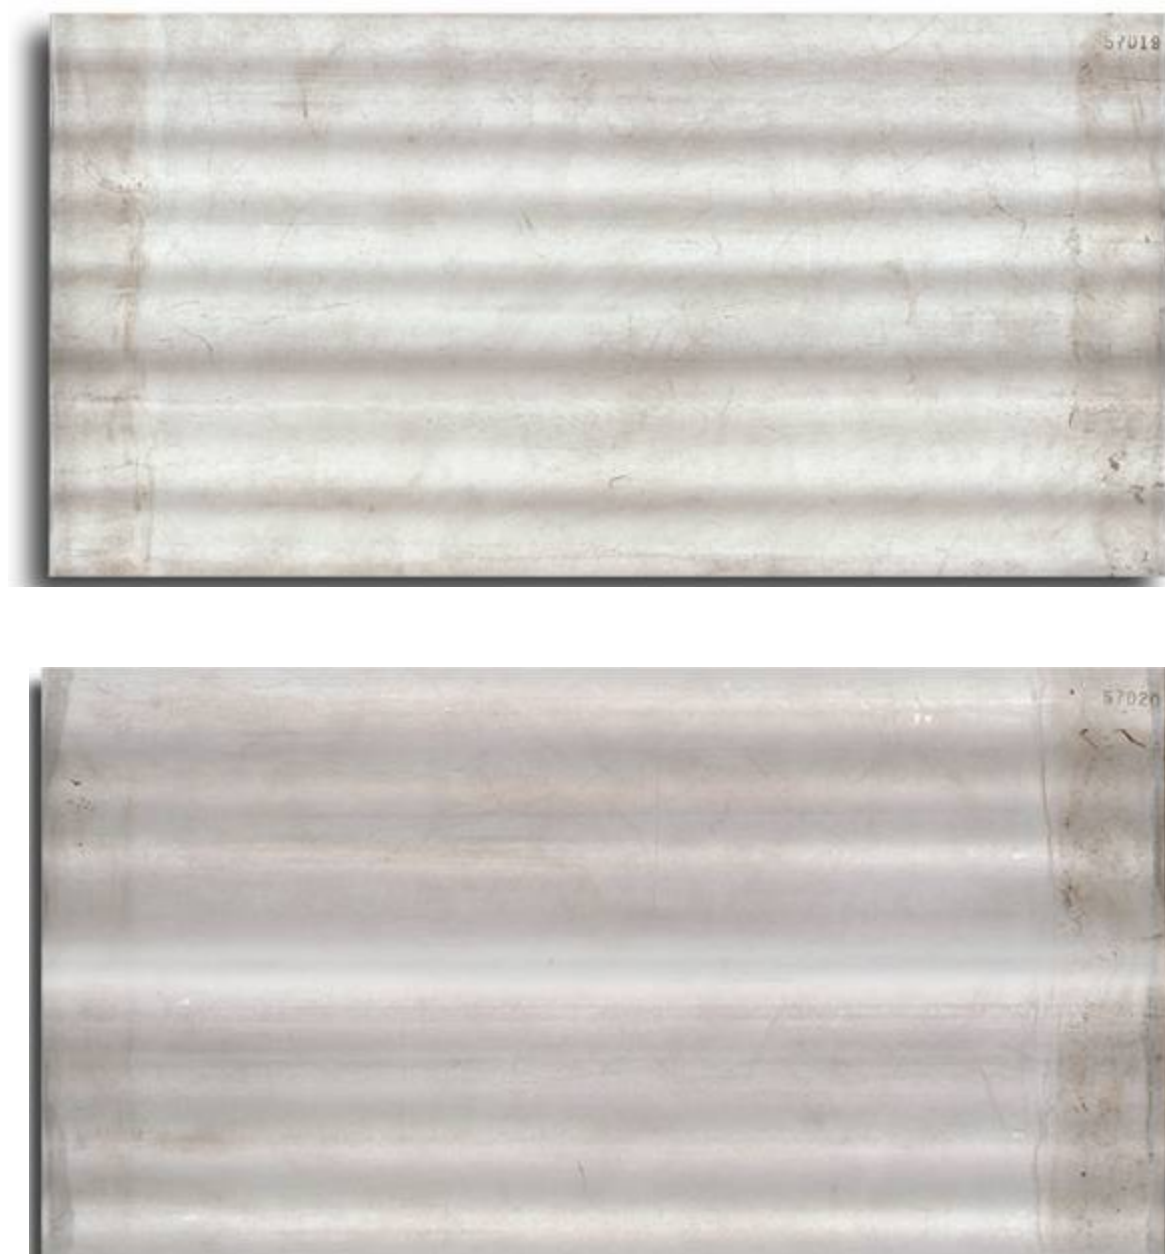
To better show a comparison of the corrosion on the two system 57 welded coupons, a series of photographs were taken of both coupons. These photographs were digitally combined to form a collage of the whole tube. The tubes show minor staining from under the cap. These two are shown in Figure 53.

Figure 53. System 57 collages, coupons 57D19 and 57D20.

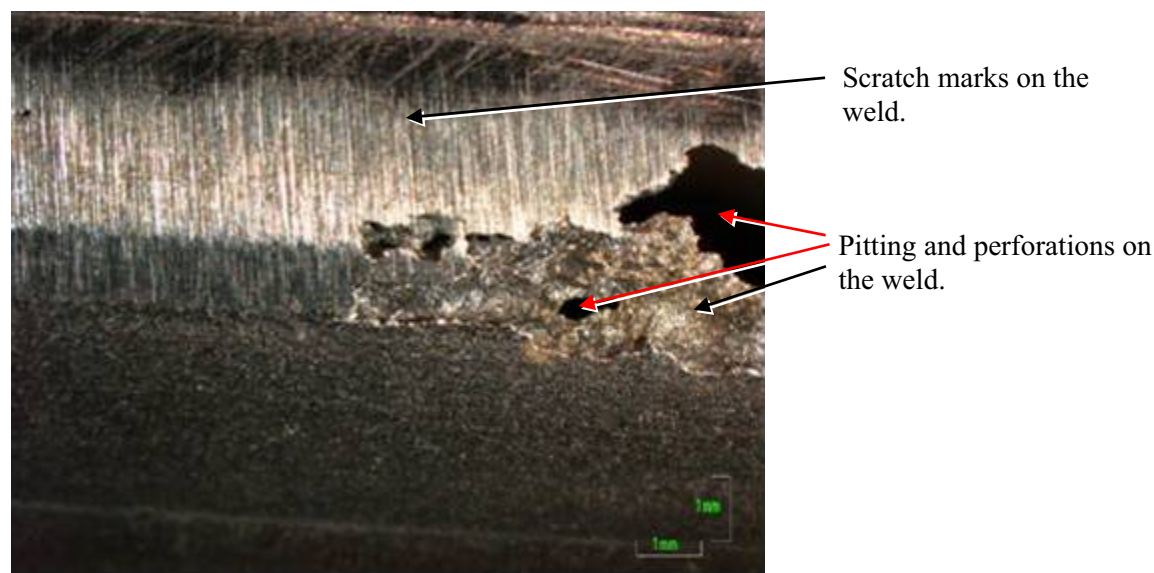
The corrosion attack—pitting, tunneling (perforations)—occurred preferentially along stringers or intermetallic inclusions oriented parallel to the rolling direction of the sheet from which the tube was fabricated. Crevice corrosion (i.e., pitting and tunneling) under the rubber caps was extreme. Coupon 62D19 had much more corrosion on it than coupon 62D20. These tubes were rolled and then seam welded using the GTAW process. Corrosion was evident adjacent to and on the weld, on sample 62D19, but there was more corrosion observed in the base metal away from the weld and heat affected zone (HAZ). Welding or the affect of welding did not appear to provide more corrosion sites. The rubber end caps did accentuate the crevice corrosion on this ferritic stainless steel material, Figures 54 and 55. The corrosion of System 62 reported in the NBS 1981 report states that similar corrosion was evident then as now.

Figure 54. 10X photograph of corrosion on sample 62D19 weld. Weld is the sanded surface.

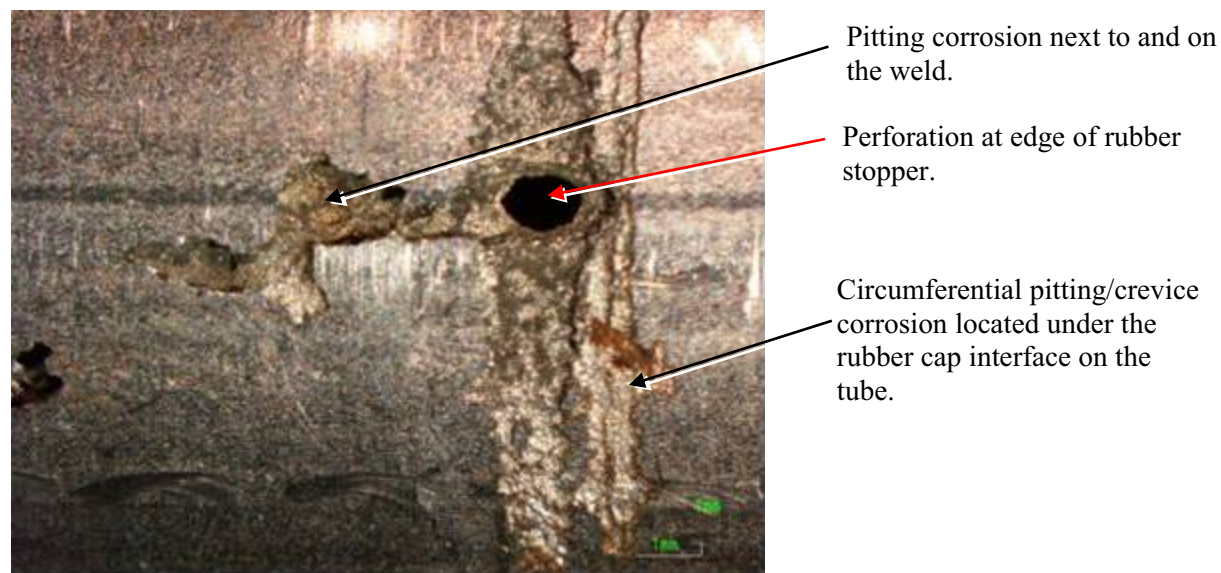
Figure 55. 10X photograph of general and crevice corrosion sample 62D19.

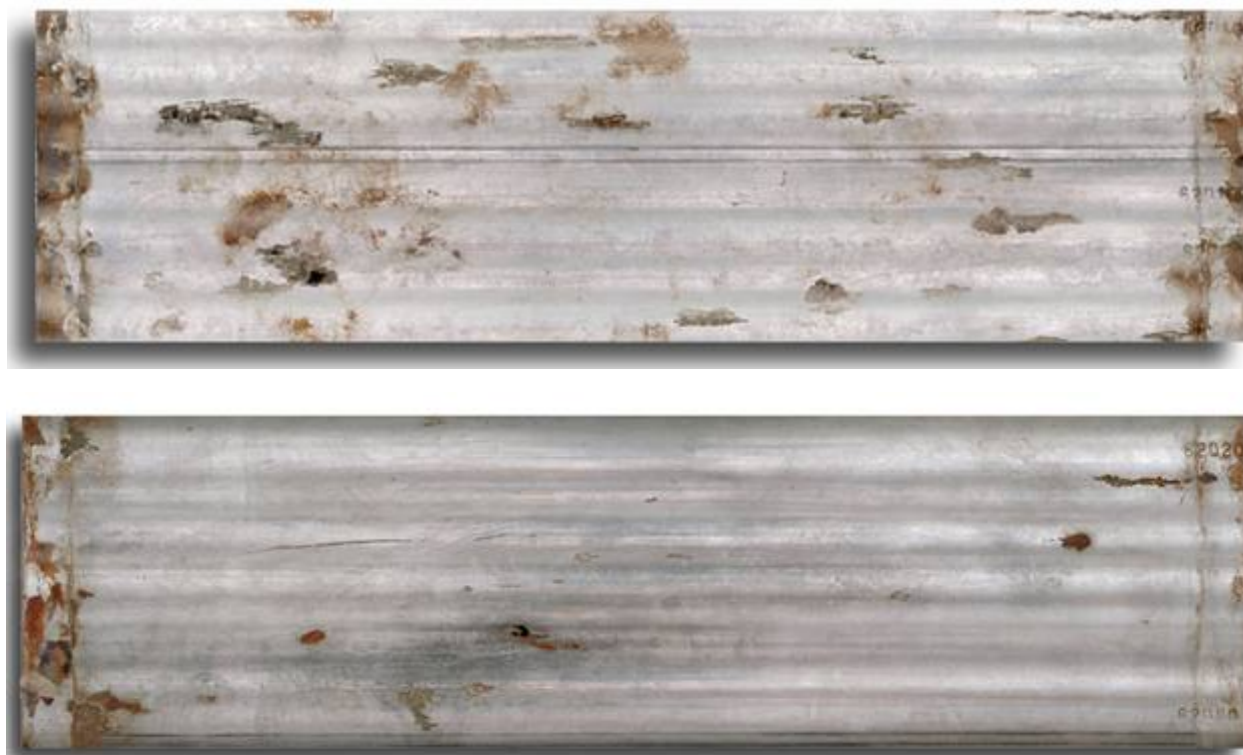
To better show a comparison between the two system 62 welded coupons, a series of photographs were taken of both coupons (see figure 56). These photographs were digitally matched/linked together into a collage of the whole tube. The corrosion under the caps was extreme with many perforations, and sample 62D19 also had numerous linear corrosion areas and multiple perforations.

Figure 56. System 62 collages, coupons 62D19 and 62D20.

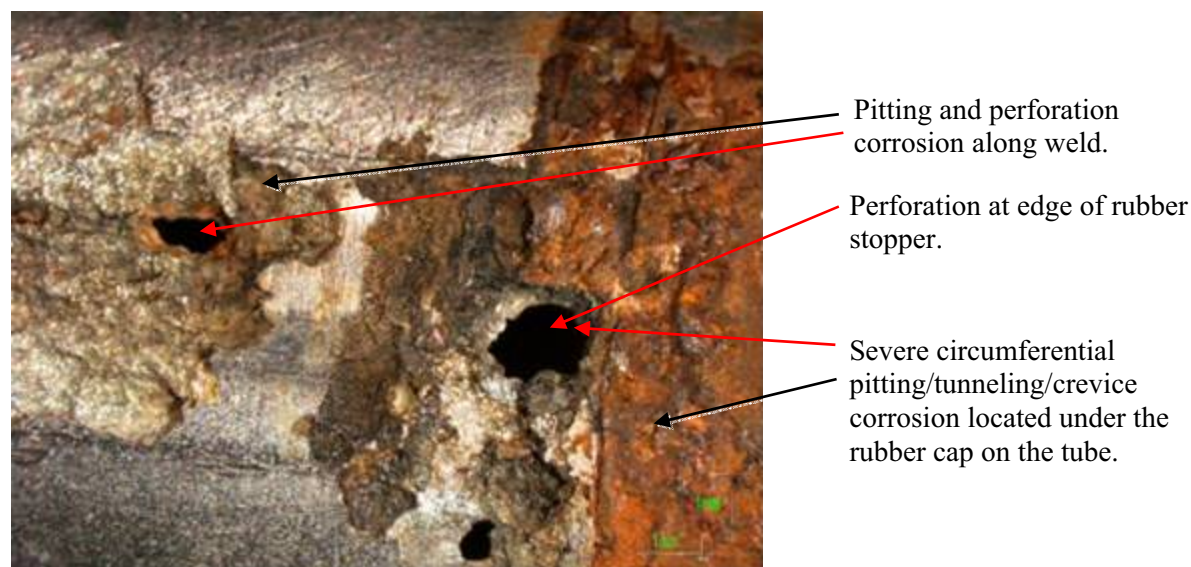
These two tubes were rolled and then seam welded using a high-frequency induction welding process. There was extensive corrosion—pitting, tunneling (perforations)—on the tubes that was typically aligned longitudinally on the tubes. The corrosion attack occurred preferentially along stringers or intermetallic inclusions oriented parallel to the rolling direction of the plate (the 0.06-in thick plate was rolled into a tube). There was crevice corrosion (i.e., pitting and tunneling) and perforations under the rubber caps on sample 63D19, Figure 57. Visual inspection showed the extent of corrosion on these tubes was similar to that on the System 62 tubes. The welds were sanded smooth by NBS prior to internment into the trenches and the sanded weld scratch marks did served as corrosion initiation sites, Figure 58.

Figure 57. 10X photograph of general and crevice corrosion sample 63D19.

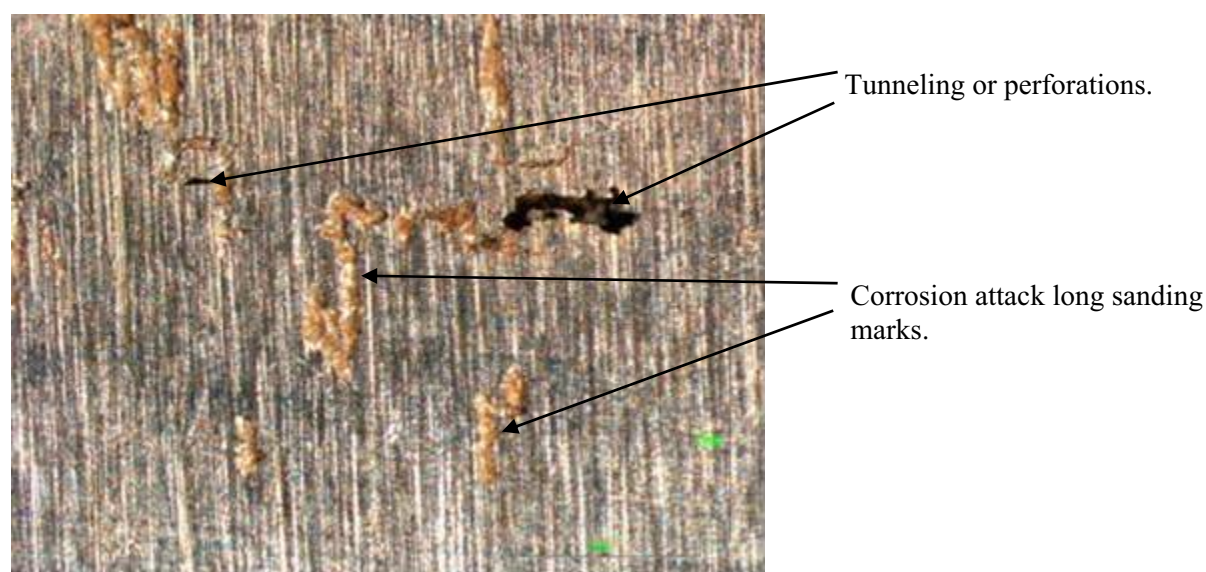
Figure 58. 30X photograph of preferential corrosion attack along scratches on weld of sample 63D19.

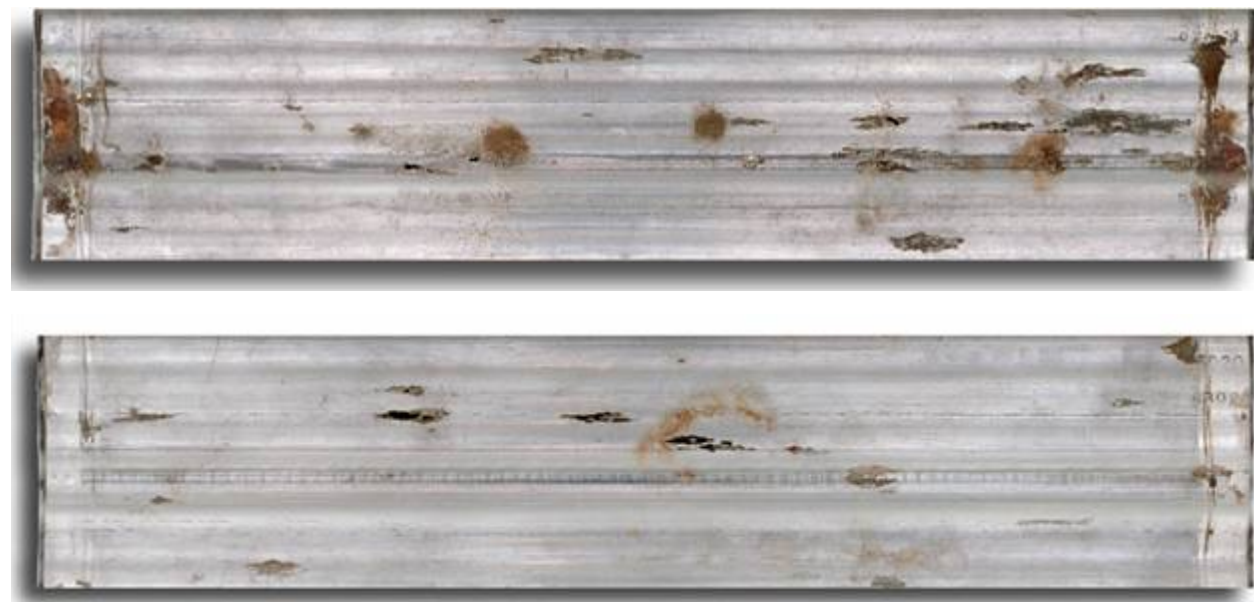
To better show a comparison between the two system 63 welded coupons, a series of photographs were taken of both coupons (see figure 59). These photographs were digitally matched/linked together into a collage of the whole tube. The corrosion under the caps was more extreme on coupon 63D19 than the other coupon. Also there was more corrosion on and near the weld on 63D19 than on 63D20. Both coupons had numerous linear corrosion areas and with multiple perforations.

Figure 59. System 63 collages, coupons 63D19 and 63D20.

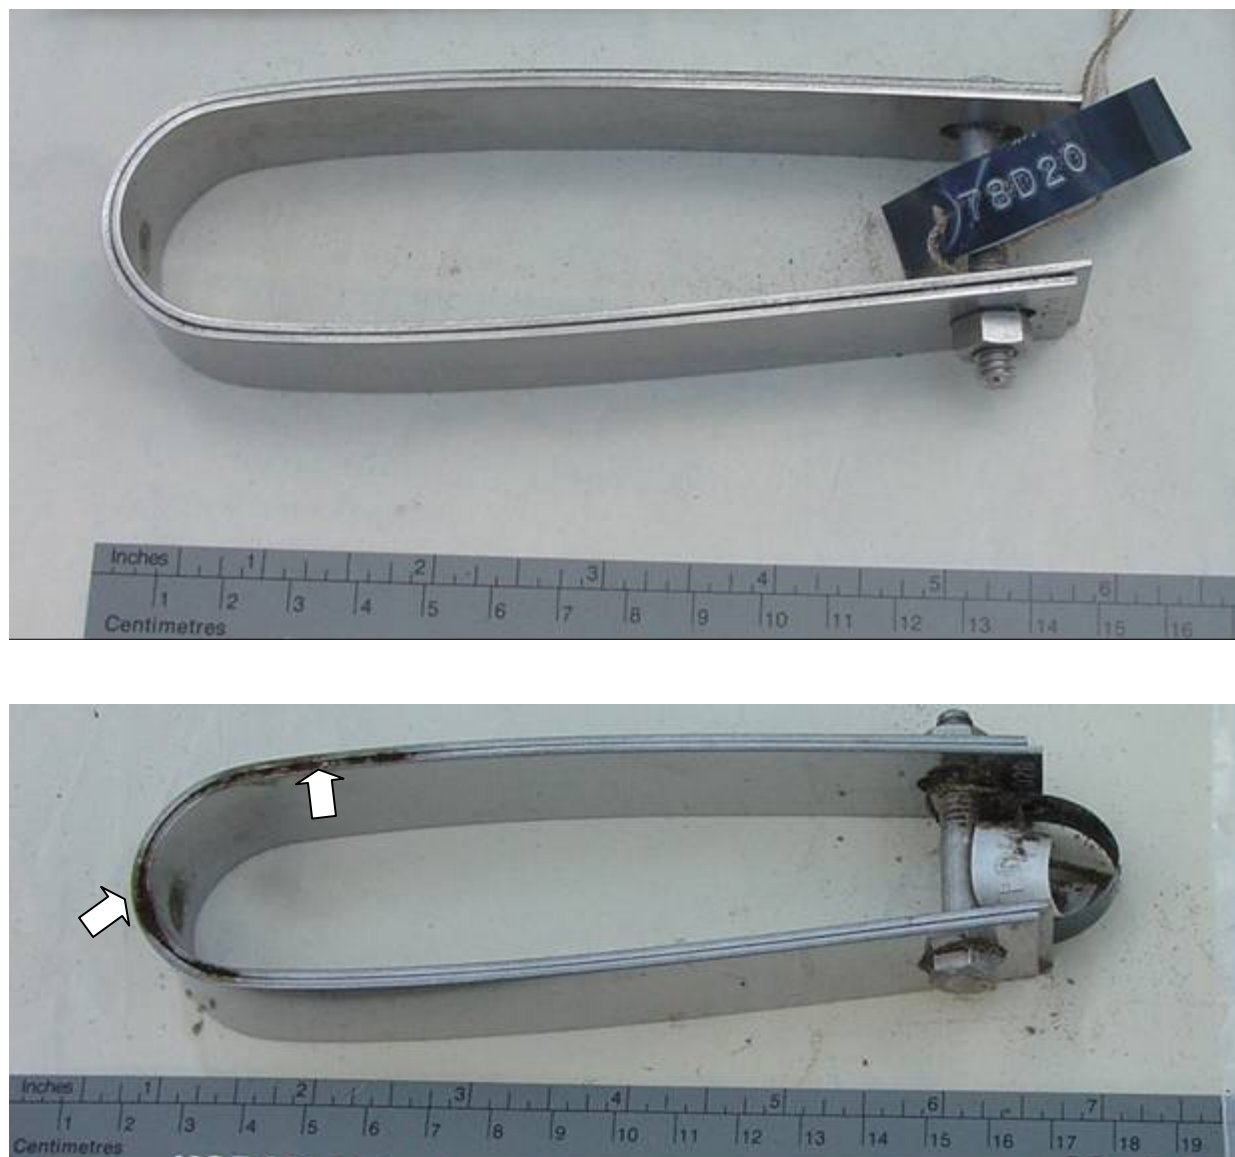
**Figure A.1.** Double U-bend samples, Type 316, Sample 78D20 (top) and Type 434, Sample 81D20 (bottom). Note crevice corrosion (arrows) in Type 434 sample.

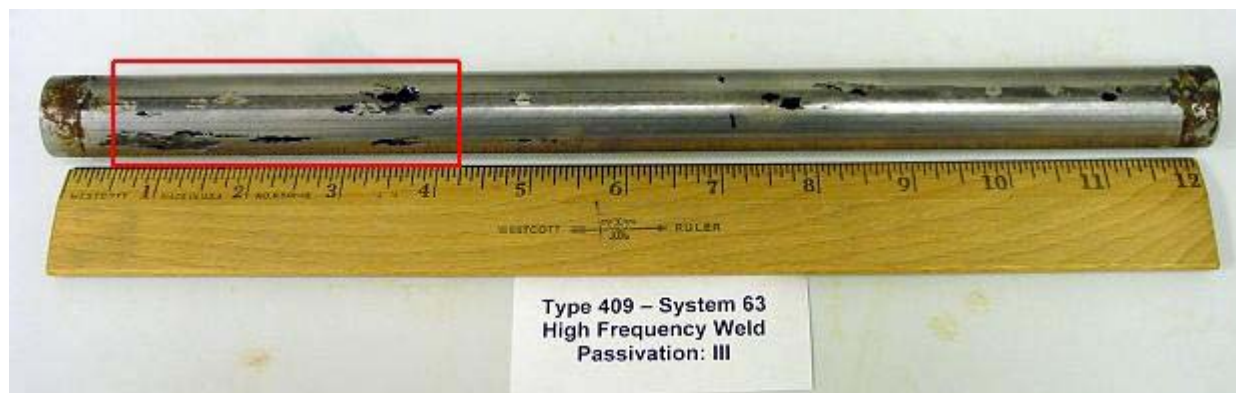
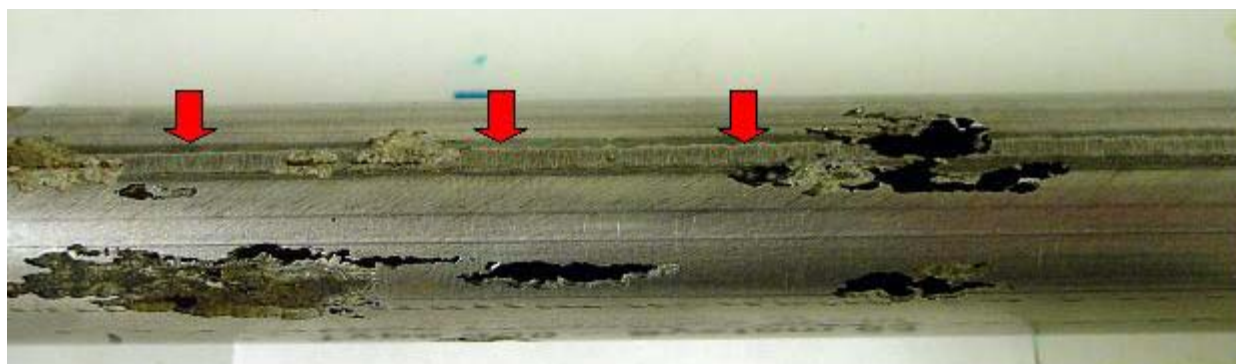
**Figure A.2.** HFI welded in Type 409 tube, Sample 63D20. The boxed area in the upper photo is shown in the lower photo. The arrows indicate the location of the weld along the tube axis. Note crevice corrosion at both ends of the tube.

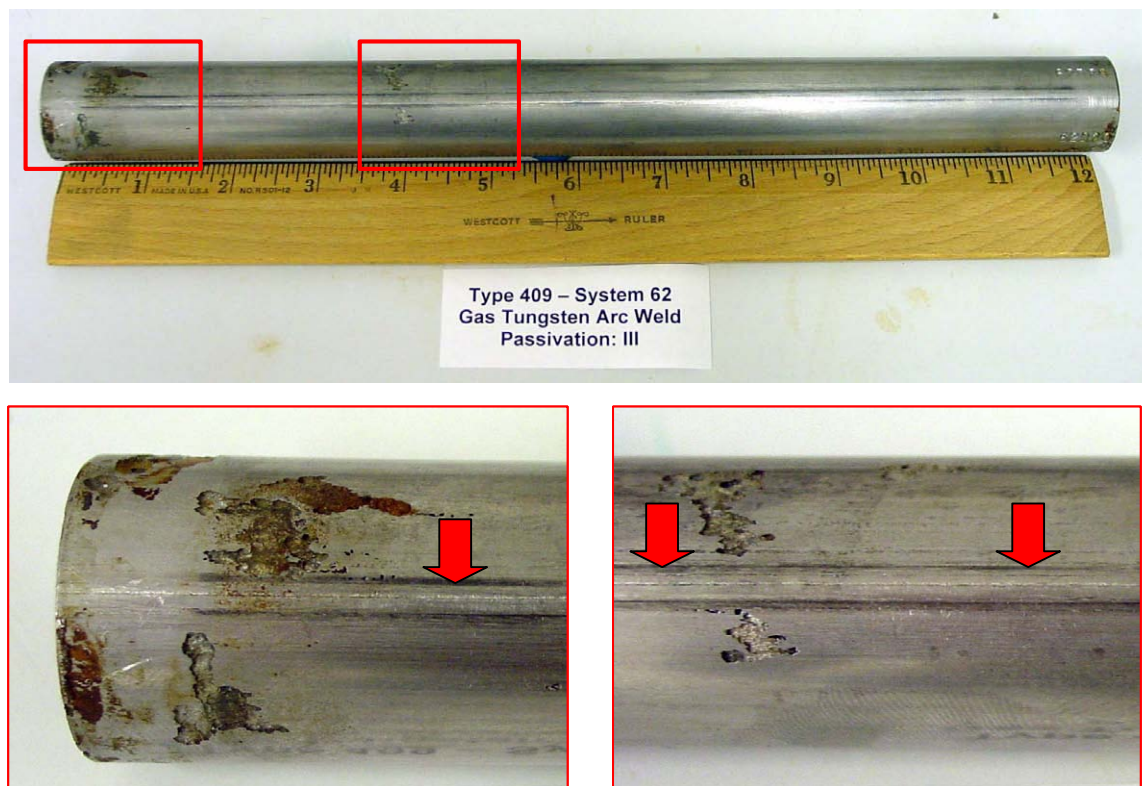
**Figure A.3.** GTA welded Type 409 tube, Sample 62D19. The weld along the tube axis is indicated by the arrows. Crevice corrosion is evident on both ends of the tube and is shown in more detail in the inset (left). Typical corrosion along the length of the tube is shown in the inset (right).
