# **Examination of the 1970 National Bureau of Standards Underground Corrosion Test Welded Stainless Steel Coupons from Site D**

January 2008

**Idaho National Laboratory  
Environmental Management Science Program  
Idaho Falls, Idaho 83415**

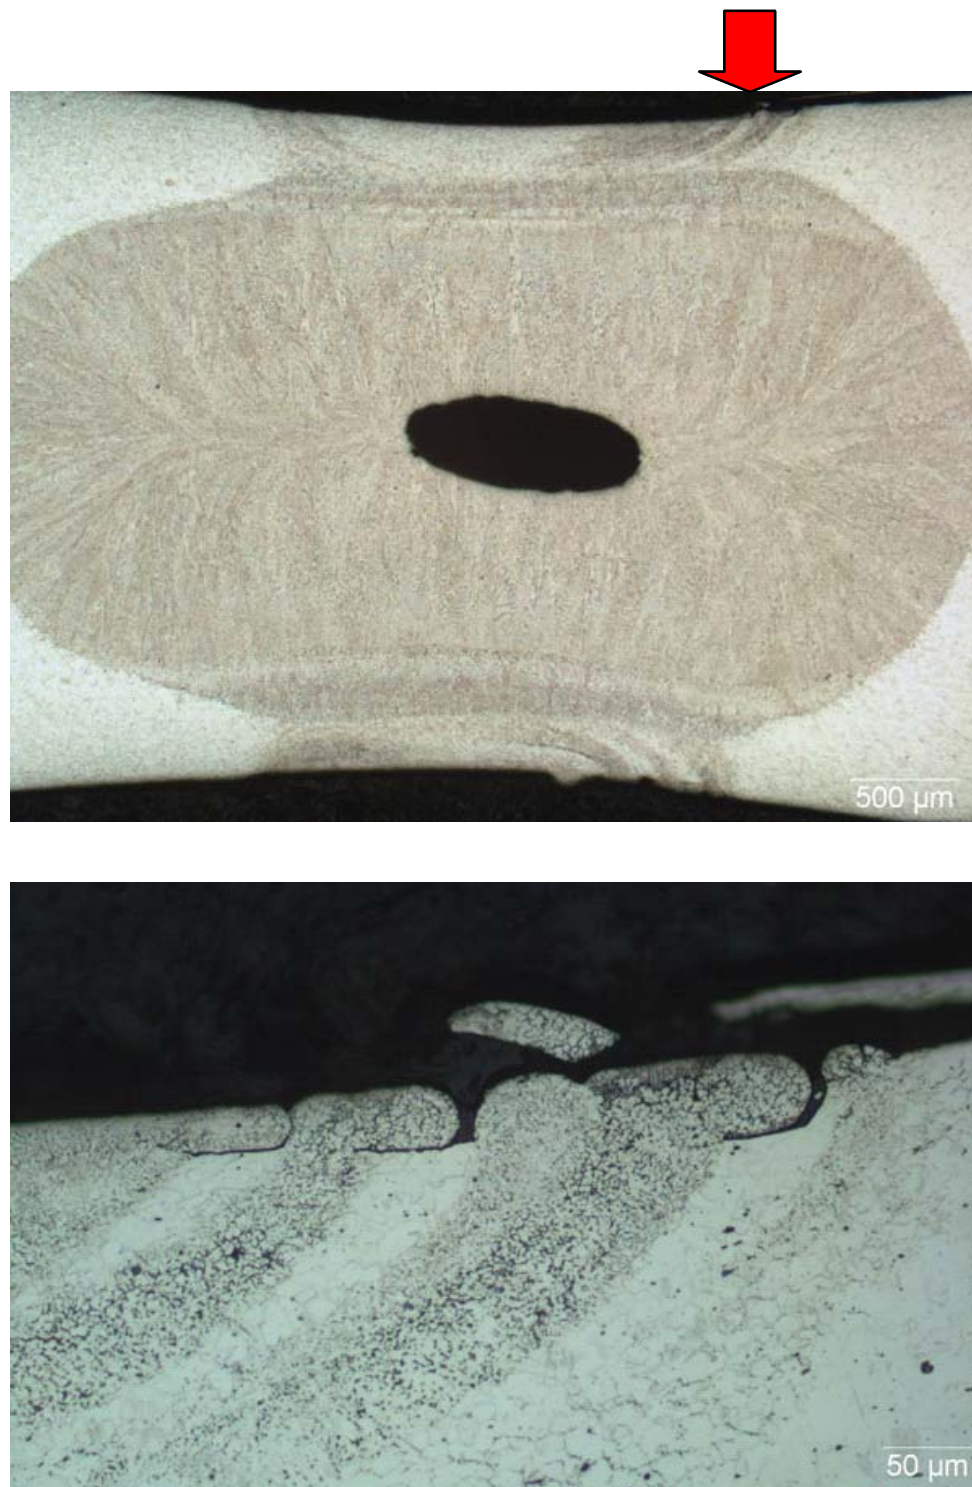
**Figure A.5.** Cross section of a Type 301 double U-bend resistance spot weld, Sample 68D20. Top – weld nugget containing a small amount of ferrite (FN 1-2) and center shrinkage cavity. Magnification, 25X. Bottom – some surface cracking (at location indicated by arrow in top photo) possibly associated with copper electrode “spitting” during welding. Magnification, 200X.

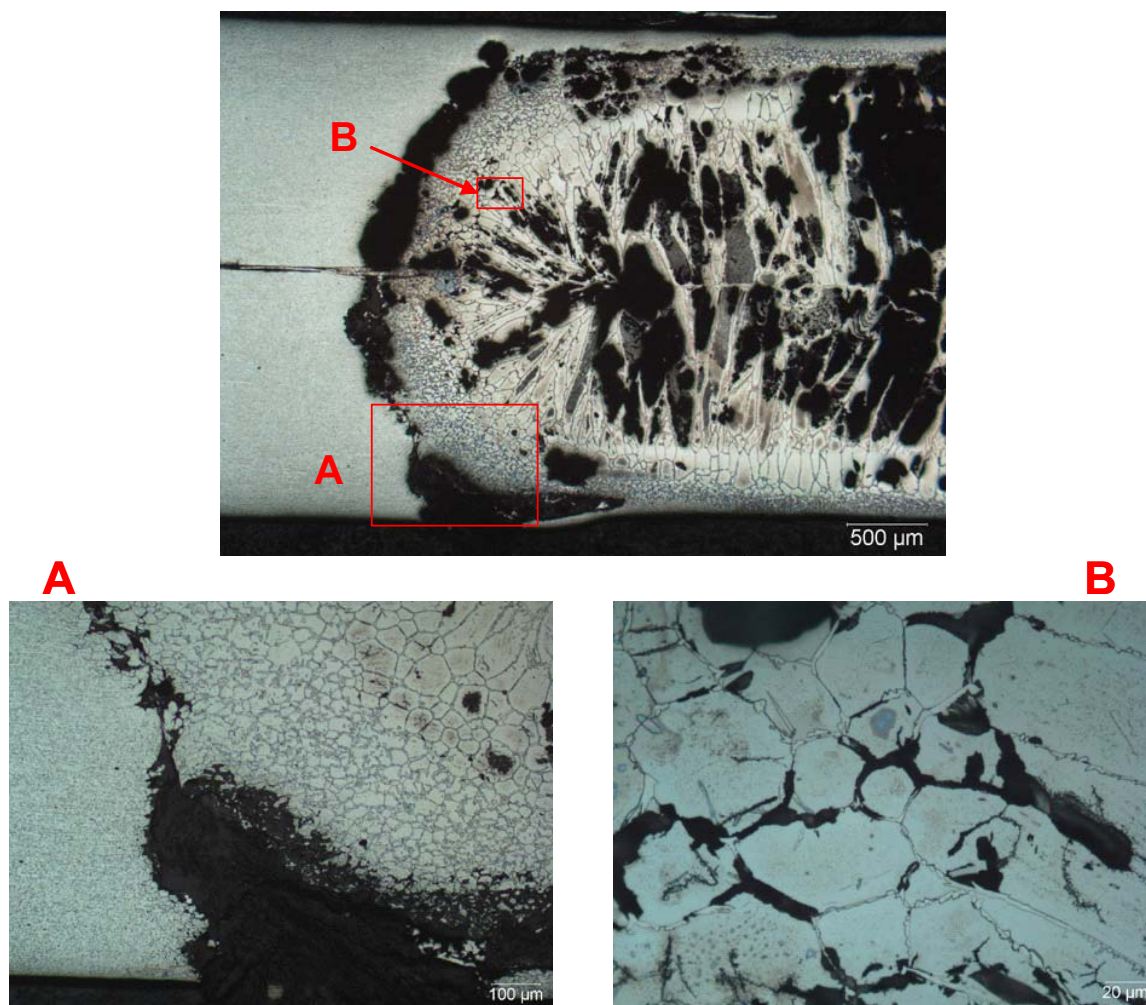
**Figure A.6.** Cross section of resistance spot weld in Type 434, Sample 81D20 showing extensive corrosion attack. Magnification, 25X. Region A – corrosion attack at interface between the base metal (left) and HAZ. Magnification 100X. Region B – corrosion in the weld nugget appears to occur preferentially at the ferrite-martensite interface. Magnification, 400X.

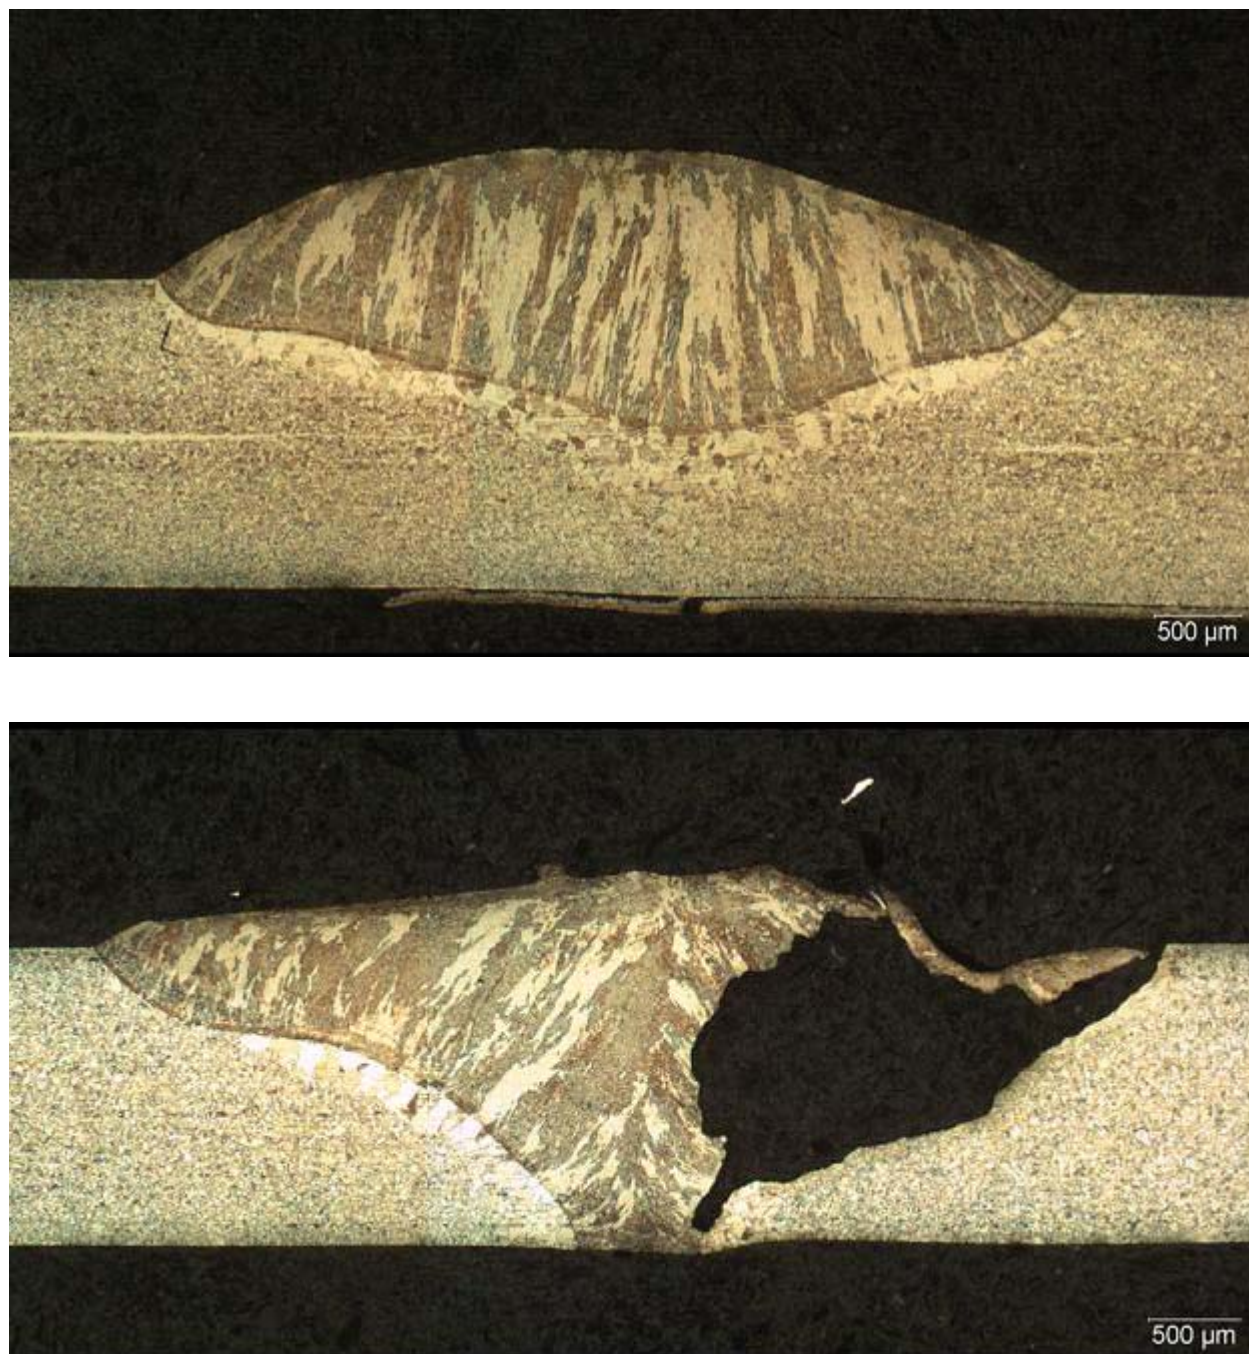
**Figure A.7.** Cross sections of welds from Type 301 cross welded plate. Top – representative cross section of weld containing some ferrite (FN 4), Sample 54D19. Bottom – section near edge of the plate that shows some attack through the weld metal, Sample 54D19. Magnification, 25X.

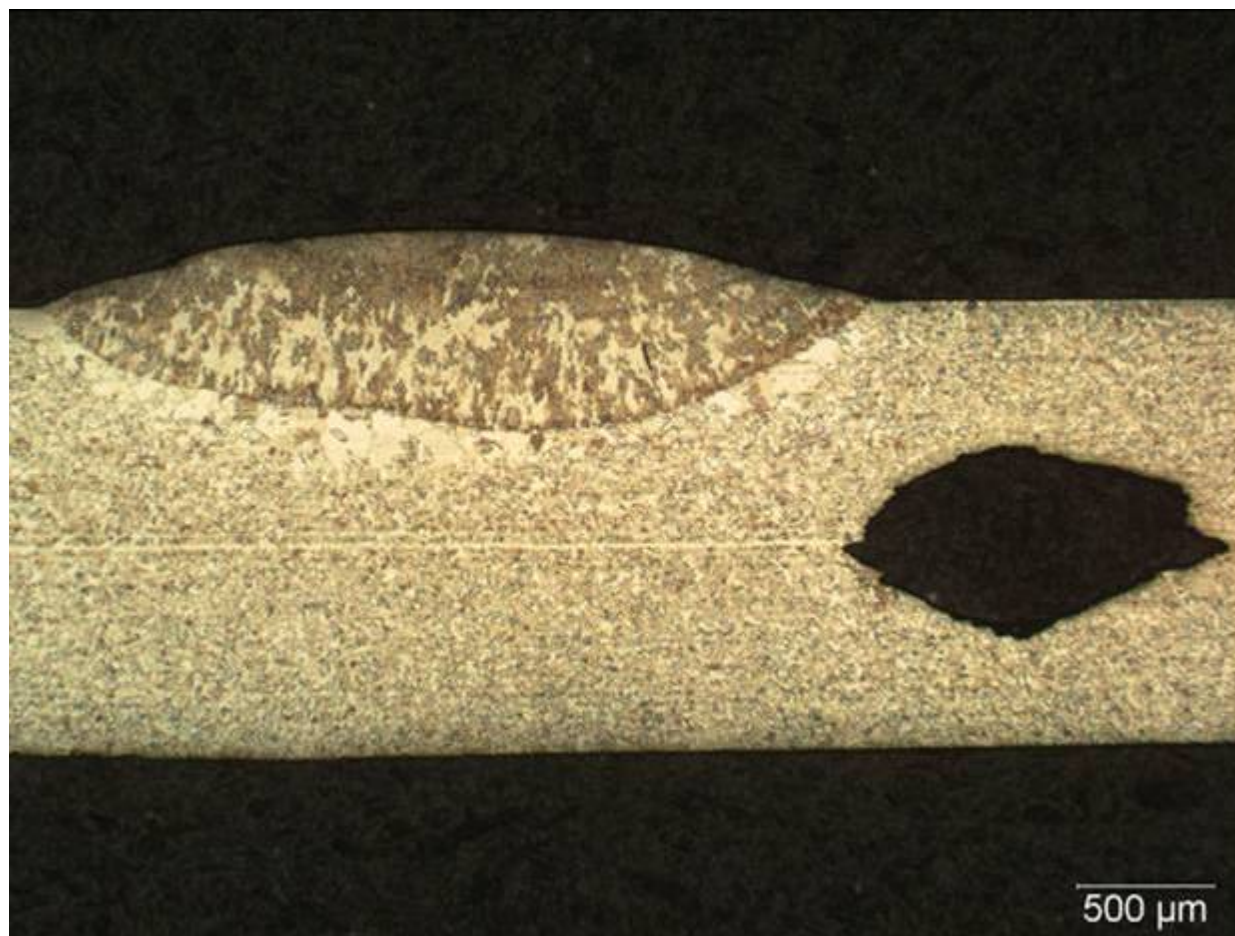
**Figure A.8.** Cross section through the weld stop region at the edge of the plate, Sample 54D20. Note that the corrosion is entirely within the base metal. Magnification, 25X.

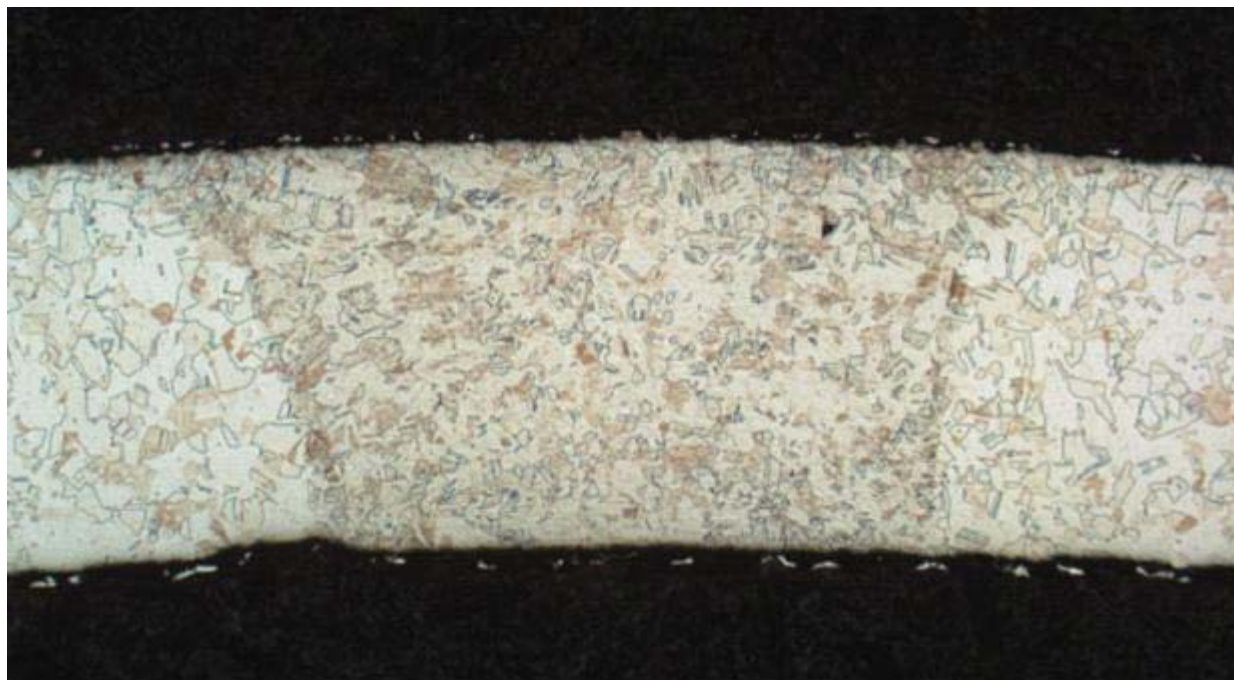
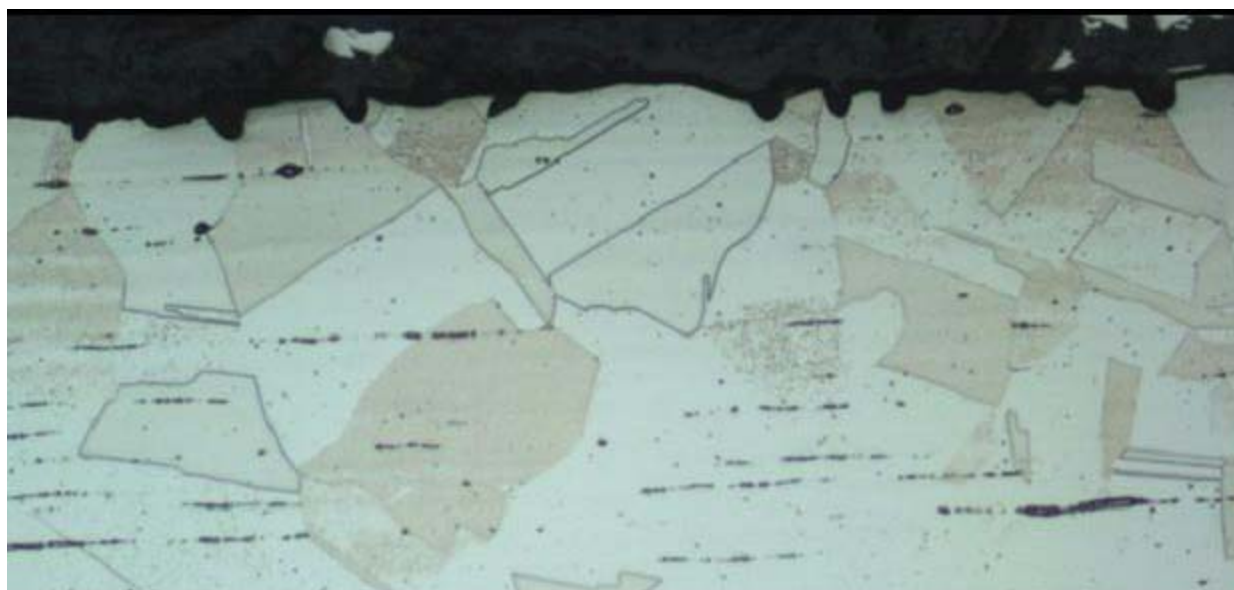
**Figure A.9.** Cross section of longitudinal seam weld in Type 304 tube, Sample 57D19. Top – weld structure is the result of annealing after welding (ASTM A249). Magnification, 25X. Bottom – shallow grain boundary attack on the tube surface. Magnification, 200X.
