Are tungsten-based nuclear fusion components truly invisible to x-ray inspection?

To cite this article: Triestino Minniti and Heather Lewtas 2022 *Nucl. Fusion* **62** 066003

UKAEA-United Kingdom Atomic Energy Authority, Culham Science Centre, Abingdon, OX14 3DB, United Kingdom of Great Britain and Northern Ireland

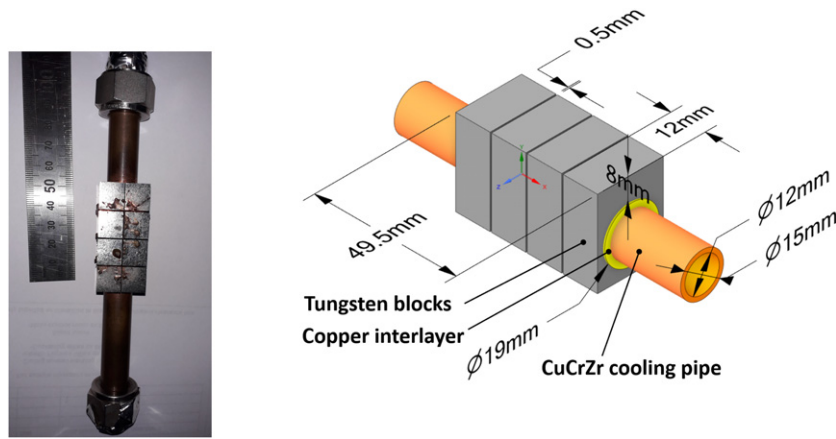
Figure 1. (Left panel) Photograph of the DEMO divertor target studied by means of 6 MeV's energy XCT. (Right panel) A schematic drawing with the relevant dimensions of the sample.

to the component is clearly visible from the x – y and y – z cross-section images which have revealed multiple failures of the inner CuCrZr alloy pipe and the oxygen-free high conductivity (OFHC) copper interlayer. Damage to the component is particularly located in the proximity of the two central monoblocks. Melted materials caused by the HHF load have been partially deposited on the external W tile surface and they are visible in the 3D volume rendering image of the specimen in figure 3(d) as well as on the picture of the sample reported in the left panel of figure 1.

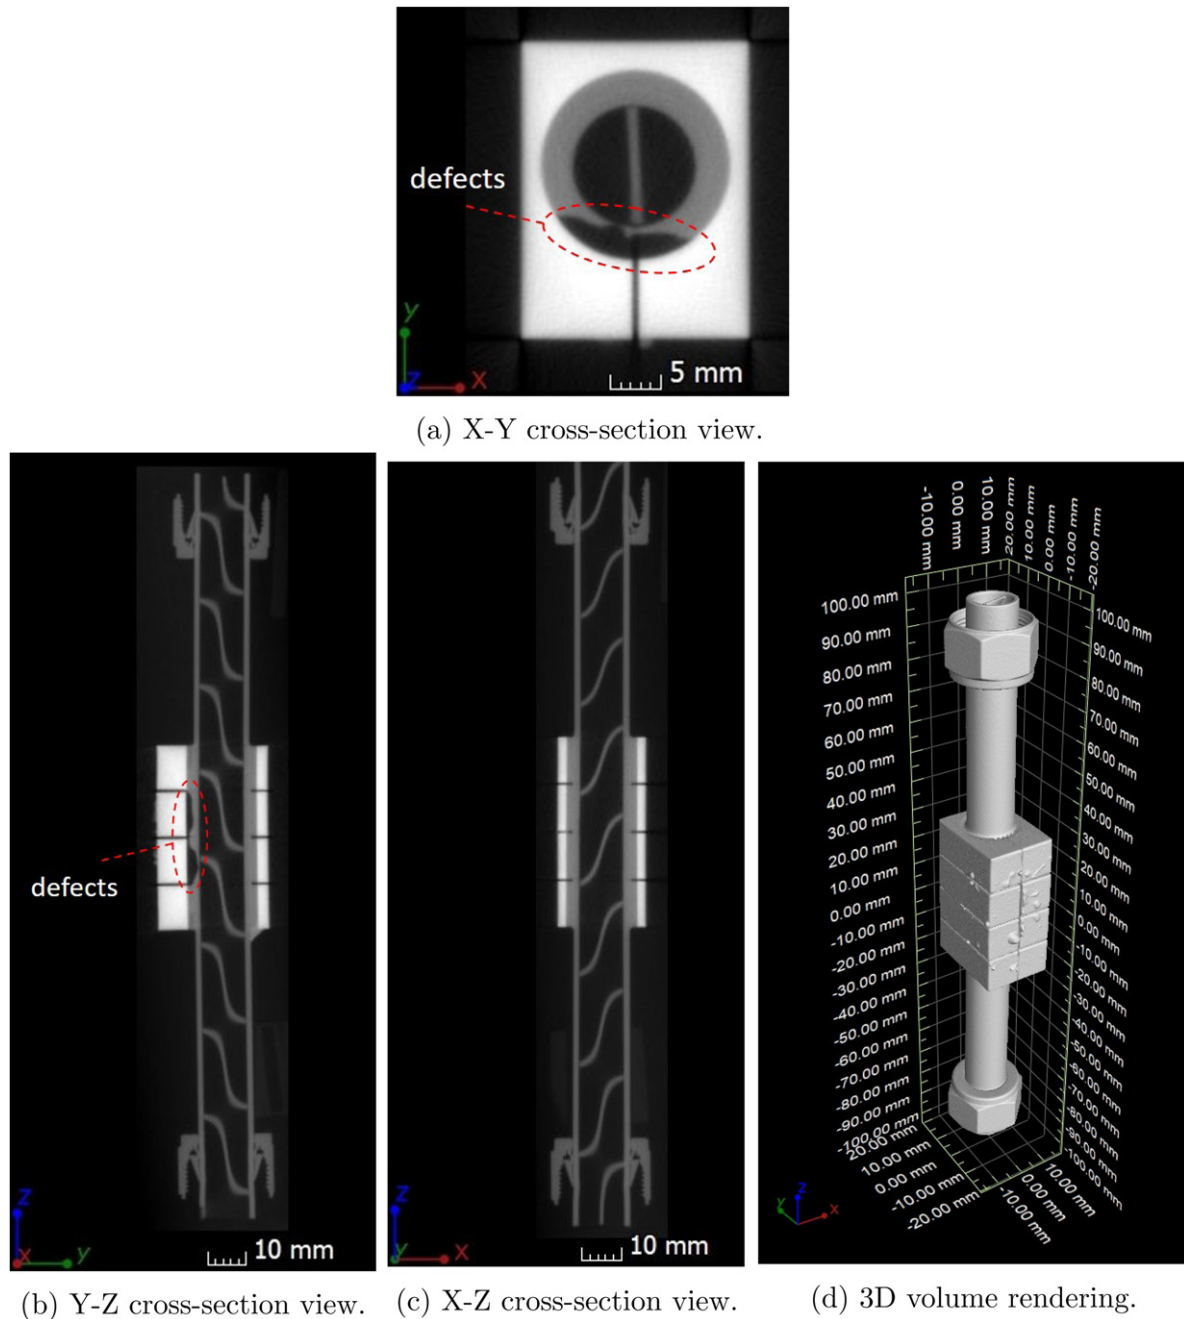
Figure 3. Cross-section views and 3D volume rendering of the DEMO divertor mock-up extracted from XCT data at MeV energy range.

In this section, we will discuss results showing volumetric defects present in the DEMO divertor mock-up caused by the HHF test performed on the HIVE facility [17] at UKAEA. The specimen was studied non-destructively with a spatial resolution (voxel size) of $139\ \mu\text{m}$ and a geometrical unsharpness of $119\ \mu\text{m}$. Smaller defect sizes with respect to the achieved spatial resolution were considered to not be distinguishable with the current experimental setup. After FBP reconstruction, some selected cross-sectional views of the specimen are reported in figures 3(a)–(c) and the full volume rendering of the object is shown in figure 3(d). From these results, damage

The x – y cross-section image of figure 3(a) has further revealed a complete loss of the structural integrity of the pipe in the proximity of the joints between monoblocks where the

pressure relief after boiling has resulted in the formation of some holes in the pipe with the subsequent loss of coolant. The good spatial resolution achieved in the tomography scan is also testified by the level of detail in the reconstruction of the threads of the two pipe fittings utilised to attach the mockup to the external cooling loop during the HHF test on HIVE, and visible in the y - z and x - z cross-section images of figures 3(b) and (c). Further, in the scan we been able to resolve details of

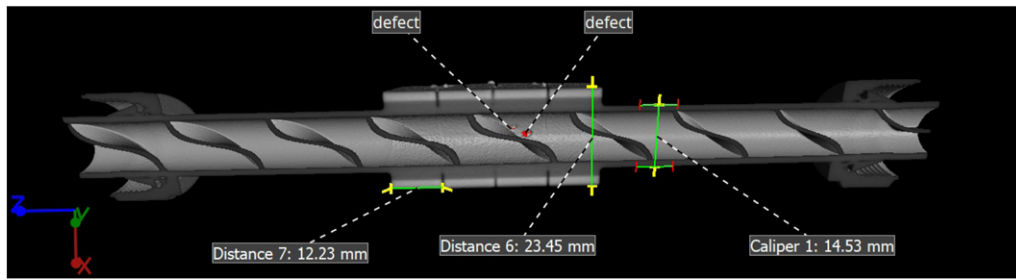
Figure 4. Volume rendering of the inner structure of the DEMO divertor mock-up where holes in the CuCrZr pipe have been highlighted ('defect' label). Metrology checks of some dimensions of the component were super-imposed as well for completeness.

the inner structure of the divertor target mockup and the helical swirl tape that runs through the entire length of the cooling pipe as shown in the cross-section images of figures 3(b) and (c), and in the subsequent figure 4. Figure 4 shows a 3D rendering of the divertor mockup where only about half of the component has been considered, this allows us to better understand the location of some of the holes present in the CuCrZr pipe, indicated in the figure with the label named 'defect'.

Metrology of the dimensions of the pipe outer diameter, W monoblock length, and monoblock thickness have been performed and are also visible in this figure. These measurements match very well with the dimensions of the component shown in the schematic drawing presented in the right panel of figure 1.

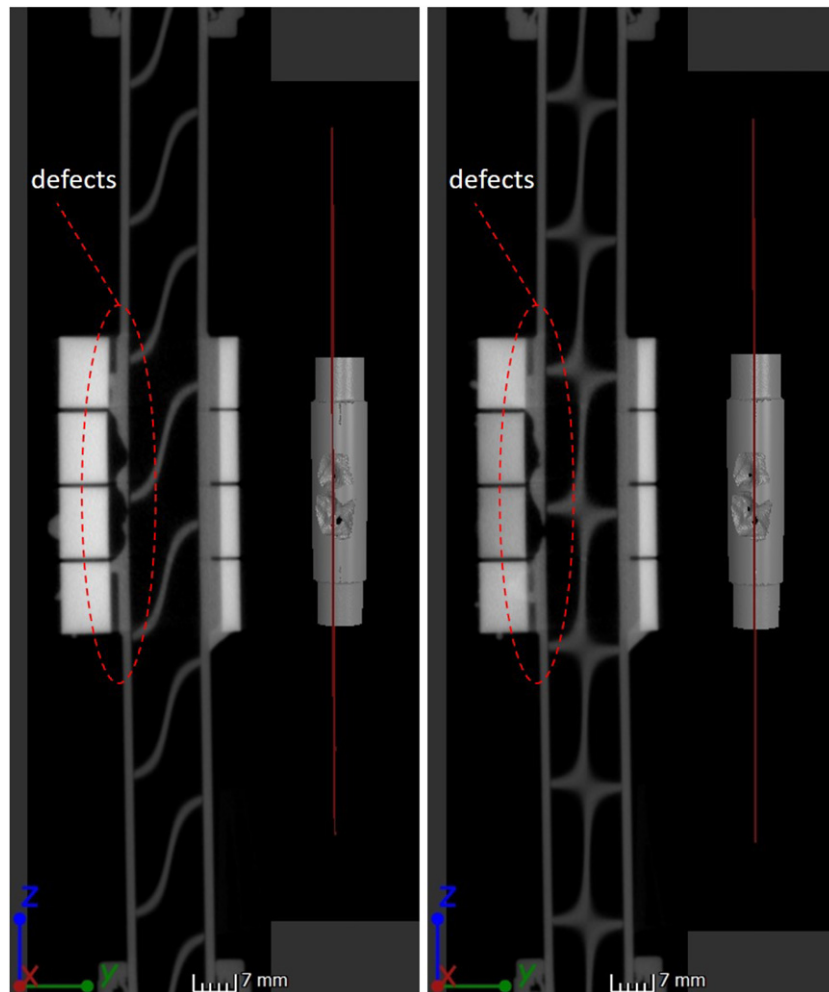
Figure 5. y - z cross-section views of the component in coincidence of the holes detected in the CuCrZr pipe. Left panel reports the first two pipe holes which are aligned vertically along the z axis, rather the third one is shown separately in the right panel of the figure. An insert displaying a 3D rendering of the component where W tiles has been masked (description provided in the main text) has been embedded in each panel for helping the reader localizing the cross-section image respect to the 3D rendering of the sample.

A better representation of the damage caused by failure during HHF load of the component has been achieved via virtual removal of the W tiles of the mock-up and obtained by masking with a cylindrical region of interest aligned in the respect to the pipe axis in the volume rendering of the sample. The result of this procedure is visible in the insert image embedded in each panel of figure 5. This image shows large melting regions in the OFHC copper interlayer and holes in the CuCrZr pipe of the specimen. Cross-section views depicted in figure 5 highlight the presence of three holes in the CuCrZr pipe which as previously said, are all located in the two central monoblocks of the divertor target. Two holes are visible in the y - z cross-section shown in the left panel of figure 5 because they were vertically aligned along the z axis. The third hole in the CuCrZr pipe is then depicted in the y - z cross-section image on the right panel of the same figure.

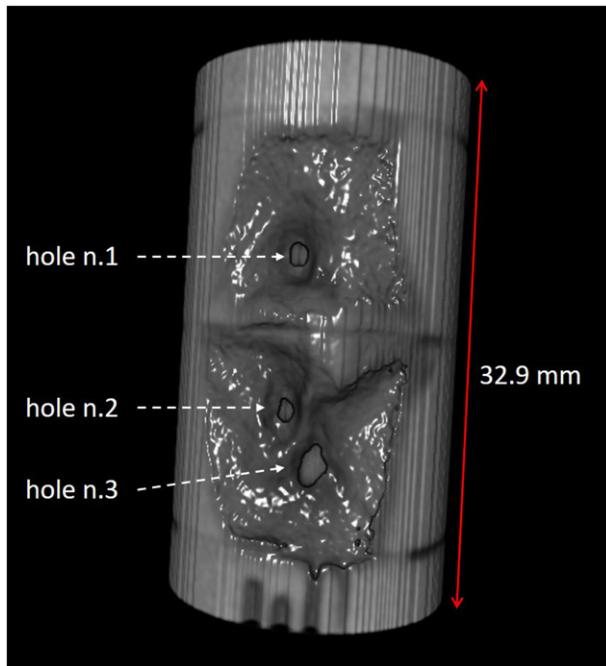
Figure 6. 3D rendering of the damage of the component caused after the HHF test performed on the HIVE facility.

To quantify the amount of material lost, a section of the volume close to the damage of the mock-up has been considered and shown in figure 6. This section has been obtained by extracting a sub-volume from the previous 3D rendering of the divertor target depicted in figure 5 where we hidden from the CT data the internal swirl tape volume with a similar procedure applied for masking the external W tiles discussed before. After manufacture and before any damage caused by the HHF load this selected section of the sample has a cylindrical shape with an external diameter of 19 mm if we sum the OFHC copper interlayer thickness of 4 mm to the pipe outer diameter

of 15 mm, an internal CuCrZr pipe diameter of 12 mm, and a length of 32.9 mm (as deduced by figure 6). With these dimensions its estimate overall volume is 5607.193 mm^3 within the assumption of a perfect cylindrical symmetry. Instead, the analysis of this section performed by means of VGSTUDIO MAX [21] has revealed a total volume of $2463.480 \pm 0.003 \text{ mm}^3$, i.e. a net loss of $3143.713 \pm 0.003 \text{ mm}^3$ of melted materials which have been partially deposited on the W tile surfaces of the component (see photo of the sample in figure 1).

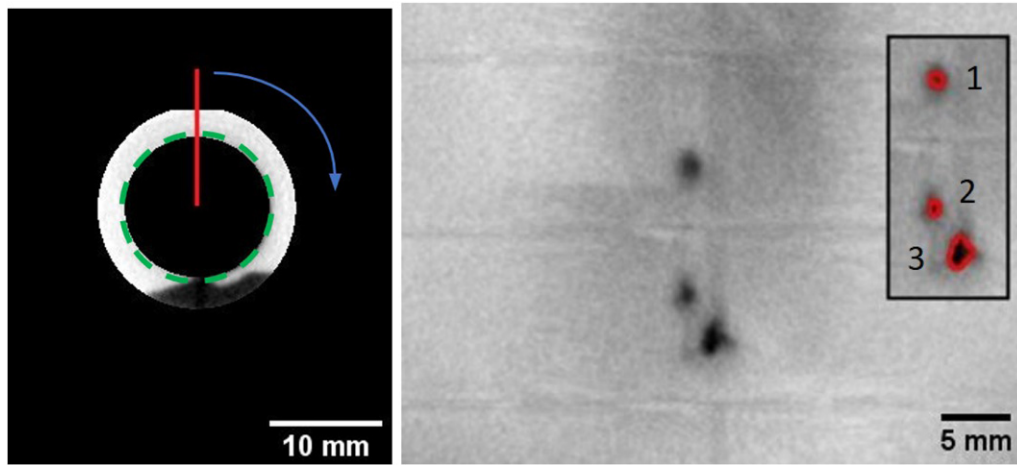
The quantification of the surface of each hole detected in the cooling pipe has followed a differ data analysis route because to its irregular geometrical shape, and it has been based on the idea of unrolling virtually the volume for the section of sample depicted in figure 6. The direction of unrolling is clockwise as highlighted by the blue arrow in the left panel of figure 7 which has been superimposed to a cross-section view of the analysed volume. From the resulting unrolled volume a slice close to the inner diameter of the pipe (following the dashed green line in figure 7) has been extracted and it is shown in the right panel of the same figure.

As expected, the holes in the CuCrZr pipe have an irregular shape difficult to evaluate with simple geometrical calculations. The computation of each hole dimension has required first the detection of its contour, after which the area could be evaluated knowing the pixel size. This has been done automatically by applying the 'analyze particles' plugin [22] available for the ImageJ software [23] to the unrolled slice. The contour limit of each hole area is visible in the insert of the right panel of figure 7 and drawn in the image as a solid red line. Table 1 shows the outcome of the analysis where we report the area of each pipe hole in square millimetres obtained by computing the number of pixels falling within each contour, its error set to be equal at the area of one pixel, the ellipse aspect ratio, and ellipse roundness after fitting the contour with an ellipsoidal function.

Figure 7. (Left panel) Virtual unrolling direction of the analysed CT volume for the section of component in figure 6 together with the indication where the slice from the unrolled volume has been taken, and reported as a dash green line in the image. (Right panel) Slice of the unrolled volume used to quantify the area of the cooling pipe holes in the DEMO divertor mock-up. The insert in figure shows the contour limit of each hole area computed by means of ‘analyze particles’ plugin [22] available for ImageJ software [23].

Table 1. Quantification of the area of each hole detected in the CuCrZr pipe of the DEMO divertor mock-up after failure by HHF load, its error, and results after fitting each hole contour with ellipsoids. In particular, the ellipse aspect ratio and ellipse roundness fitting parameters are provided.

ID number	Area (mm ²)	Error (mm ²)	Ellipse aspect ratio	Roundness
1	0.746	0.019	1.211	0.826
2	0.637	0.019	1.478	0.676
3	2.486	0.019	1.448	0.691
