Title: Canless HIP Development for Aluminum Cladding of LEU Fuel Foils using Electron Beam Welding

# **Canless HIP Development for Aluminum Cladding of LEU Fuel Foils using Electron Beam Welding**

## **Summary Report for FY12**

MST-6  
Los Alamos National Laboratory  
March 13, 2013

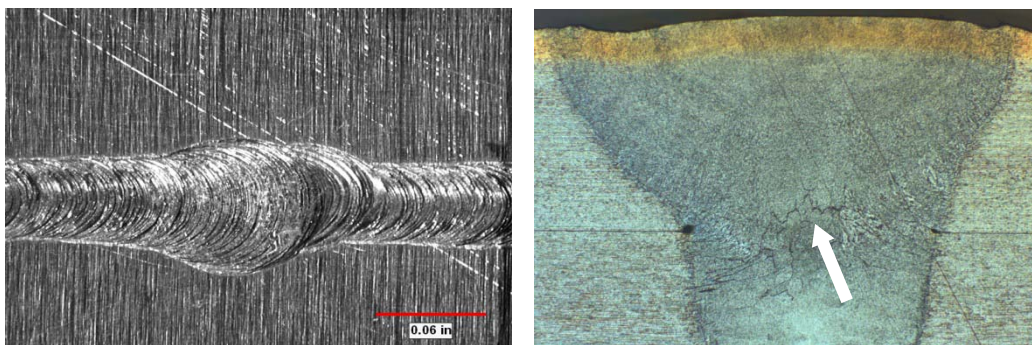
Figure 5: a) Top surface of weld bead showing divot defect and b) cross-section of divot showing solidification cracking across lap interface (see arrow).

The metallographic cross-section of divots (see Figure 5b) showed the presence of solidification cracking. These cracks are oriented in the plane of the lap joint, which is an abnormal occurrence. Normally such cracking is observed along the weld centerline, originating from solidification shrinkage stresses. This suggests that other imposed stresses may be at play here due perhaps to translational movement of plates relative to one another. The sudden translation of plates (e.g. due to inadequate hold-down force and clamping) could also explain the weld pool disturbance observed from the surface.

Thus, in summary, there are at least four possible explanations for this observed defect:

- 1) Insufficient clamping force allowing material movement during welding
- 2) Inhomogenities in material (compositional variations or inclusions)
- 3) Erratic electron gun behavior (e.g. gun arc-out).
- 4) Unstable EBW keyhole

By October 2012 there was increasing evidence of beam instability for the EBW machine used in this study (i.e. small variations observed in current and voltage even when welding ferrous alloys). It was decided at this point to rebuild and clean the electron gun. This involved replacing the filament with a new tungsten ribbon and polishing the gun itself, to remove metallic vapor deposits. This is a maintenance task that had not been done for over a year, as it is normally done only when needed. Practice welds were made on several 24 inch long strips of aluminum both before and after the gun rebuild. It was discovered that after the gun rebuild, there were no more divots observed. This provides strong evidence that the origin of weld divots is linked to arc-outs caused by deposits on the gun.

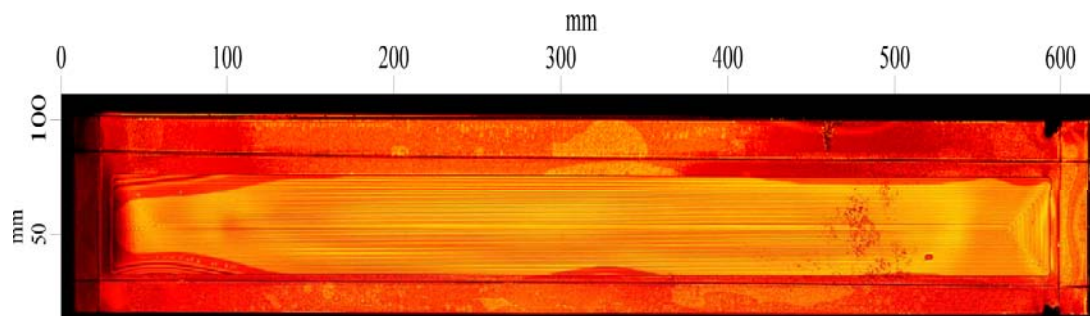
After HIPing, the fuel foils (with divots) were examined and found to be intact with little difference in appearance or flatness from before HIPing. Also, there was no indication of problems with creep. When foils were evaluated using scanning ultrasonic (UT) inspection, however, it became apparent that there was no bonding and that the welds had leaked during HIPing. In particular, water was found to leak into and out of the HIPed plates during UT testing, where water is used as the transducer couplant. The UT technique uses a pulse-echo method whereby a strong reflectance signal represents an unbonded interface. Where there is bonding (or water), more of the signal gets transmitted through the foil as opposed to being reflected, thus resulting in a weaker reflection signal. The strong reflectance signal in Figure 7, as represented by the light yellow color in the middle of the foil, suggests a condition of non-bonding. The darker color around the perimeter is likely due to the presence of water.

Figure 7: Ultrasonic scan of canless HIPed surrogate fuel foil having weld divot defects. Light color (yellow) indicates high reflectance signal in pulse-echo UT technique.

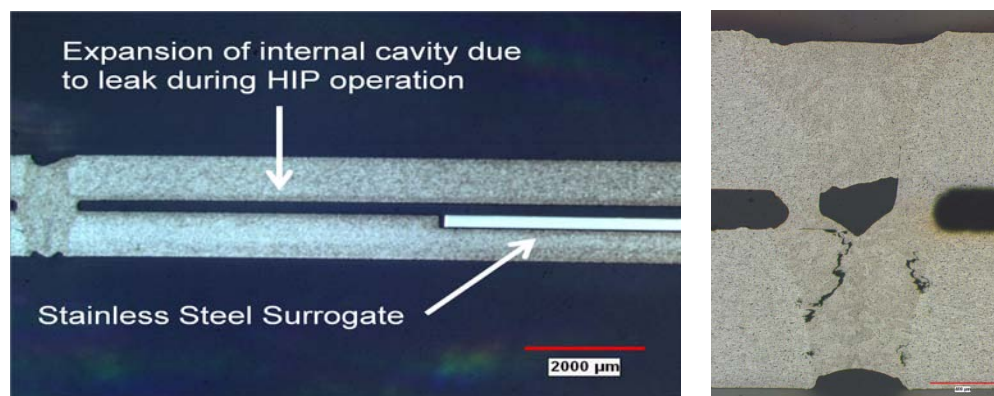
After UT inspection, one of the foils was cross-sectioned in the vicinity of a divot and examined at varying depths via multiple grind and polish iterations (see Figure 8). It is clear from Figure 8a that i) there was no Al-Al or Al-SSt bonding, and ii) there is a large gap between plates, indicative of pressure buildup between aluminum plates during HIP depressurization. The nature of the weld in this macrograph (with outward flow of weld metal at the lap interface) suggests that there may have been some gap even before HIP processing. This provides added evidence of a weld fixture problem, with insufficient clamping force to completely close the gap prior to welding.

Figure 8: Cross-sections of surrogate fuel foil assembly in vicinity of weld divot processed with canless HIPing.

Figure 8b, taken closer to the center of the divot, shows solidification cracking that has opened up considerably due to pressure build up between aluminum plates during HIP depressurization. The large cavity located at the weld center is abnormal in appearance. It appears to have formed as a result of liquid feeding around a cavity, perhaps a result of pool ejection or keyhole collapse. There are also clear signs of partial cavity fill-in (vertical lines along cavity wall) where oxidation prevented wetting (i.e. cold shut).

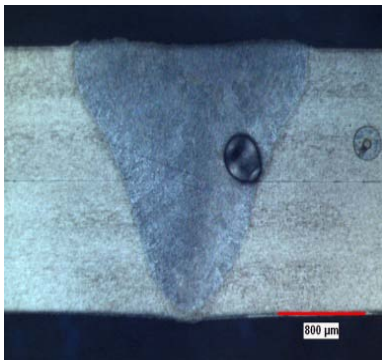
Before welding a second set of surrogate fuel foil assemblies, some minor corrections in weld parameters and fixturing were made in attempt to address the weld divot problem. Weld parameters were adjusted to broaden the weld pool by means of defocusing (i.e. broadening) the electron beam. Weld keyholes formed using sharp focus (original parameters) are inherently less stable. By running a series of welds on scrap plate, a set of parameters giving full penetration and a smooth over-bead was selected as listed in Table 2. By defocusing the beam (i.e. focus slightly above plate surface), the weld width is increased (i.e. decreased power density) and, accordingly, a higher current is needed to maintain penetration. The weld cross-section corresponding to these new parameters is given in Figure 9. Note that the EB weld is now more like a gas-tungsten arc weld in shape (not size), eliminating the characteristic nail-head apparent in Figure 5. Also note a large gas pore originating at the lap joint, often observed in these cross-sections.

Figure 9: Weld cross-section from practice coupon corresponding to revised EBW parameters of Table 2. Large gas pore is observed originating from lap interface.

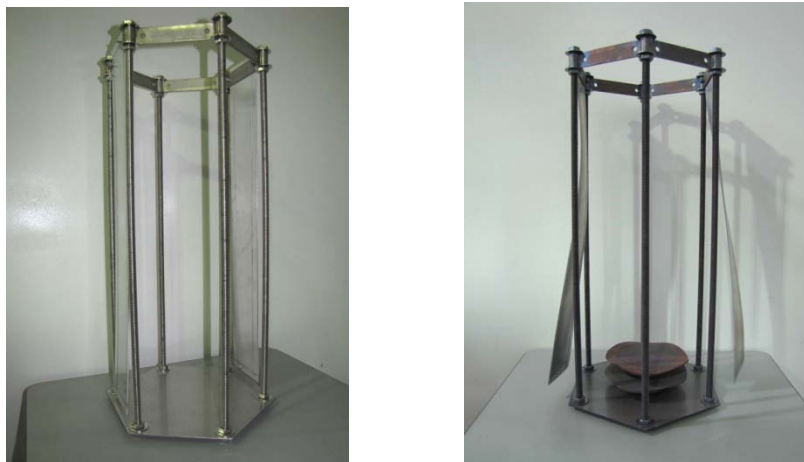
The HIP processing of two surrogate fuel foil assemblies, with repair-welded divots, resulted in foils having extensive distortion (both twisting and bending). This behavior is unlike the previous two assemblies that leaked, did not bond, and did not distort from HIPing. This distortion is characterized in Figure 11 where before-HIP and after-HIP photographs are compared. This suggests that some bonding between aluminum and stainless steel must have occurred.

Figure 11: HIP fixture with hanging canless surrogate fuel foil assemblies a) before HIPing and b) after HIPing. Foils are observed to have both bend and twist distortion as a result of HIP operation.

There remain several topics of concern regarding Canless HIP processing that require further development, primarily involving pre-weld preparation and fixturing for both welding and HIPing. There is presently at LANL a concurrent study looking at optimum surface treatment and cleaning procedures to promote bonding during HIP processing. These improvements will need to be implemented and evaluated in the Canless HIP process. How bond strength is influenced by delay time between cleaning (i.e. oxide removal) and EBW hermetic sealing also needs to be examined, as does the degree of vacuum in the hermetic seal. If a cleaned part sits for too long a time, the possibility for surface contamination and oxide growth may degrade the resulting HIP bond. Also important is the magnitude of the hermetic vacuum, which is likely influenced by EBW pump-down time in addition to hold-down pressure applied in the weld fixture. This hermetic vacuum should be measured for various different conditions of pump time and clamping pressure, and then be correlated with bond strength. Establishing acceptable process limitations will be needed when implementing the Canless HIP process on a large scale. Finally, it is clear that more restraint is needed in the HIP fixture to prevent excessive bending and twisting associated with dissimilar metal thermal contraction.

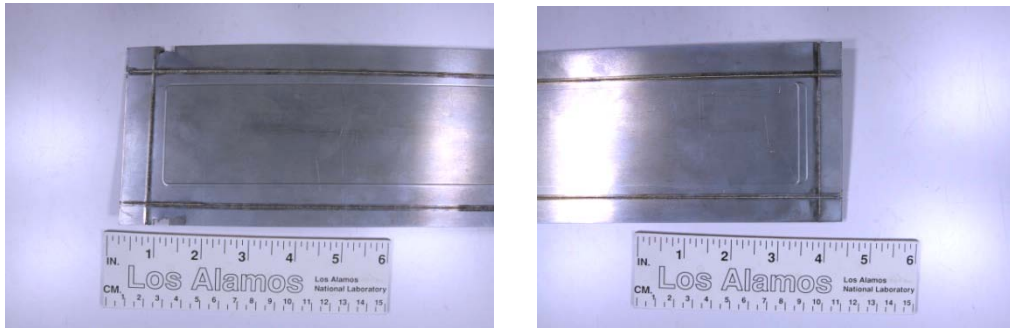
In addition to this distortion, the position of the embedded stainless steel foil could clearly be seen in each assembly (e.g. Figure 12a) due to indentations caused by aluminum flow around the stainless steel foils during HIPing. In one assembly, the foil was found to reside outside the pre-machined pocket meant to hold the foil in place (Figure 12b). The camber associated with the stainless steel foil (machined from coiled stock) makes it act like a spring during assembly and prevents it from laying flat in the machined pocket. This spring action no-doubt also influenced the foil distortion behavior observed in Figure 11b.

Figure 12: Post HIP foil assemblies showing a) outline of encased stainless steel foil and b) indication that stainless steel foil slipped out of pocket.

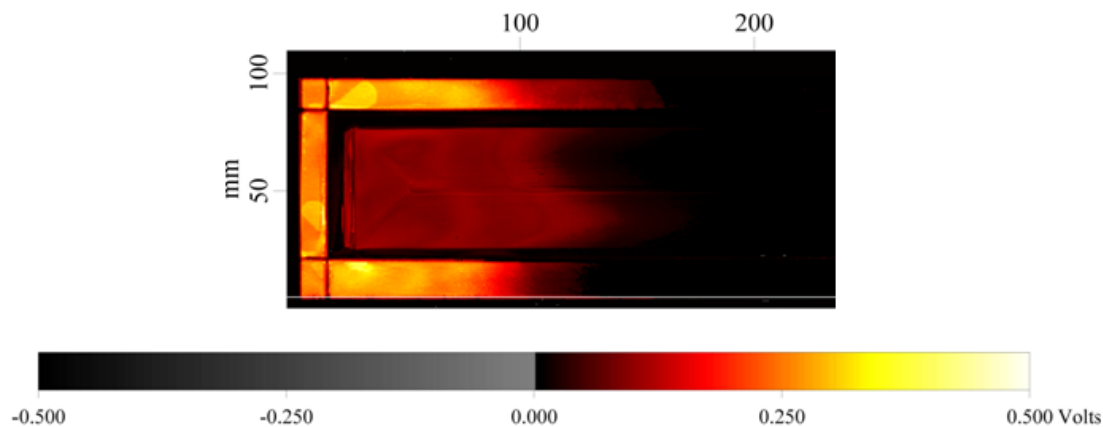
Applying scanning ultrasound inspection after HIP processing was made particularly difficult due to foil distortion. In order to achieve efficient send/receive transducer performance, the transducer must remain perpendicular to the plate surface. When not perpendicular, much of the signal may be lost. Thus, the foil assemblies were examined in segments, aligning the transducer as best as possible within each segment. One of the foils showed evidence of good bonding on one side only (see Figure 13). Light colors indicate strong reflectance, which indicates an interface and possibly a poor bond. In Figure 13, the outer perimeter (outside the hermetic seal) is the brightest indicating non-bonding. The black region just inside the hermetic seal indicates good Al-Al bonding with little if any reflectance. The lighter region in the middle of the foil represents a good Al-SSt bond, where the dissimilar metal interface is expected to reflect a weak signal even when bonded.

Figure 13: Scanning ultrasound image take from the end of a HIPed surrogate foil assembly.

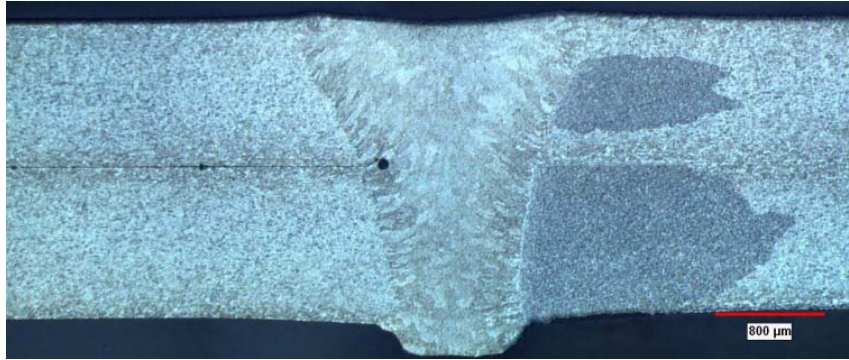
A cross-section taken from a HIPed assembly is characterized in Figures 14-16, specifically from a region that UT inspection predicted there to be Al-SSt bonding. Figure 14 confirms that there is Al-Al bonding inside the hermetic seal, but not outside. This is to be expected, since outside the hermetic seal there will be heavy oxidation at faying aluminum surfaces (formed at elevated temperature) preventing solid-state bonding. The dark etching regions of aluminum appear to correspond to regions of compression strain (e.g. around the inside of the weld).

Figure 14: Weld cross-section of HIPed surrogate foil assembly showing Al-Al bonding on the inner (right) side of hermetic seal. Dark etching regions appear to relate to areas of compression strain experienced during HIPing.

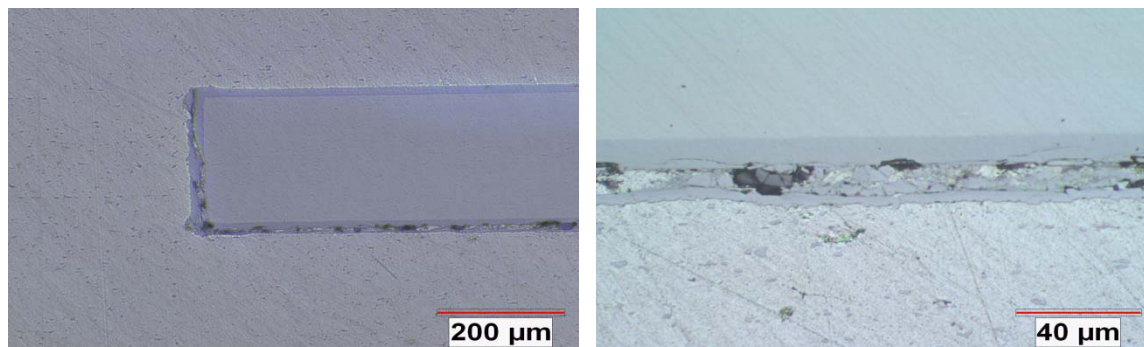
When the encased SSt foil is observed at low magnification (Figure 15), the interface between Al and SSt is found to consist of a heavily fragmented band of intermetallic compounds (20-30 microns thick). The presence of this band confirms that there was bonding between Al and SSt allowing diffusion of Fe, Cr, Si and Al across the bond interface. The fracture surfaces observed within the intermetallic could have served to give indications of non-bonding noted during UT inspection. Aluminum appears to have extruded between the fractured intermetallic in some places.

Figure 15: Cross-section of HIPed surrogate foil assembly showing a) stainless steel foil (center) surrounded by 6061 aluminum with intermetallic compounds at interface and b) higher magnification view of fractured interface intermetallics.

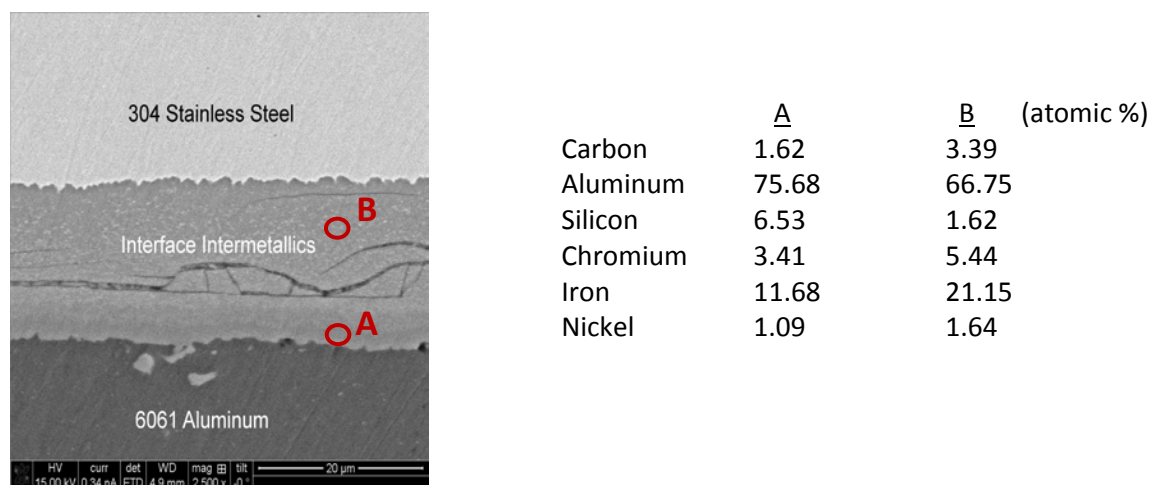
SEM/EDX analysis (Figure 16) confirmed that there exists a compositional gradient across the band of intermetallics: C, Fe, and Cr diffuse toward the Al; Al and Si diffuse toward the SSt. A uniform layer of intermetallic (2  $\mu\text{m}$  thick) is found adjacent to the aluminum that appears to consist of the aluminum-rich intermetallic  $\text{FeAl}_6$  (see Figure 16, point A). Further away from this layer there is a thicker layer (Figure 16, point B) that is richer in iron and chromium, closer to  $\text{FeAl}_3$  stoichiometry. This thicker layer appears to consist of two different phases.

Figure 16: SEM macrograph of HIPed surrogate foil assembly showing Al-SSt interface intermetallics with corresponding EDX analysis at two different circled areas: A and B.

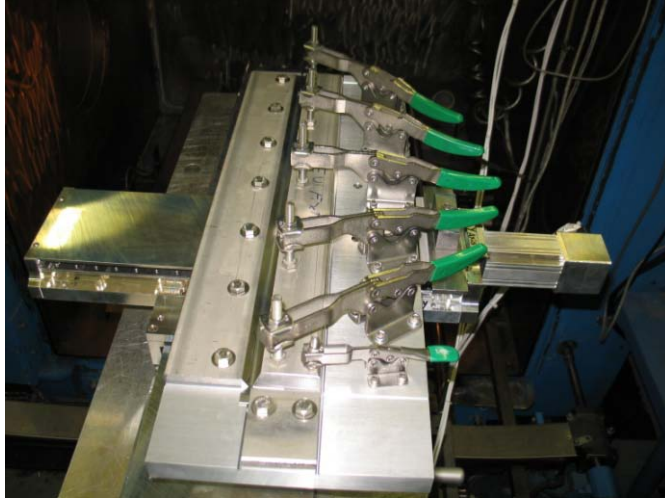
Initial trials were made to evaluate the new fixture and see if this had any effect on eliminating divots. Four 24-inch lap joint strips of 6061 aluminum (0.037 inch thick x 1½ inch wide) were welded using the parameters of Table 2. One strip had no divots, two strips had one divot, and one strip had two divots. This corresponds to approximately 1 divot per 24 inches of weld and does not appear to be a significant improvement over the original fixture.

Figure 17: New EBW welding fixture incorporating improvements including stainless steel hold-down bars, higher clamping pressure, and use of toggle clamps for the central region.
