## Study of fatigue fractures of Al-Mn alloy

**Abstract.** Aluminum alloys have become a standard application in automotive industry due to their strength to weight ratio and corrosion properties. Aluminum alloys based on Al-Mn (class 3XXX) that are applied as components in air conditioning modules in automotive as well as in construction and consumer industries are often submitted to vibrations which can eventually lead to fatigue cracks and in the end to complete failure of the components. The study of fatigue failures of cyclic loaded Al-Mn alloy was performed using fractographic analysis on scanning electron microscope JEOL JSM-649OLV. The loading was realized from 100,000 to 1,369,000 cycles at room temperature. The features of fatigue fracture surfaces were discussed comparing different tempers of the A3003 alloy, specifically in the temper 1/4 hard (H12) and full soft (O). The results for corresponding loading cycles were compared. Areas close to the crack initiation were characterized by radial marks corresponding to fatigue propagation. Fracture was propagated through the growing lines in form of fine striations with secondary cracks and microcracks between them. The stri

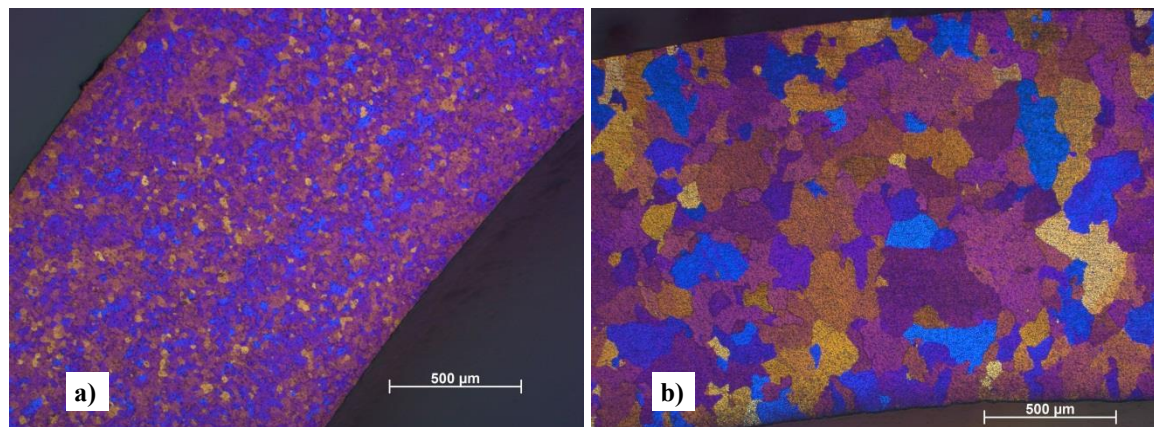
The color etched microstructures in the transverse cross section of H12 and O specimens are presented in figure 1. The work hardened temper (H12) showed equiaxed fine grained structure with recrystallized grains with average size of 20  $\mu\text{m}$  (figure 1 a). The annealed microstructure (O temper) is characterized by coarse grains with average size of 200  $\mu\text{m}$  (figure 1 b).

**Figure 1.** Microstructure of the cross sections of Al-Mn tubes: a) fine grain size structure for H12 temper; b) coarse grain size structure for O temper.

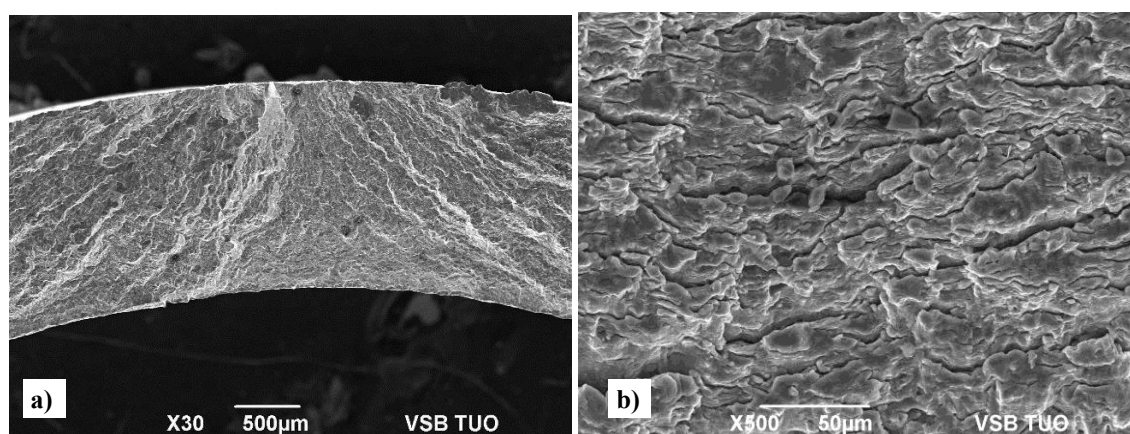
The comparison of fatigue behavior was performed with respect to both different tempers of the material (H12 and O, respectively) and the number of fatigue cycles. Fatigue crack initiation of both specimens set started at the locality with highest stress concentration, therefore at outer surface of the tubes. From here the crack propagated across the tube wall until the final fracture was accomplished. Macroscopically, the crack propagation is proved by radial steps with quasi-cleavage facets (figure 2a, 3a, 4a, 5a, 6a and 7a). Microscopically, the fatigue failure propagated through the growing lines in the form of fine striations between of which the secondary cracks and microcracks were observed (figure 2b, 3b, 4b, 5b, 6b and 7b). The morphology of final crack was

For the H12 temper, as the number of the fatigue cycles increased the tendency to large steps development was remarked in initiation and propagation areas that could be related to fine grained microstructure and the strengthened temper. Unlike H12 fracture surfaces the fatigue areas of O specimens showed more rough relief that correspond to coarse grain size structure of soft temper. The occurrence of ductile striation confirmed the plastic deformation behaviour during fatigue loading. The secondary cracks or microcracks were generated after the magistral crack passing. Although the striation represent certain response to each loading cycle and some differences in striation distances were remarked, it was not possible to determinate this characteristic as a proof related with the cycle number during fatigue loading. More detailed analysis of dislocation structures by means of transmission electron microscopy [7] would give more information to generalize the effect of number of loading cycles on the fracture feature.

**Figure 2.** SEM fractography of specimen 1 fatigue tested in H12 temper, 106,890 cycles: a) view of crack initiation and b) detail of initiation area with steps, secondary microcracks and striations.

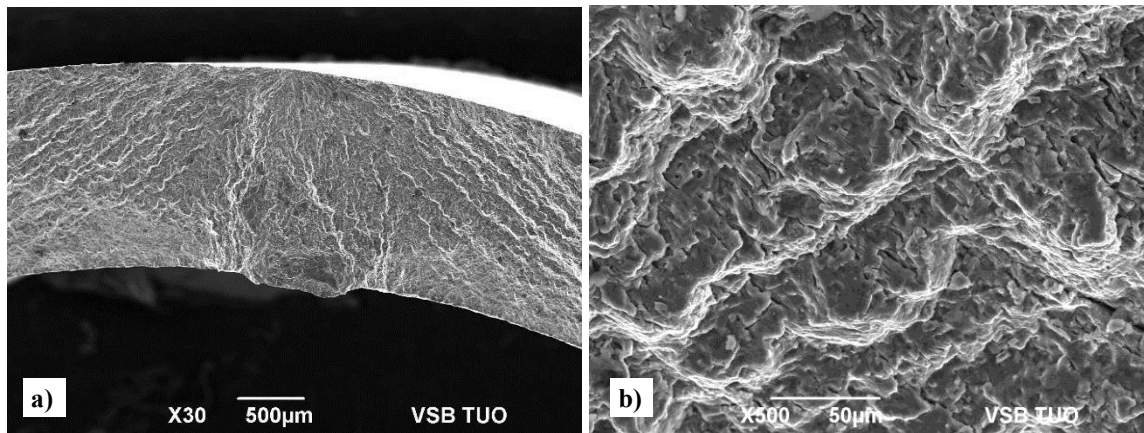
**Figure 3.** SEM fractography of specimen 2 fatigue tested in H12 temper, 487,080 cycles: a) view of crack initiation and b) detail of initiation area with steps, secondary microcracks and striations.

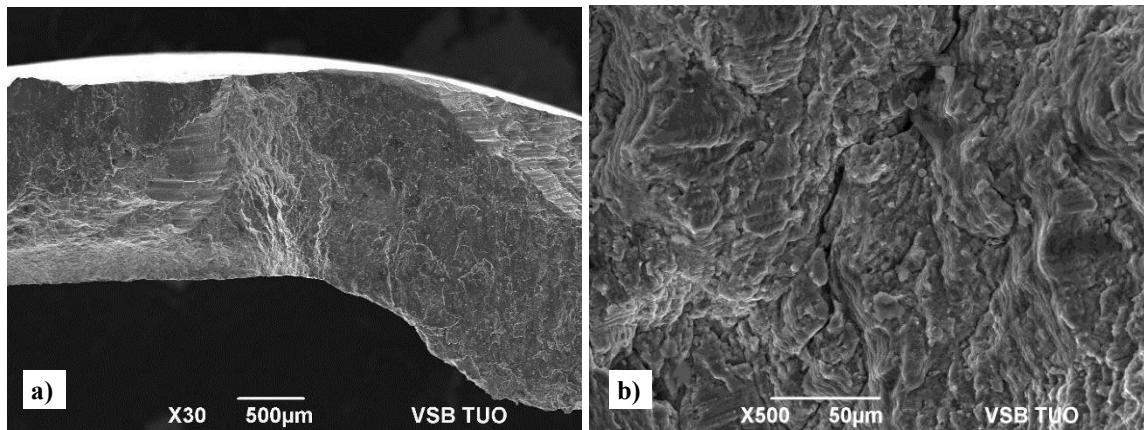
**Figure 4.** SEM fractography of specimen 3 fatigue tested in H12 temper, 1,369,000 cycles: a) view of crack initiation and b) detail of initiation area with steps, secondary microcracks and striations.

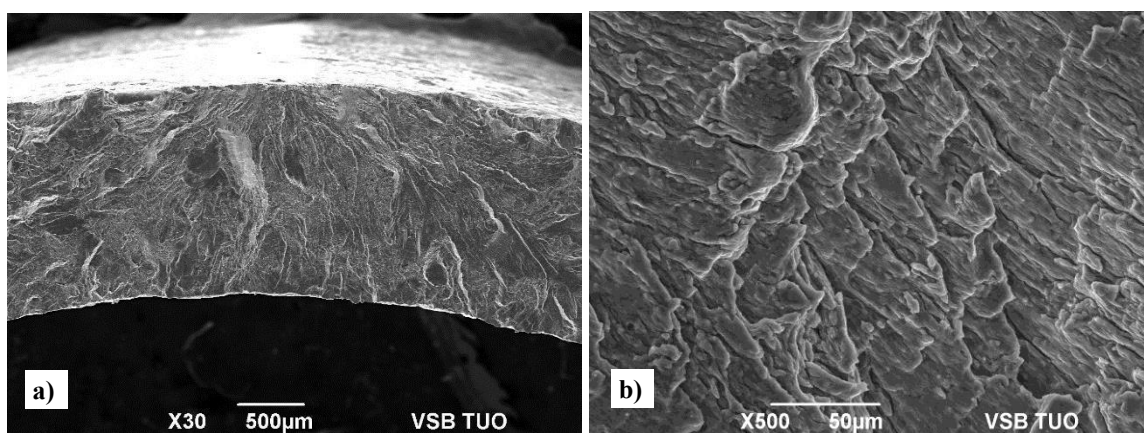
**Figure 5.** SEM fractography of specimen 1 fatigue tested in O temper, 100,000 cycles: a) view of crack initiation and b) detail of initiation area with steps, secondary microcracks and striations.

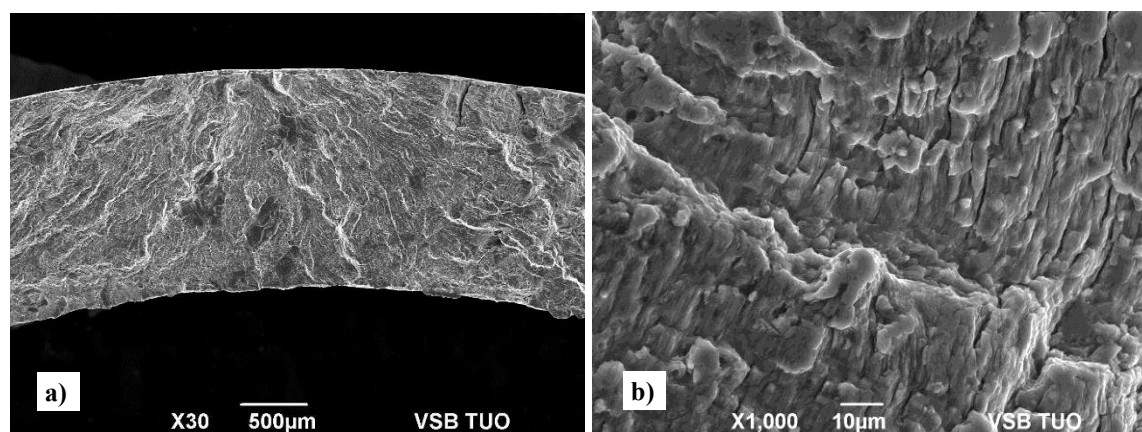
**Figure 6.** SEM fractography of specimen 2 fatigue tested in O temper, 302,000 cycles: a) view of crack initiation and b) detail of initiation area with steps, secondary microcracks and striations.

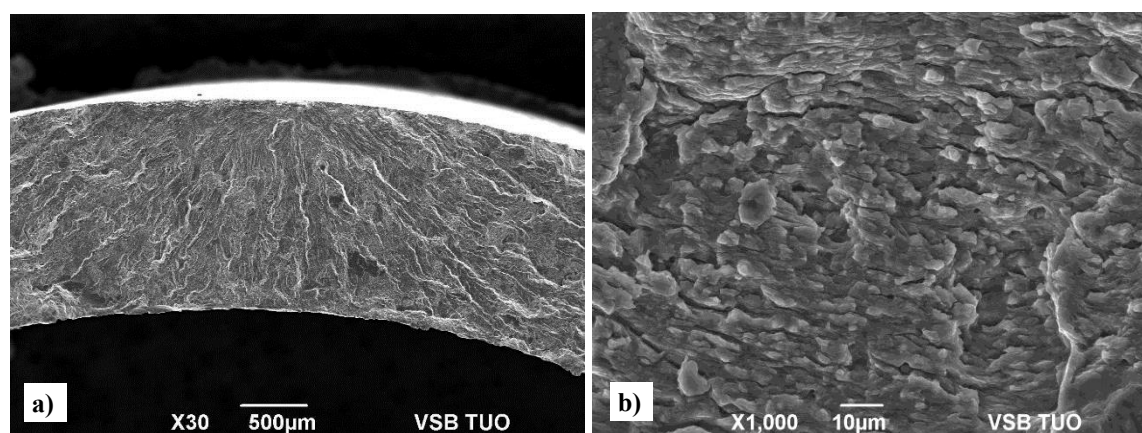
**Figure 7.** SEM fractography of specimen 3 fatigue tested in O temper, 950,000 cycles: a) view of crack initiation and b) detail of initiation area with steps, secondary microcracks and striations.
