**IMPROVEMENT OF WEAR COMPONENT'S
PERFORMANCE BY UTILIZING
ADVANCED MATERIALS AND NEW
MANUFACTURING TECHNOLOGIES:
CASTCON PROCESS FOR MINING APPLICATIONS**

Quarterly Technical Progress Report

For the period starting October 1, 2002, ending December 31, 2002

DE-FC26-01NT41055

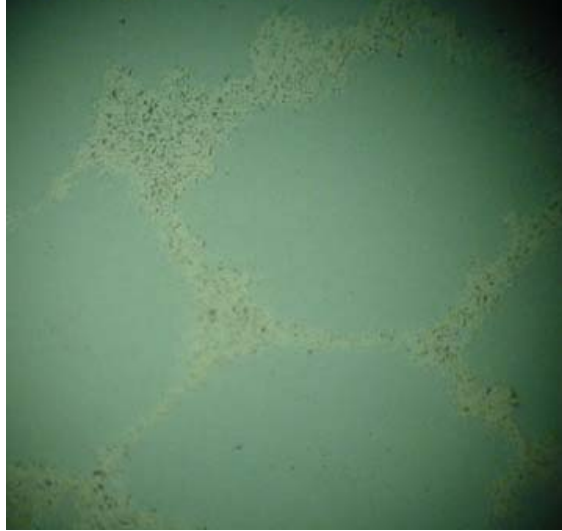
Upon polishing, the part was viewed under a microscope to see if residual carbon was present (Figure 1). Residual carbon is typically observed as black or dark spots. No significant amount of C-porosity was observed in the piece. In stating that, however, ACR does not have the ability to rate the amount of C-porosity present within the part as compared to the carbide industry. Each supplier of carbide standardizes a technique and reference from which a piece is quantified as being saturated by C-porosity, thus deemed unacceptable. However, the insert has less visible C-porosity than some of the sample inserts ACM has sectioned.

Figure 1. WC(6%Co)-Co FM after etching at 20X, 1st view.

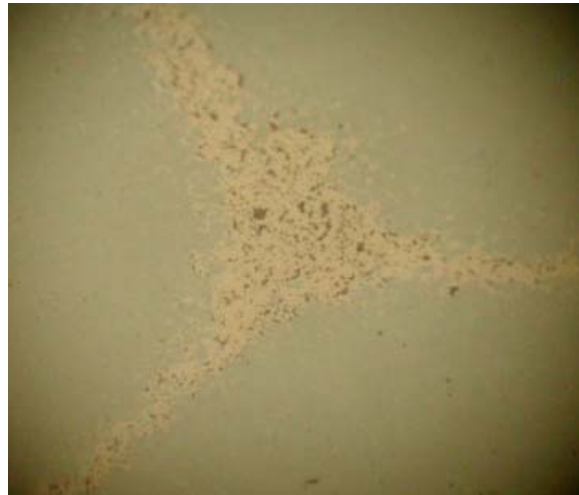
The bottom surface of the insert was etched to reveal eta phase (a darker orange color of Figure 2). Eta phase is the lack of carbon. Again, eta phasing is also considered a defect in the carbide industry. The figures attached are taken after etching. There is very little eta phase present in the carbide core. However, there is eta phase present throughout the cobalt interface. This makes sense since there should be little or no carbon in the pure cobalt interface.

Figure 2. WC(6%Co)-Co FM after etching at 20X, 2nd view.

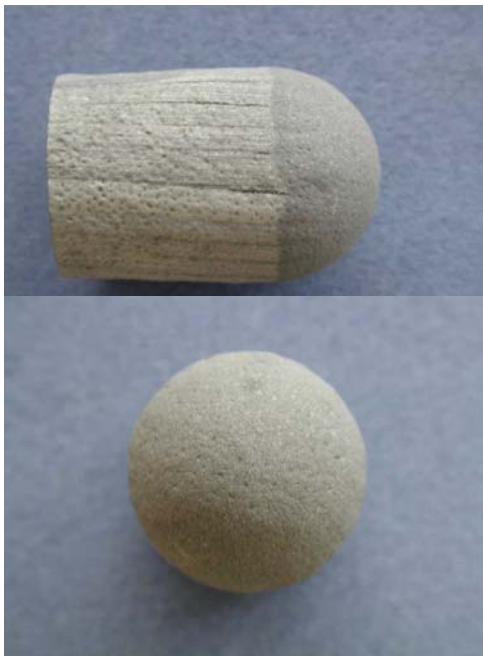
appearance of the insert after burn-out and sintering. Bloating is obvious on the upper part of the insert, which suggests that confinement by sand weight is not sufficient.

Figures 3 – 6: Confinement burnout, Test 1. Insert was embedded in a clay crucible filled with silica sand. The confinement came from the weight of top sand. The heating rate was 0.5°C/min from room temperature to 500°C, followed by a sintering to 1100°C for two hours.

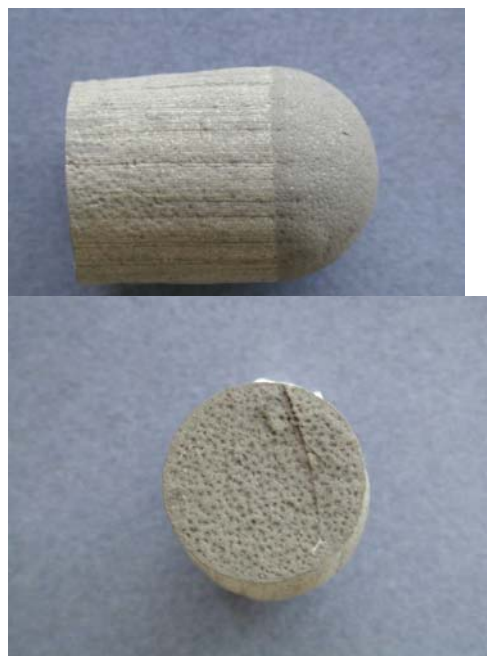
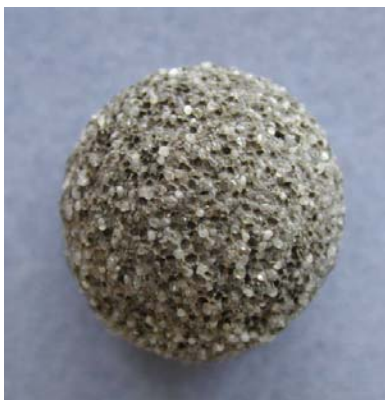
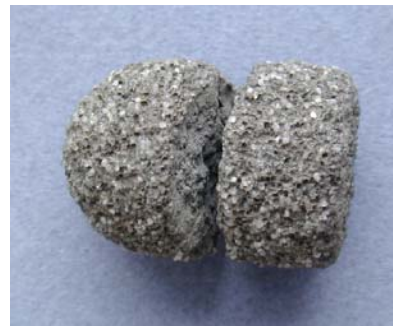
The second insert was embedded in a metal container fully filled with silica sand and covered by a metal lid. The confinement was introduced by the metal container's resistance to expansion. Figures 7-9 show the appearance of the insert after burn-out and sintering. From these figures, we can see that FM material penetrated into the surrounding sand and there are many large internal pores. We think this is due to the coarse surrounding sand (20-28 mesh) giving little resistance to the penetration of FM material into the sand interspaces.

Figures 7 – 9: Confinement burnout, Test 2. Insert was embedded in a metal container fully filled with silica sand and covered by a metal lid. The confinement was introduced by the metal container's resistance to expansion. The heating rate was 0.5°C/min from room temperature to 500°C, followed by a sintering to 1100°C for two hours.

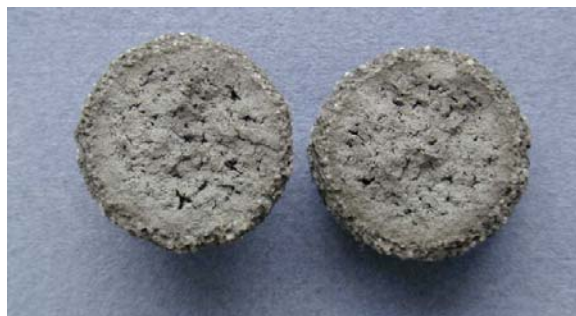
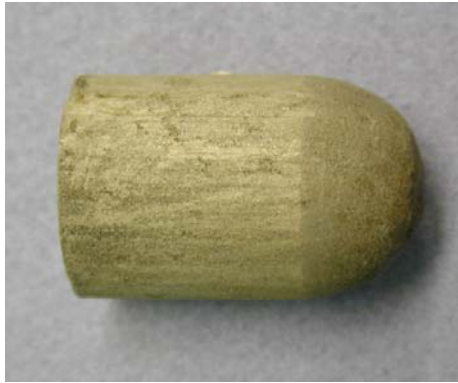
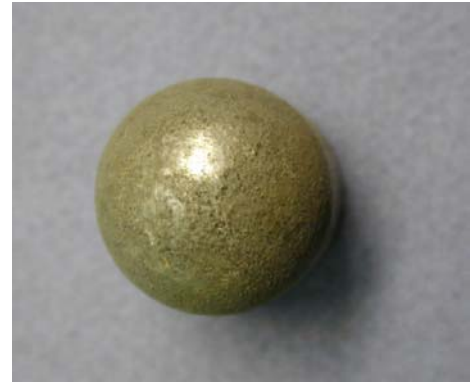
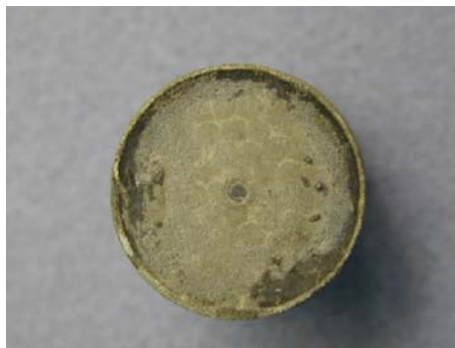
The third insert burn-out and sintering was the same as the second one except much finer (100-150 mesh) graphite sand was used as the surrounding material. Figures 10-12 show the appearance of the resulting insert. There were no cracks or bloating at all. However, a density measurement revealed that the insert was not fully dense. The insert absorbed water. The insert was then sintered to 1200°C for one hour and checked for its density after cooling. The insert still absorbed water. The insert was sintered to higher temperatures in every 50°C increment, until 1350°C for one hour. The insert absorbed no water, assuming over 95% relative density. The insert was then sent to ACM for 1300°C and 30 ksi container-less HIPping.

Figures 10 – 12: Confinement burnout, Test 3. Insert was embedded in a metal container fully filled with graphite sand and covered by a metal lid. The confinement was introduced by the metal container's resistance to expansion. The heating rate was 0.5°C/min from room temperature to 500°C, followed by a sintering to 1100°C for two hours. The insert was then sintered to 1200°C for one hour. Then the insert was sintered to higher temperatures in every 50°C increment, until 1350°C for one hour.
