CASE REPORT

Cross stimulation and unusual ventricular activation in a patient with dual chamber pacemaker

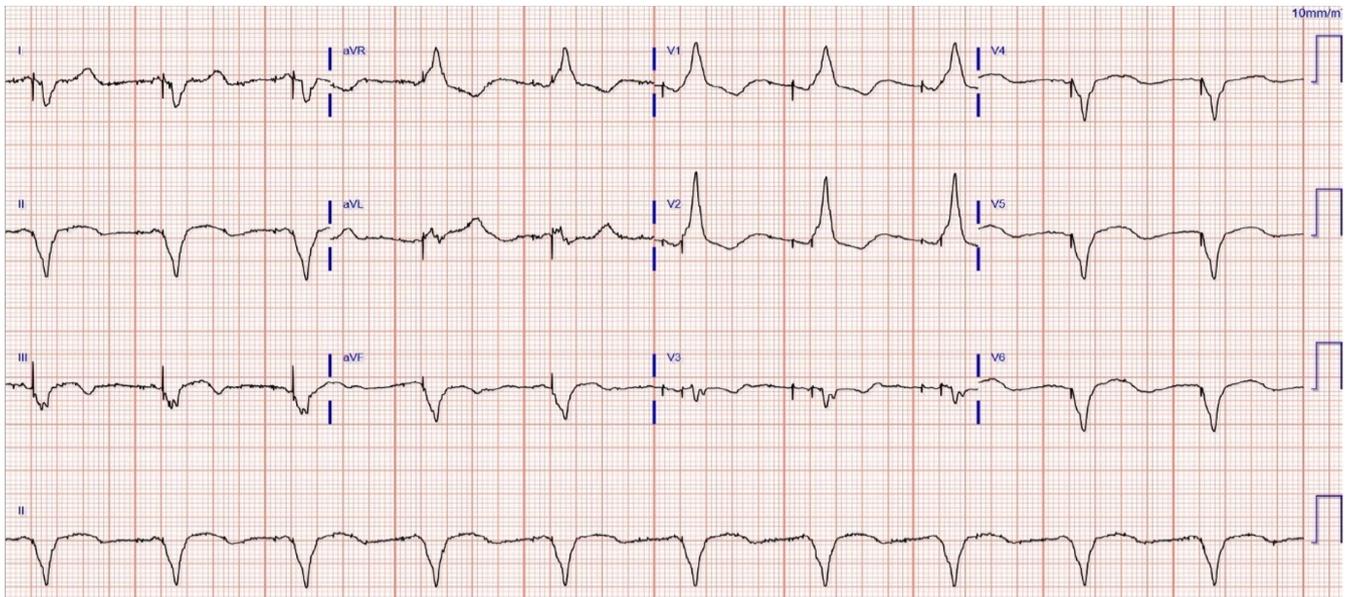
atrial lead to the ventricular connector and ventricular lead to the atrial connector of the pacemaker generator. In this case, the initial post-implant ECG ([Figure 1](#)) shows bipolar atrial and ventricular pacing with an AV interval of 150 milliseconds (ms). The presence of a right bundle morphology with ventricular pacing is consistent with either implantation of the ventricular lead in the coronary sinus or placement of the lead deep in the right ventricular septum. Other differential diagnosis includes (1) left ventricular (LV) endocardial stimulation (a) via Patent Foramen Ovale (PFO) or atrial septal defect (ASD), (b) via unrecognized arterial access, (c) via ventricular septal defect (VSD) or (2) right ventricular (RV) apical stimulation with some rotation or enlargement. A subsequent lateral chest X-ray confirmed the posterior location of the ventricular lead most likely in a branch vessel of the coronary sinus ([Figure 3](#)).

FIGURE 1 Twelve-lead ECG following implantation of a dual-chamber pacemaker in 2013 shows atrial and ventricular pacing spike followed by atrial and ventricular capture respectively

amplitude than measured P wave amplitude), which results in atrial depolarization most likely hidden inside the ST interval. Paced P wave was observed to be relatively lower amplitude even in [Figure 1](#). Also, there is no retrograde atrial activation to inhibit the second spike, due to underlying atrioventricular block. When the pacemaker was programmed to AAI mode the second spike disappeared, effectively changing the pacemaker mode to VVI mode. Since the procedure was performed at outside hospital, she was given the option

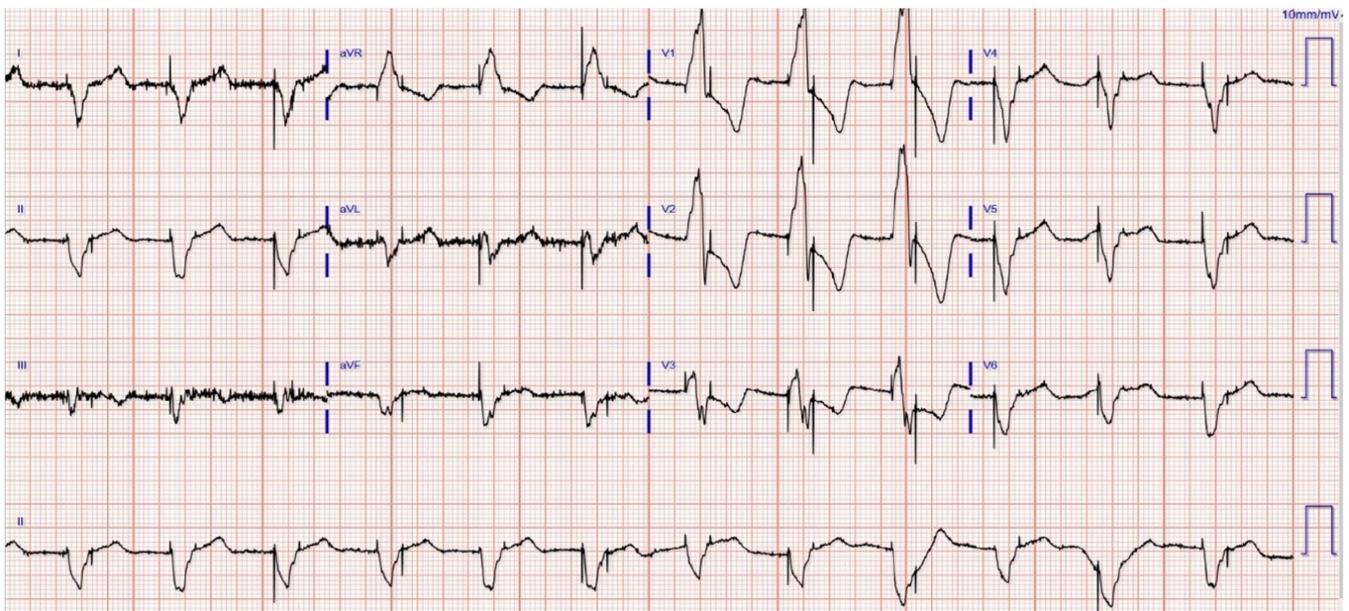
The second ECG ([Figure 2](#)) shows two pacing spikes, with the first spike activating the ventricles and the second spike occurring exactly at an interval of 150 ms. The first spike is originating from the atrial port, connected to the ventricular lead, activating the left ventricles followed by the second spike, which is connected to the atrial lead, activating the atria. Ventricular depolarization following the "atrial" spike is due to the inadvertent connection of the

FIGURE 2 Twelve-lead ECG on admission, 3 months after generator replacement showing atrial spike stimulating ventricle and ventricular spike resulting in p wave which is low amplitude and buried inside ST interval

ventricular lead into the atrial port of the dual-chamber generator during generator replacement. Since it was a double switch and the atrial lead was attached to the ventricular port, the second or “ventricular” spike occurs due to relative under sensing on the ventricular channel (Since this channel was supposed to sense R wave instead of P wave, it was programmed at 3 mV to sense R waves, but due to lead misplacement, this channel, which is now an atrial channel, is under sensing P waves because of higher programmed

to either continue observation or open the pocket and correct the leads. The patient decided to continue observation. The patient is being closely followed up in the clinic at regular intervals and has been doing well.

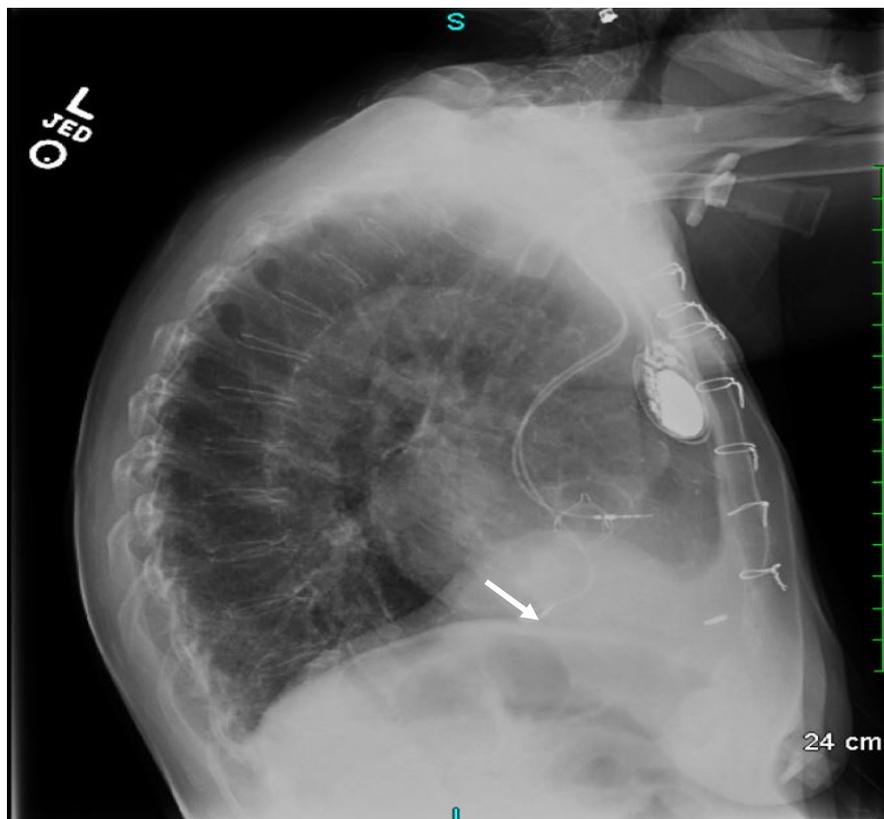
FIGURE 3 Chest X-ray showing lateral view after device implantation. The white arrow represents the posterior location of RV lead
