# Discoloration of the Wetted Surface in the 6.1D Dissolver

SRNL-STI-2013-00717

**Keywords:** *H-Canyon, Dissolver,  
Discoloration, Corrosion*

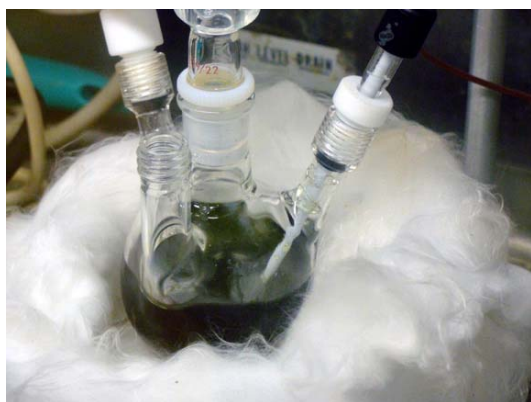
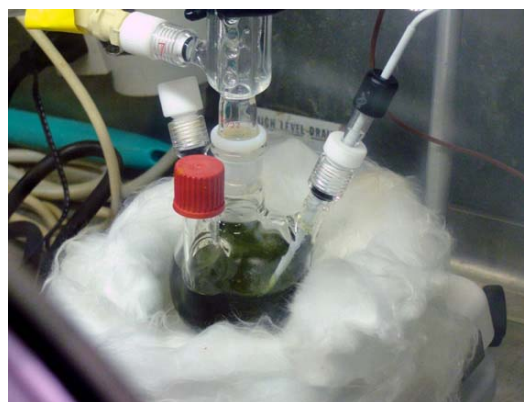
**Figure 3-1. Dissolution of Nylon Bag in 8 M Nitric Acid Solution**

Before

After

There were no discernible differences in the appearance of the solution when compared before or after the dissolution of the nylon. Complete dissolution of the small piece was achieved and no residues attributed to the nylon were observed.

The ratio of the nylon to the volume of solution used in the initial experiment was approximately 14 g of nylon per liter of solution. This value is greater than one hundred times the ratio used in the 6.1D dissolver for a Pu metal dissolution. The approximate mass of nylon bag used to contain one can of Pu metal is 77 g. Ten cans of Pu per batch are charged to the 6.1D dissolver which contains 6000 L of solution; therefore, the ratio used in dissolver is 0.13 g/L. The second nylon dissolution experiment was performed using this ratio. Figure 1 shows photographs of the vessel before and after the dissolution of the nylon material.
