SAND2012-3521  
Unlimited Release  
Printed April 2012

## **EDS V25 Containment Vessel Explosive Qualification Test Report**

The V25 containment vessel was procured by the Project Manager, Non-Stockpile Chemical Materiel (PMNSCM) as a replacement vessel for use on the P2 Explosive Destruction Systems. It is the first EDS vessel to be fabricated under Code Case 2564 of the ASME Boiler and Pressure Vessel Code, which provides rules for the design of impulsively loaded vessels. The explosive rating for the vessel based on the Code Case is nine (9) pounds TNT-equivalent for up to 637 detonations. This limit is an increase from the 4.8 pounds TNT-equivalency rating for previous vessels. This report describes the explosive qualification tests that were performed in the vessel as part of the process for qualifying the vessel for explosive use. The tests consisted of a 11.25 pound TNT equivalent bare charge detonation followed by a 9 pound TNT equivalent detonation.

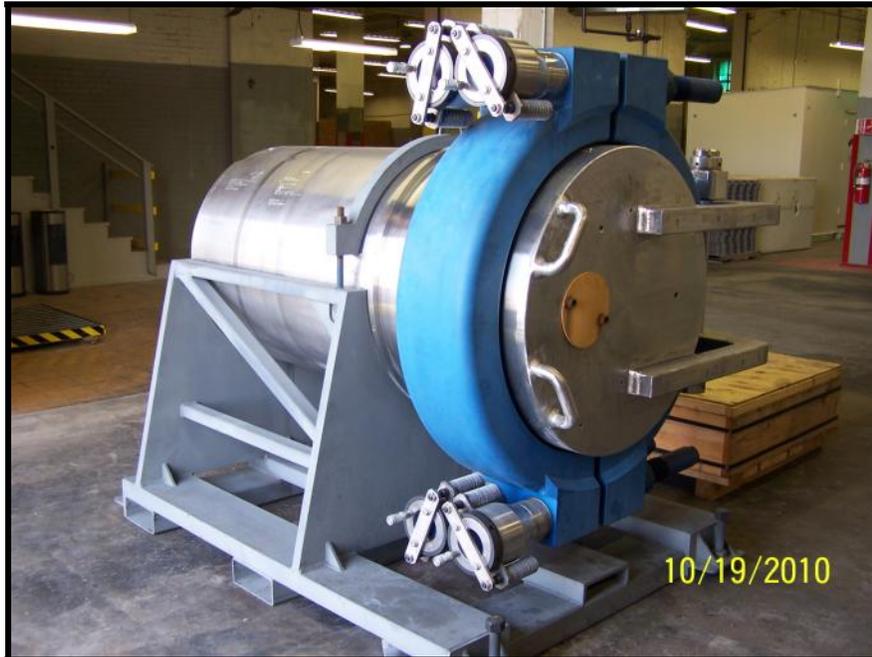
Figure 1: This image shows the EDS vessel mounted in the shipping fixture.

A new EDS vessel (S/N: JH2830801, P/N: H90063-119-3), owned by the Project Manager, Non-Stockpile Chemical Materiel (PMNSCM), was to be tested as part of the process for qualifying the vessel for explosive use. The proposed explosive rating for the vessel, shown in Figure 1, was nine (9) lbs. TNT-equivalent for up to 637 detonations. This limit is an increase from 4.8 lbs. TNT-equivalency rating from previous vessels. The increase in the rating is based on ASME Code Case 2564 and recent tests and structural analysis. EDS vessel dimensions and further specifications can be found in the test plan.

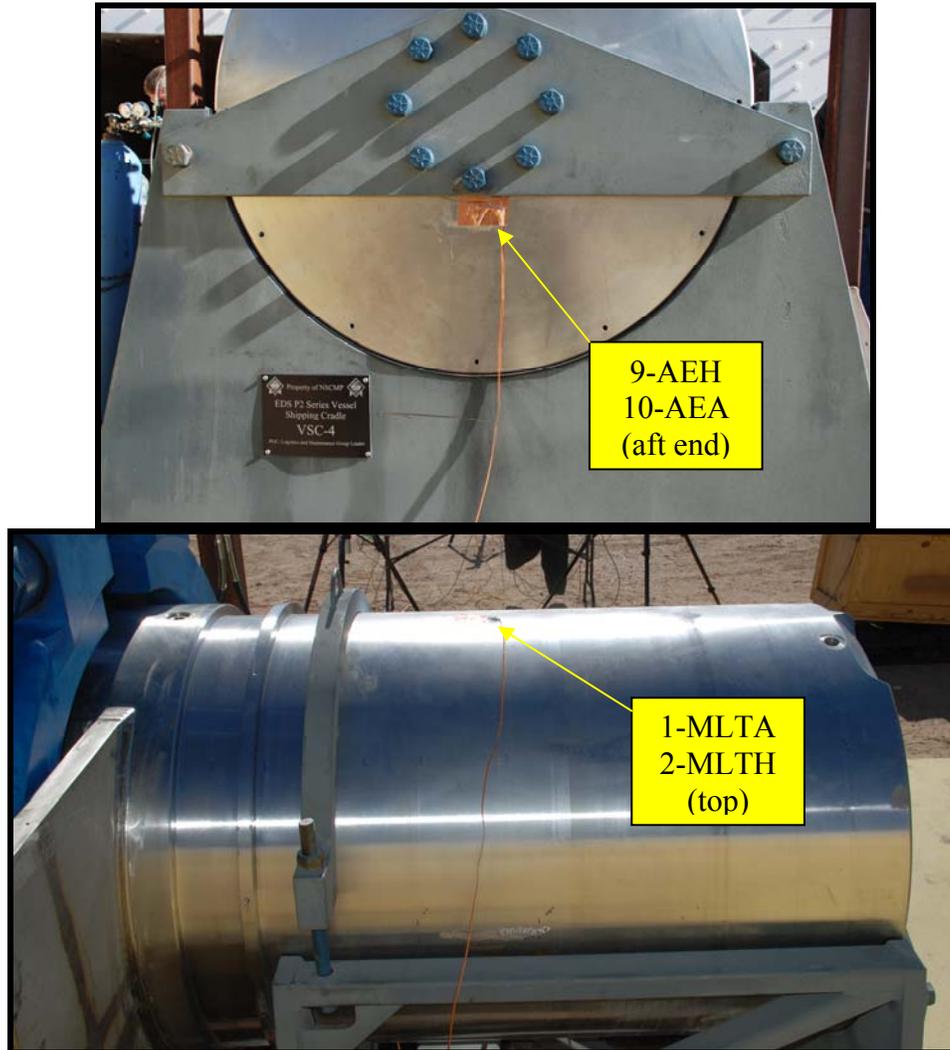
**Figure 6: These images illustrate the locations of strain gauges on the EDS vessel. Data from these positions were compared to modeling data.**

**The name of each gauge indicates the position and strain direction measured. For example, “MLTA” indicates Mid-Length Top Axial. An “H” following the position indicates hoop strain measurement.**

As mentioned previously, ten (10) separate strain gauges were installed on the exterior surfaces of the EDS vessel and on the clamp surfaces. Data from only two strain gauge positions were compared to simulation data. These positions are shown in Figure 4. Figure 6 below shows the actual installed strain gauges at positions 1, 2, 9, and 10 (waist and aft, respectively). The name of each respective gauge is also given.

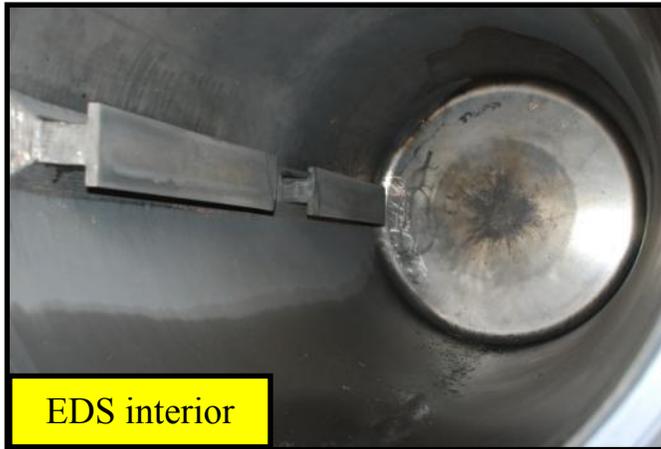
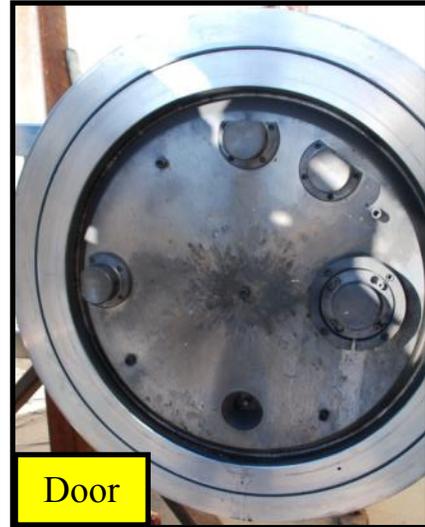
A thorough physical inspection of the EDS vessel before and after each test was conducted. The purpose of this inspection was to note any damage or unexpected behavior caused by the detonation and blast effects. Typical post-detonation views of the EDS vessel interior are shown below in Figure 11.

Figure 11: Representative condition of EDS vessel interior surfaces following detonation and de-pressurization. Blast marks (non-damaging) are evident on flat door and end (aft) surfaces.
