Case Studies of Duct Retrofits and Guidelines for Attic and Crawl Space Duct Sealing

November 2011

Prepared by
OAK RIDGE NATIONAL LABORATORY
Oak Ridge, Tennessee 37831-6283
managed by
UT-BATTELLE, LLC
for the
U.S. DEPARTMENT OF ENERGY
under contract DE-AC05-00OR22725

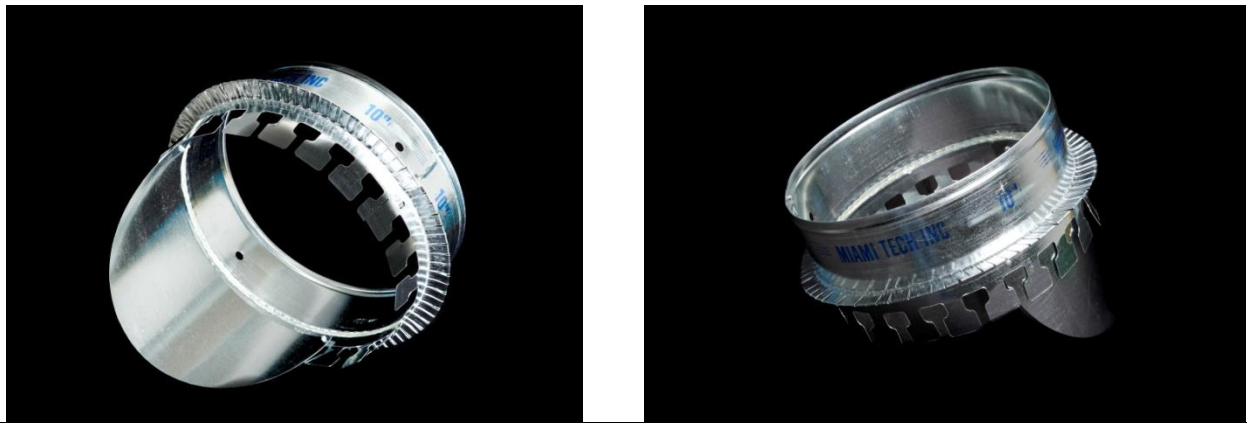
Figure 4. A round take-off collar with a scoop. The scoop helps to turn more of the air in the main trunk up through the take-off.

For this duct retrofit all the ducts in the crawl space were removed and replaced with a round hard duct supply trunk with flex duct supply branches to the floor registers. A scoop was installed where the metal chase comes off the supply trunk to the attic to increase air flow to the upstairs registers. A scoop is a smooth, low-restriction method of redirecting duct air flow by 90 degrees (see Figure 4).

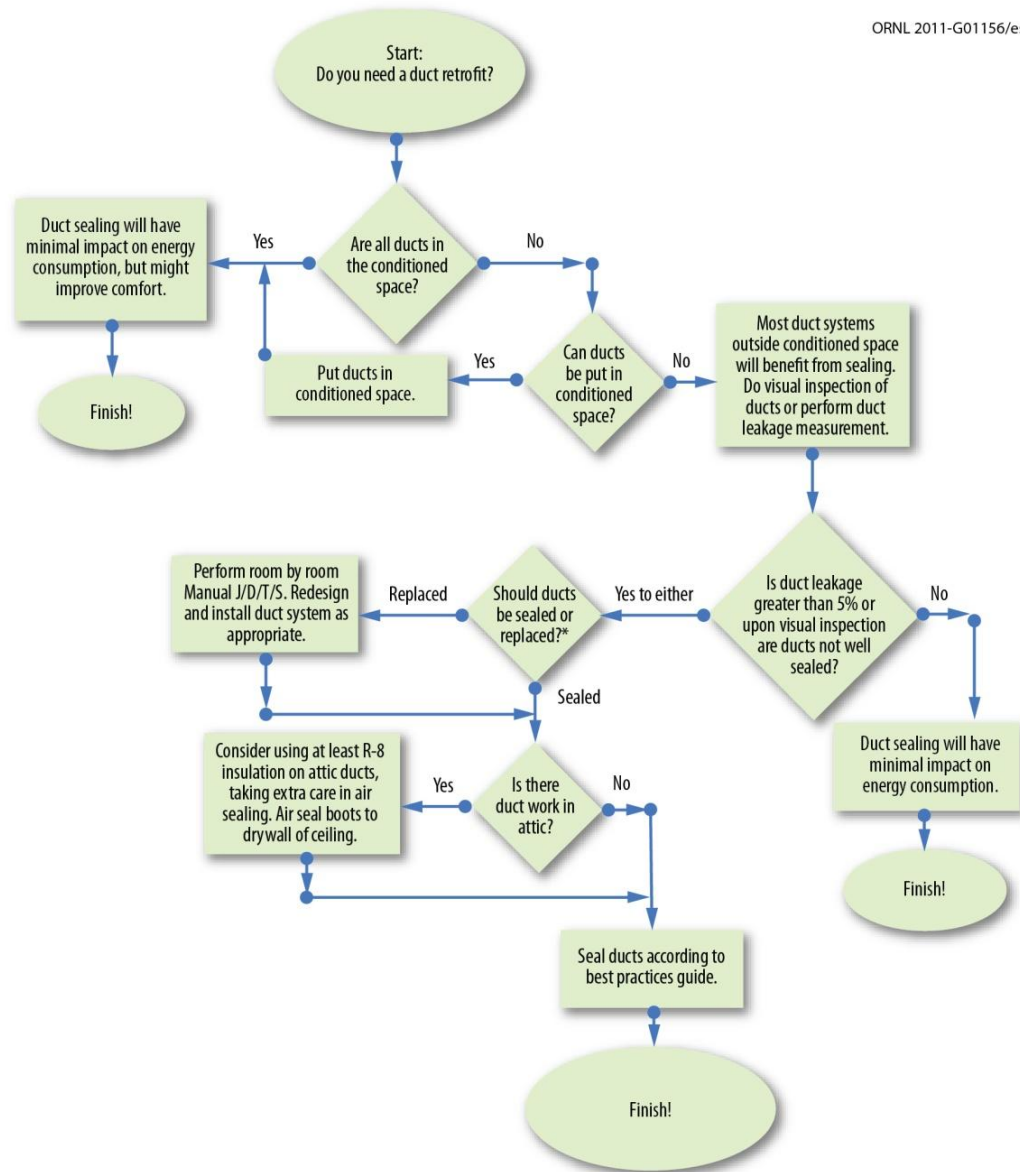
Figure 9. This duct retrofit decision chart can help homeowners and professionals determine whether a duct retrofit is needed, where sealing ducts will provide the greatest benefits, and whether insulation should be added around ducts.*

When considering a retrofit of HVAC ducts, homeowners can use the “Duct Retrofit Decision Chart” to help determine the best scope for the work — whether to move or replace ducts, where sealing ducts will provide the greatest benefits, and whether insulation should be added.
