Findings of Hydrogen Internal Combustion Engine Durability

Final Technical/Scientific Report

DE-FC26-06NT43027

Electric Transportation Engineering Corporation
430 S. 2nd Ave
Phoenix, AZ 85003

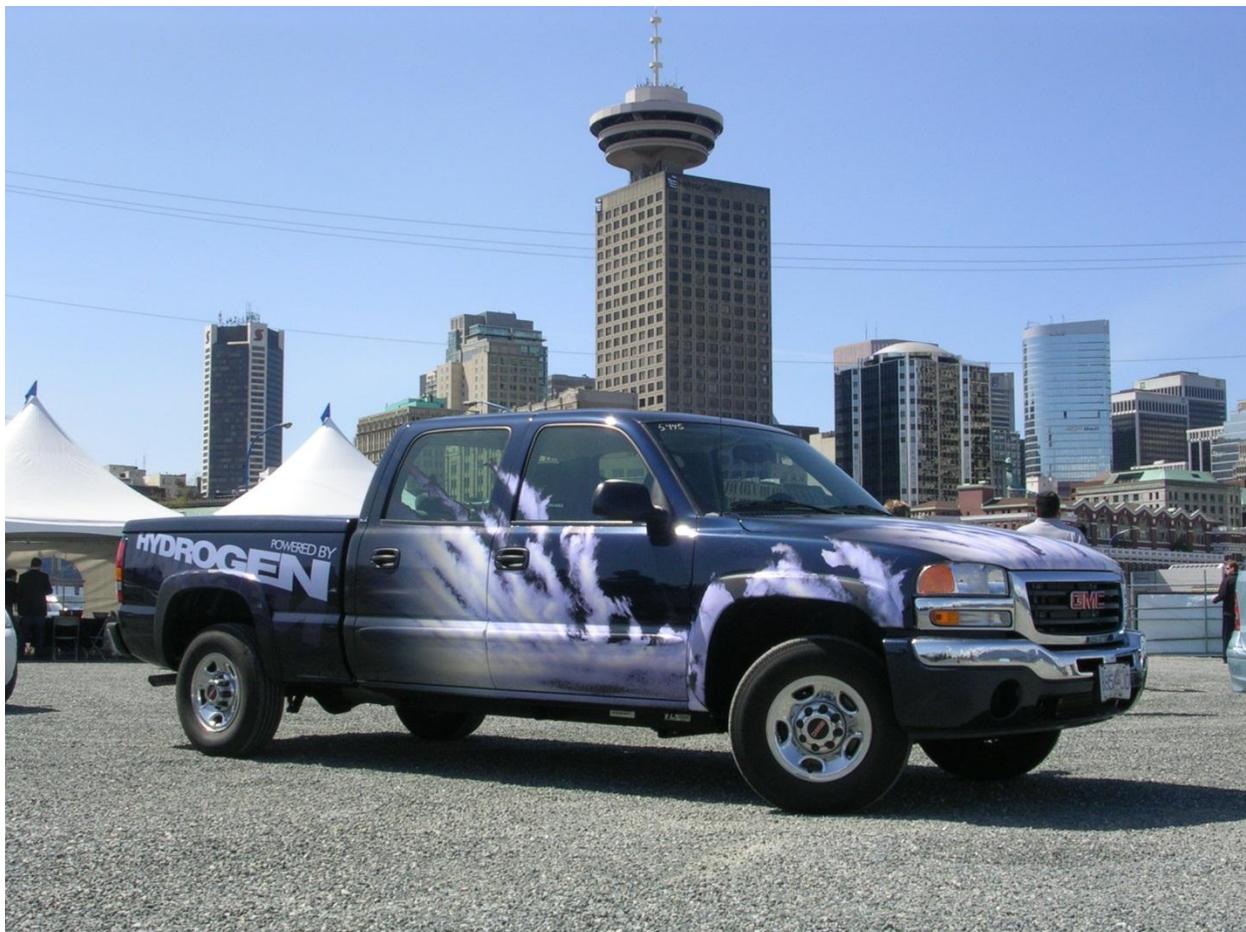
Figure 1--HICE Truck

Roush Industries converted eight GMC Sierra 1500HD pickup trucks with HICE engines of identical design to the unit built for task one along with hydrogen storage cylinders sufficient to provide 150 miles of city range and 200 miles of highway range. Figure 1 shows one of the eight HICE trucks in Vancouver, BC.

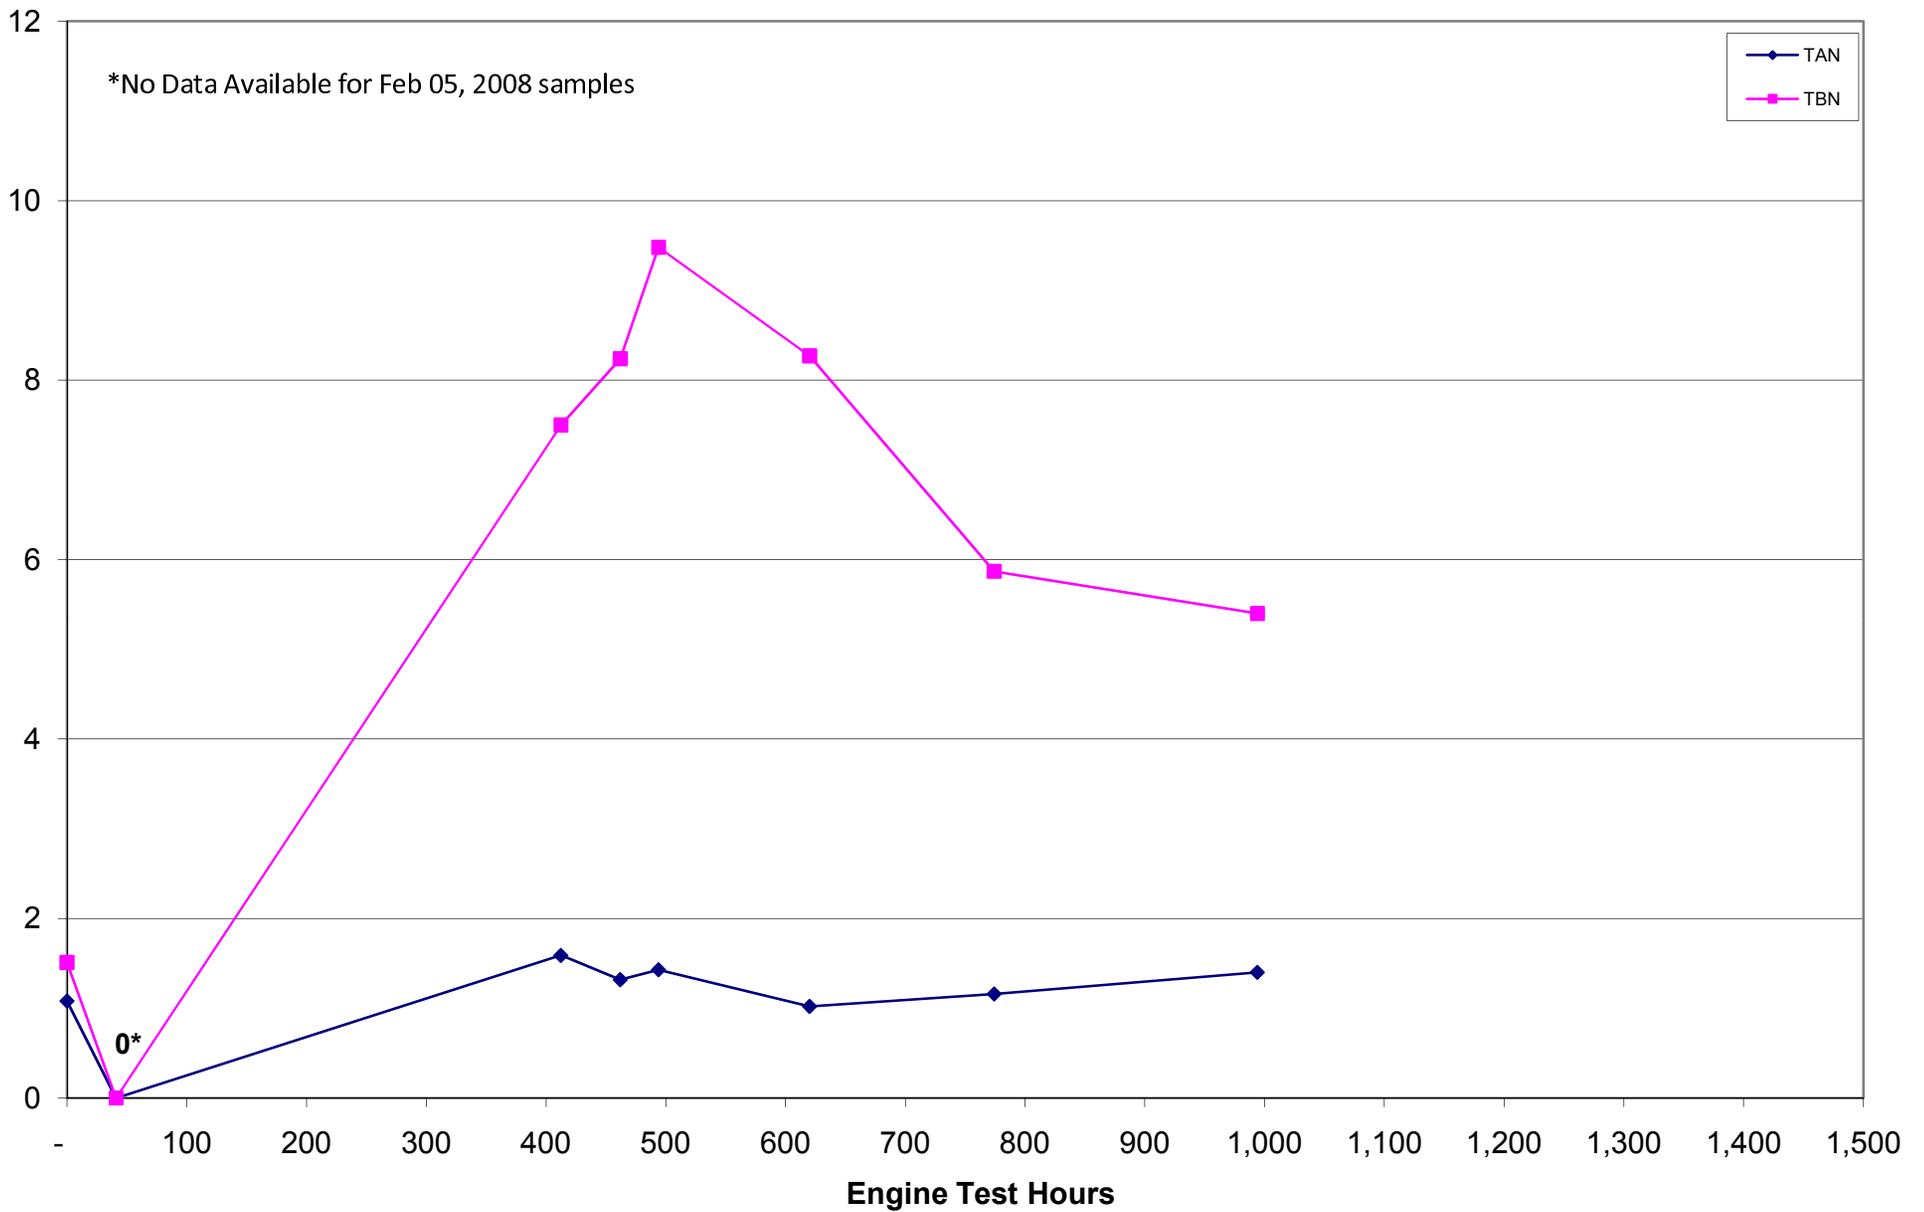
HICE Durability Vehicle: 5445 Staveley Services Oil Analysis Results: TAN & TBN

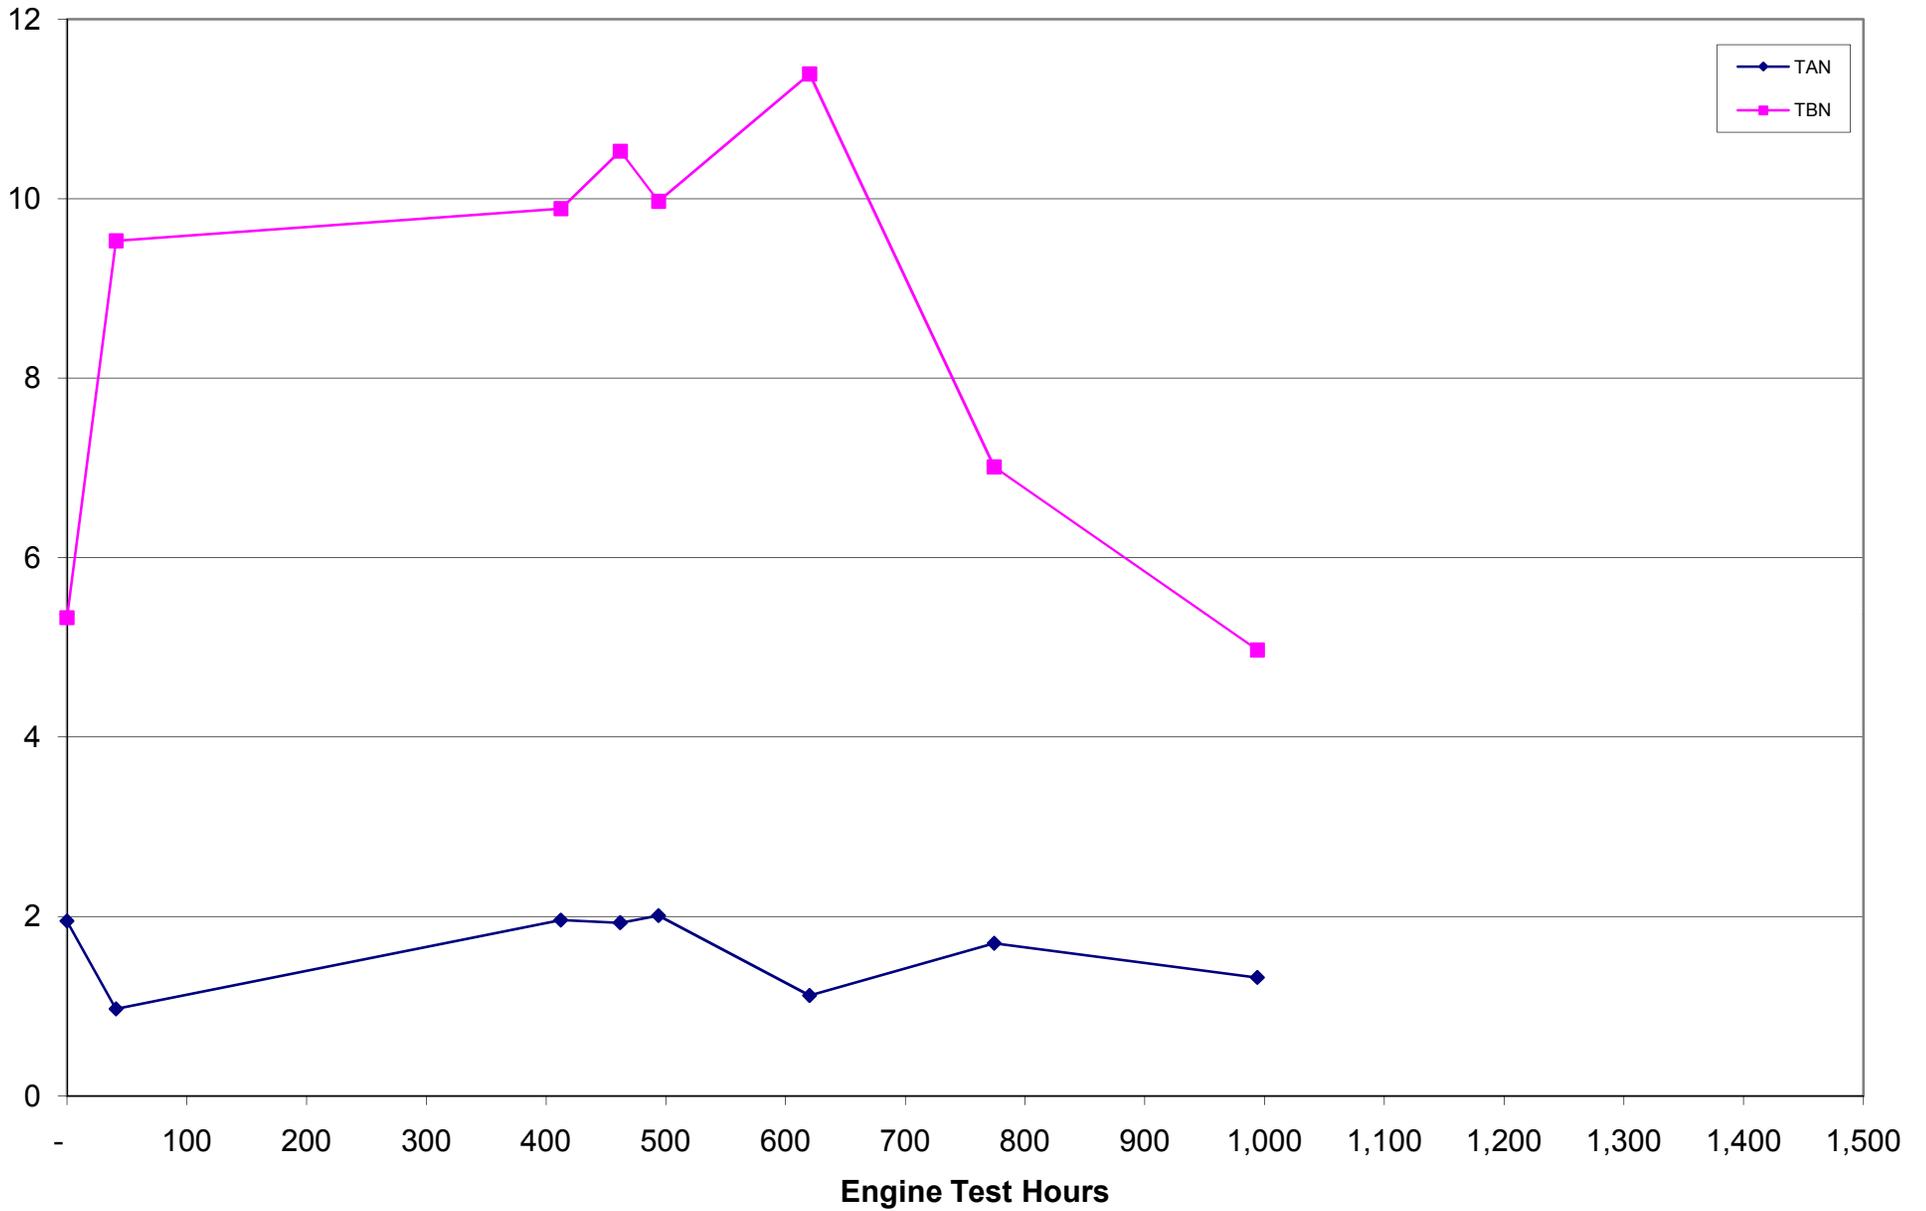
HICE Durability Vehicle: 5445
BTS Oil Analysis Results: TAN & TBN

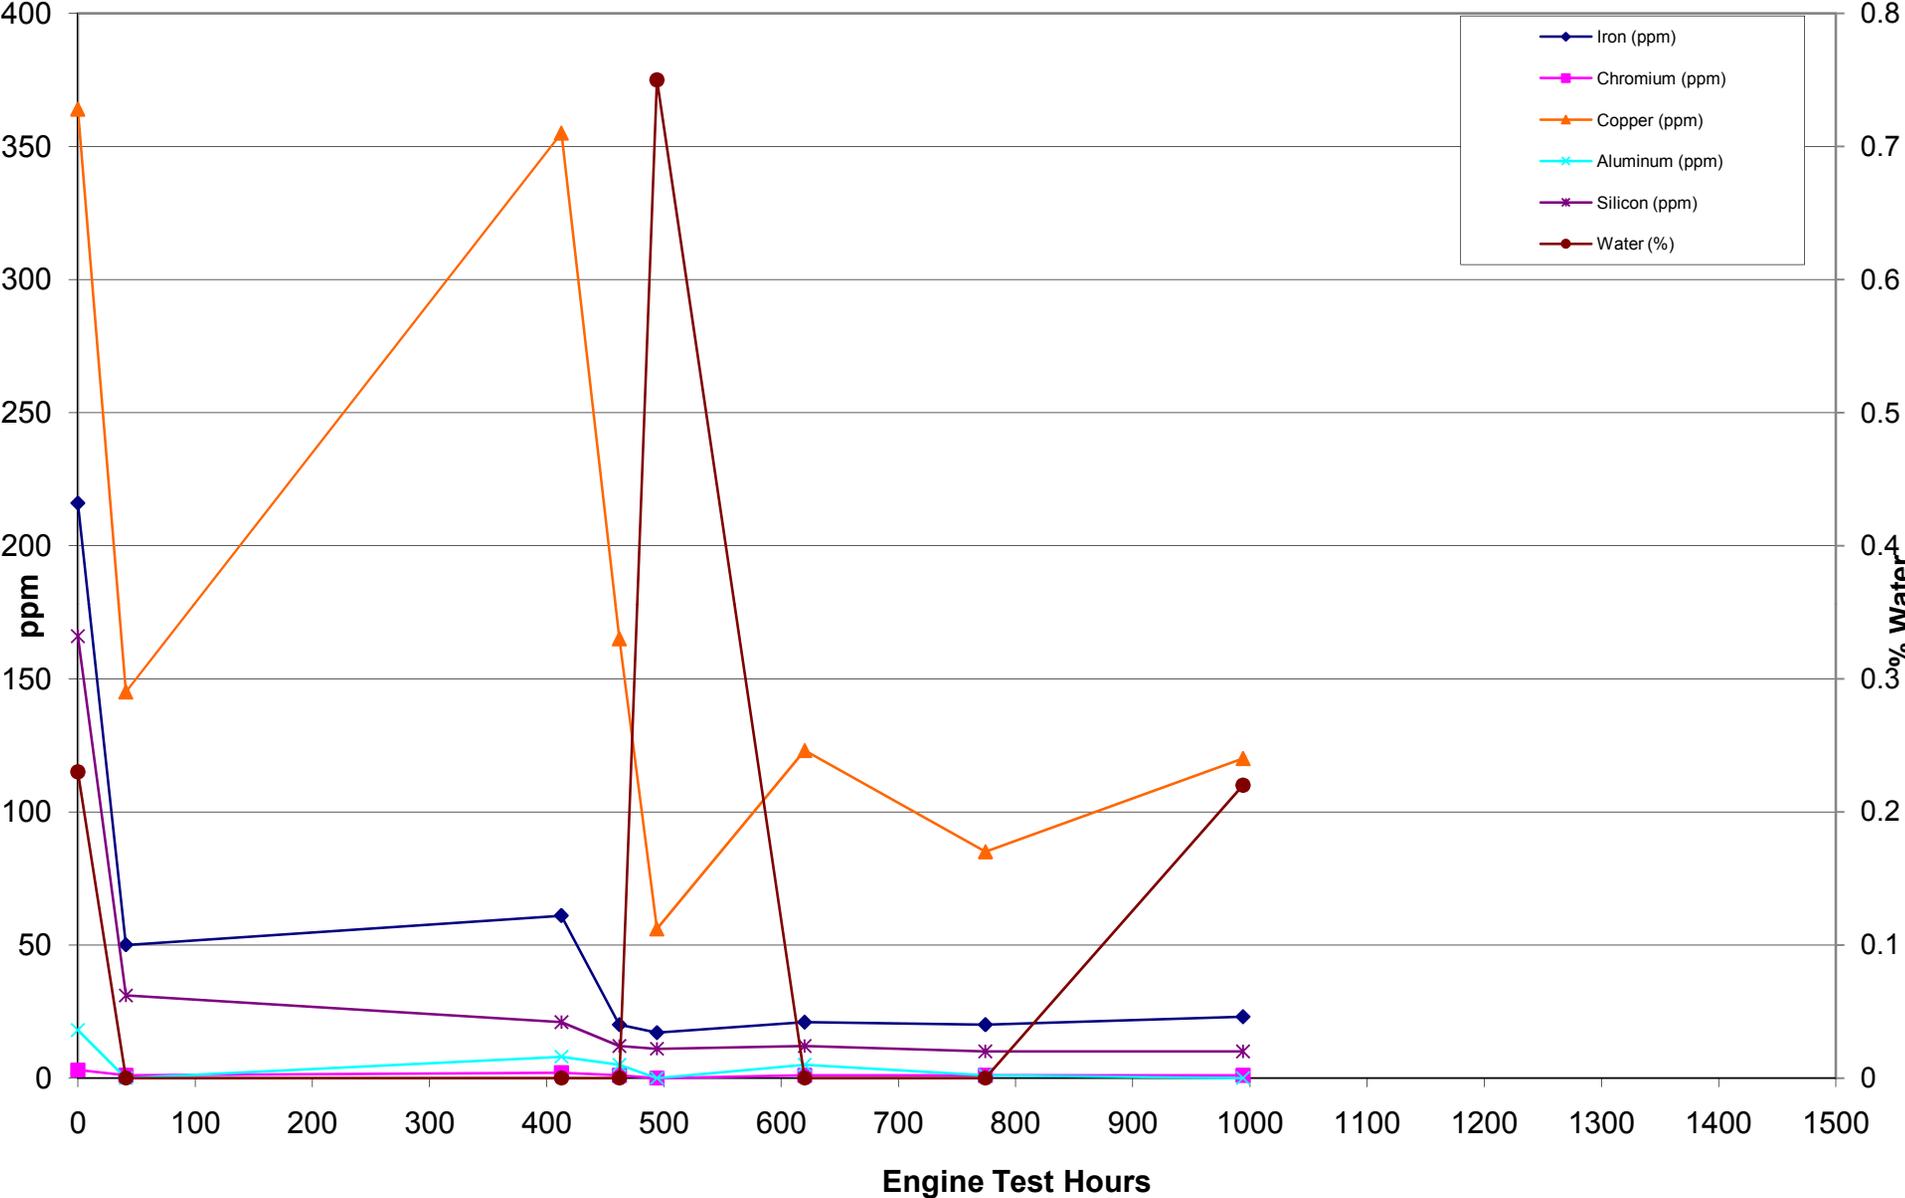
HICE Durability Vehicle: 5445 BTS Oil Analysis Results--Wear Metals

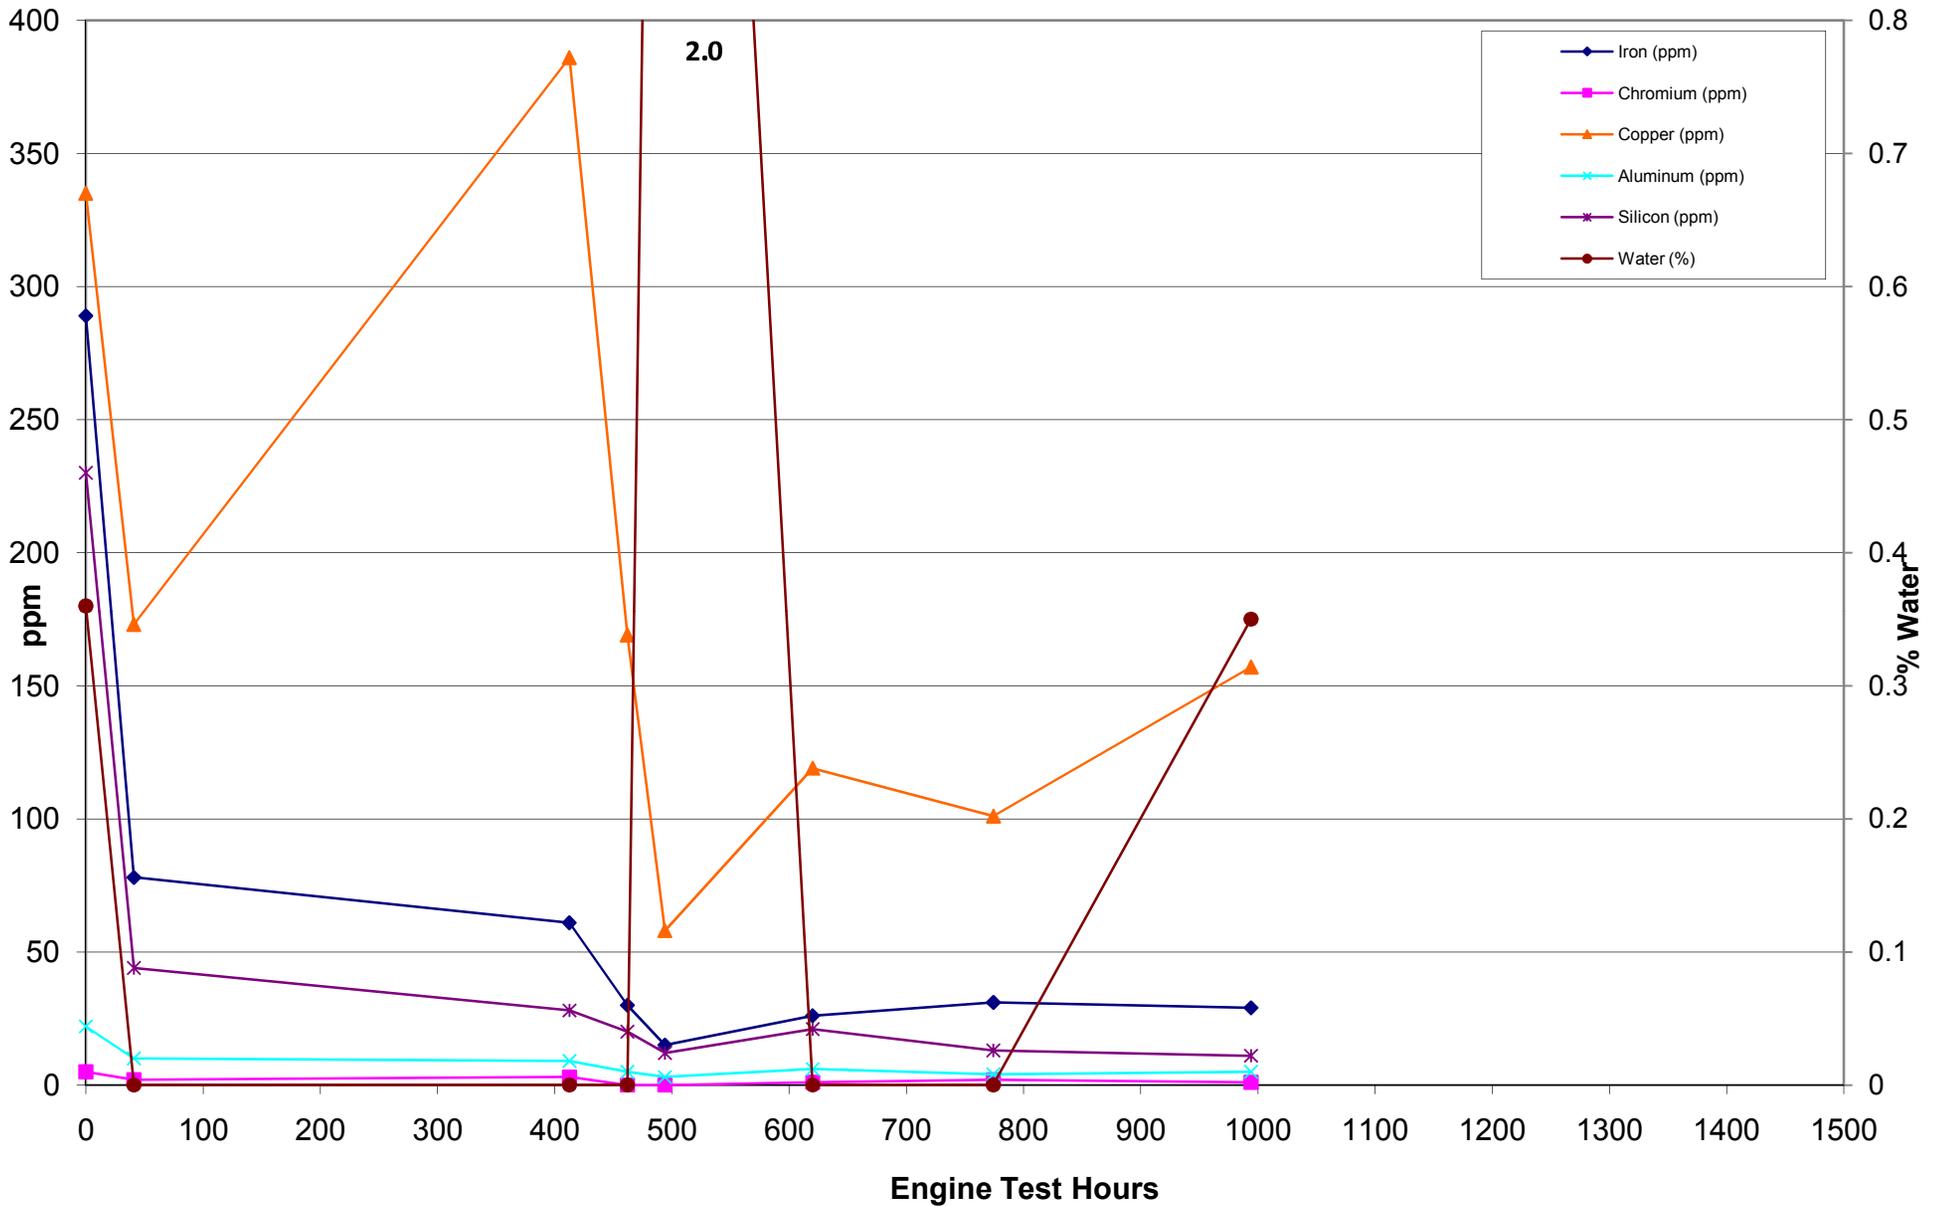
HICE Durability Vehicle: 5445 Staveley Services Oil Analysis Results--Wear Metals

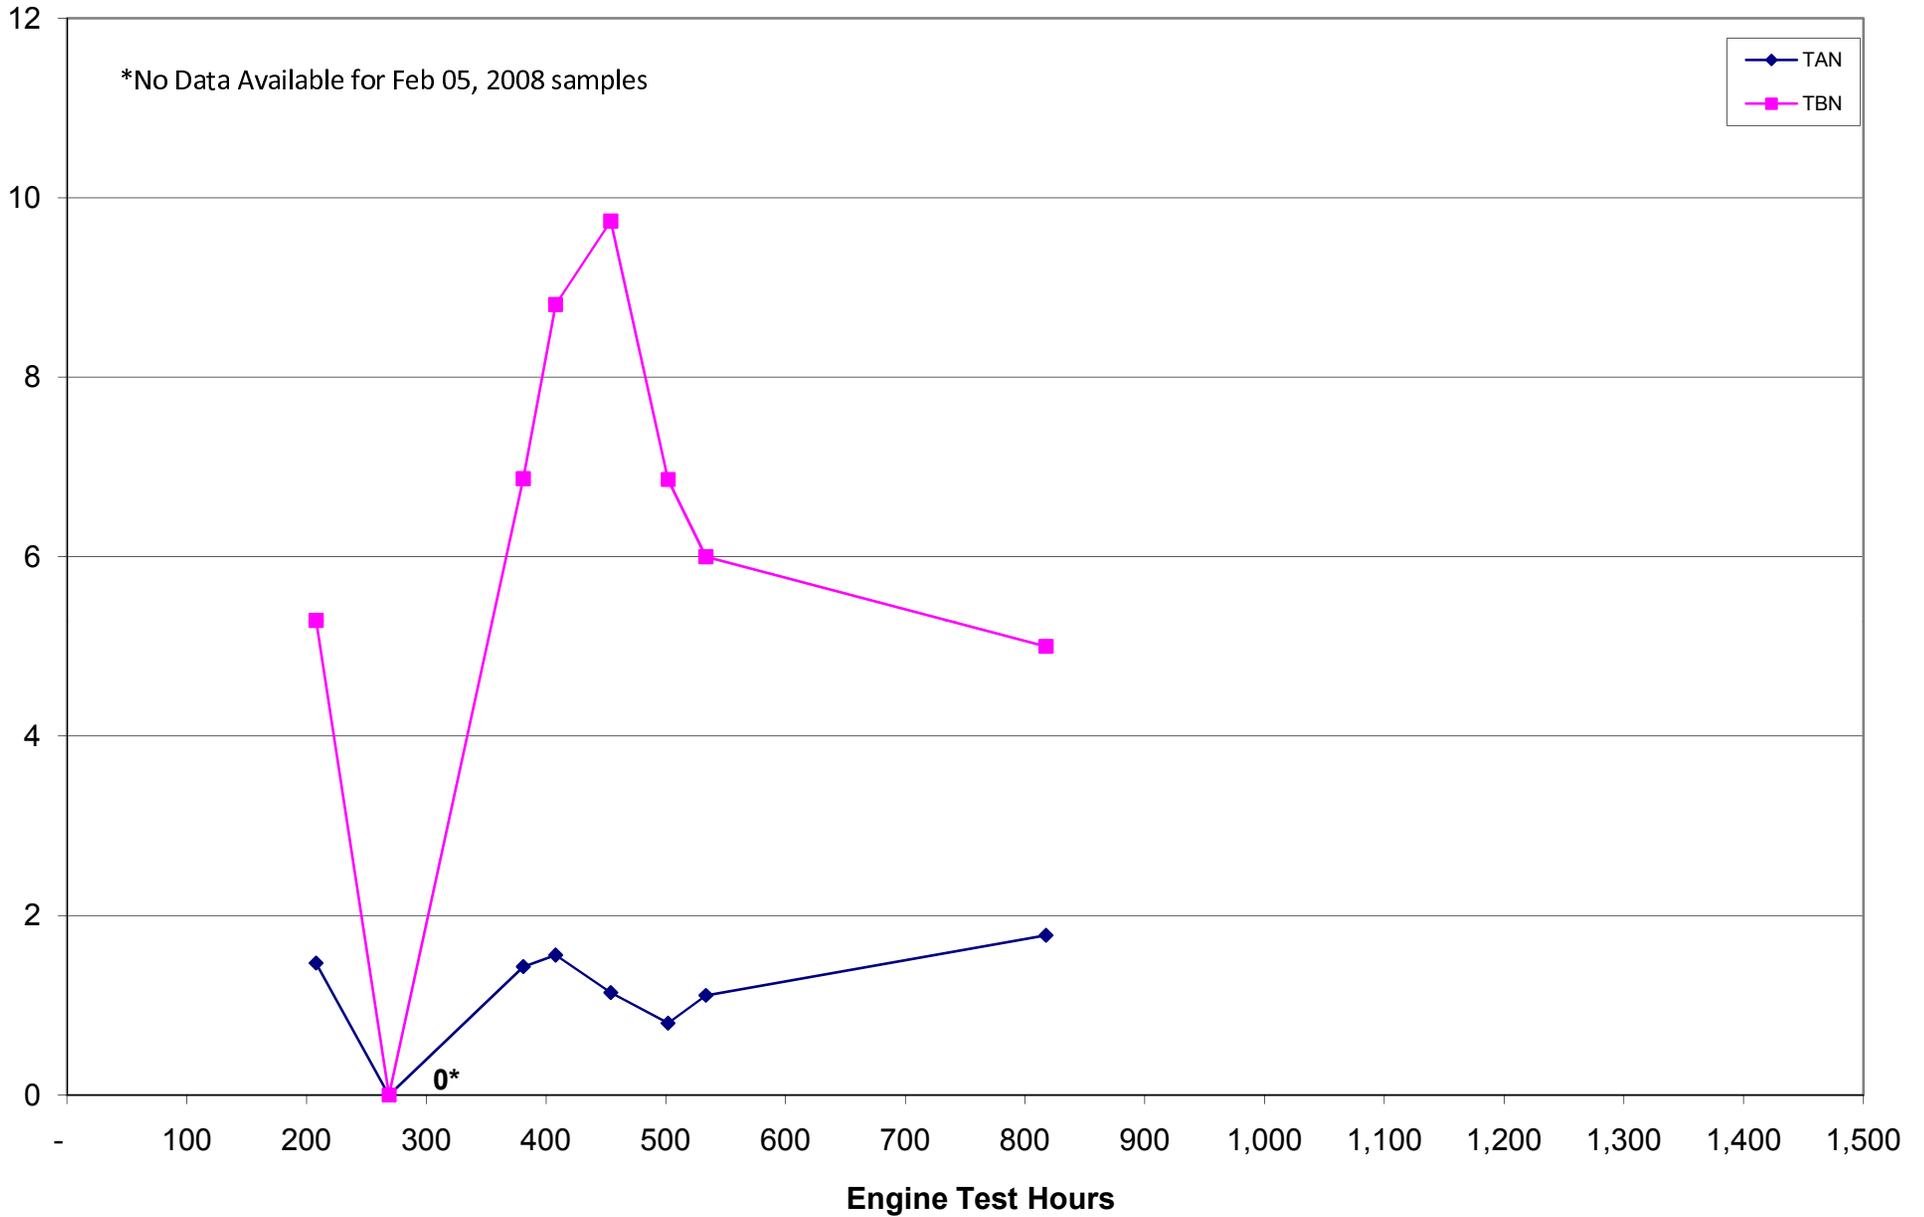
HICE Durability Vehicle: 5561 Staveley Services Oil Analysis Results: TAN & TBN

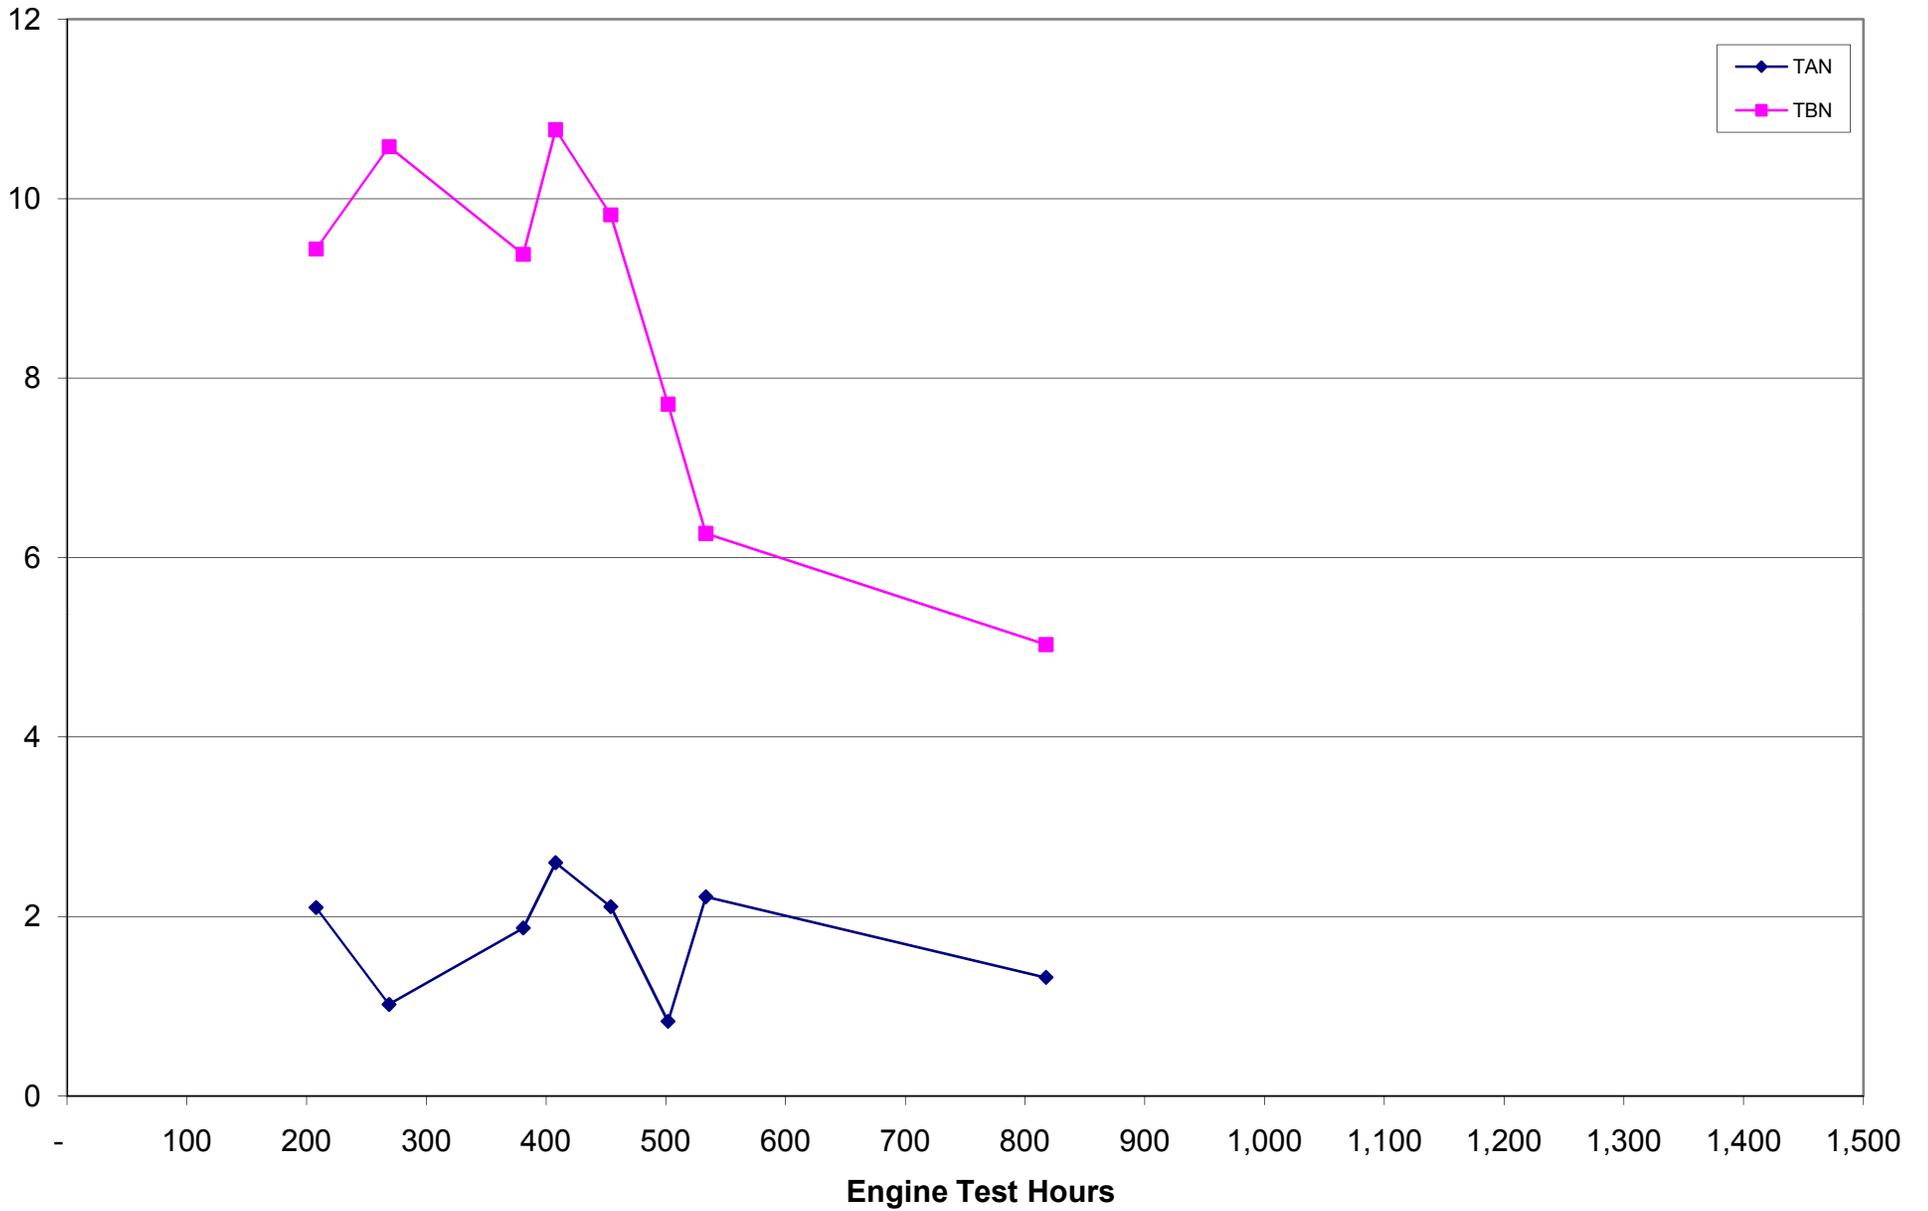
HICE Durability Vehicle: 5561
BTS Oil Analysis Results: TAN & TBN

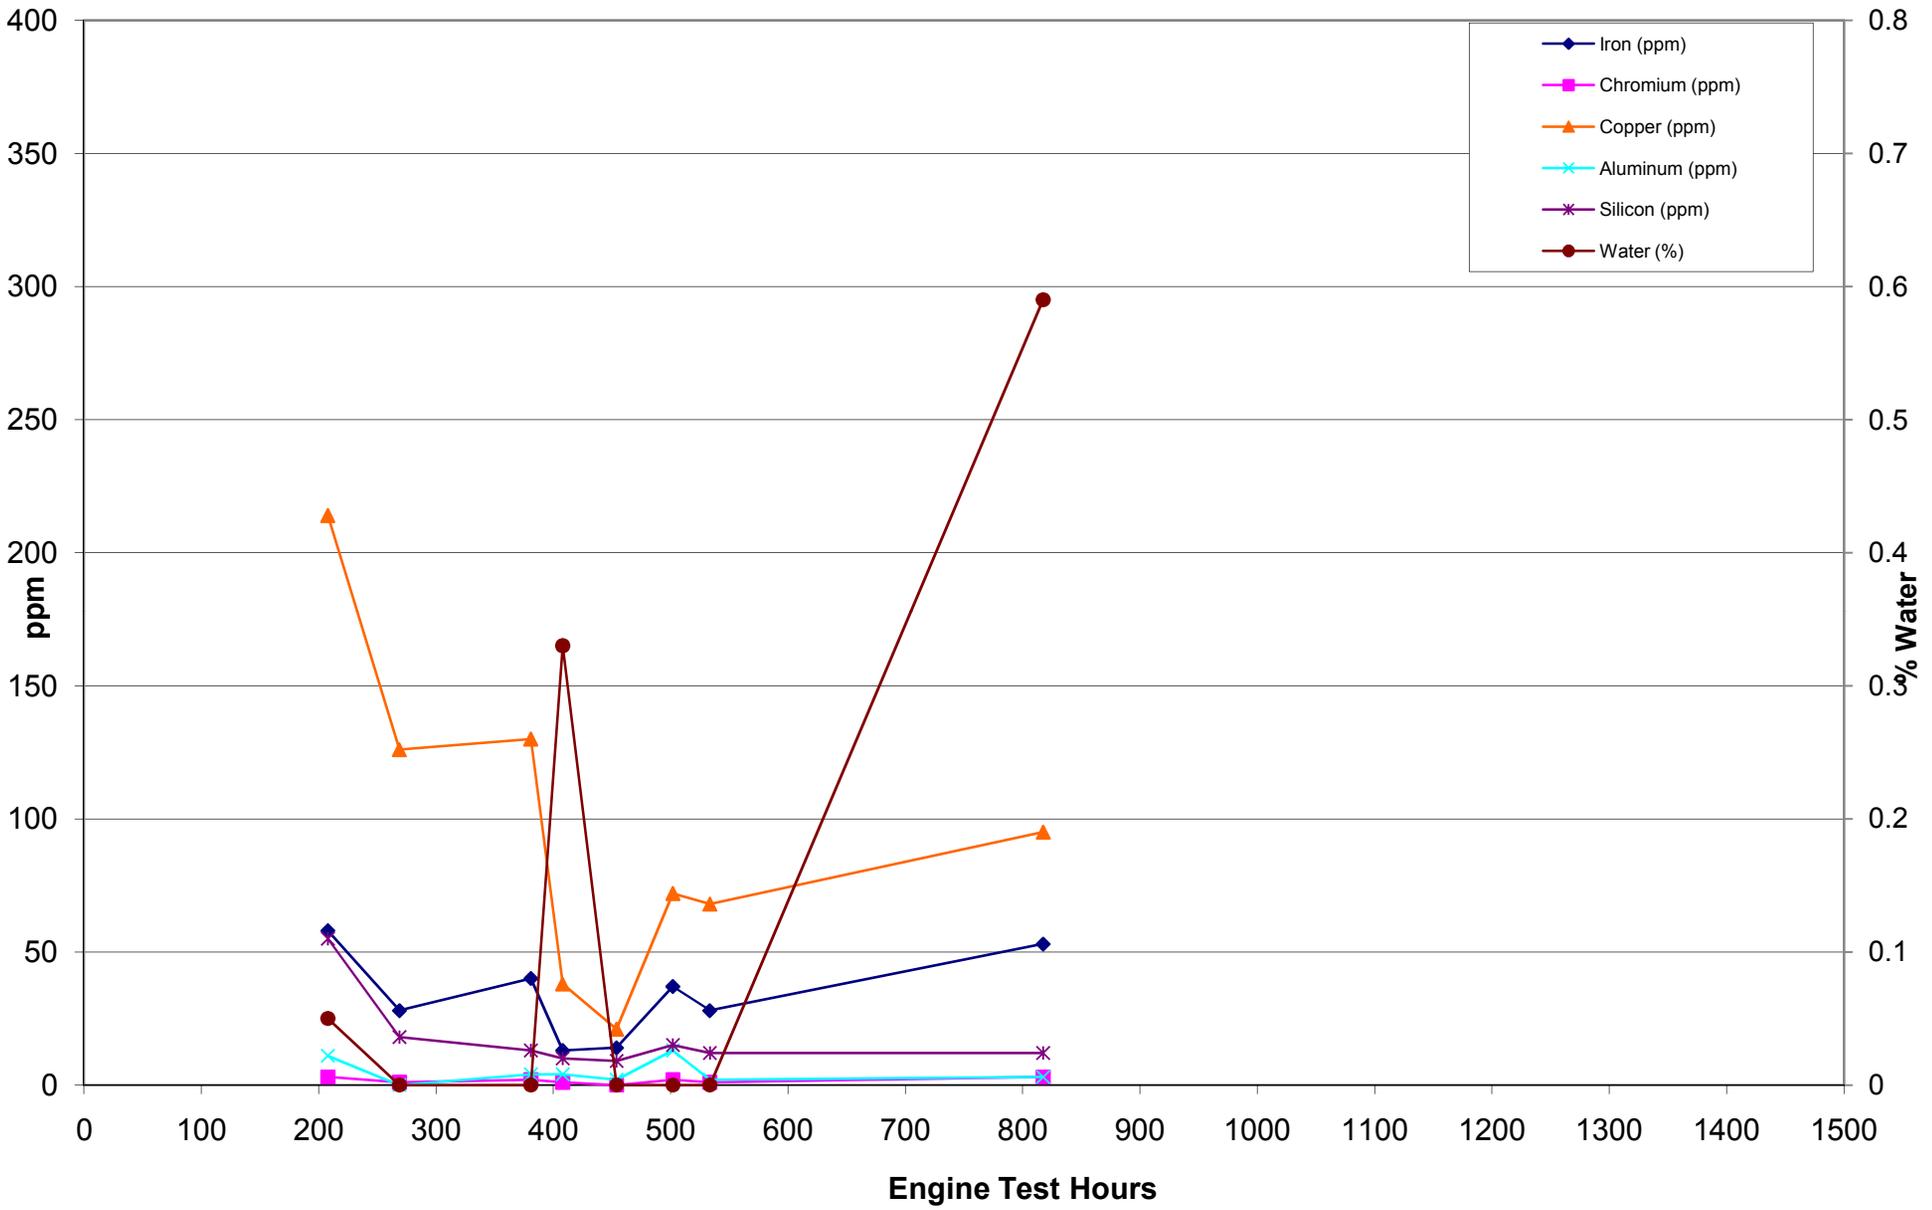
HICE Durability Vehicle: 5561 BTS Oil Analysis Results--Wear Metals

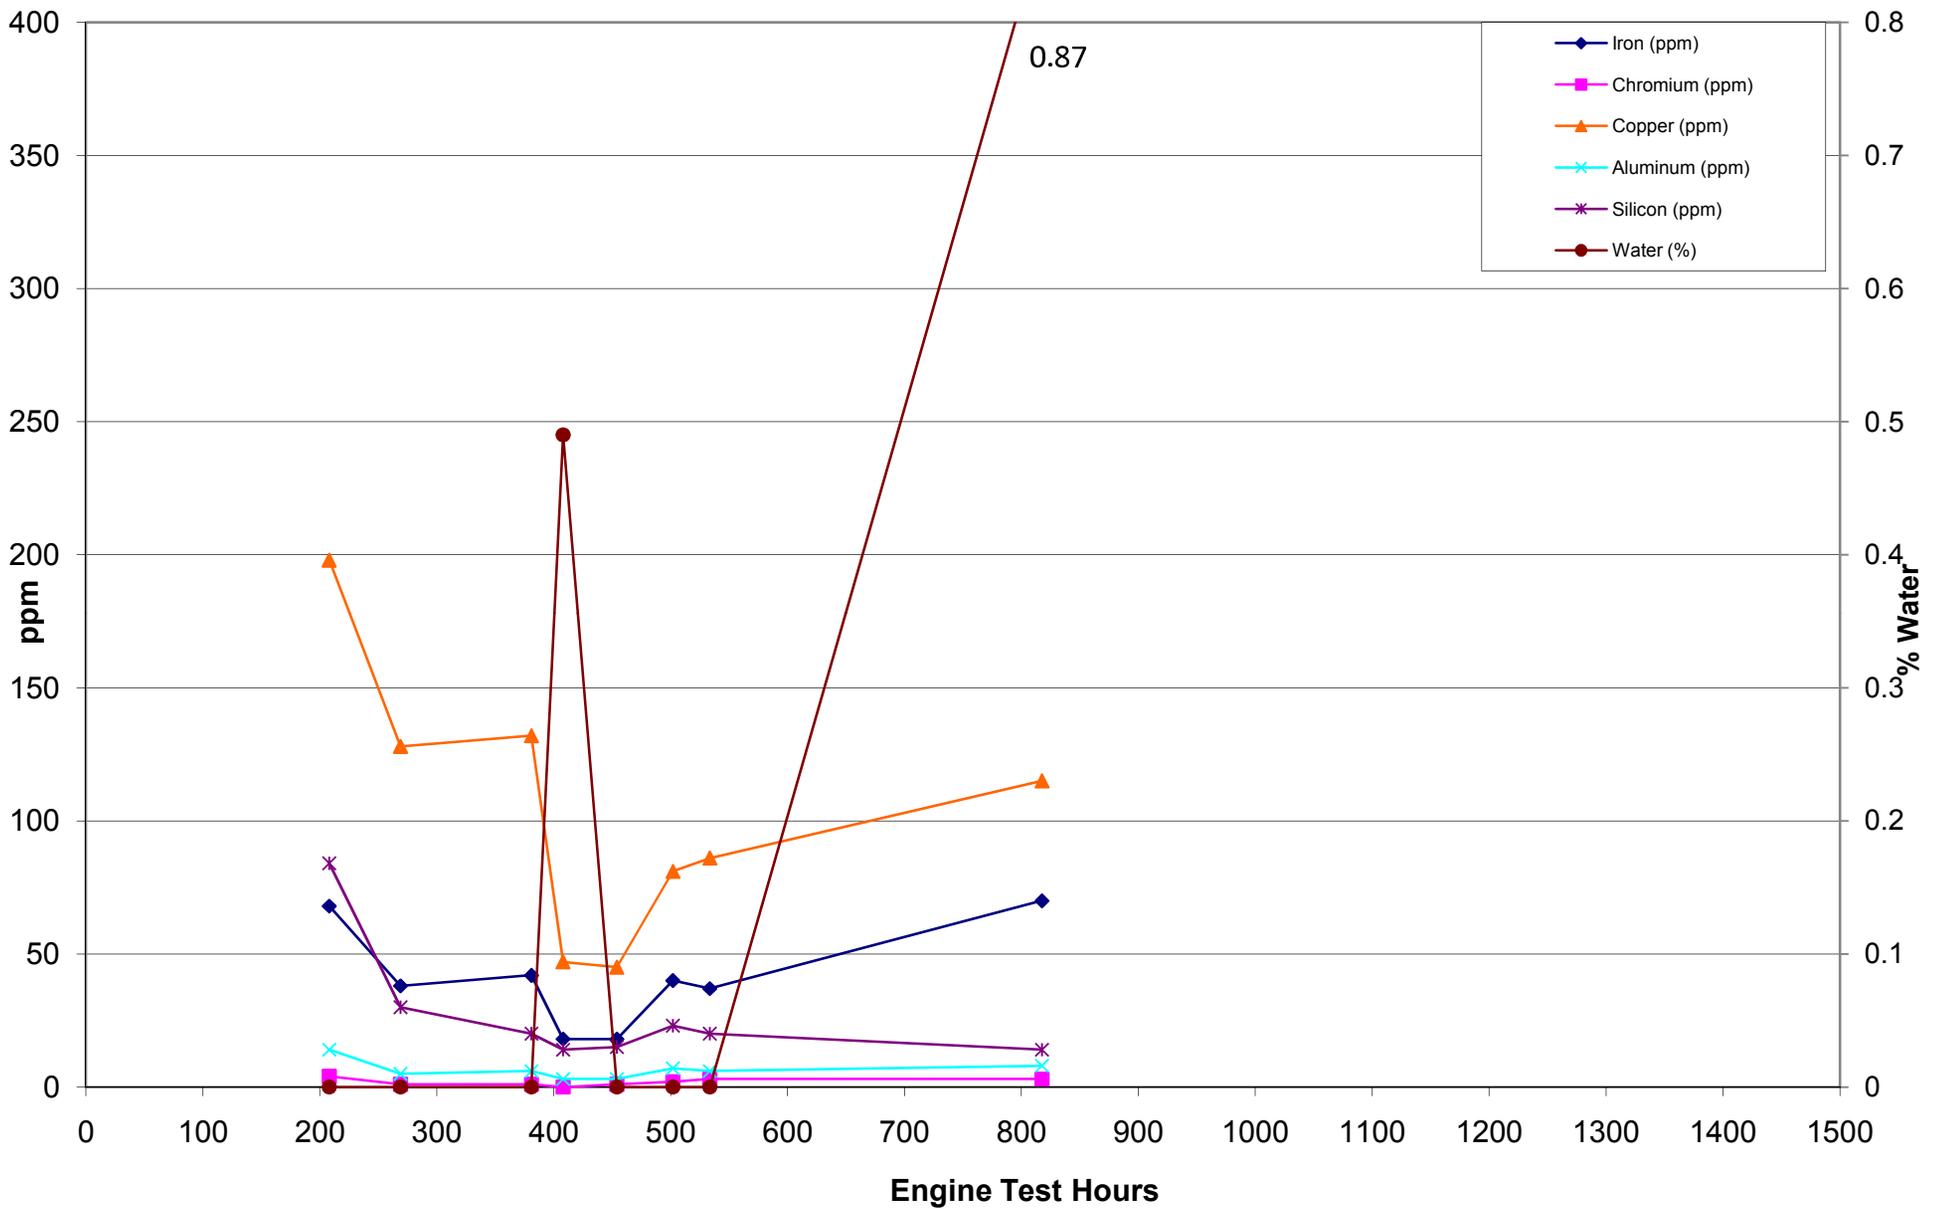
HICE Durability Vehicle: 5561 Staveley Services Oil Analysis Results--Wear Metals

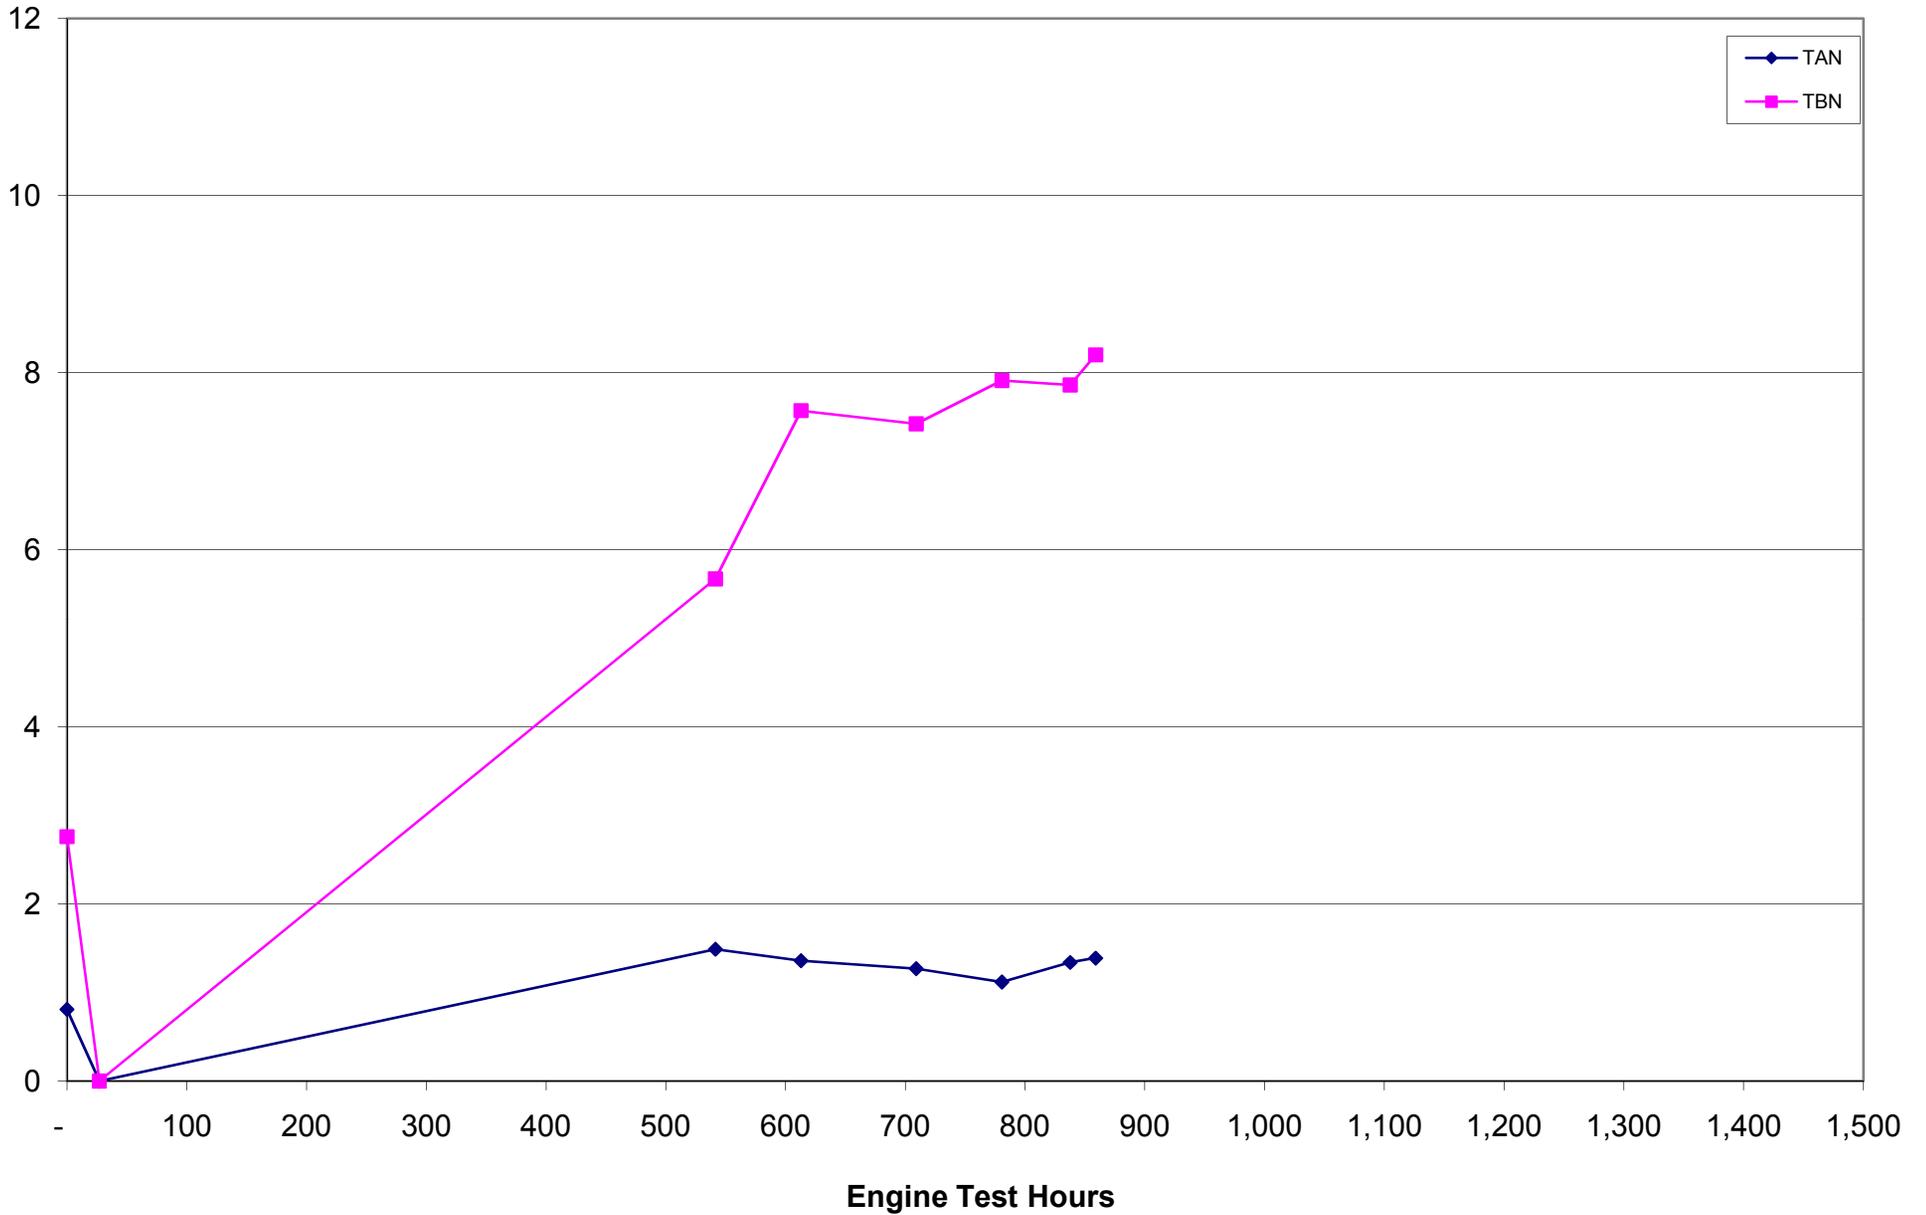
HICE Durability Vehicle: 5562
Staveley Services Oil Analysis Results: TAN & TBN
