Findings of Hydrogen Internal Combustion Engine Durability

Final Technical/Scientific Report

DE-FC26-06NT43027

Electric Transportation Engineering Corporation
430 S. 2nd Ave
Phoenix, AZ 85003

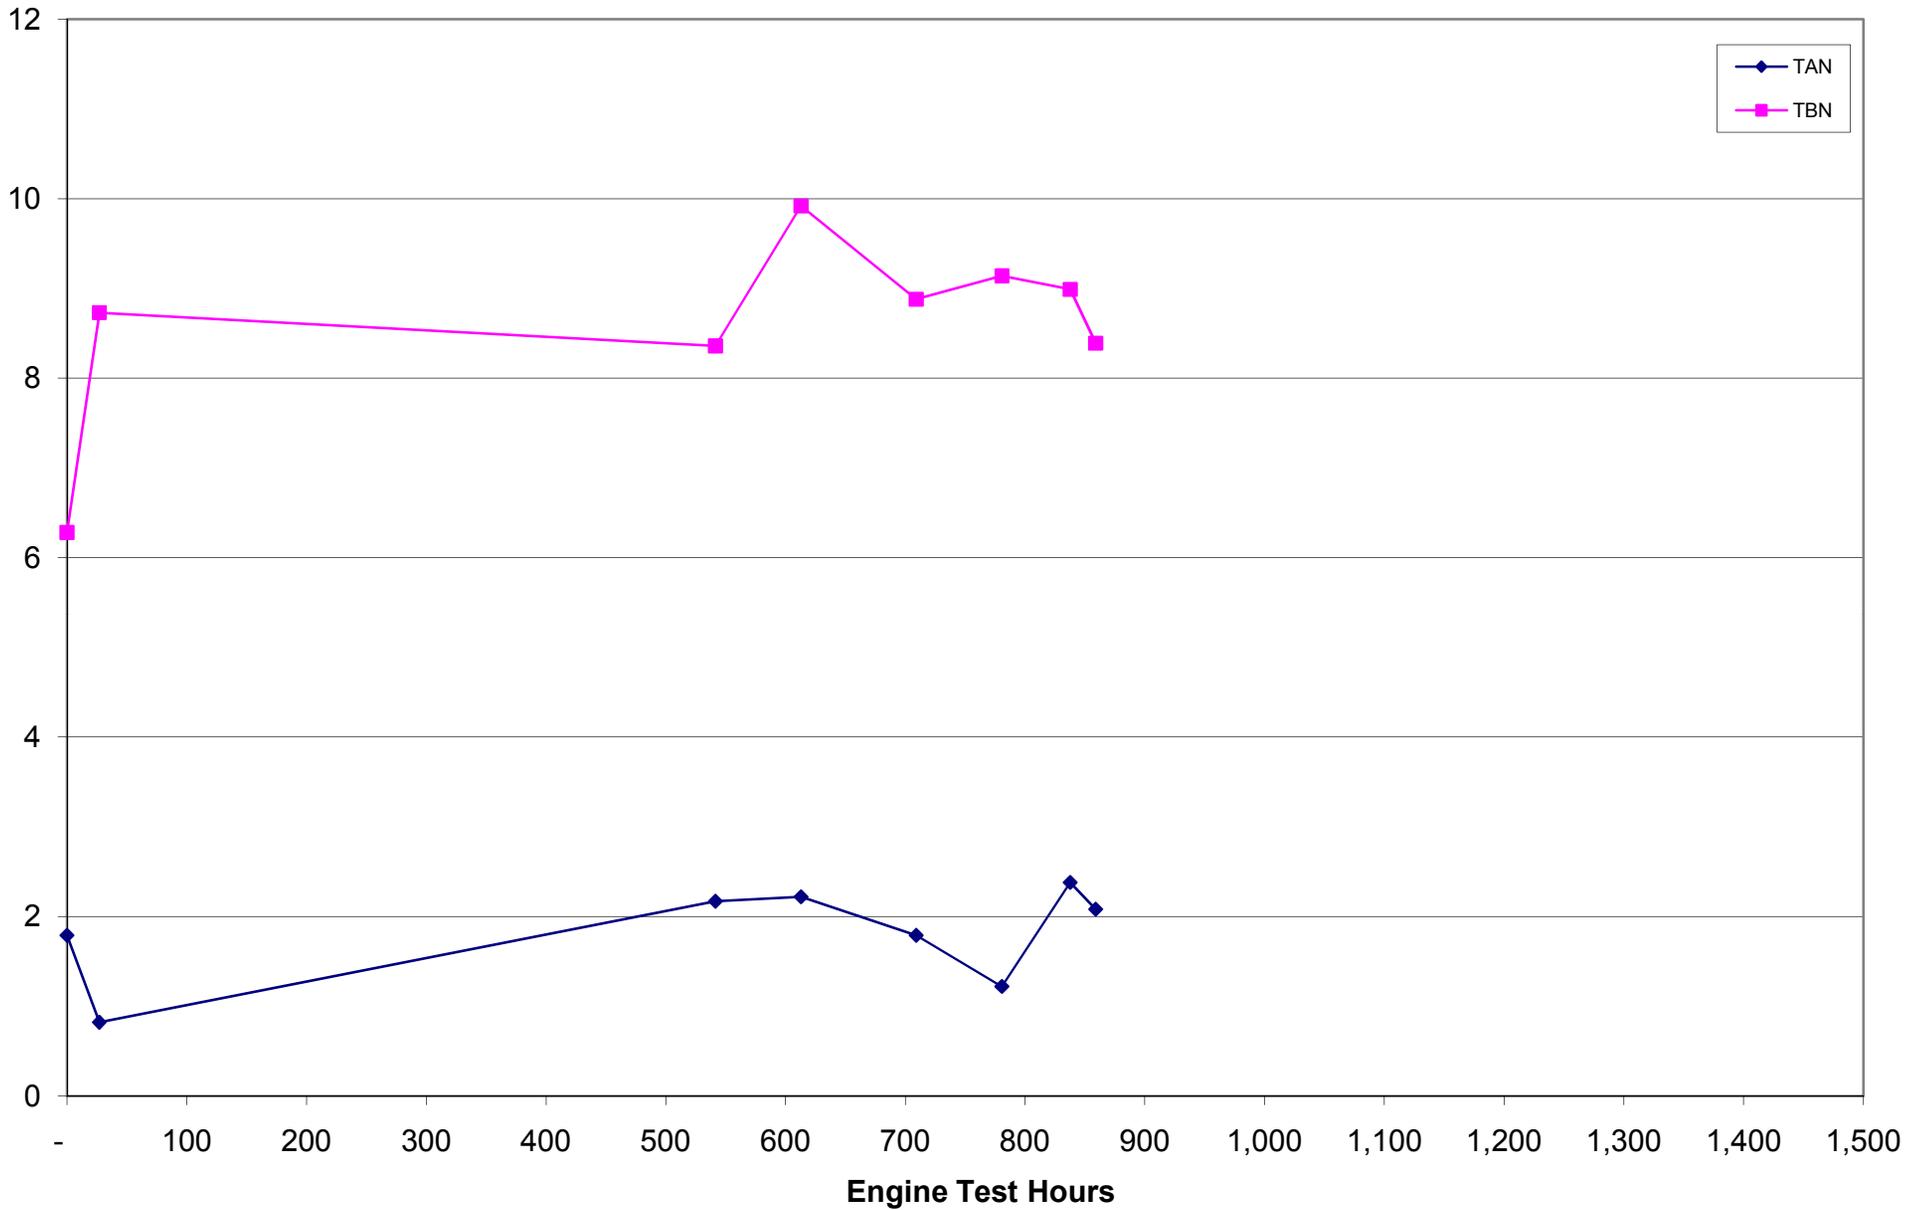
HICE Durability Vehicle: 5562
BTS Oil Analysis Results: TAN & TBN

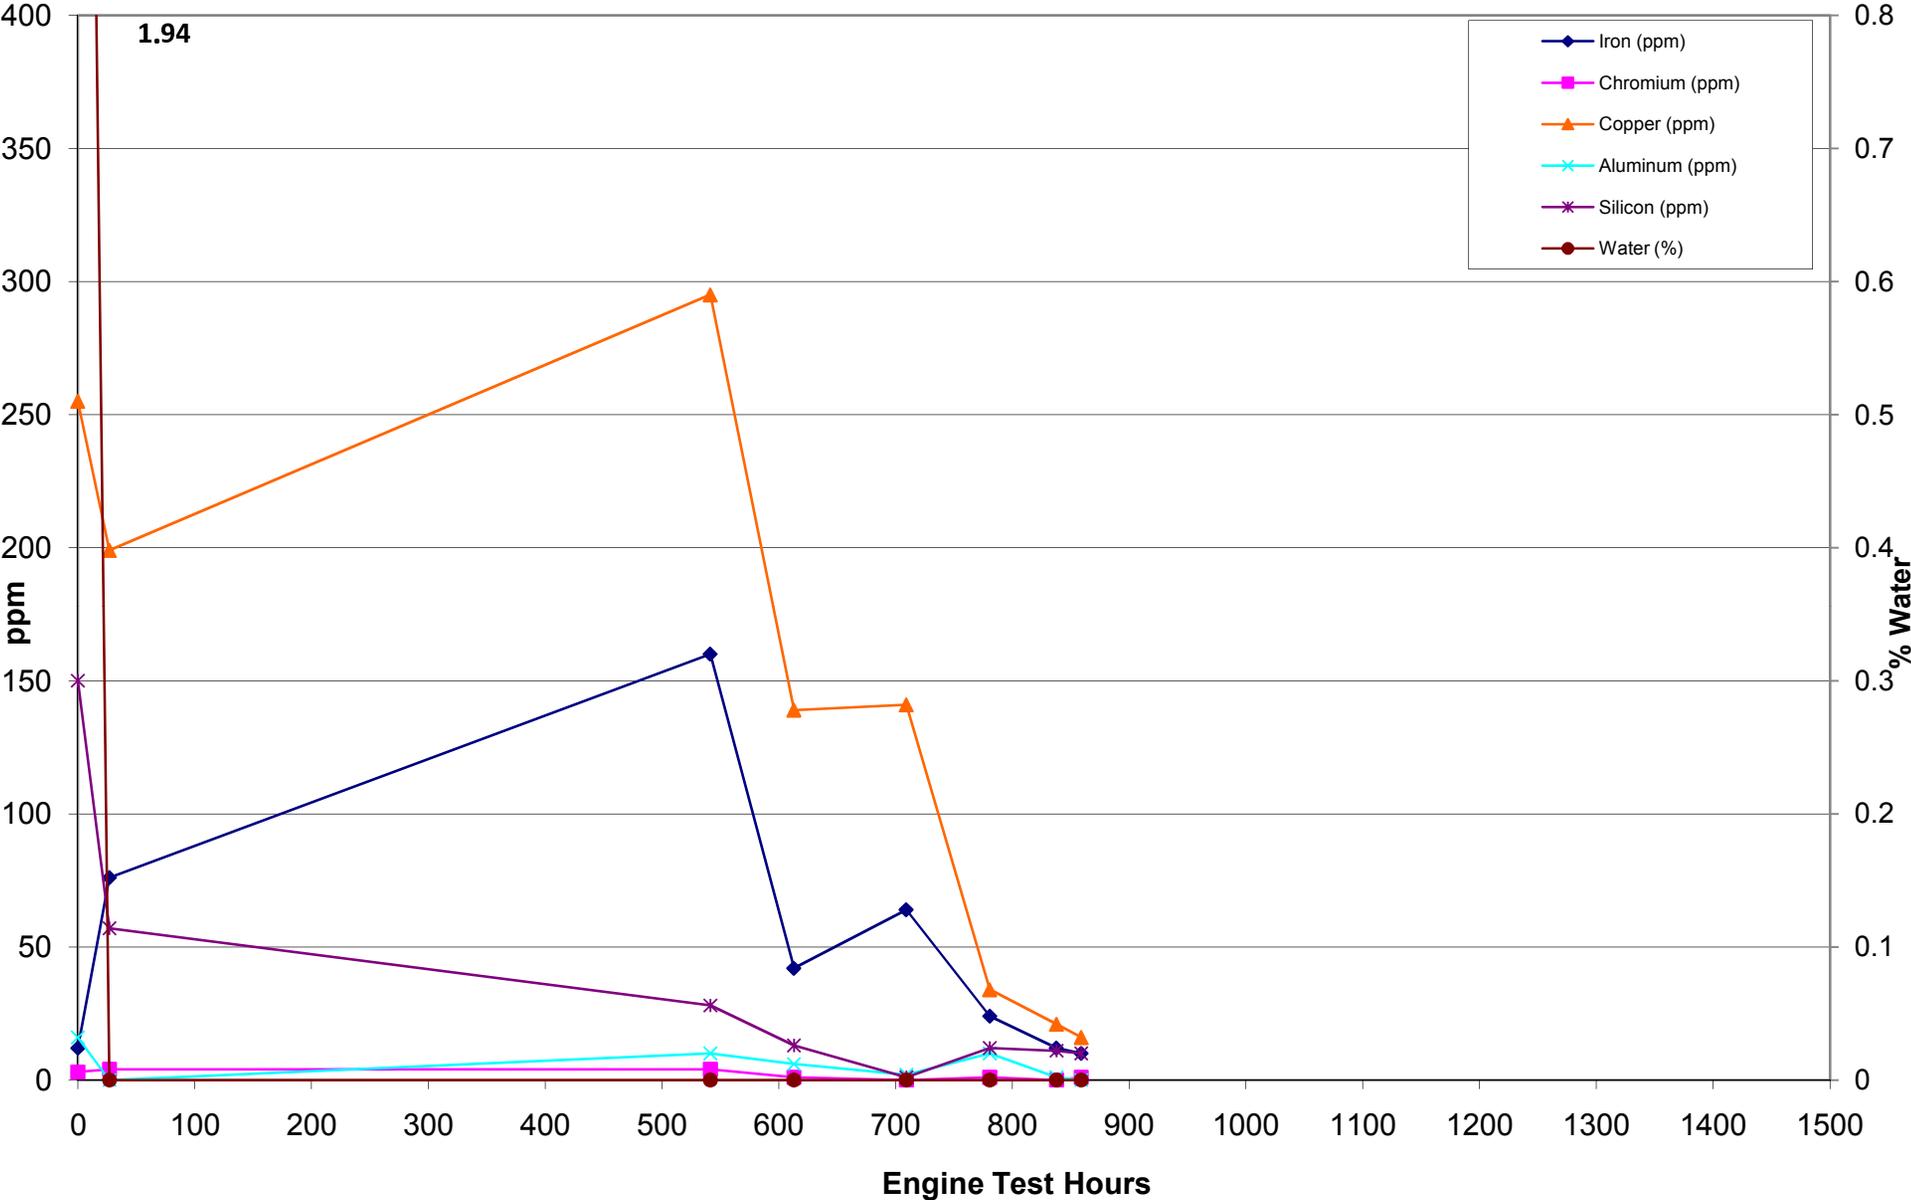
HICE Durability Vehicle: 5662 BTS Oil Analysis Results--Wear Metals

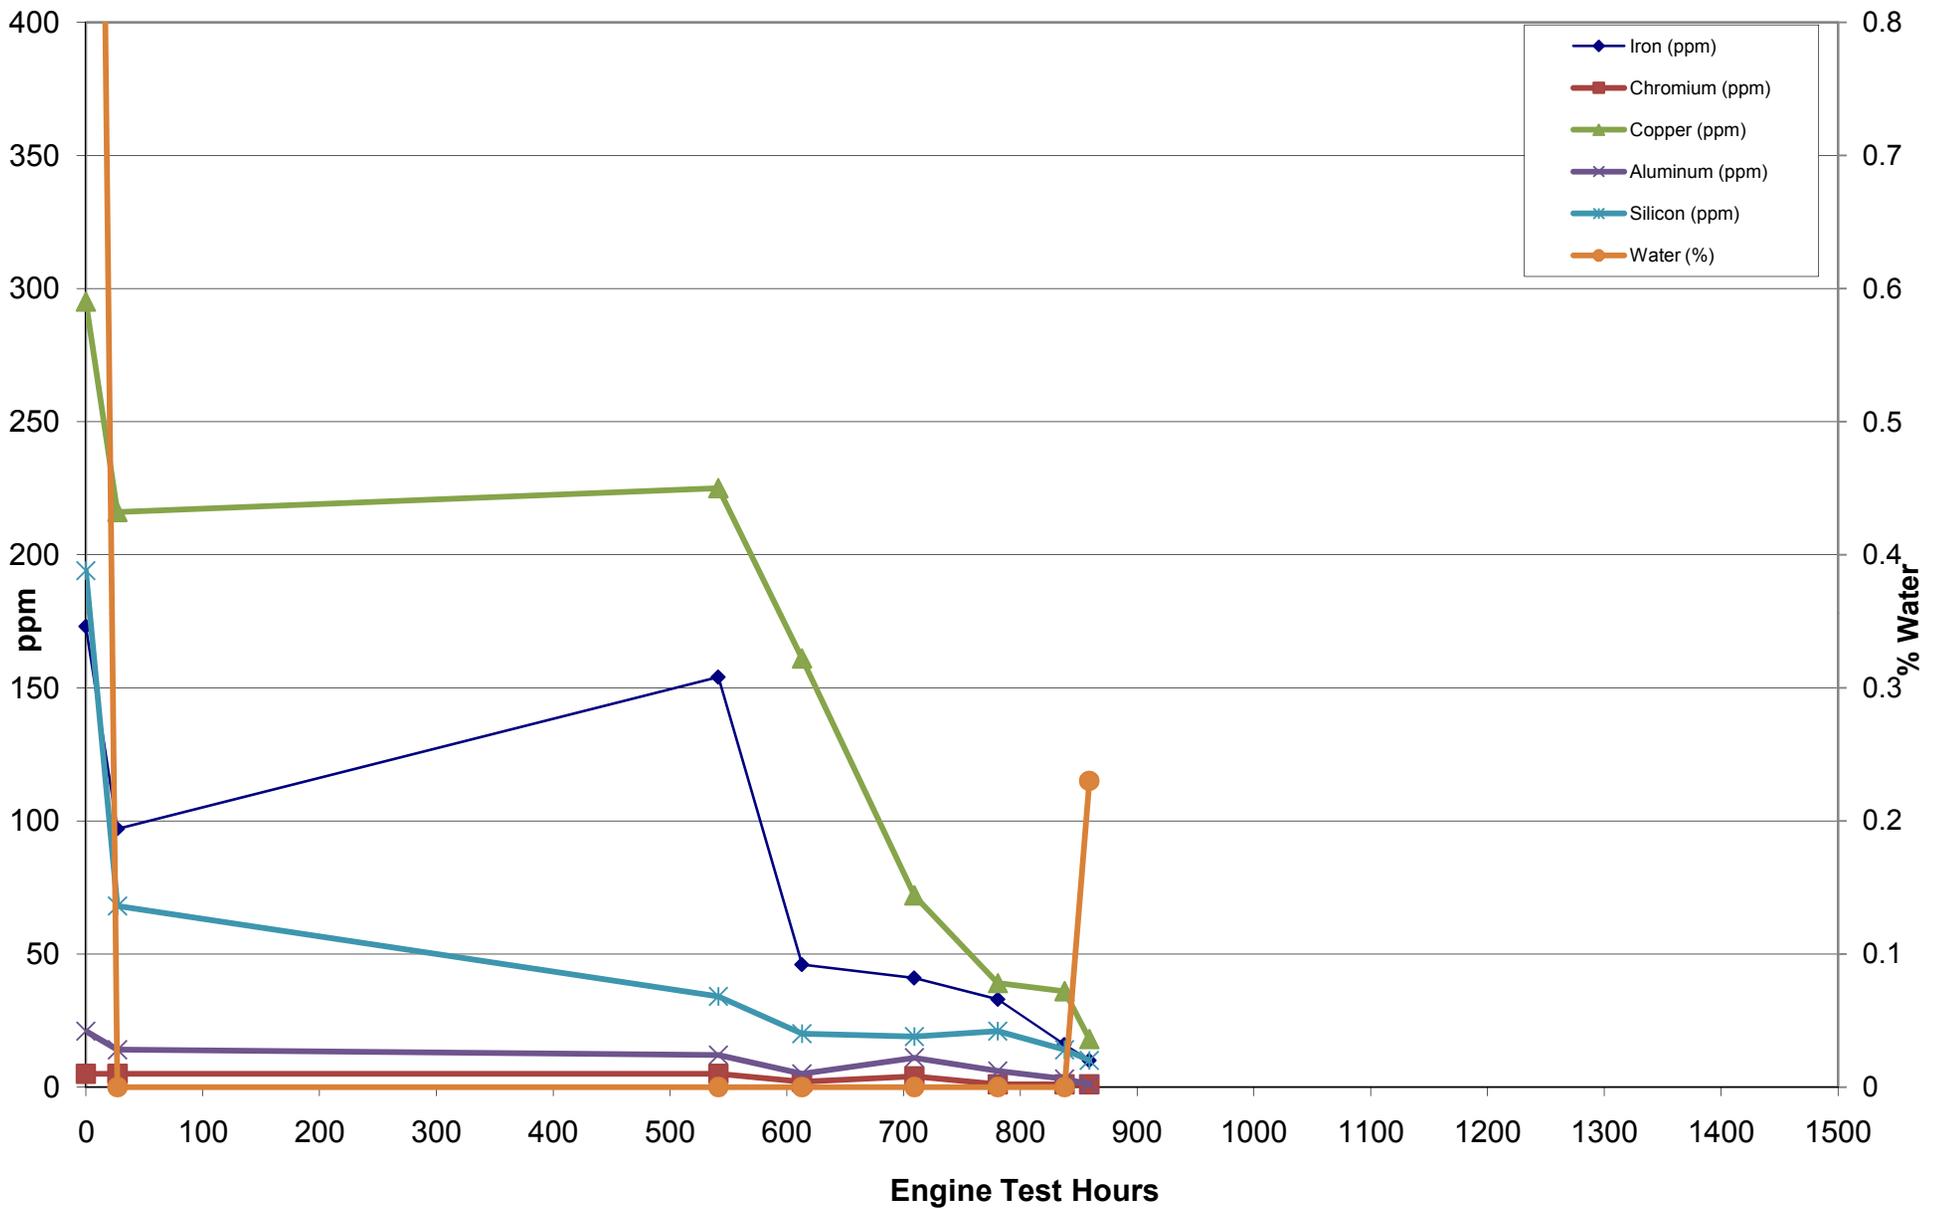
HICE Durability Vehicle: 5562 Staveley Services Oil Analysis Results--Wear Metals

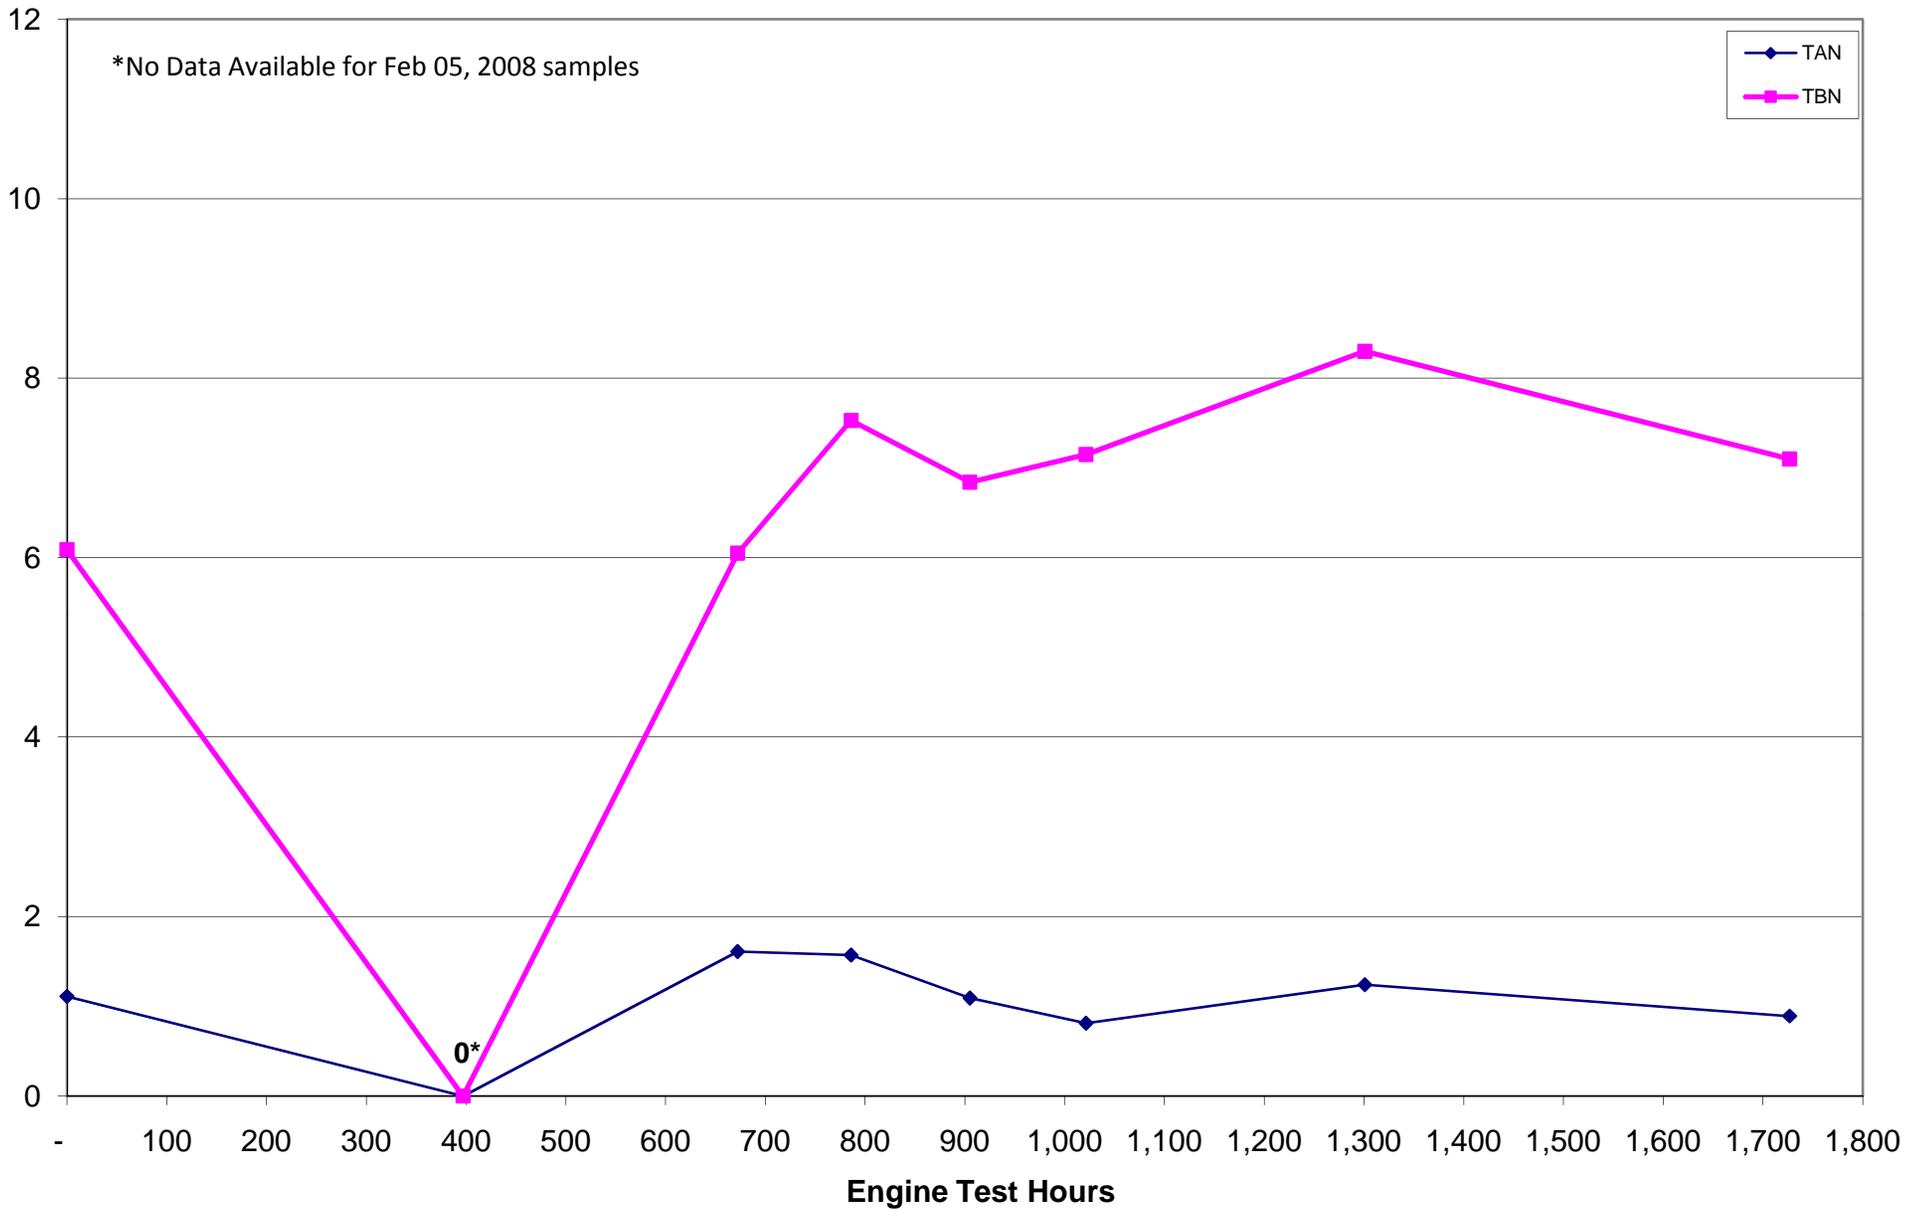
HICE Durability Vehicle: 5563
Staveley Services Oil Analysis Results: TAN & TBN

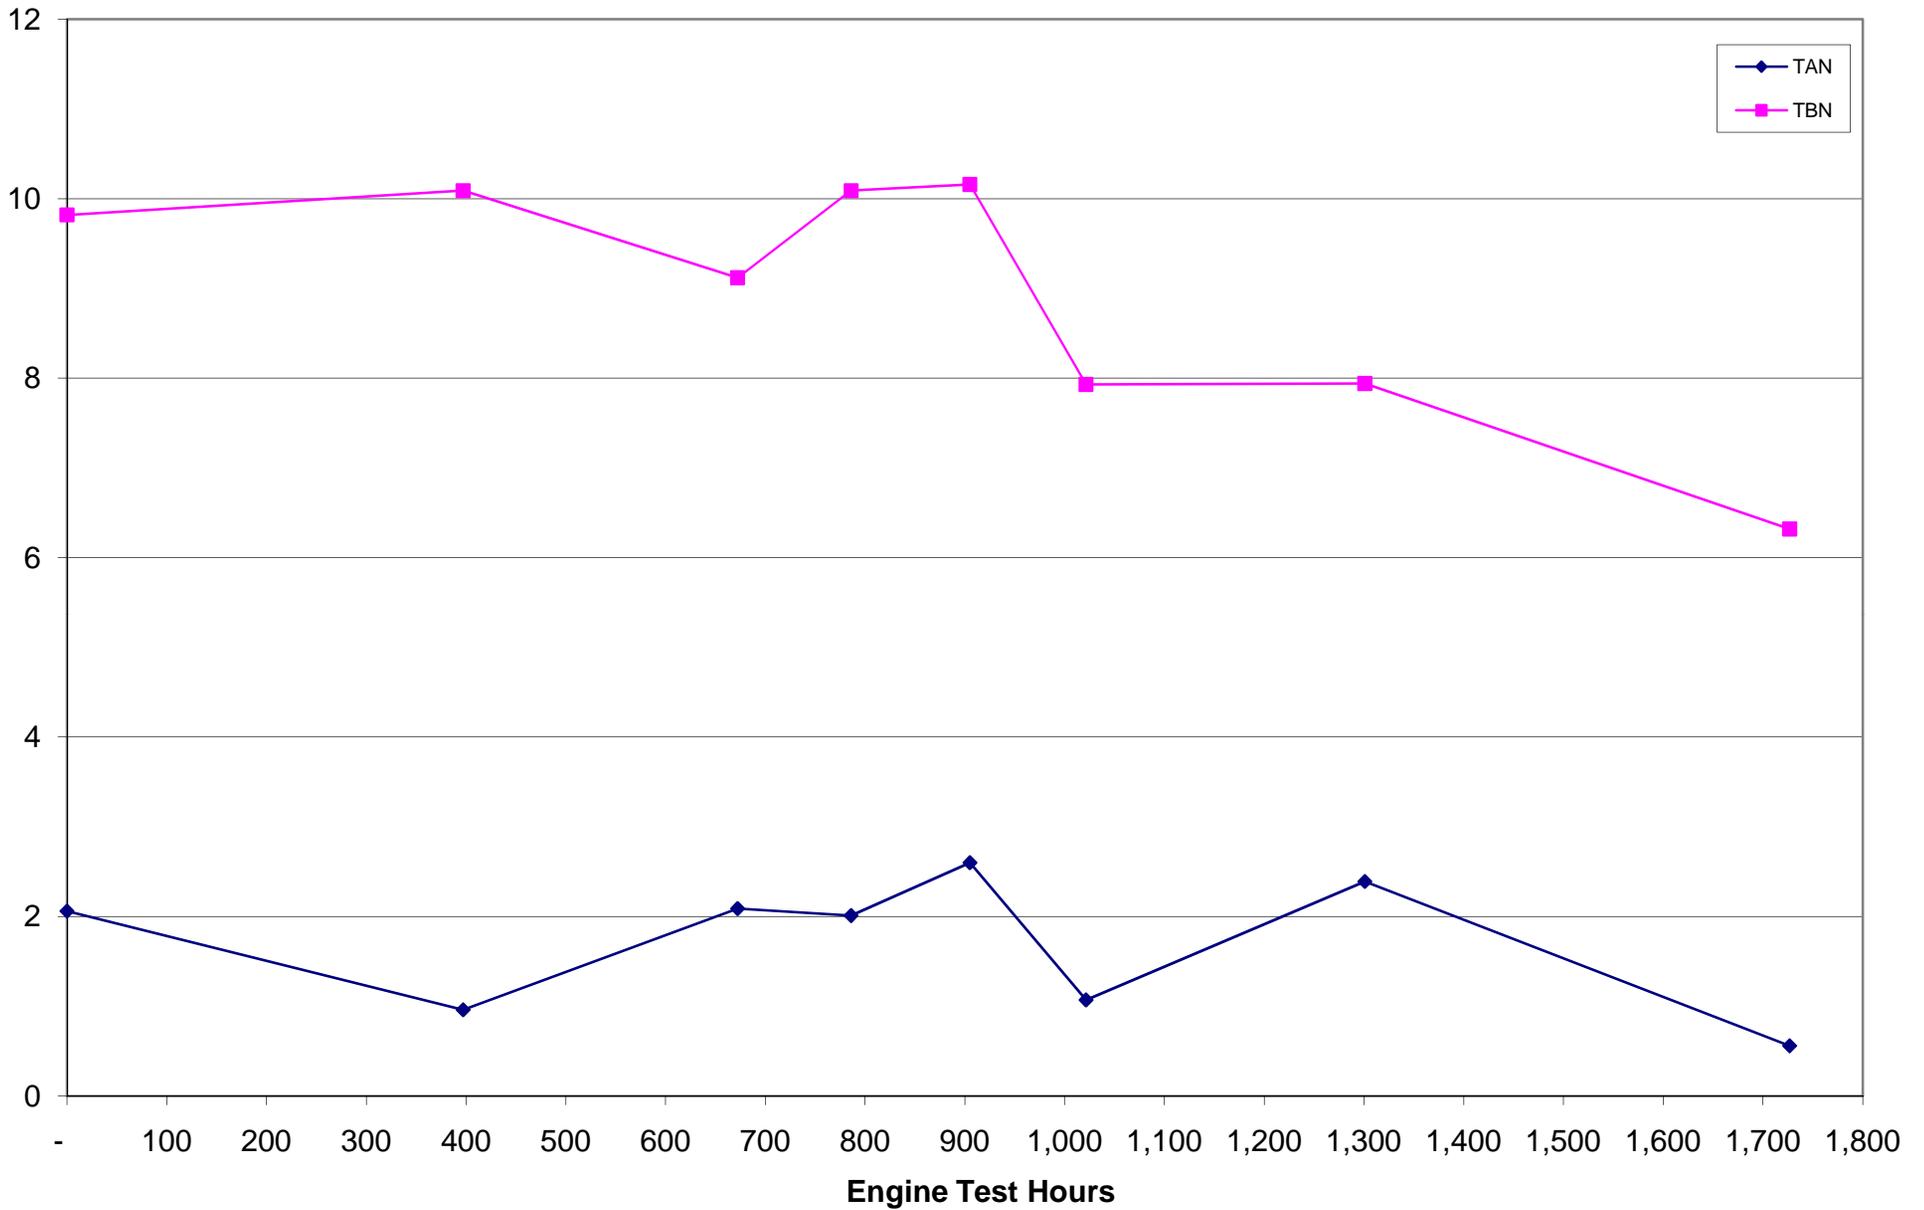
HICE Durability Vehicle: 5563
BTS Oil Analysis Results: TAN & TBN

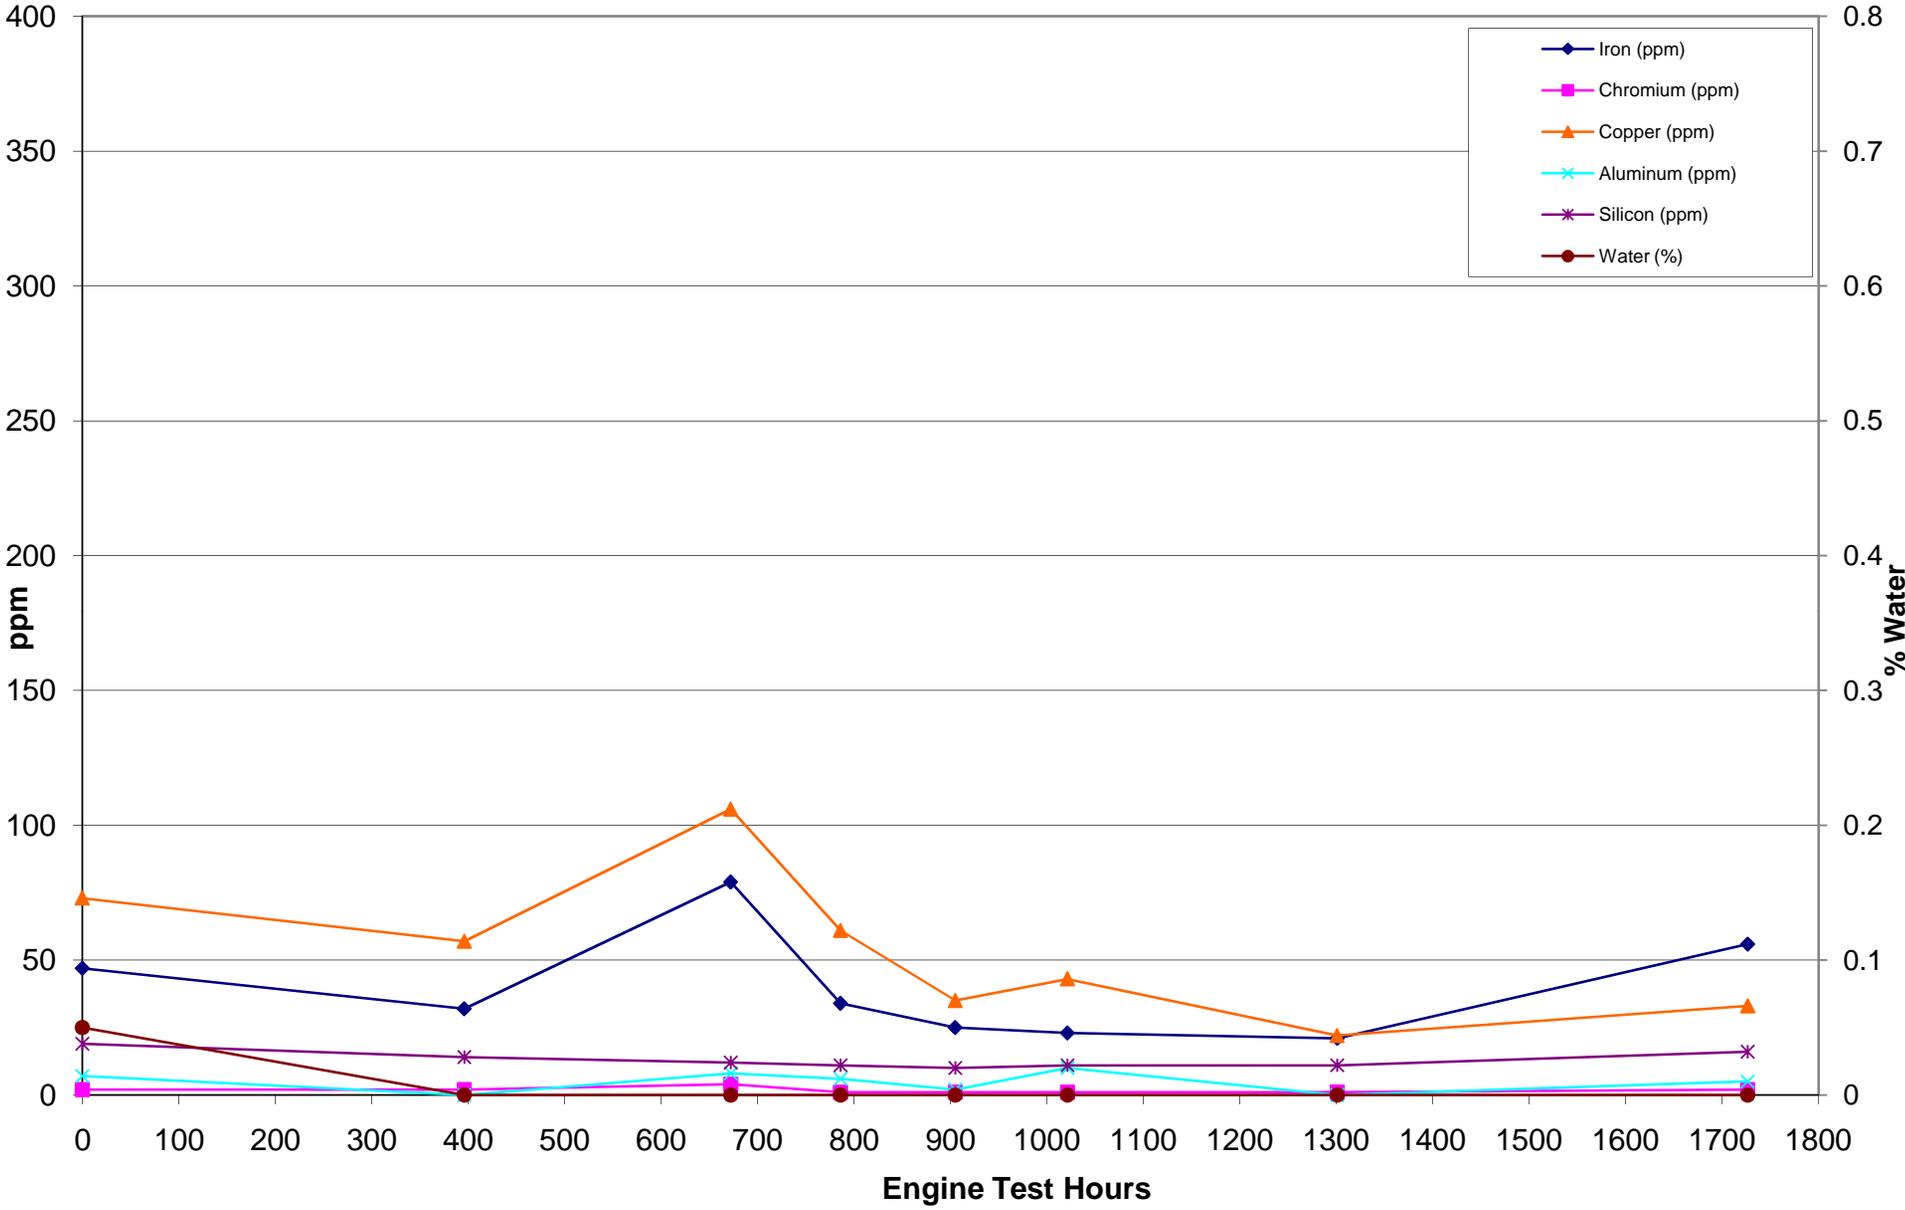
HICE Durability Vehicle: 5563 BTS Oil Analysis Results--Wear Metals

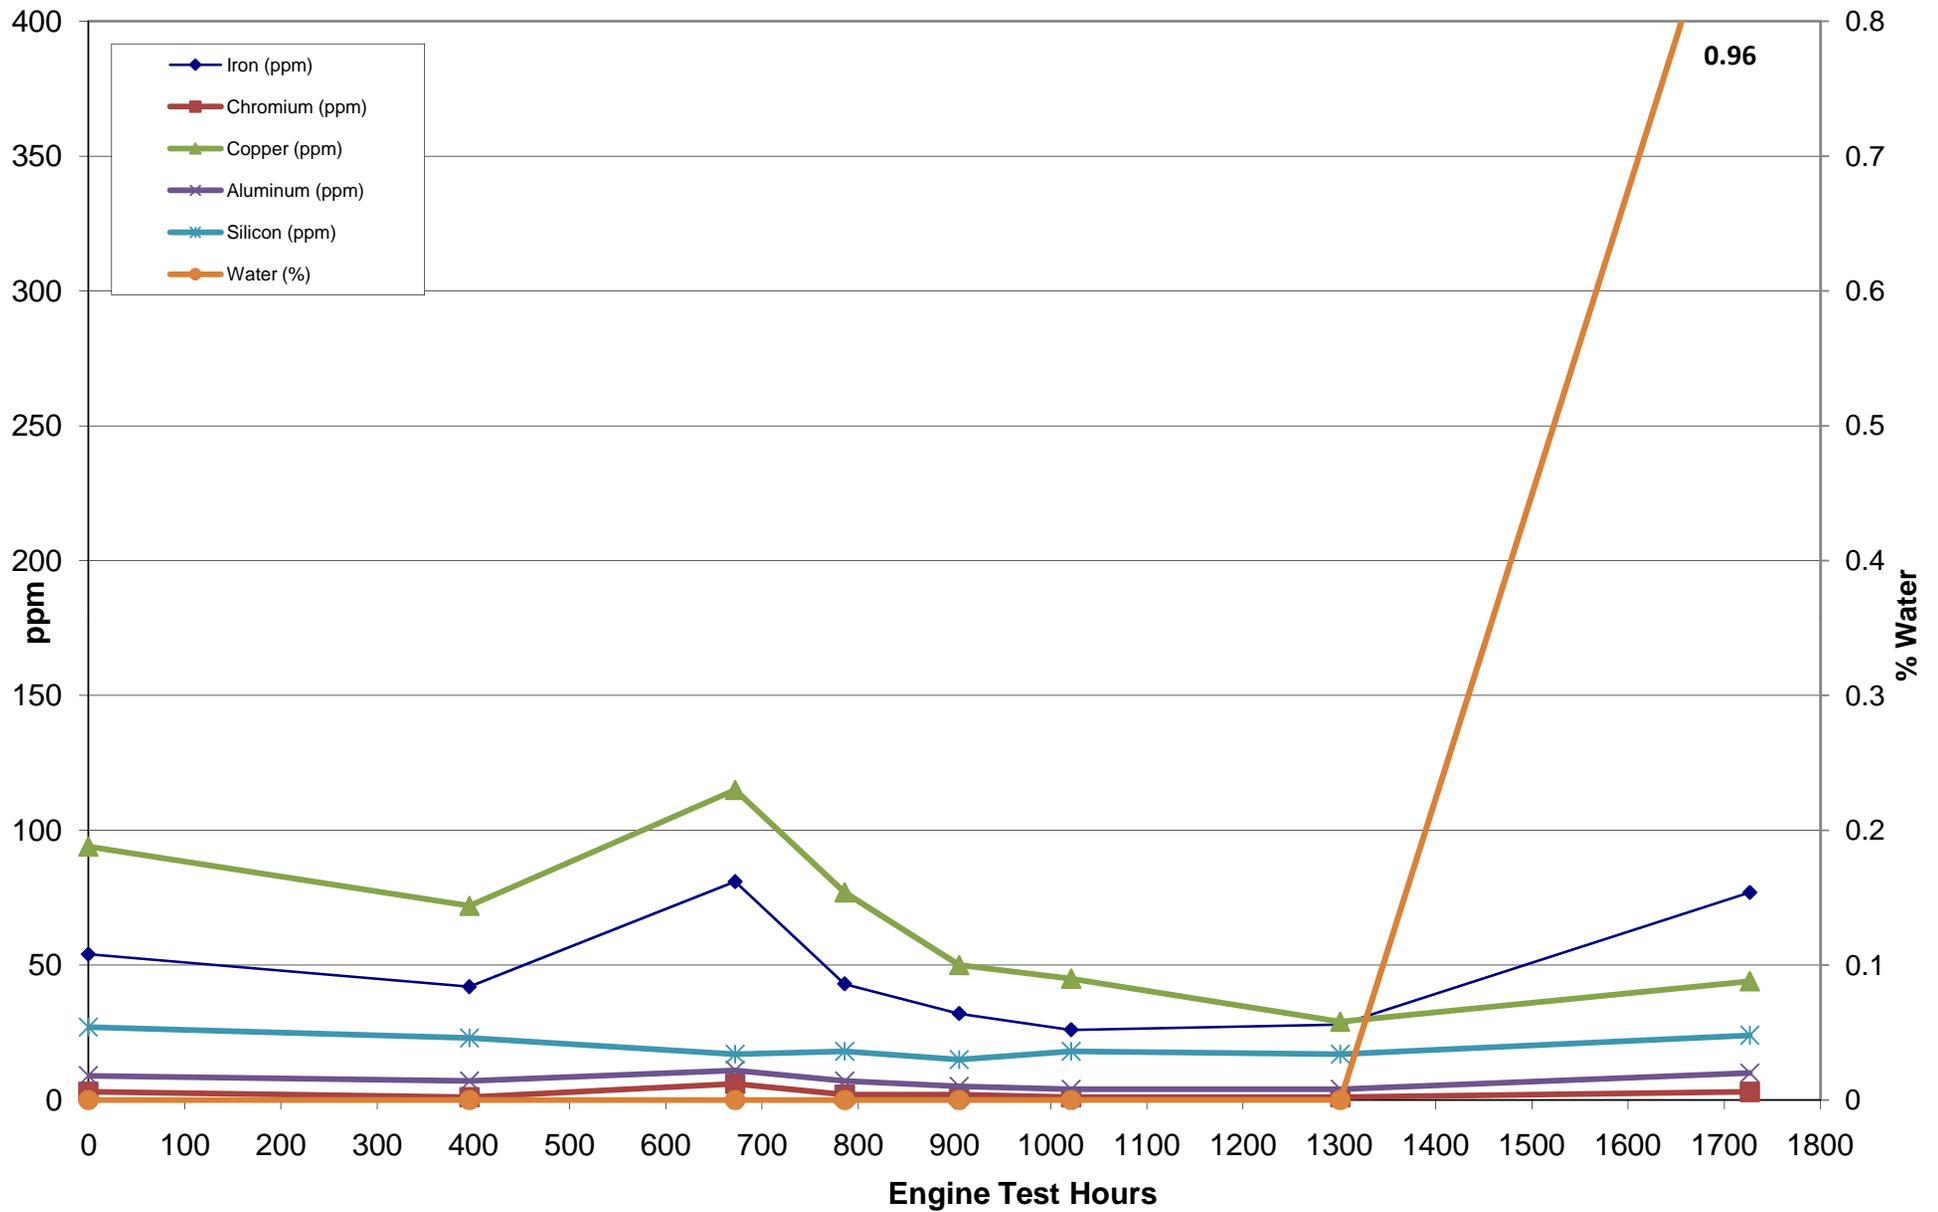
HICE Durability Vehicle: 5563 Staveley Services Oil Analysis Results--Wear Metals

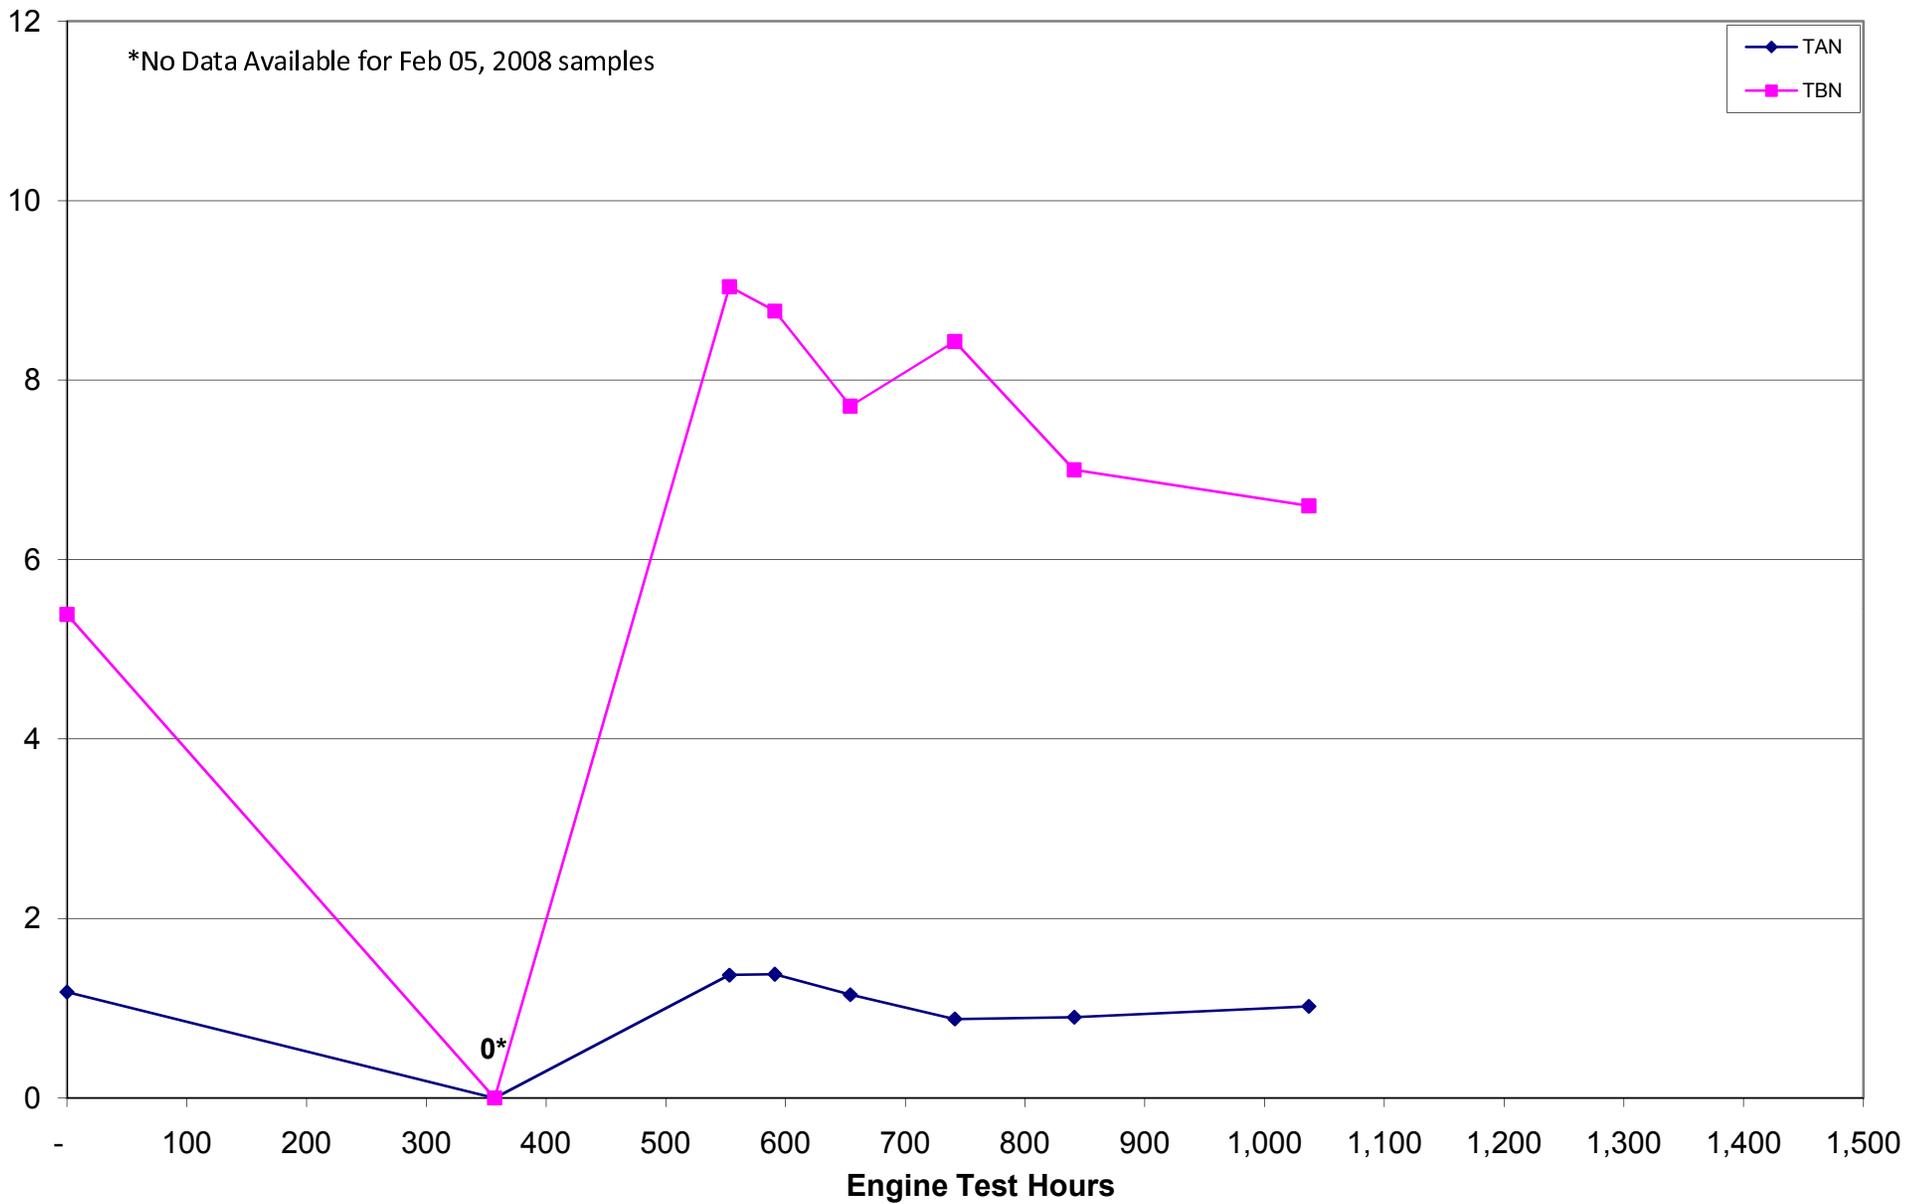
HICE Durability Vehicle: 5564
Staveley Services Oil Analysis Results: TAN & TBN

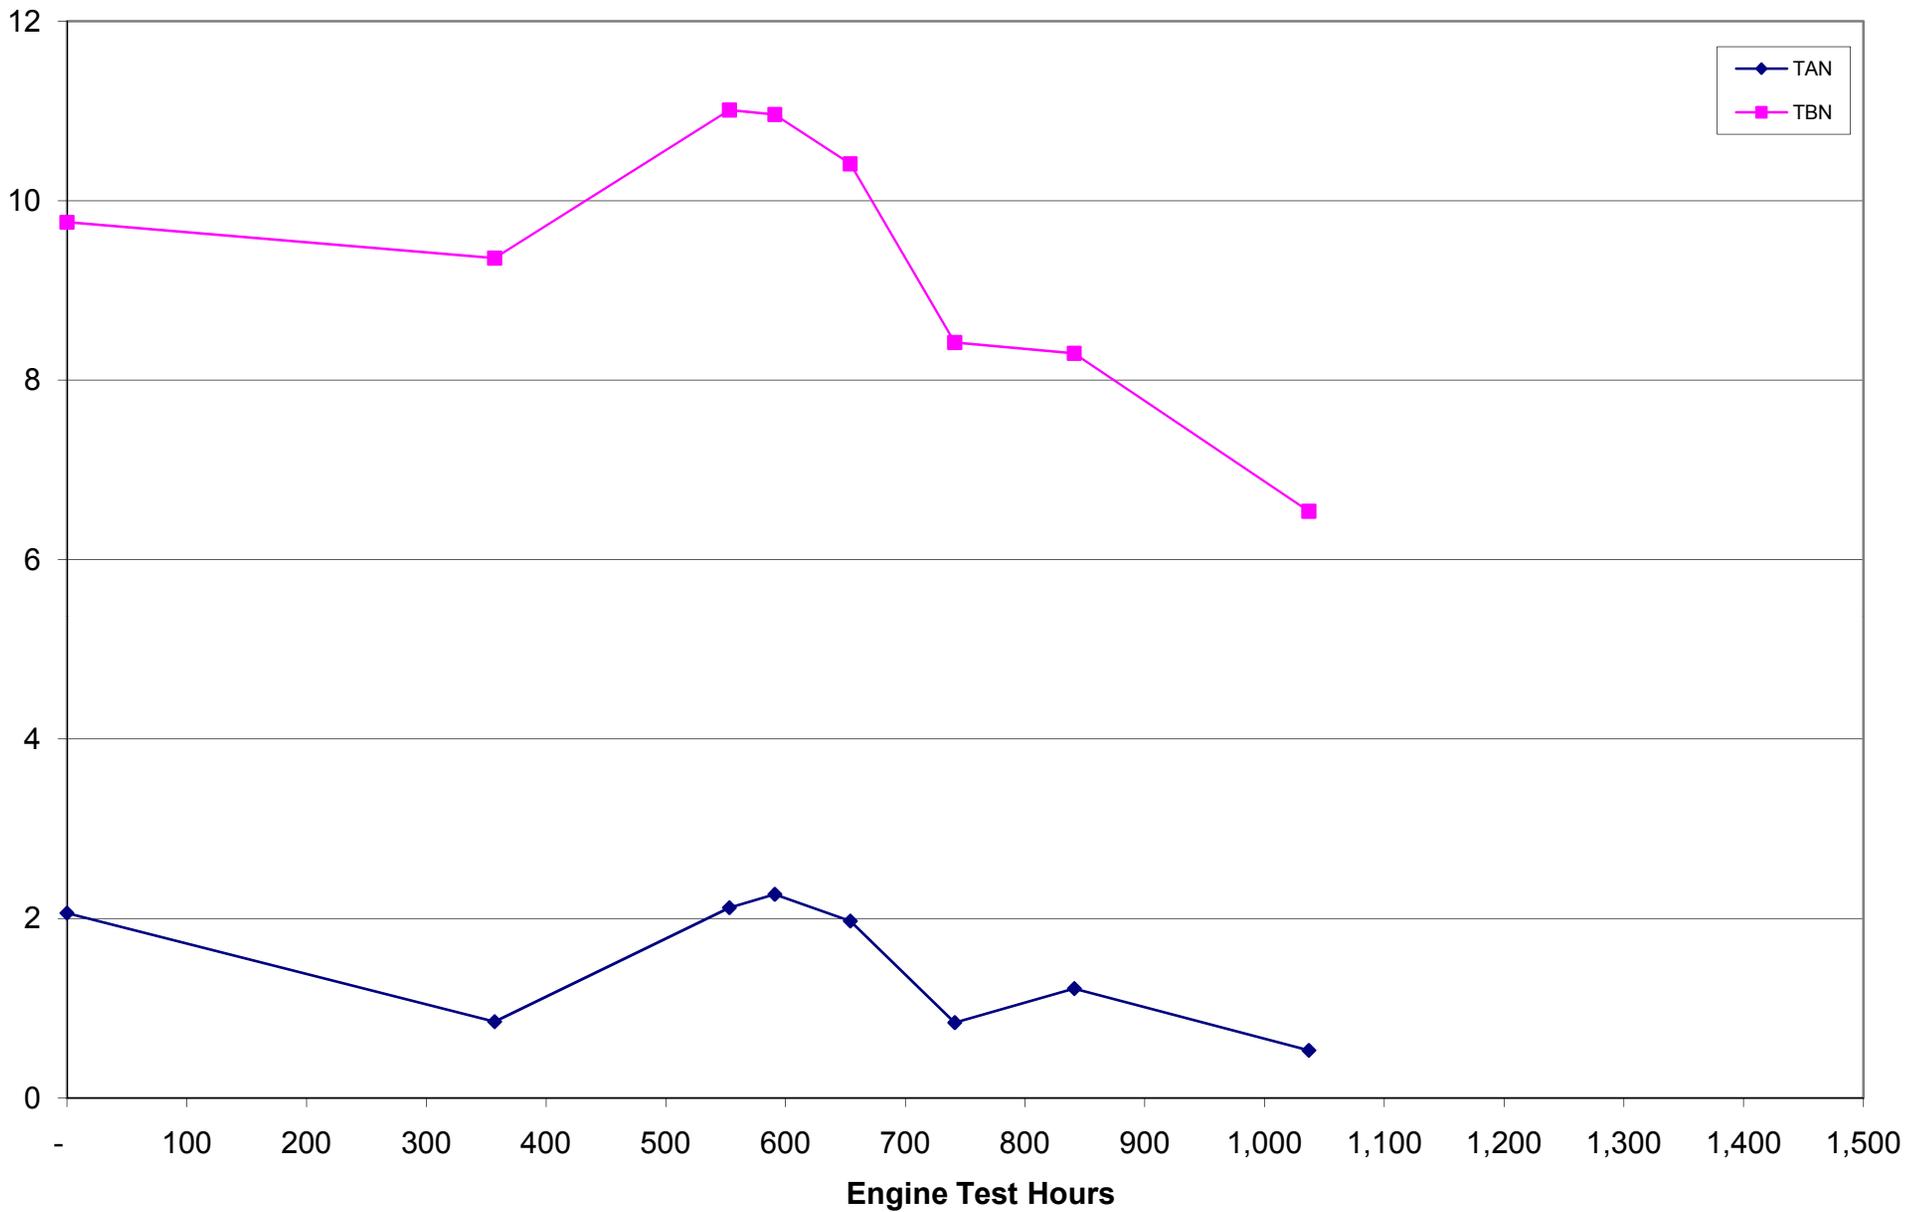
HICE Durability Vehicle: 5564
BTS Oil Analysis Results: TAN & TBN

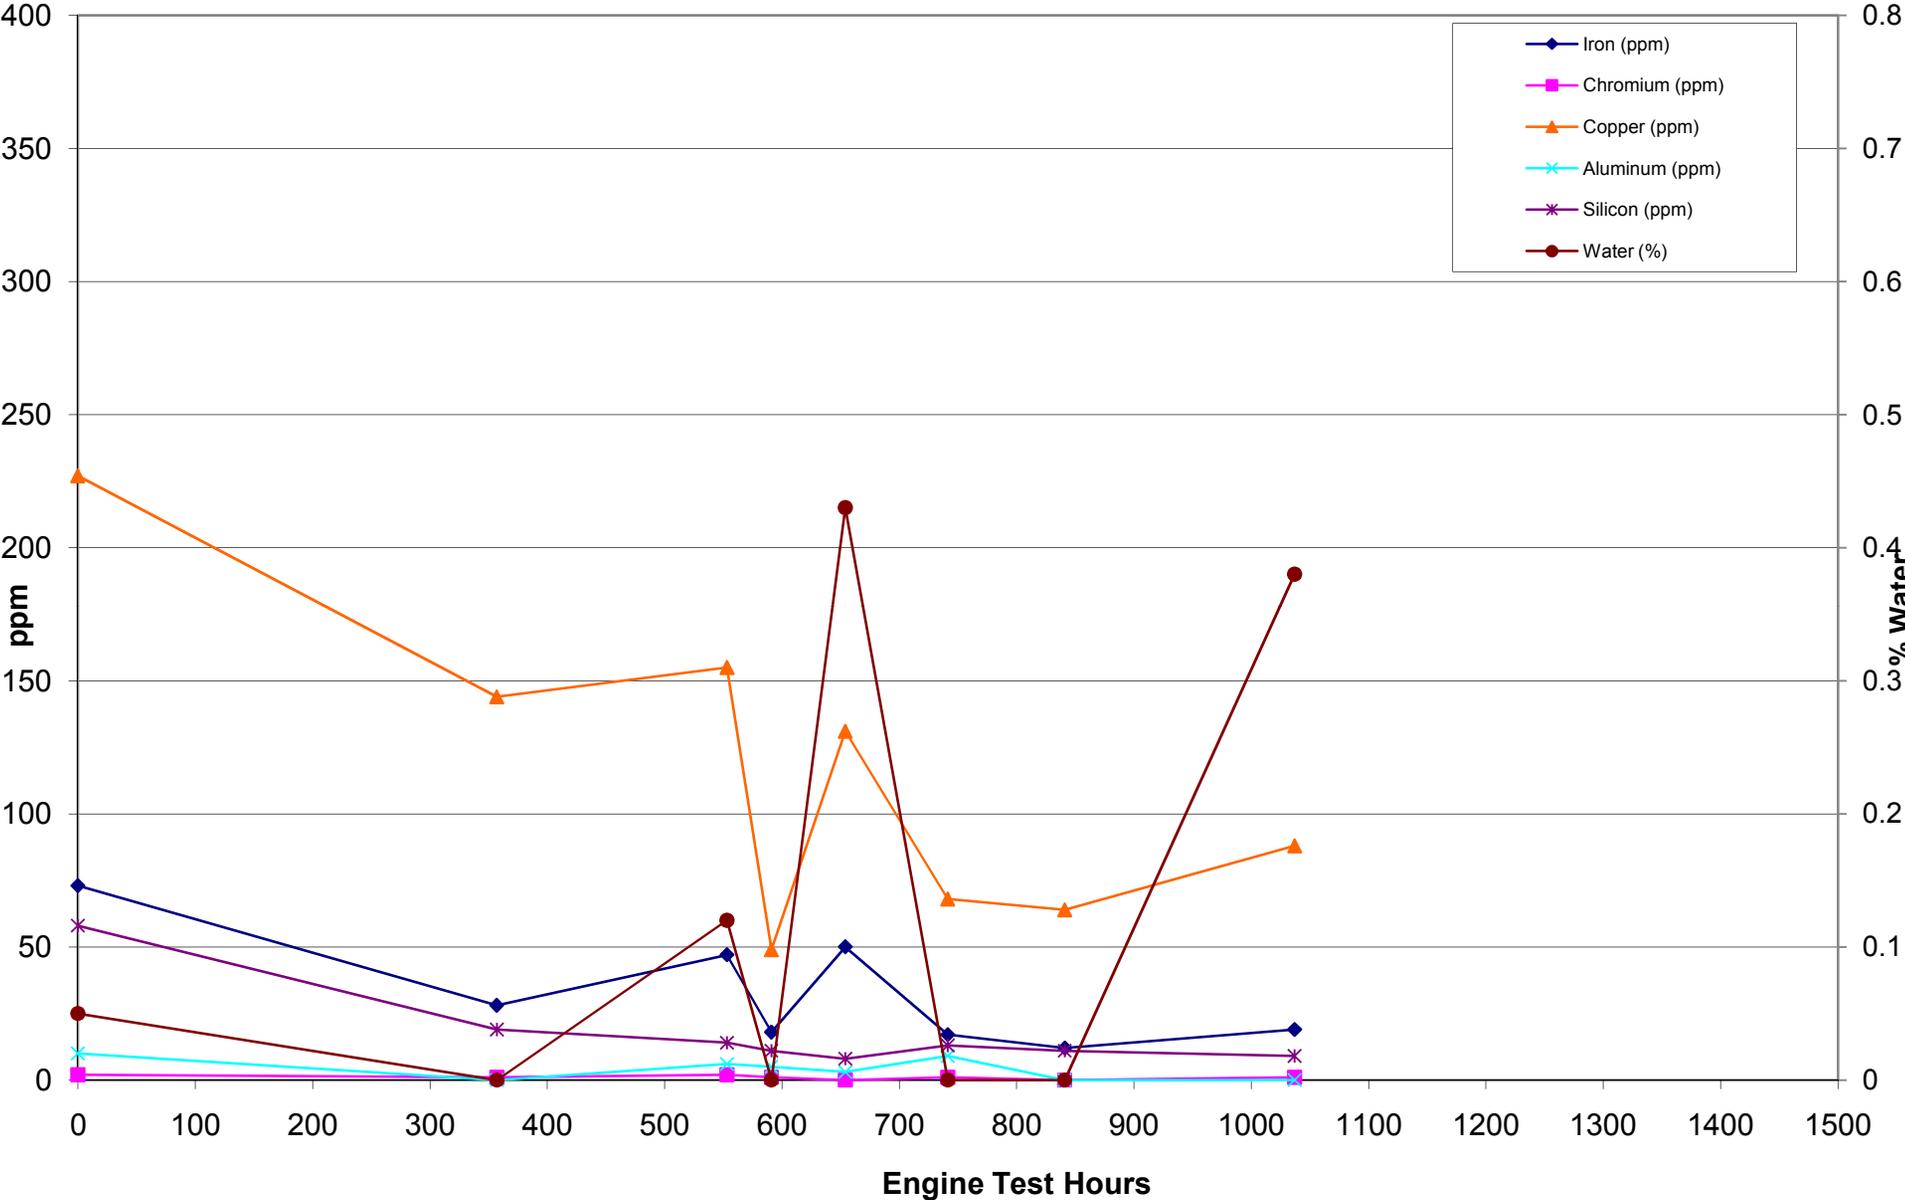
HICE Durability Vehicle: 5564 BTS Oil Analysis Results--Wear Metals
