Findings of Hydrogen Internal Combustion Engine Durability

Final Technical/Scientific Report

DE-FC26-06NT43027

Electric Transportation Engineering Corporation
430 S. 2nd Ave
Phoenix, AZ 85003

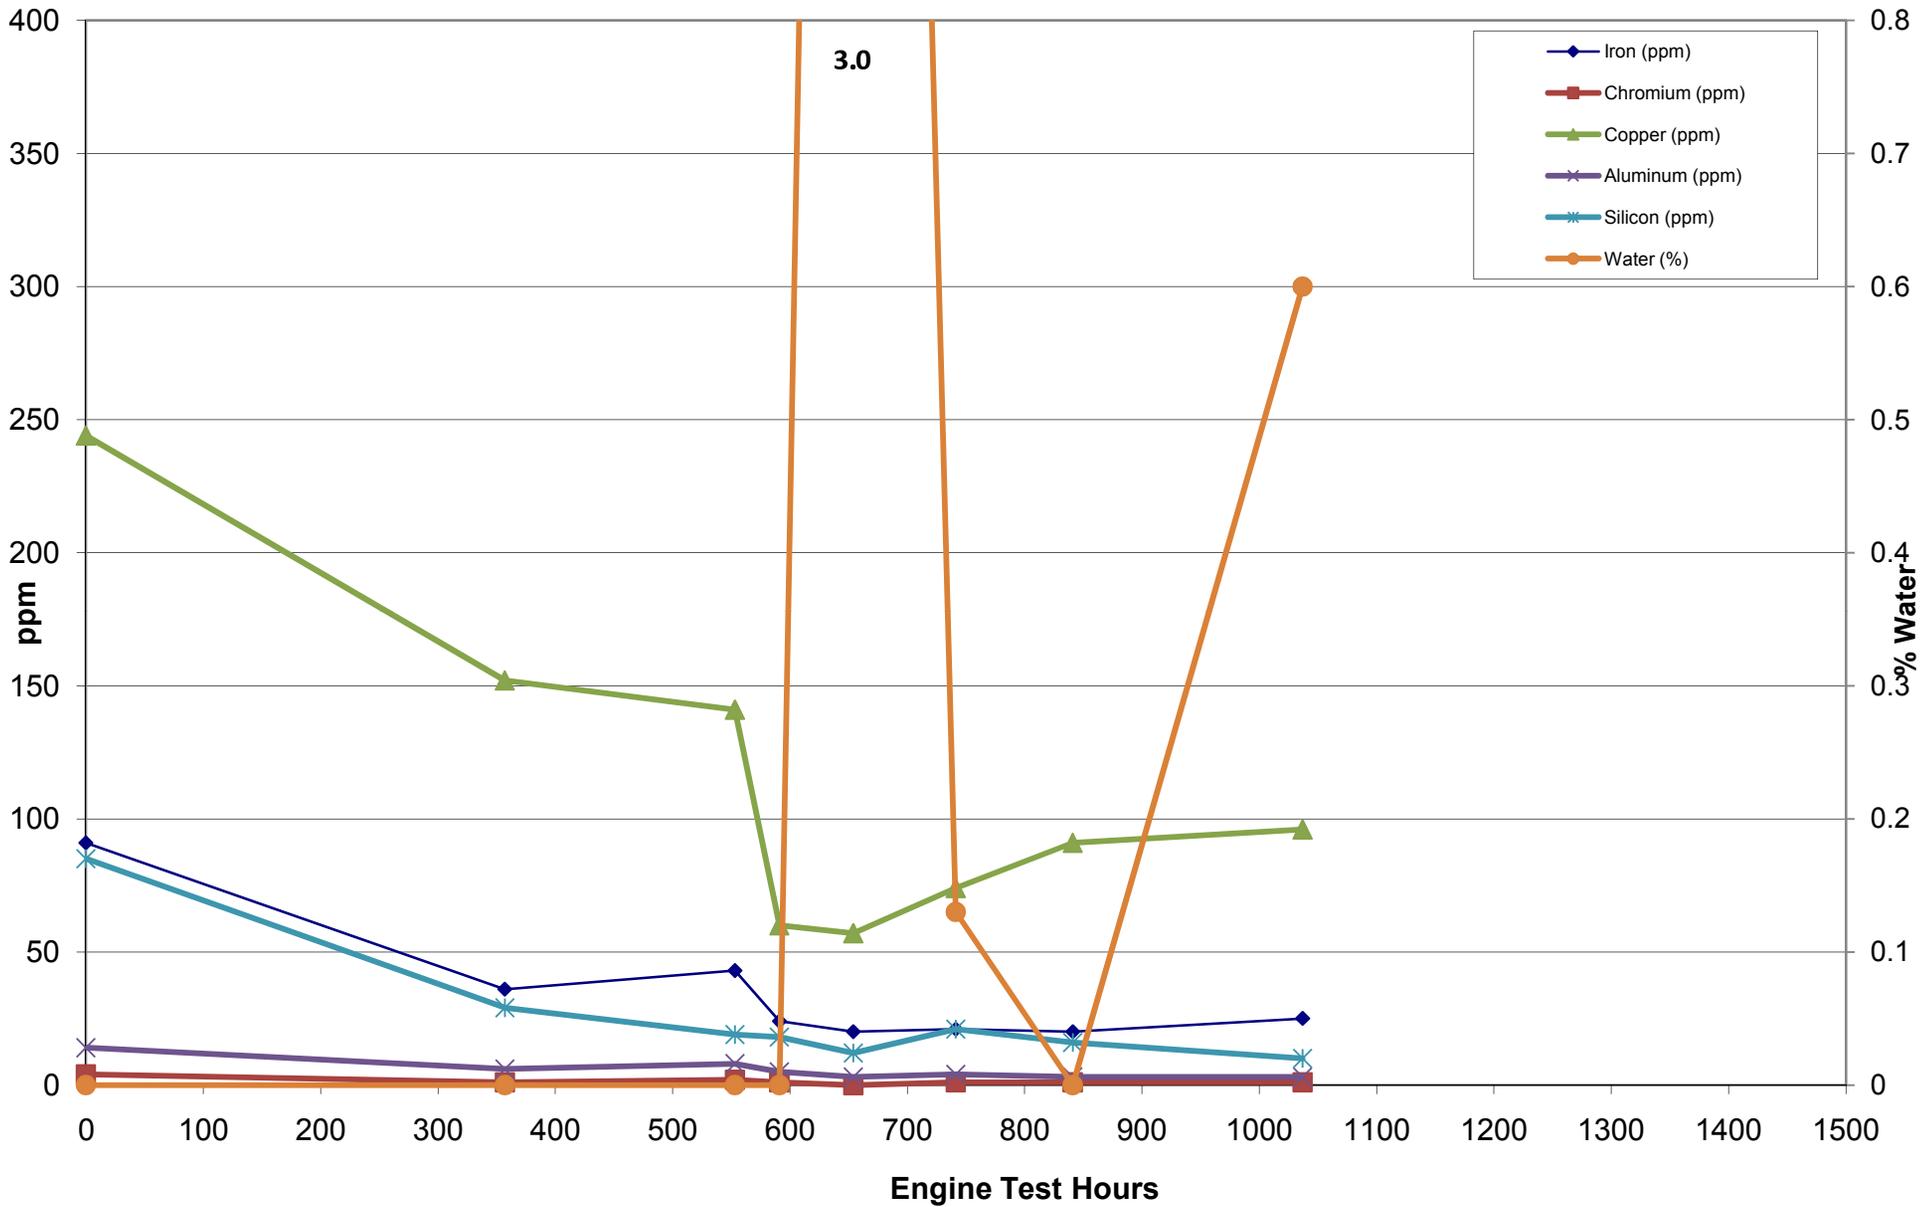
HICE Durability Vehicle: 5564 Staveley Services Oil Analysis Results--Wear Metals

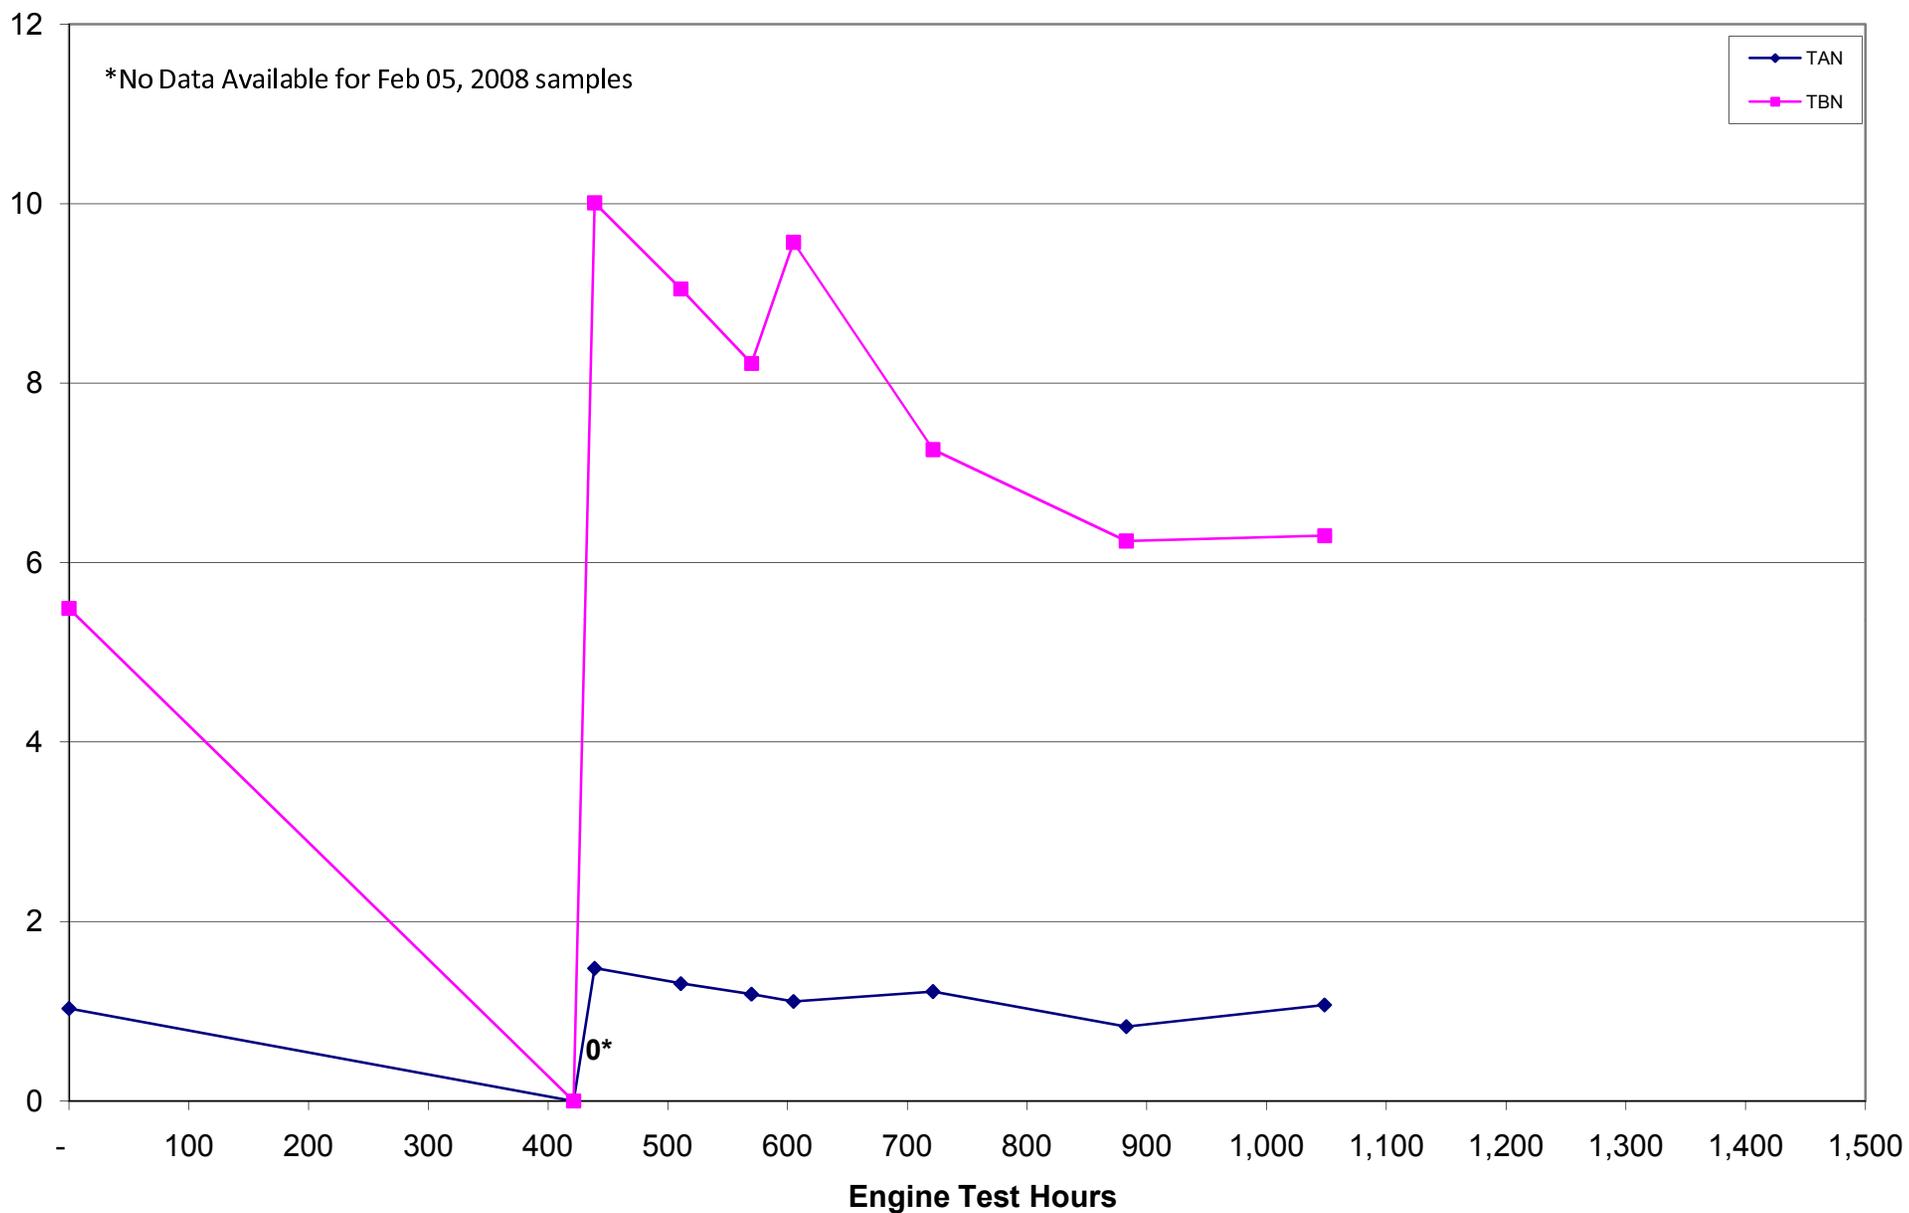
HICE Durability Vehicle: 5565 Staveley Services Oil Analysis Results: TAN & TBN

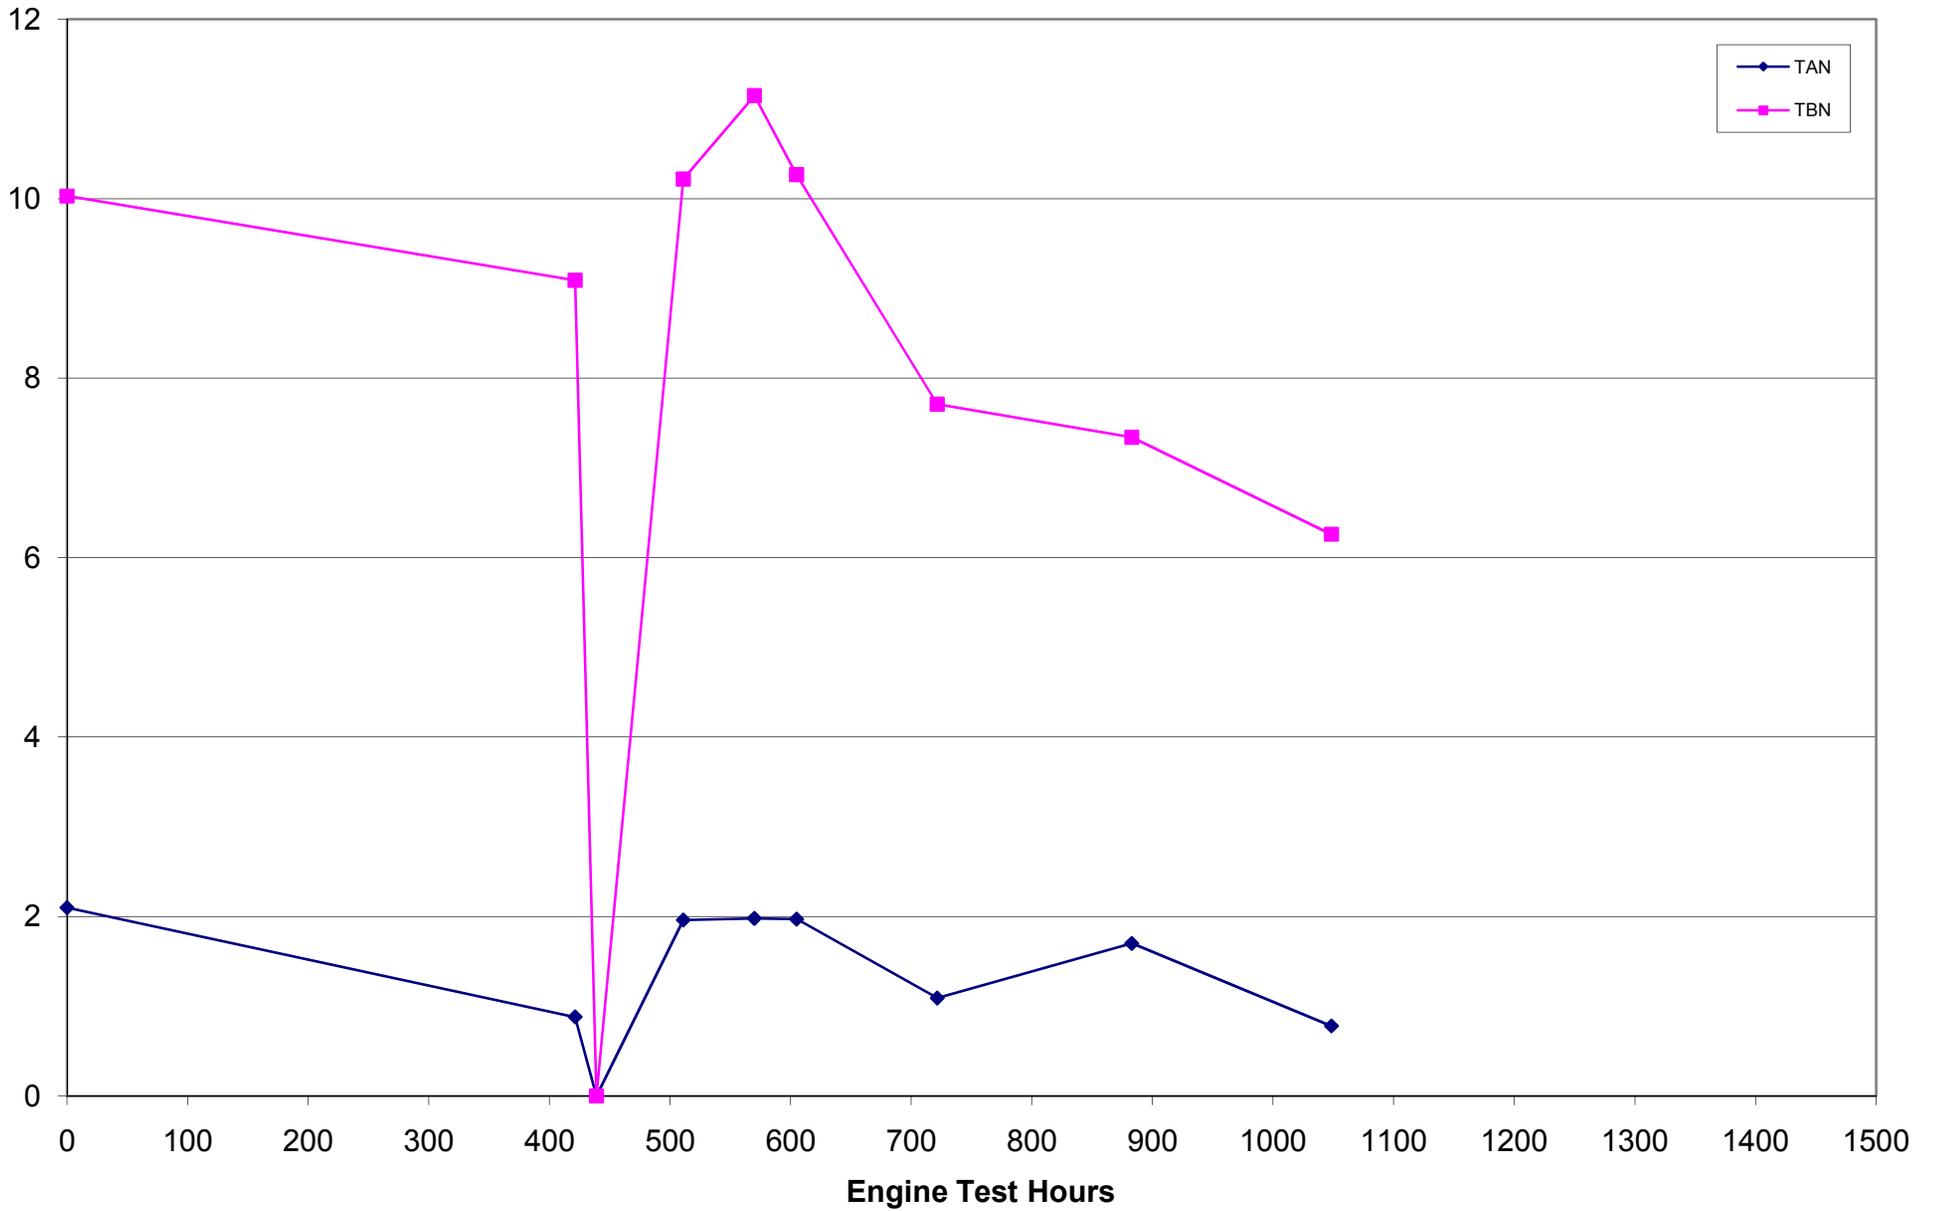
HICE Durability Vehicle: 5565
BTS Oil Analysis Results: TAN & TBN

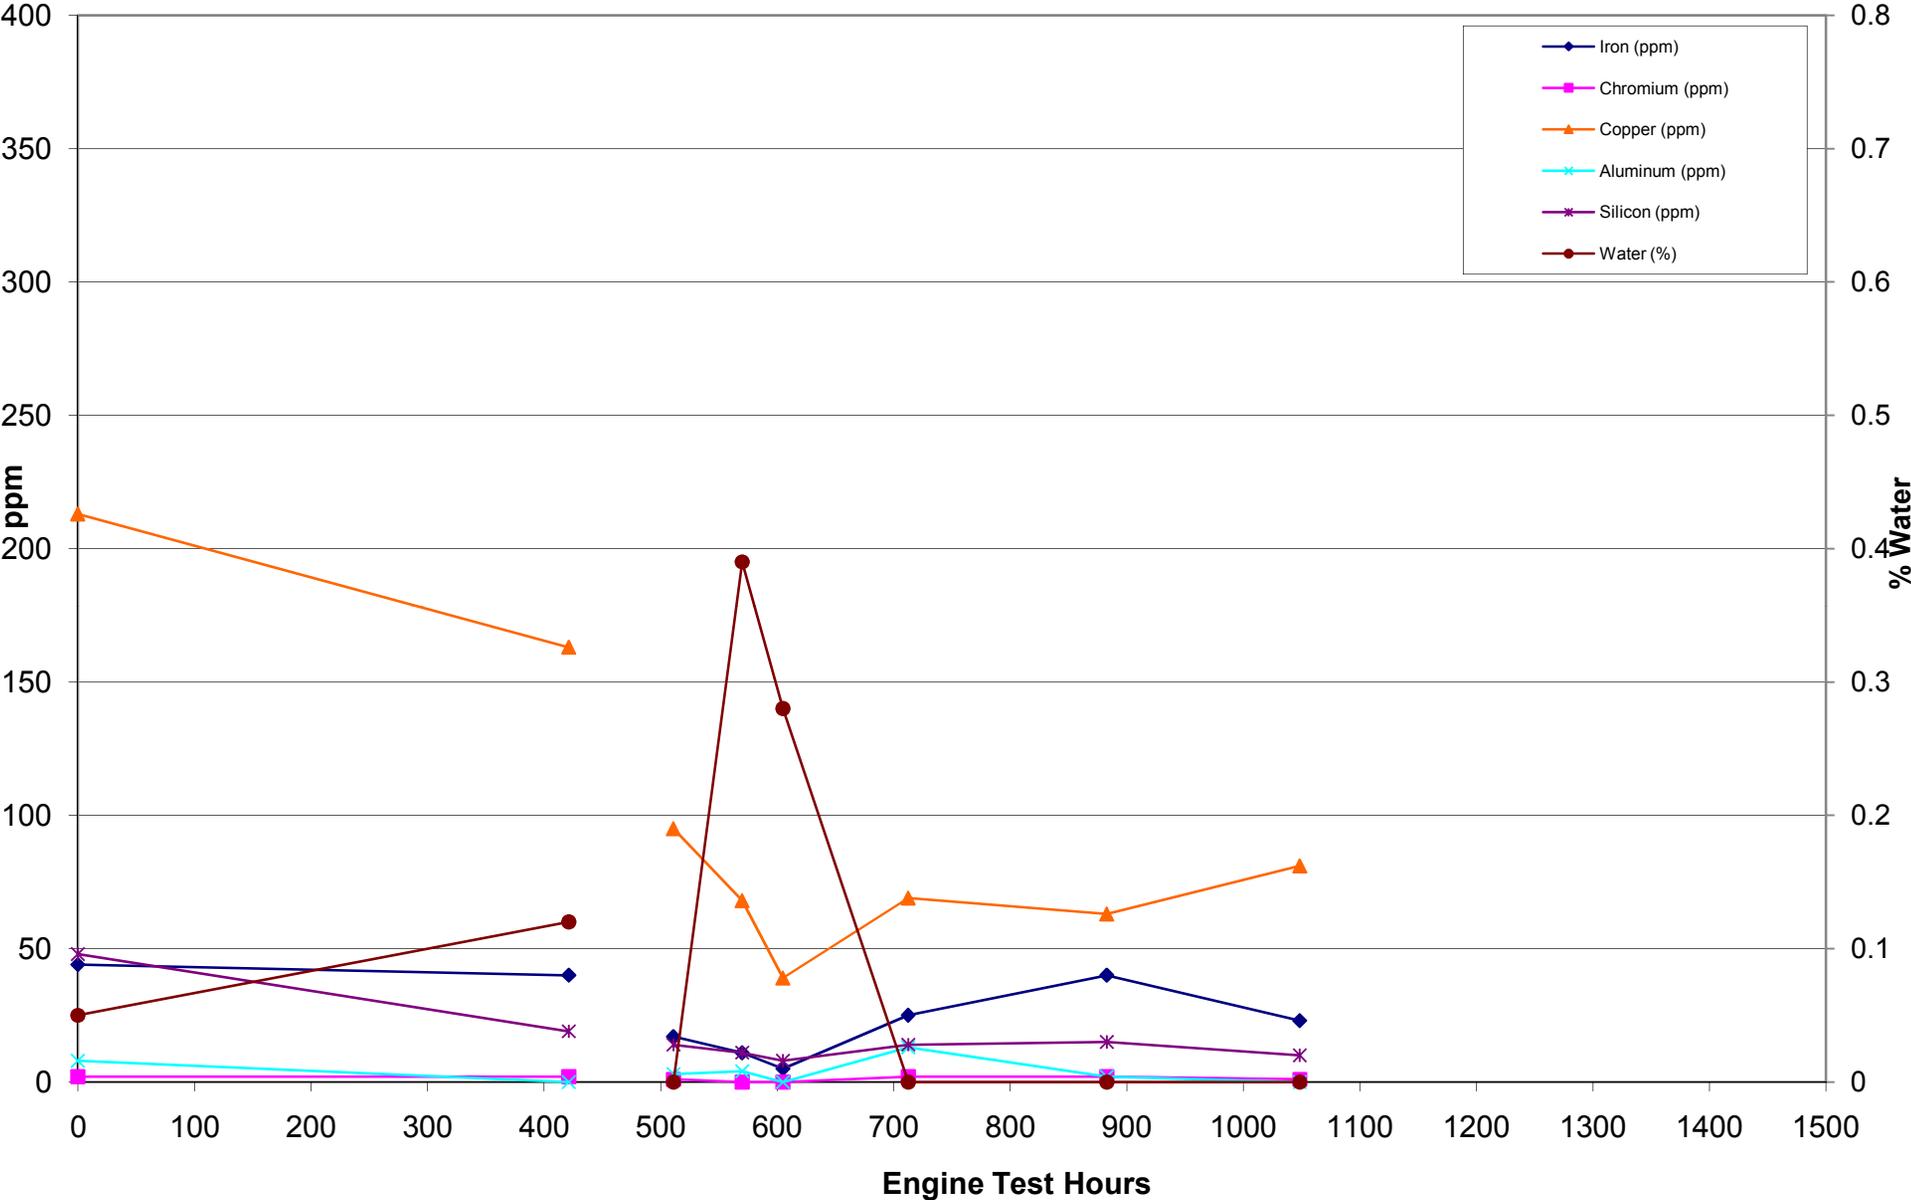
HICE Durability Vehicle: 5565 BTS Oil Analysis Results--Wear Metals

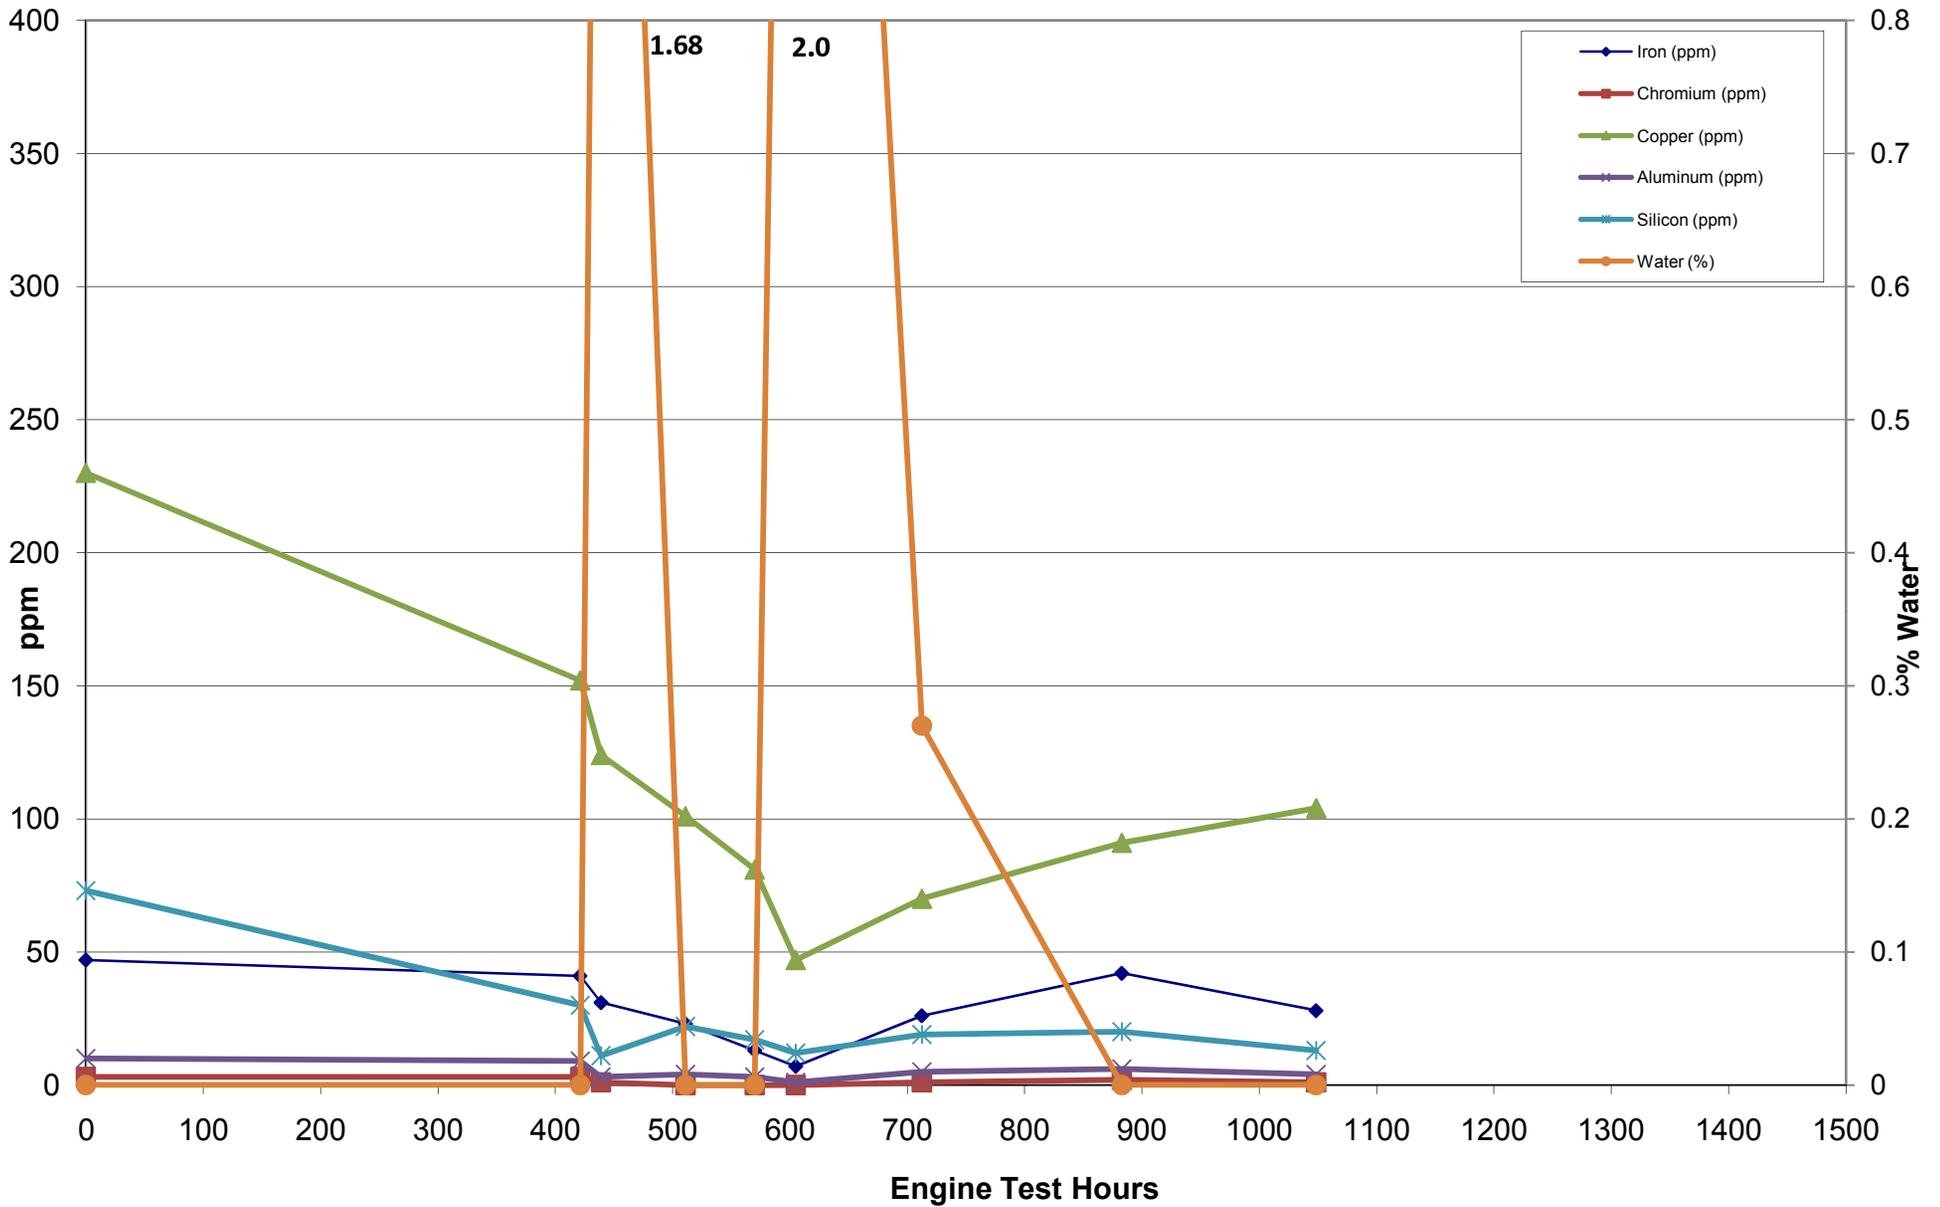
HICE Durability Vehicle: 5565 Staveley Services Oil Analysis Results--Wear Metals

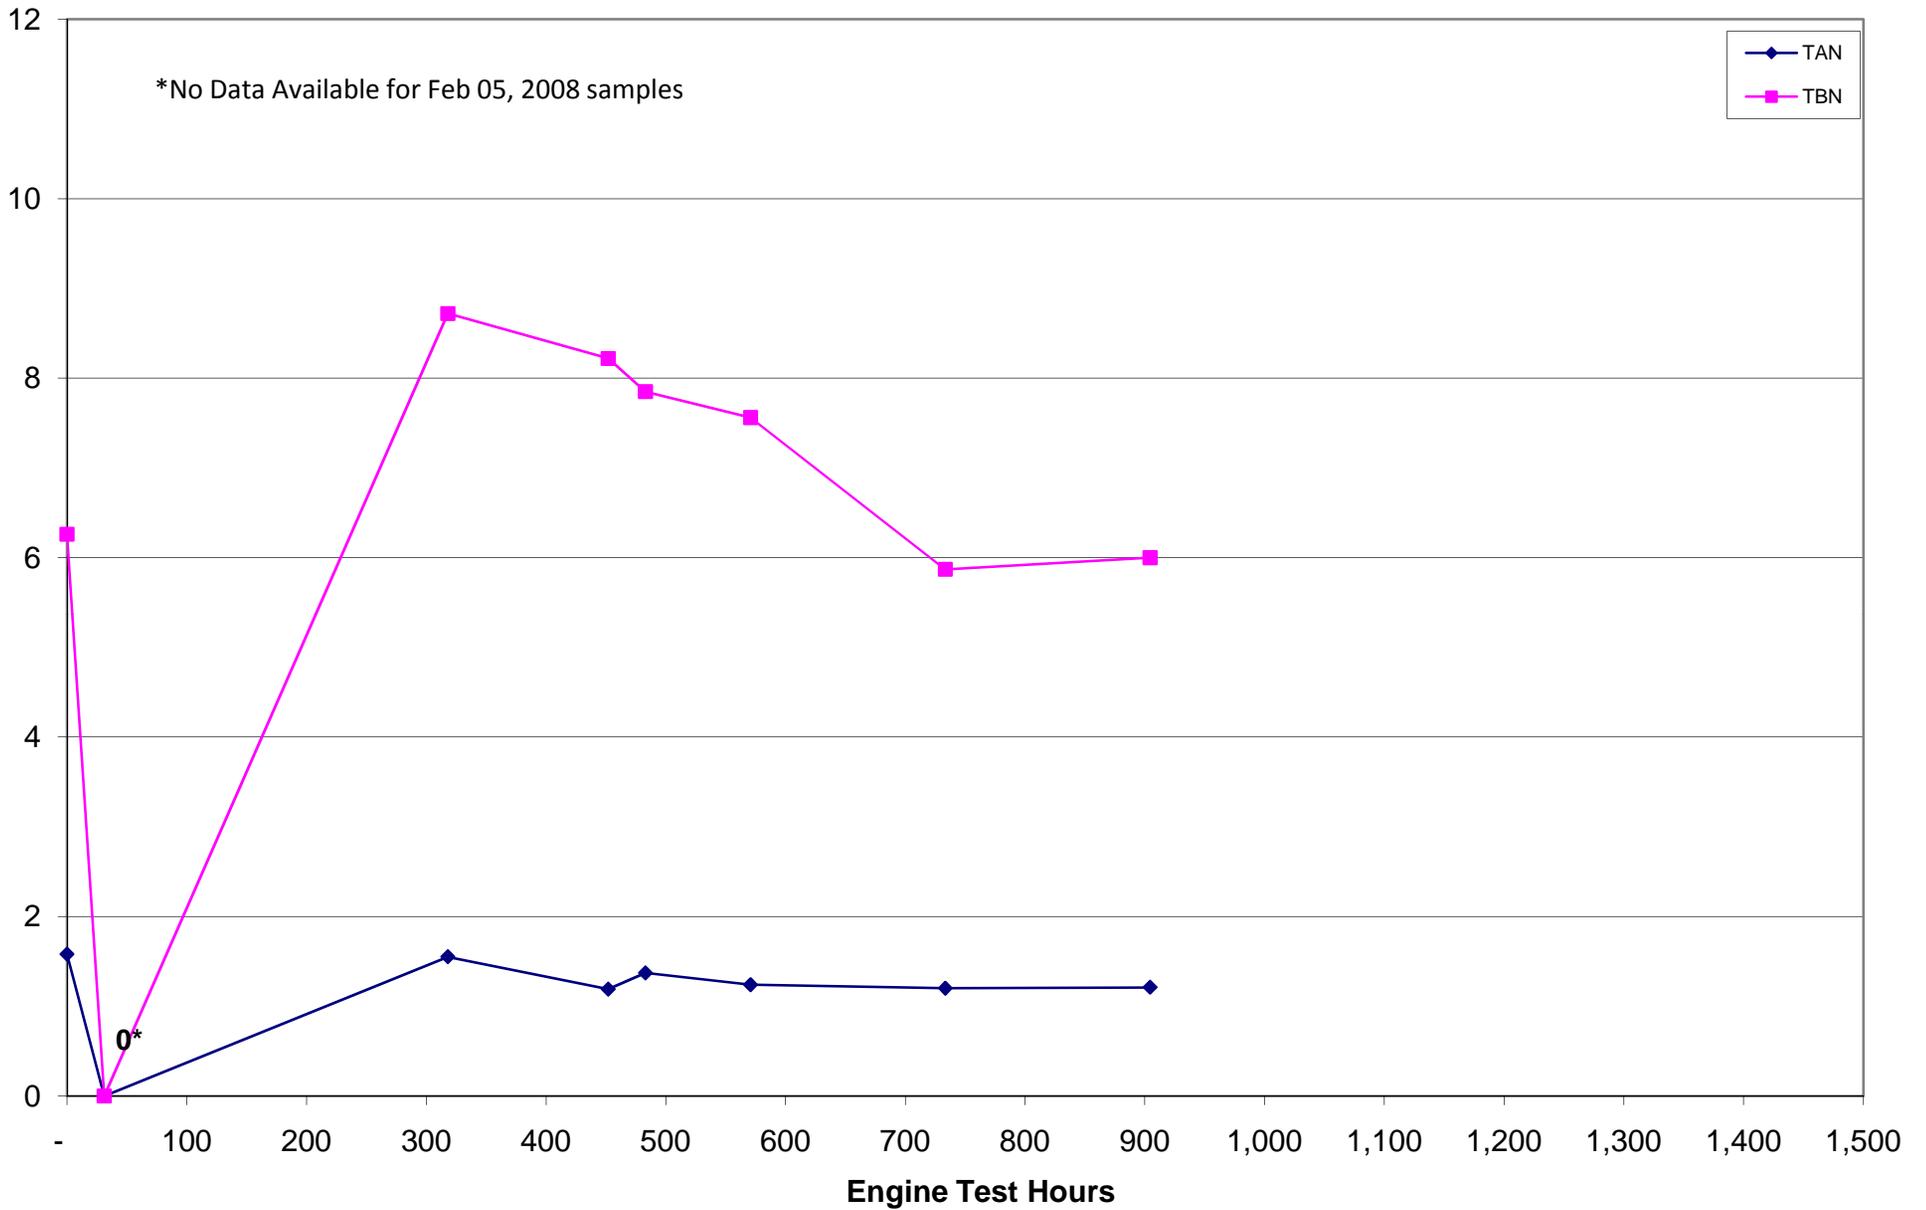
HICE Durability Vehicle: 5566
Staveley Services Oil Analysis Results: TAN & TBN

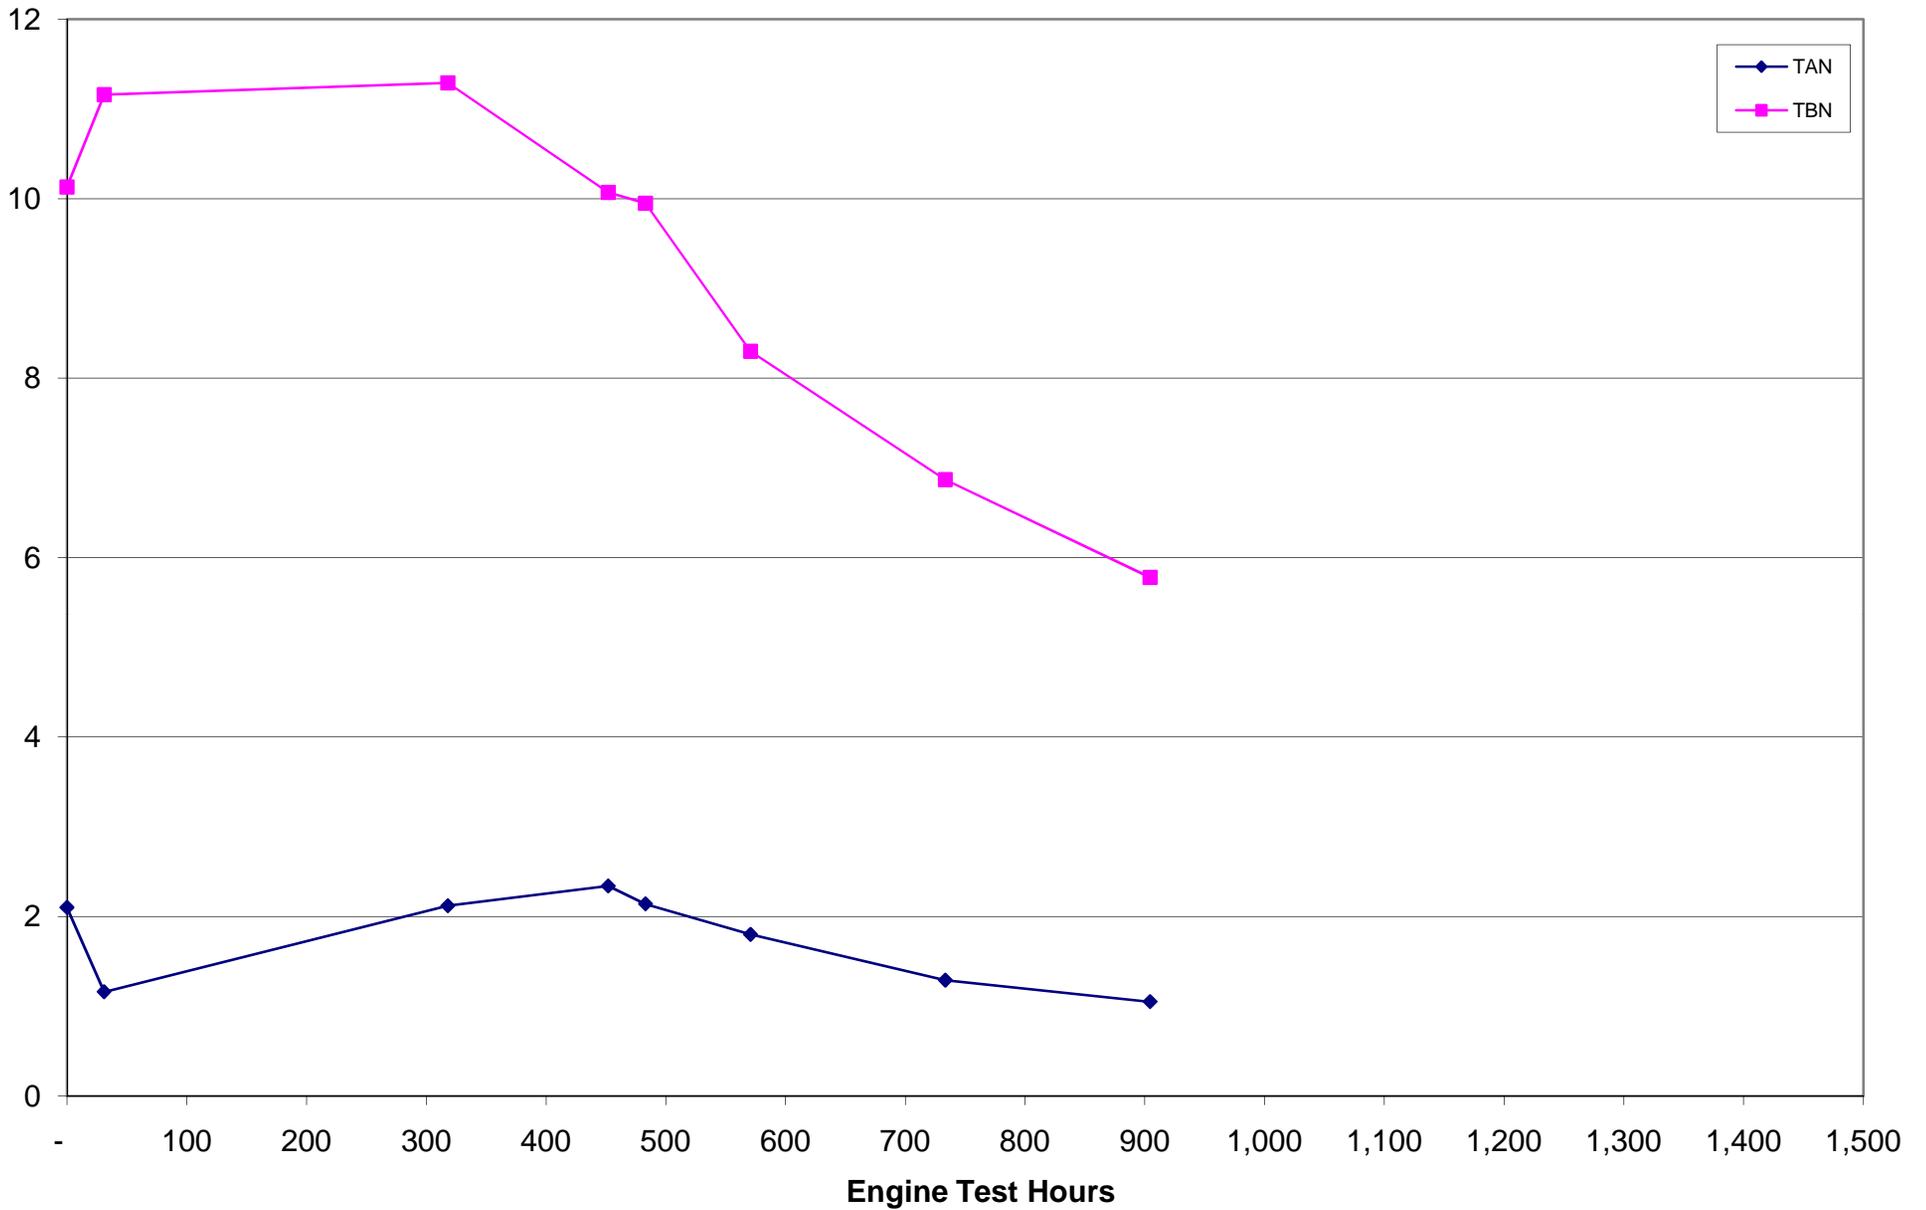
HICE Durability Vehicle: 5566
BTS Oil Analysis Results: TAN & TBN

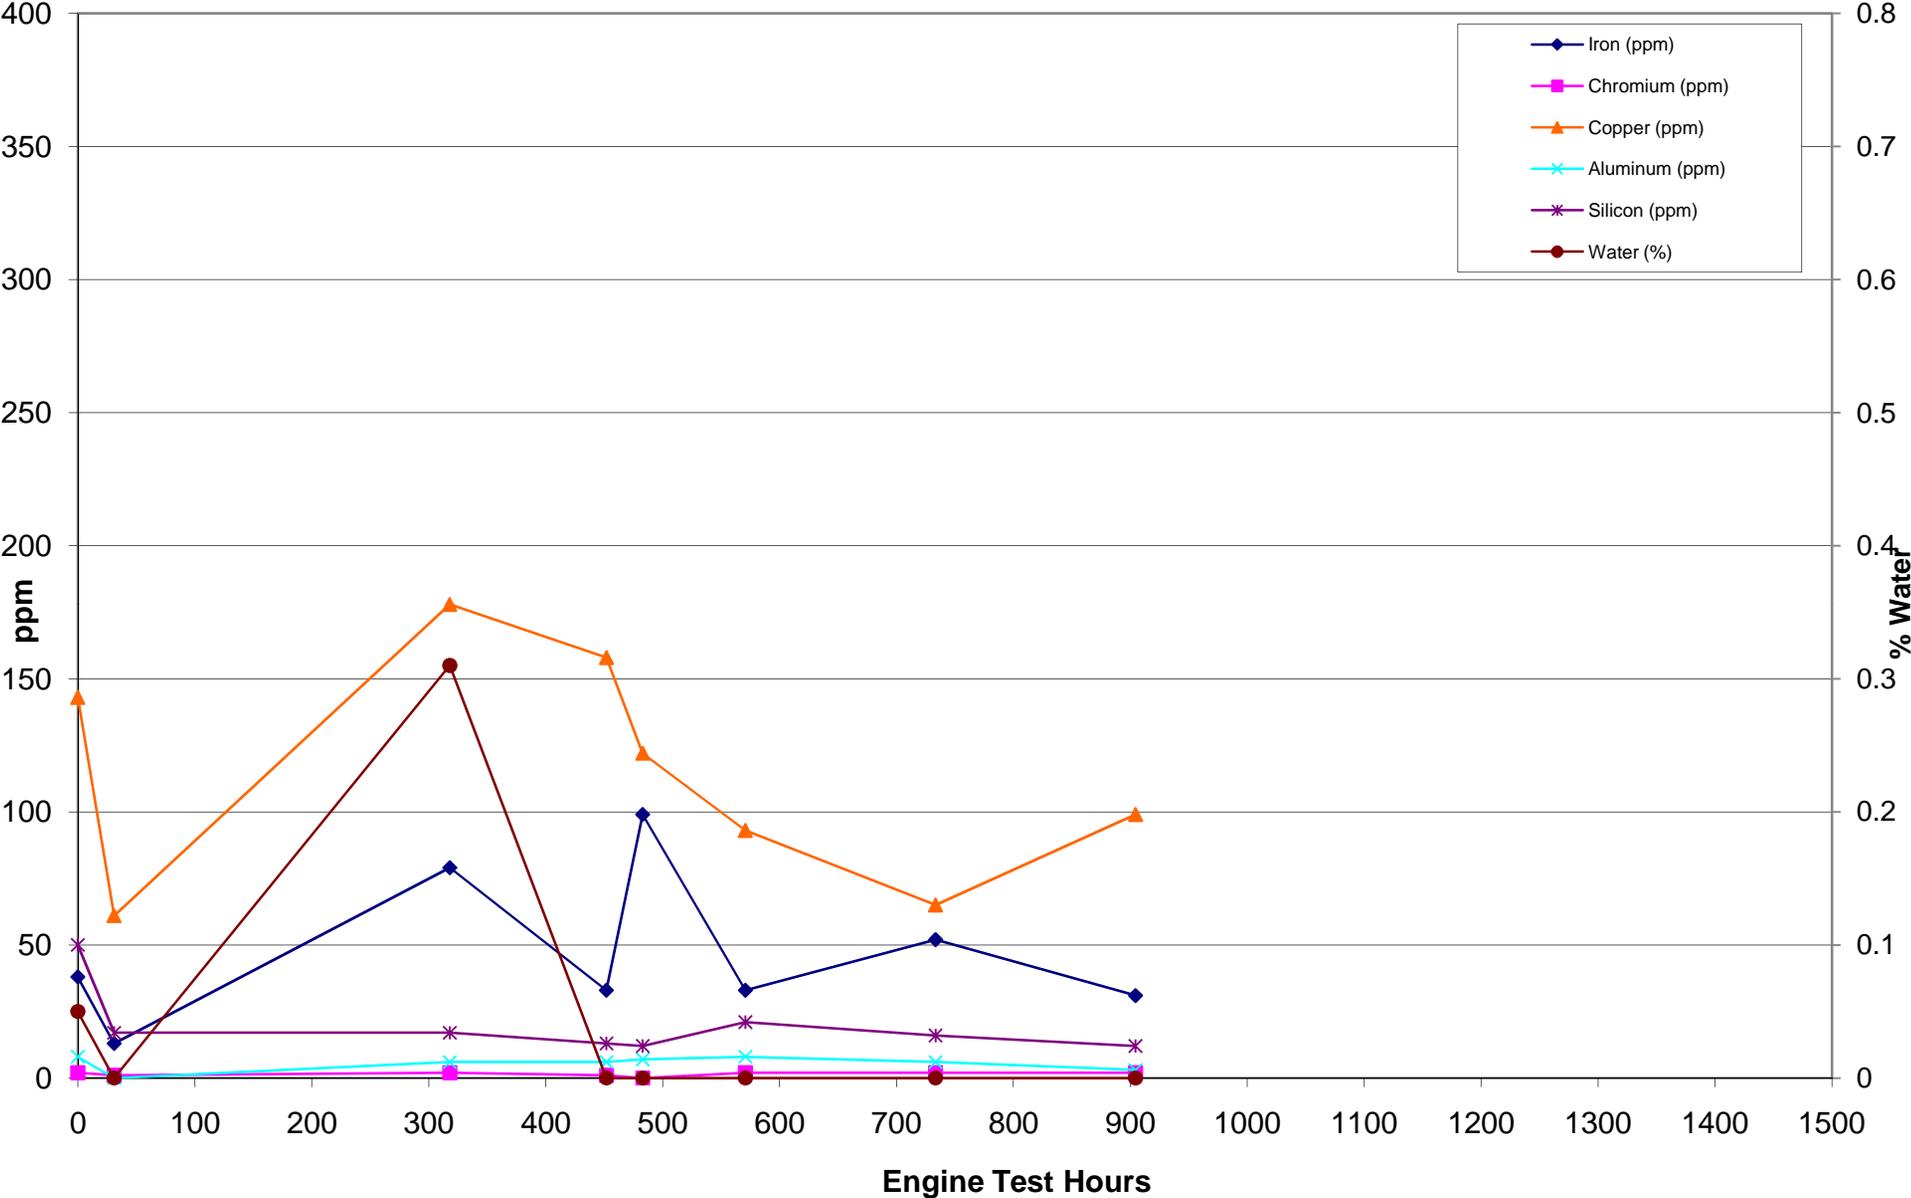
**HICE Durability Vehicle: 5566
BTS Oil Analysis Results--Wear Metals**

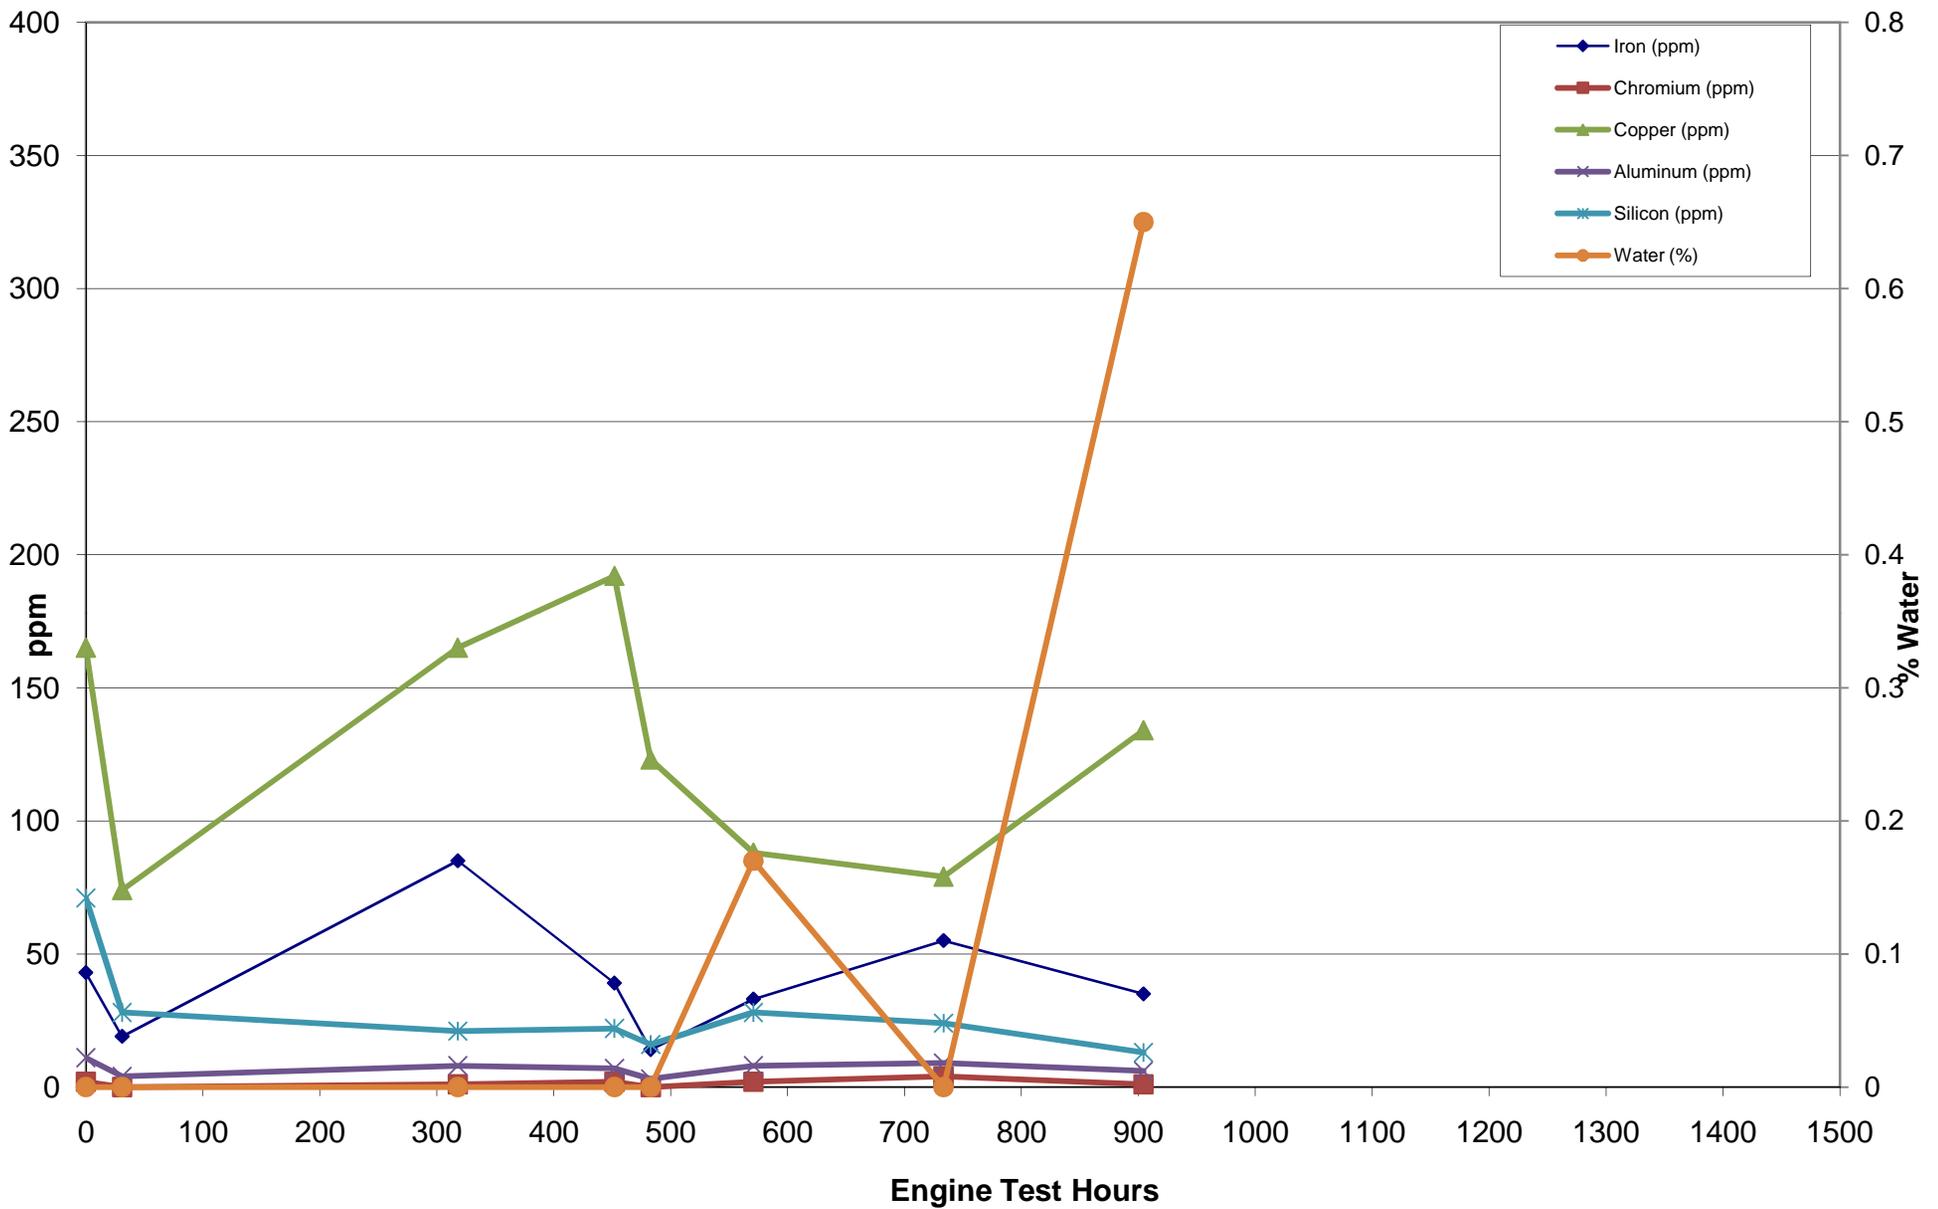
HICE Durability Vehicle: 5566 Staveley Services Oil Analysis Results--Wear Metals
