Findings of Hydrogen Internal Combustion Engine Durability

Final Technical/Scientific Report

DE-FC26-06NT43027

Electric Transportation Engineering Corporation
430 S. 2nd Ave
Phoenix, AZ 85003

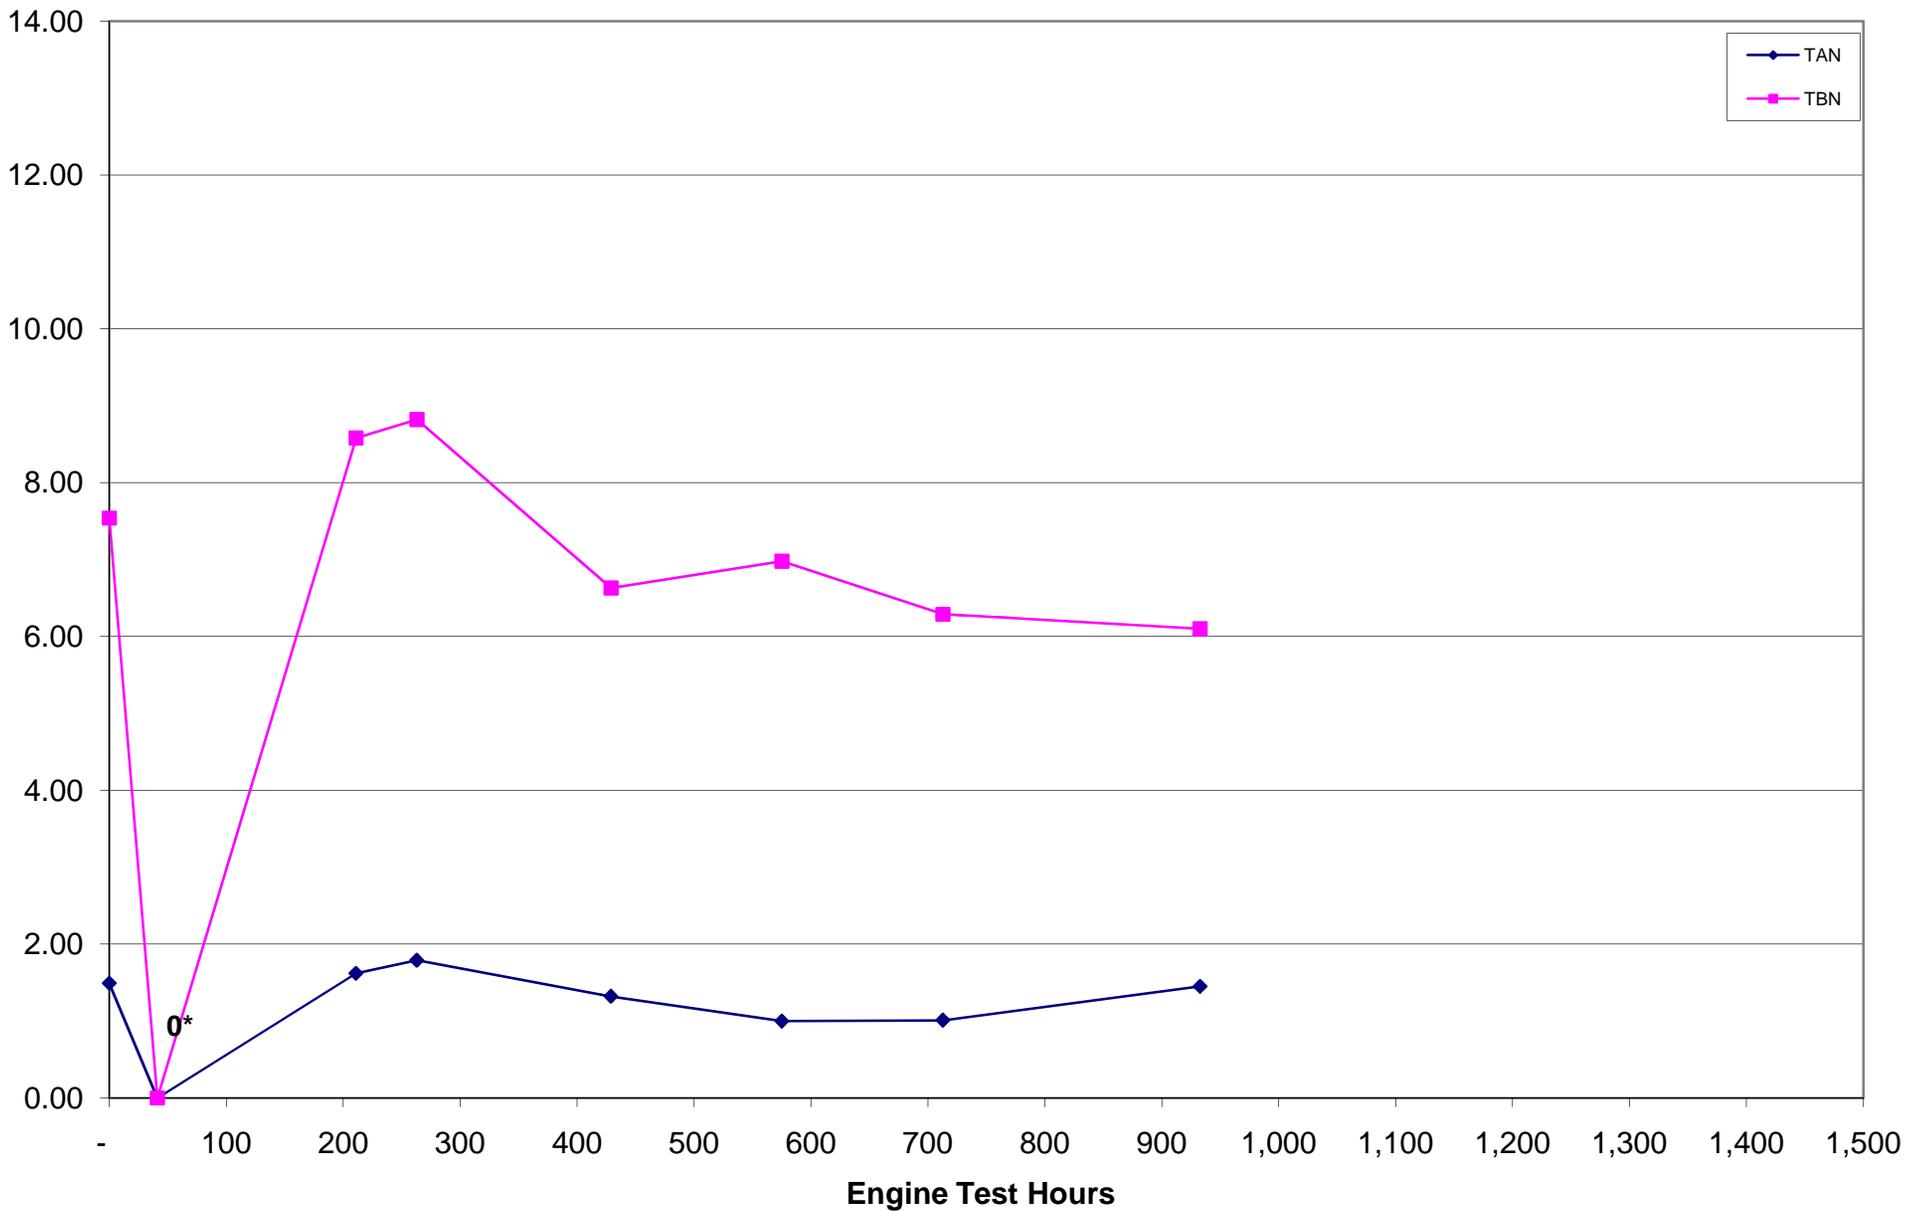
HICE Durability Vehicle: 5567
Staveley Services Oil Analysis Results: TAN & TBN

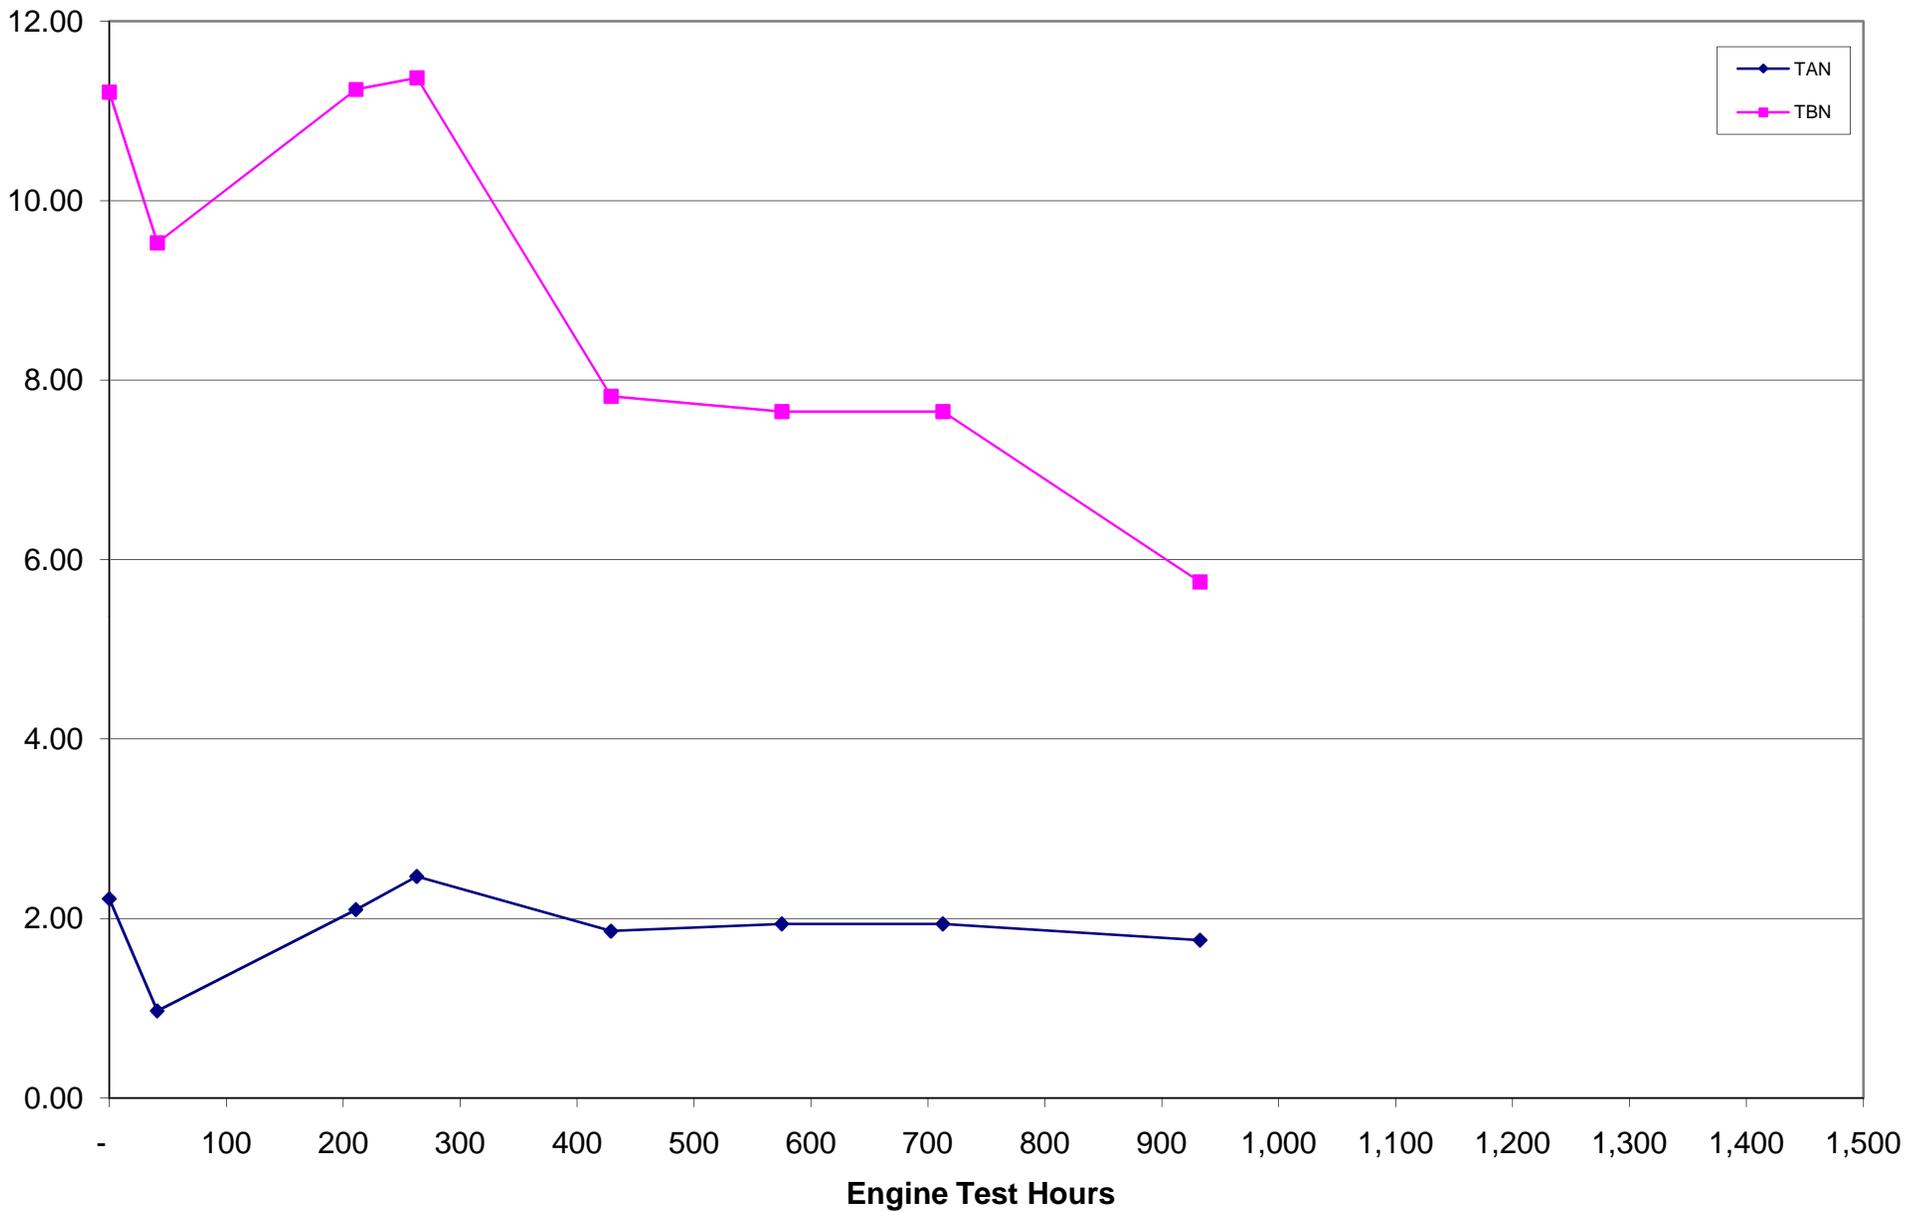
HICE Durability Vehicle: 5567
BTS Oil Analysis Results: TAN & TBN

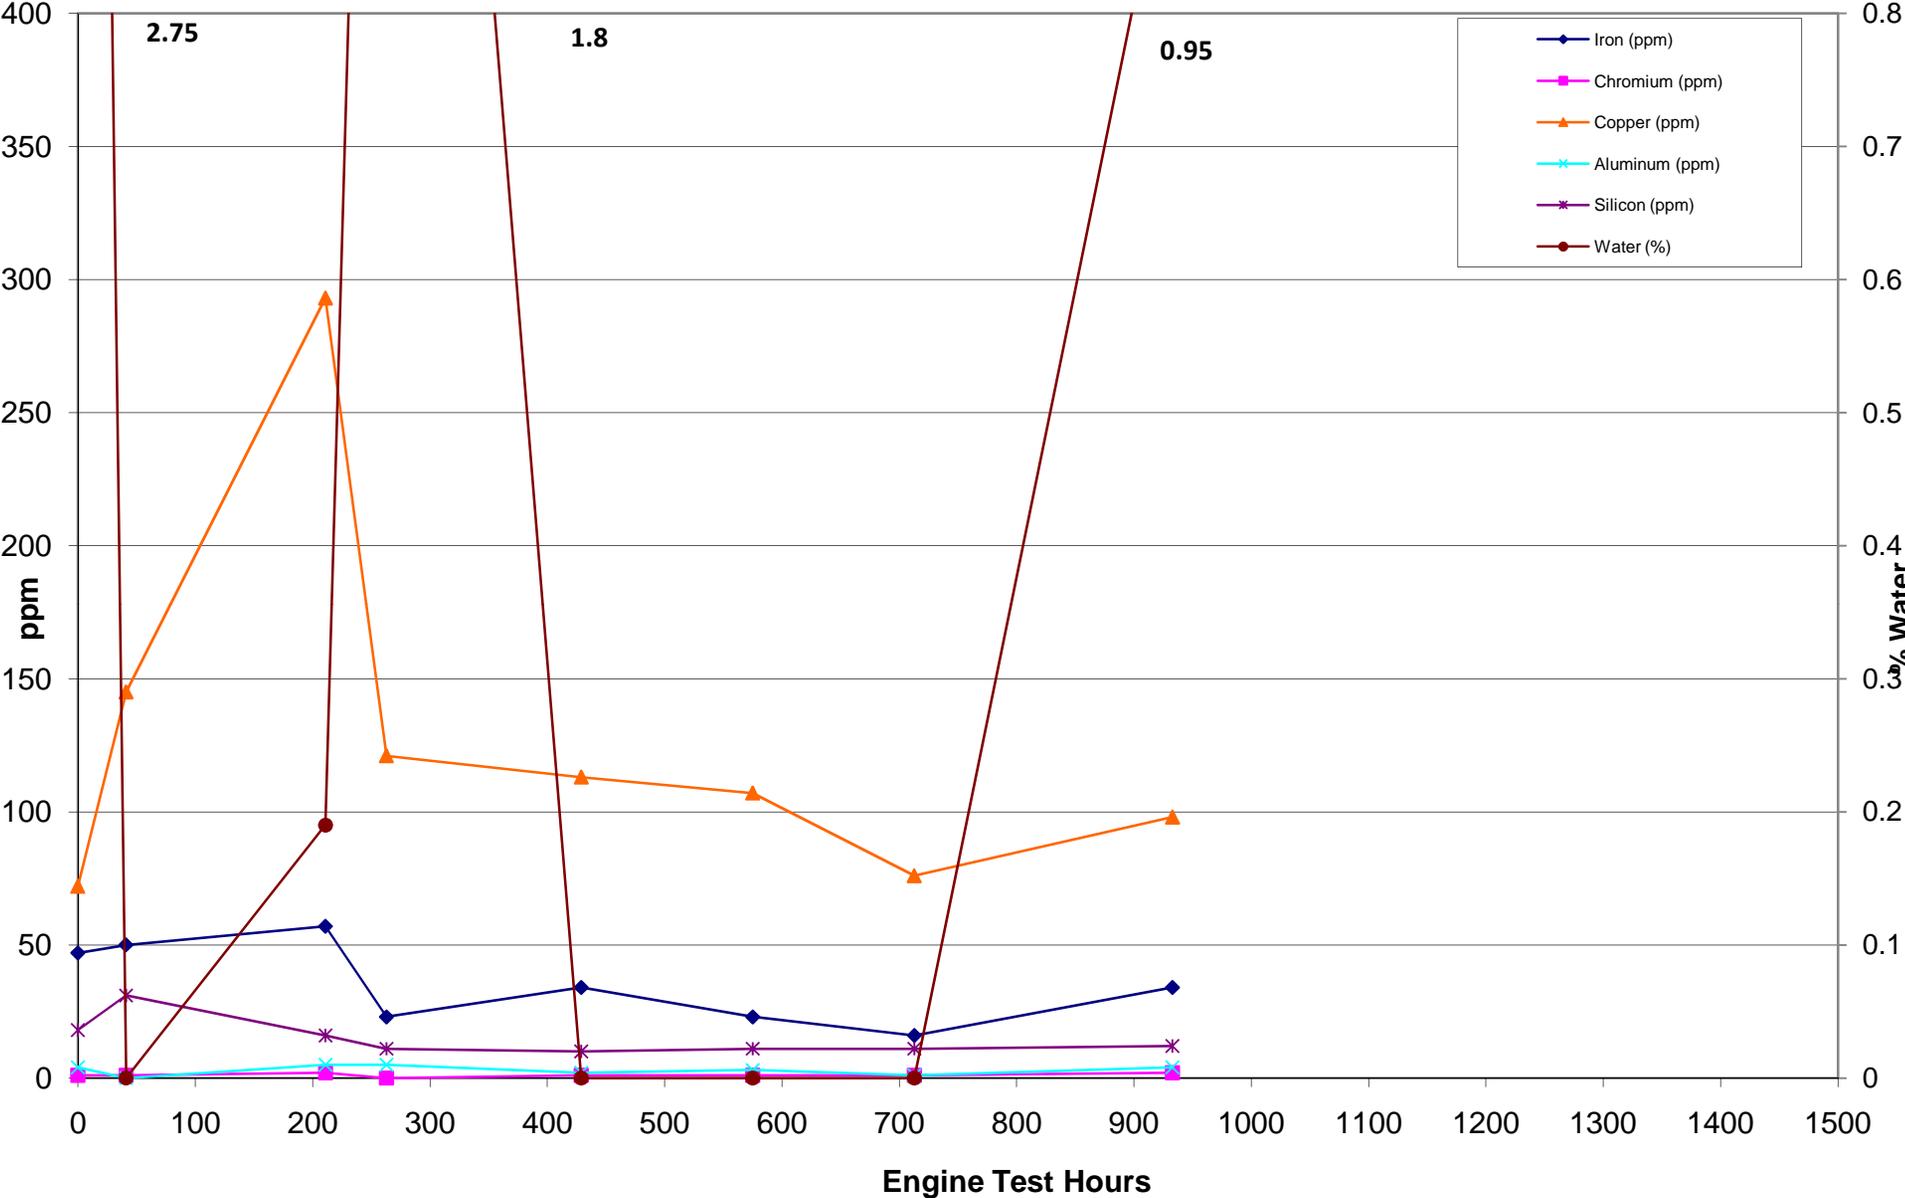
HICE Durability Vehicle: 5567 BTS Oil Analysis Results--Wear Metals

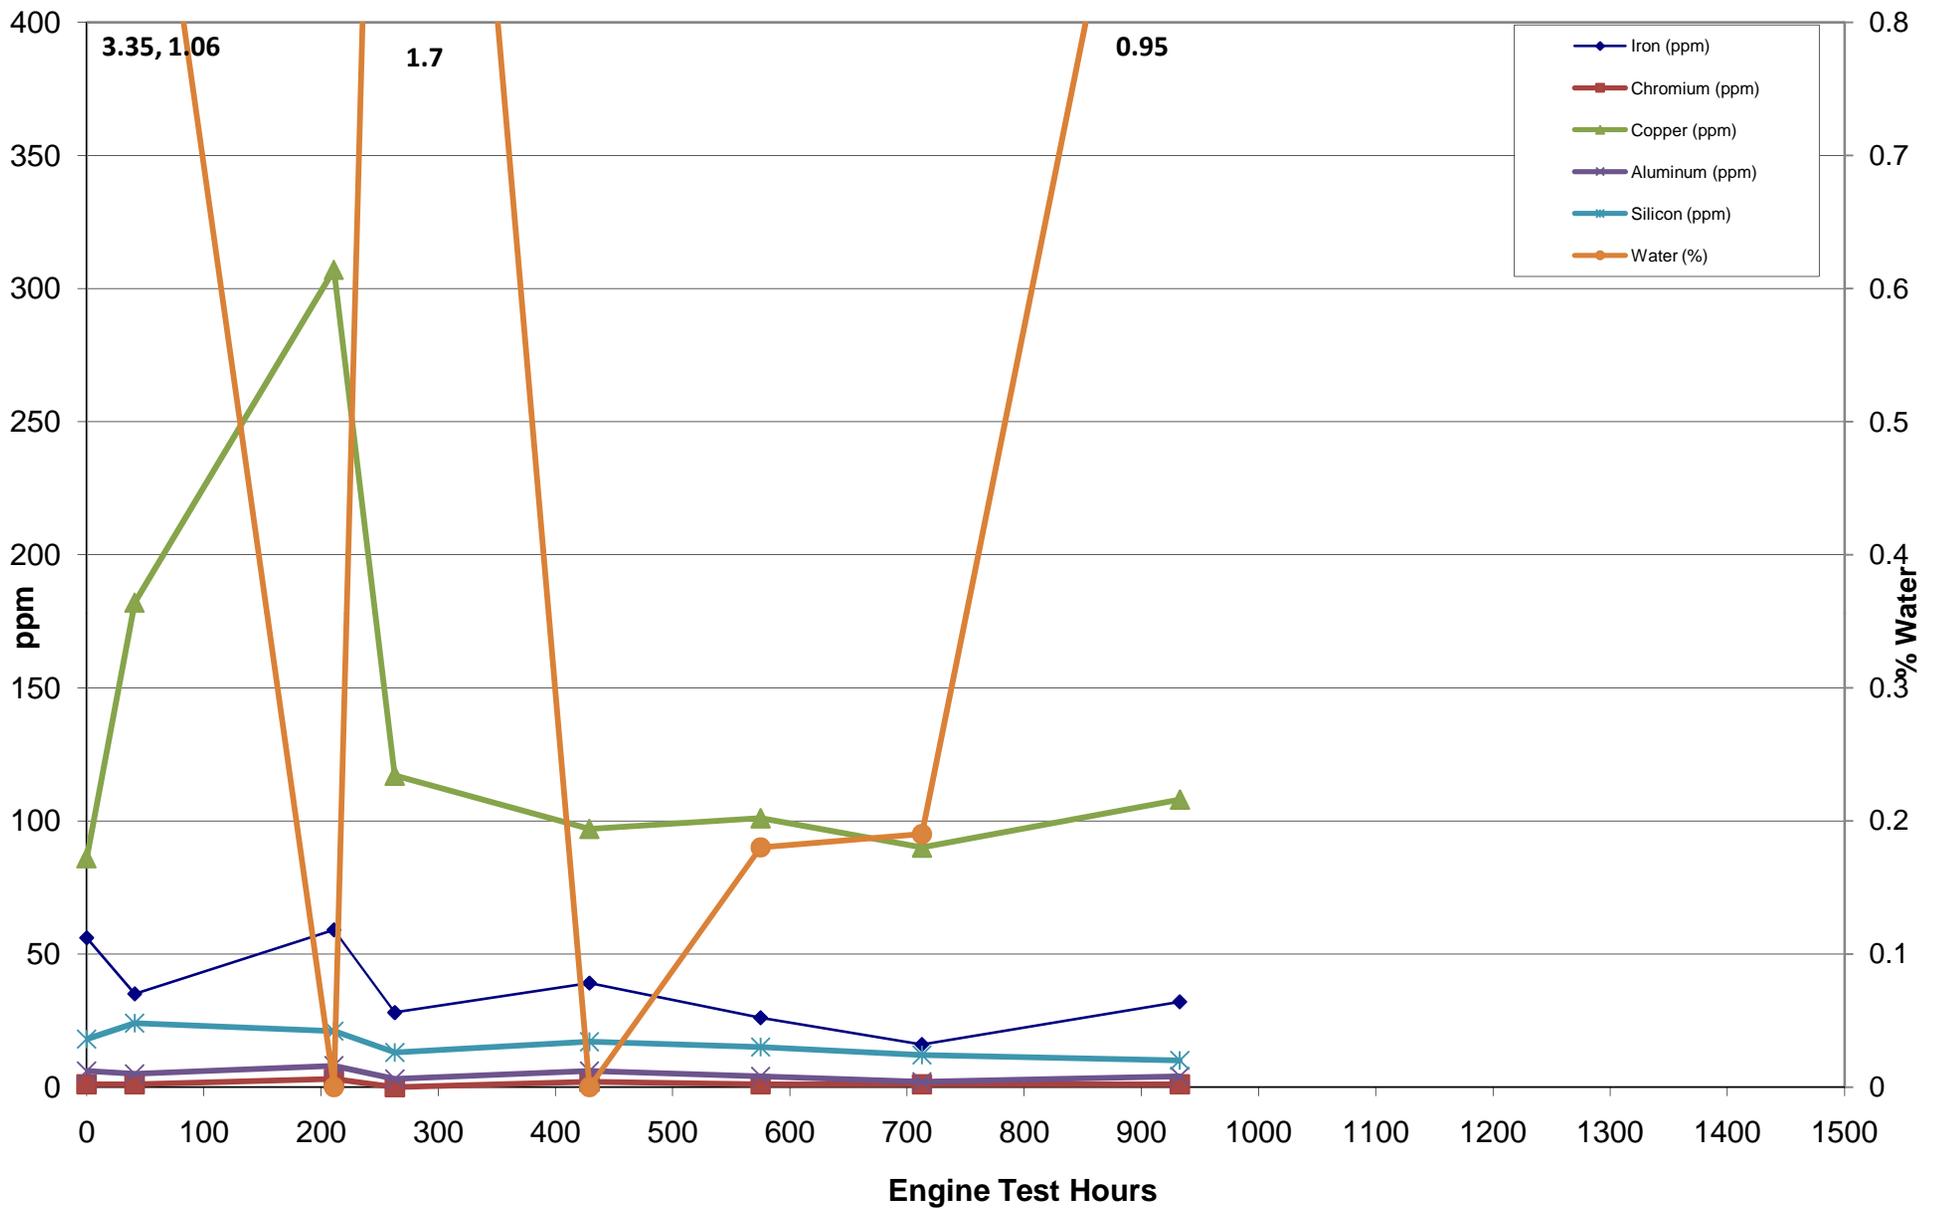
HICE Durability Vehicle: 5567 Staveley Services Oil Analysis Results--Wear Metals

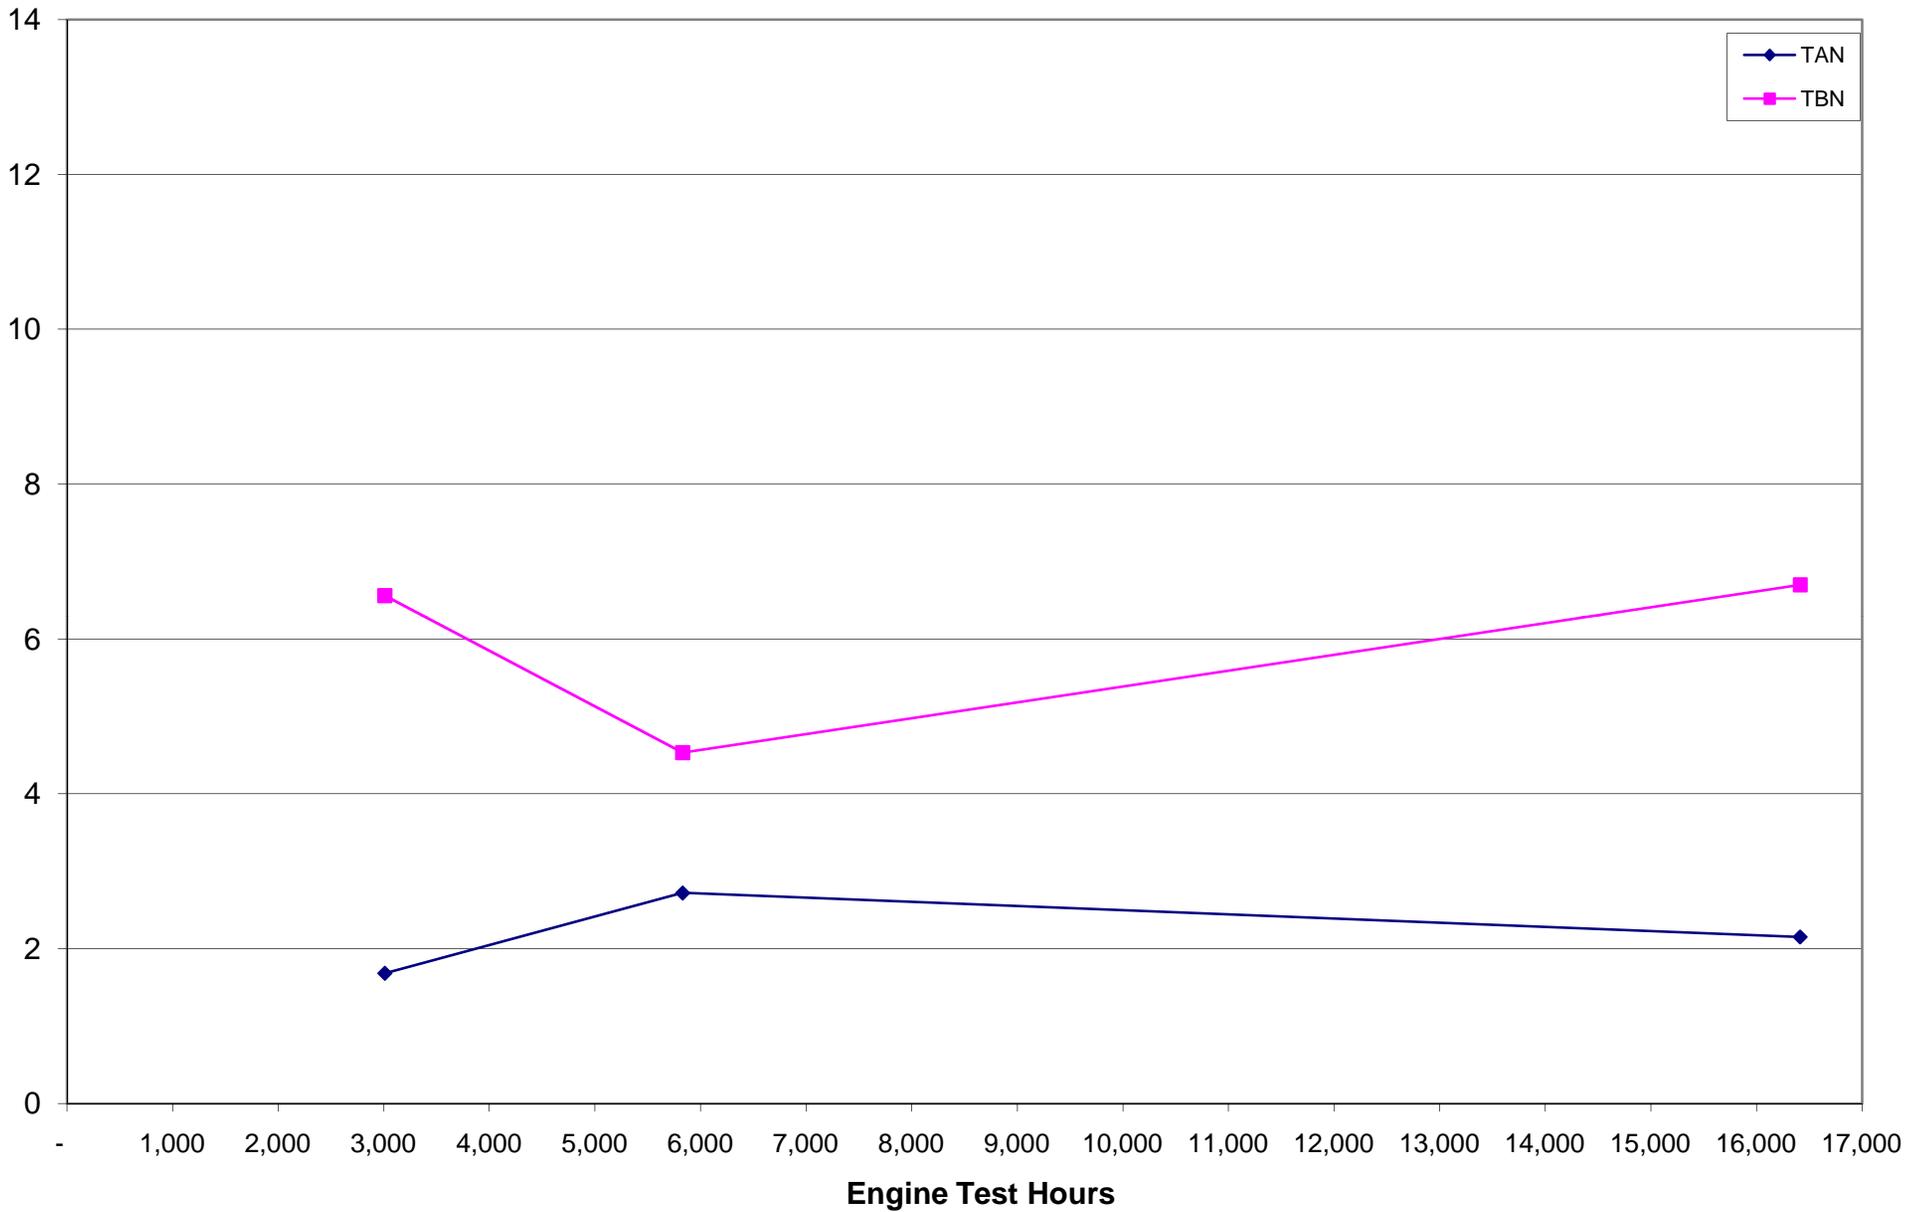
HICE Durability Vehicle: 6000
Staveley Services Oil Analysis Results: TAN & TBN

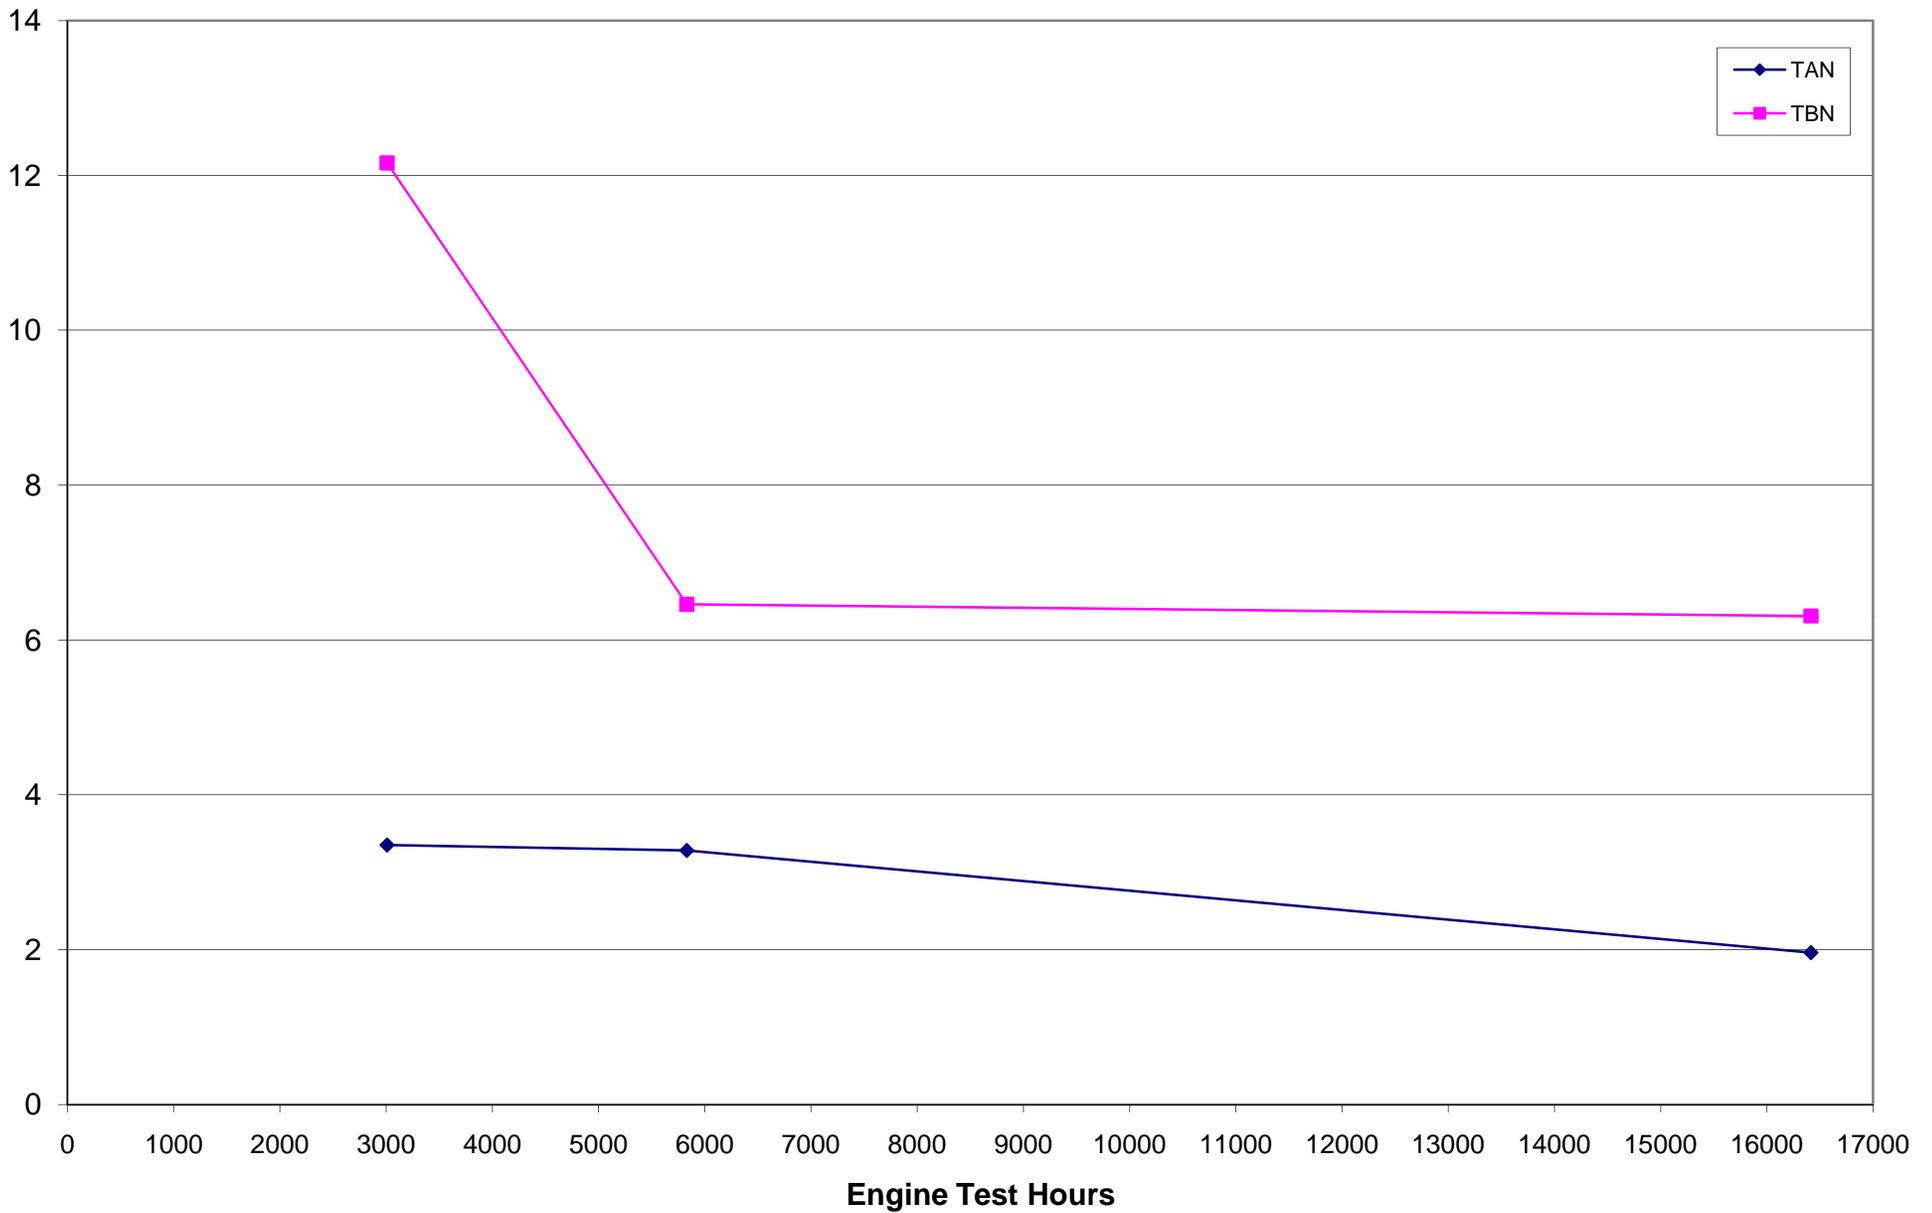
HICE Durability Vehicle: 6000
BTS Oil Analysis Results: TAN & TBN

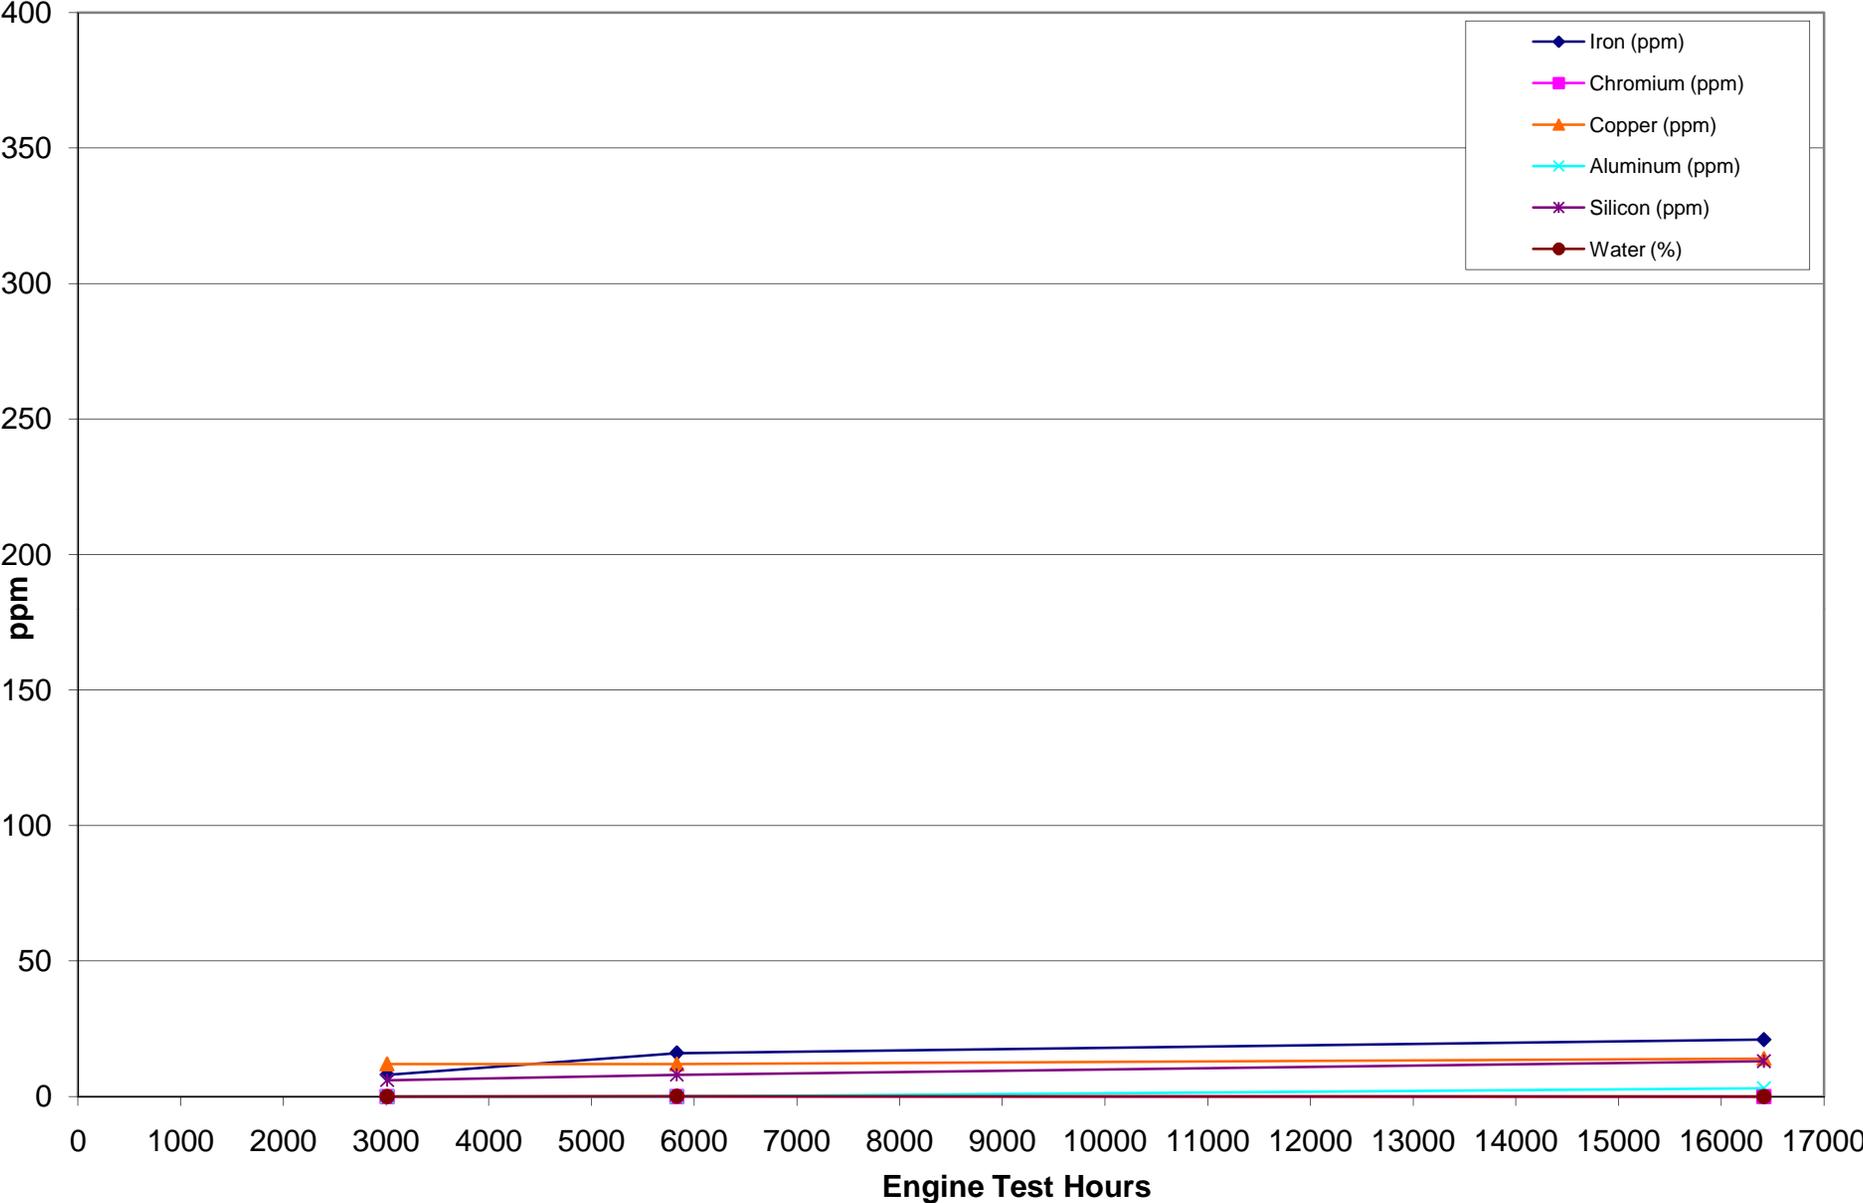
HICE Durability Vehicle: 6000 BTS Oil Analysis Results--Wear Metals

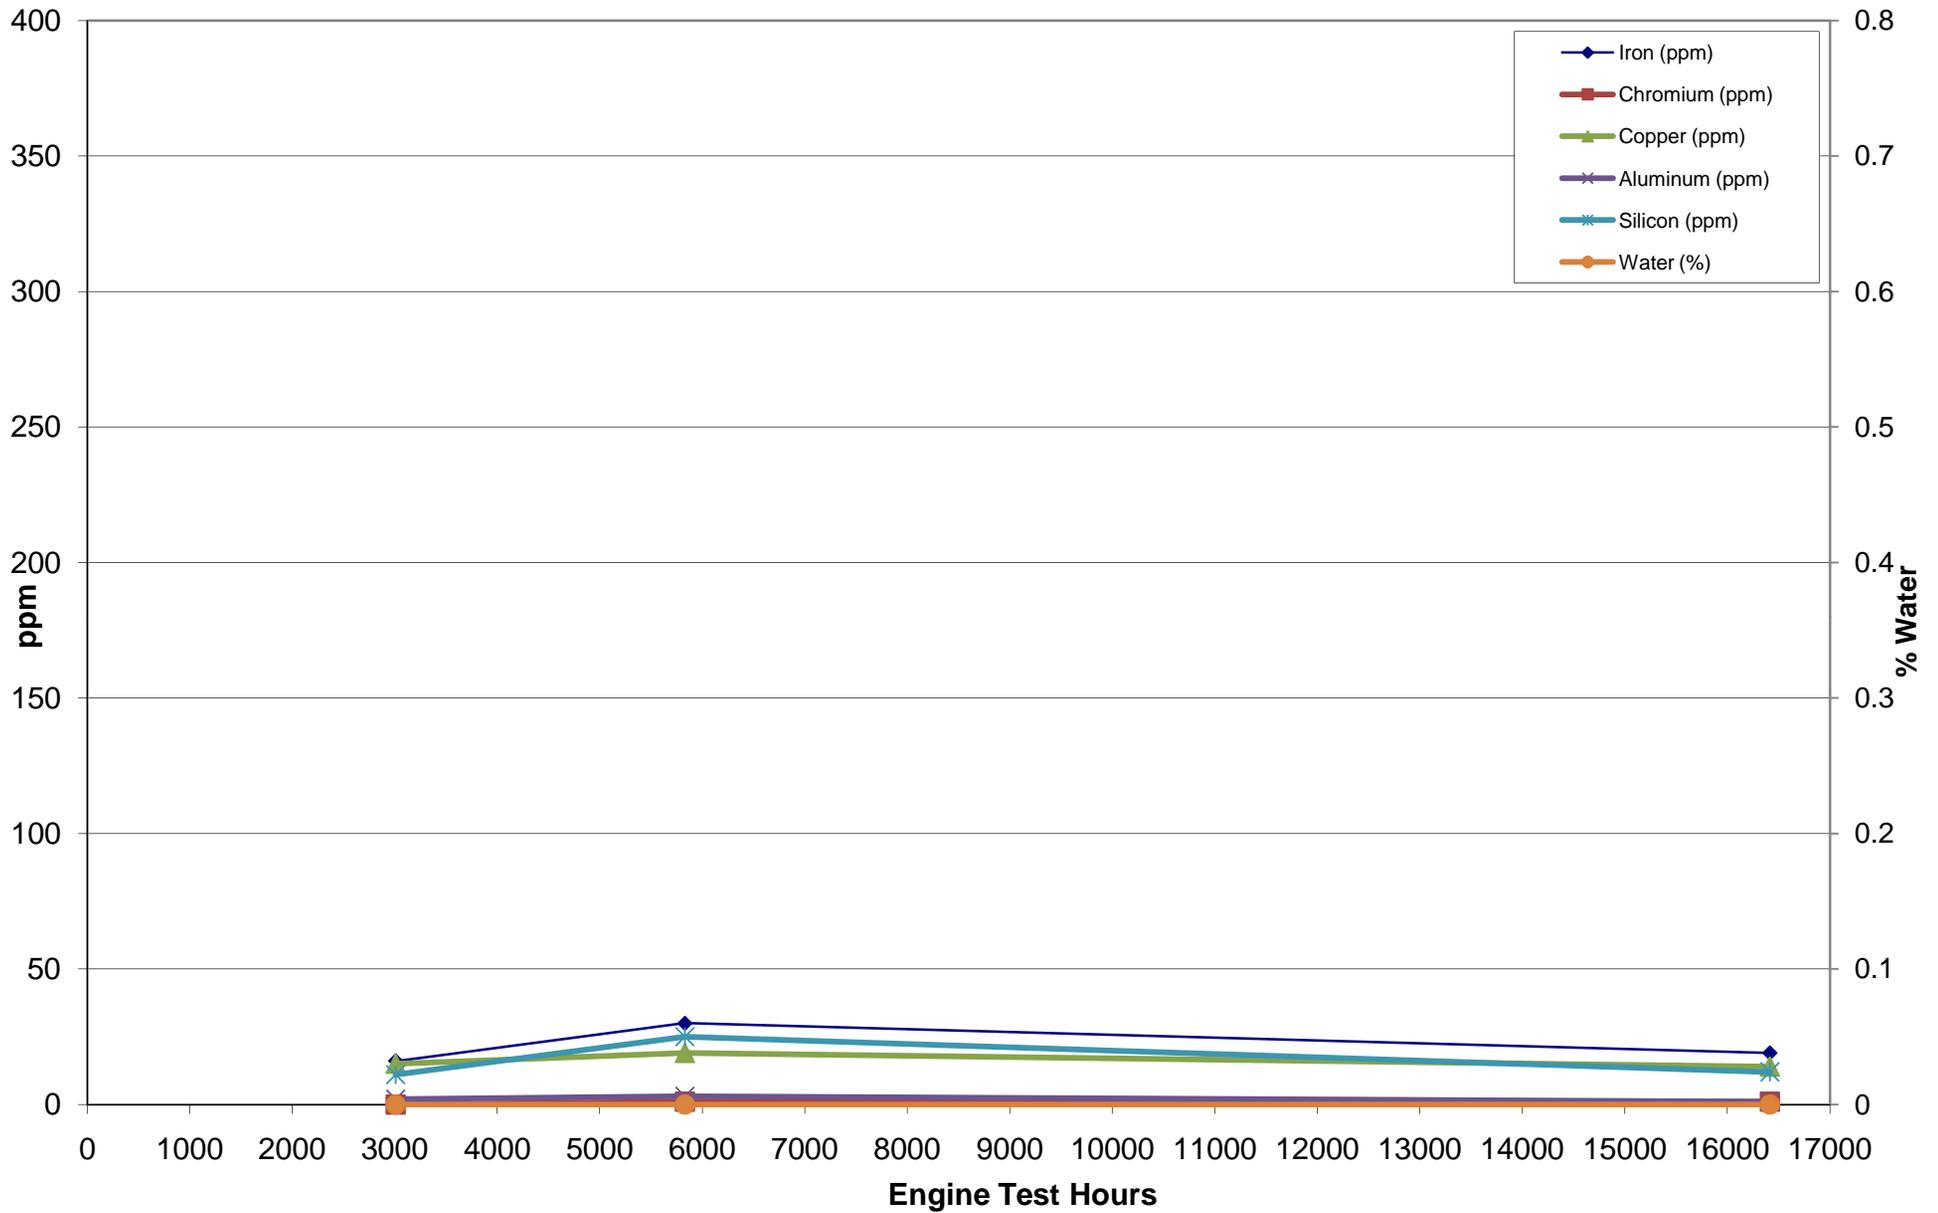
HICE Durability Vehicle: 6000 Staveley Services Oil Analysis Results--Wear Metals

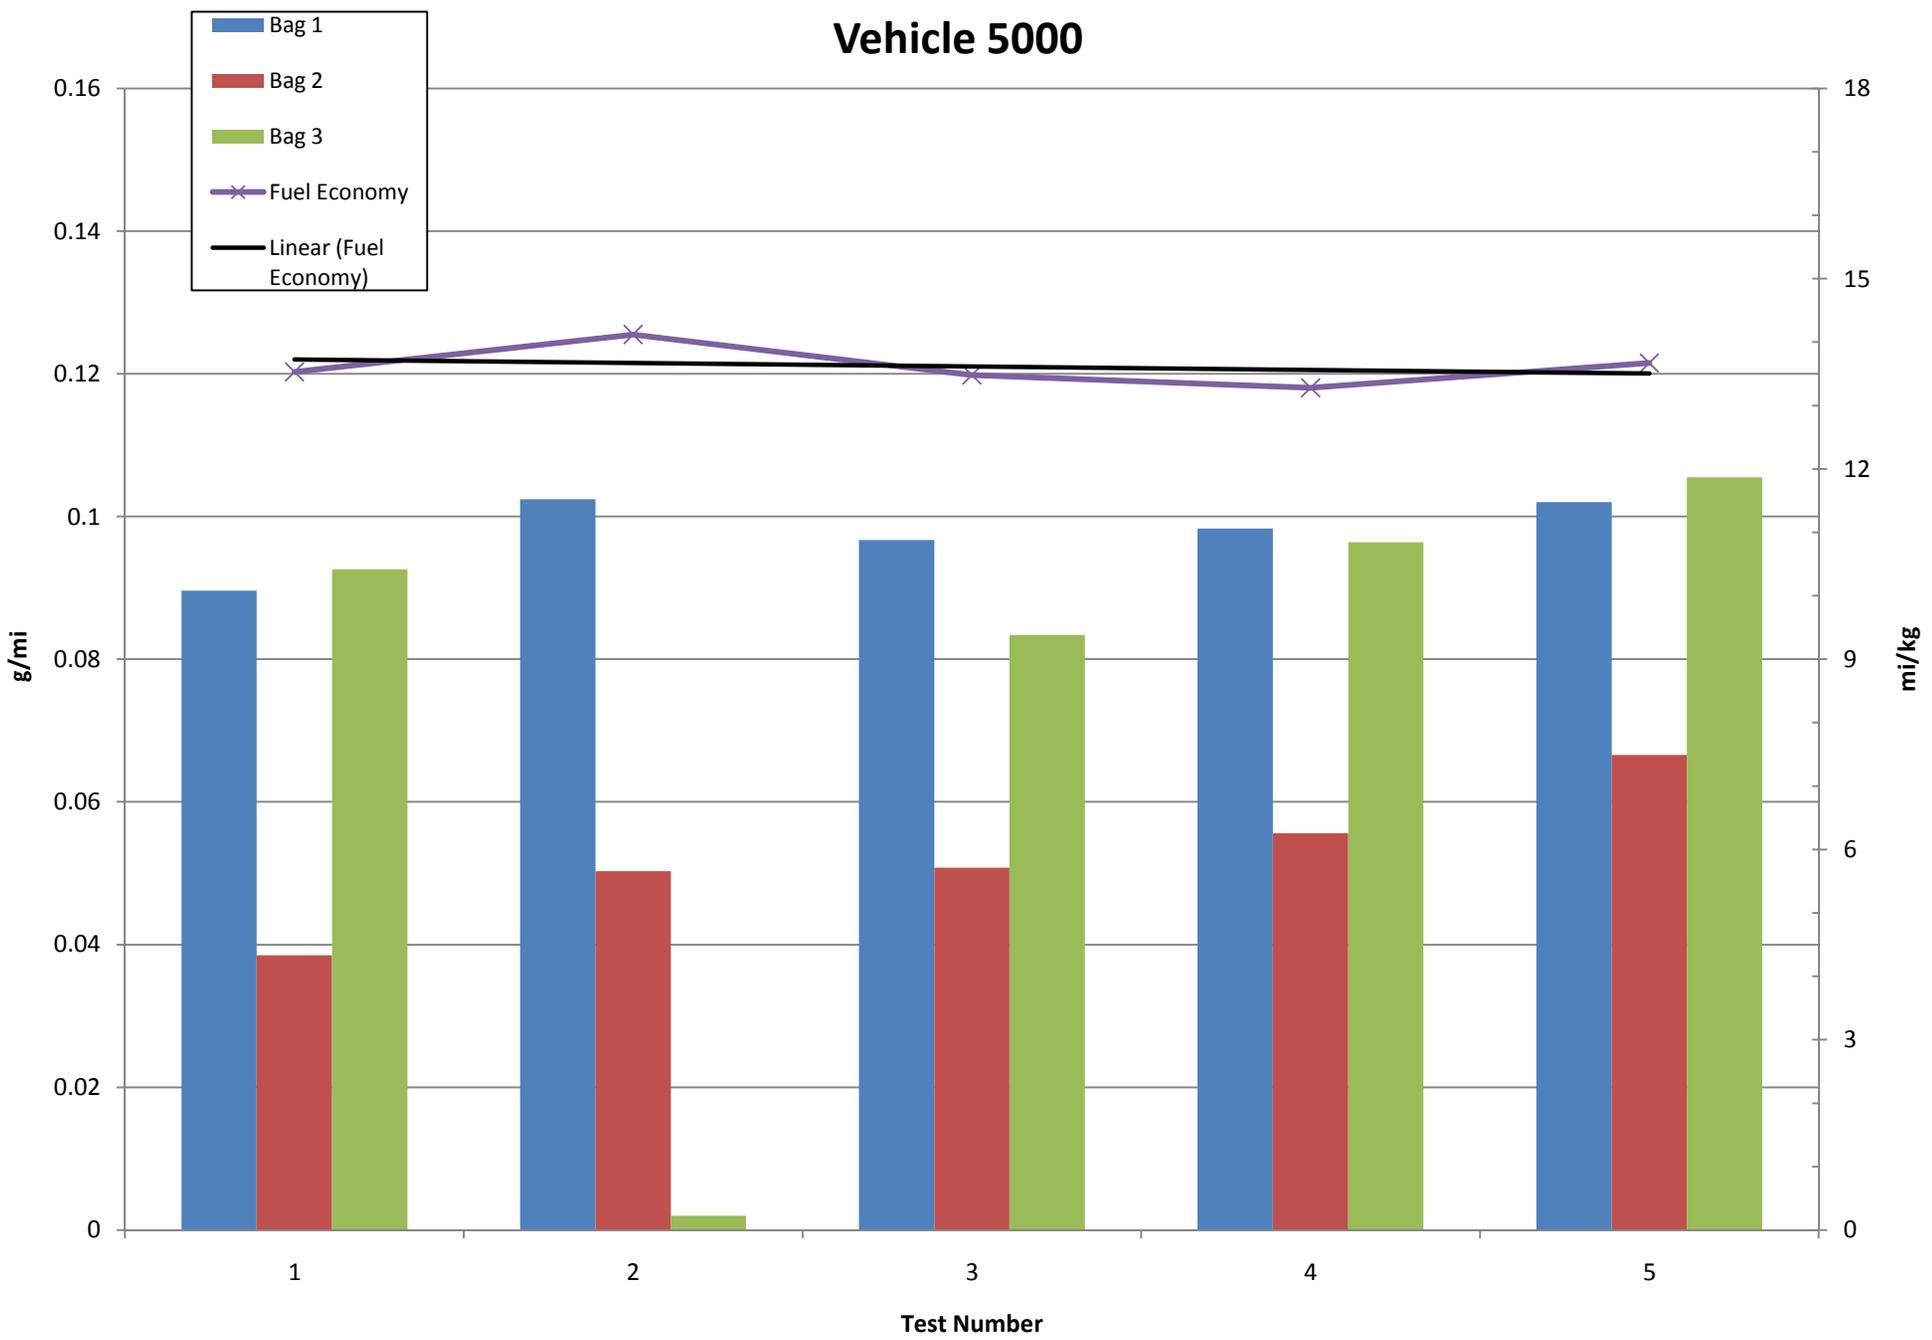
EPA75 Cold Start NOx Vehicle 5000
