Findings of Hydrogen Internal Combustion Engine Durability

Final Technical/Scientific Report

DE-FC26-06NT43027

Electric Transportation Engineering Corporation
430 S. 2nd Ave
Phoenix, AZ 85003

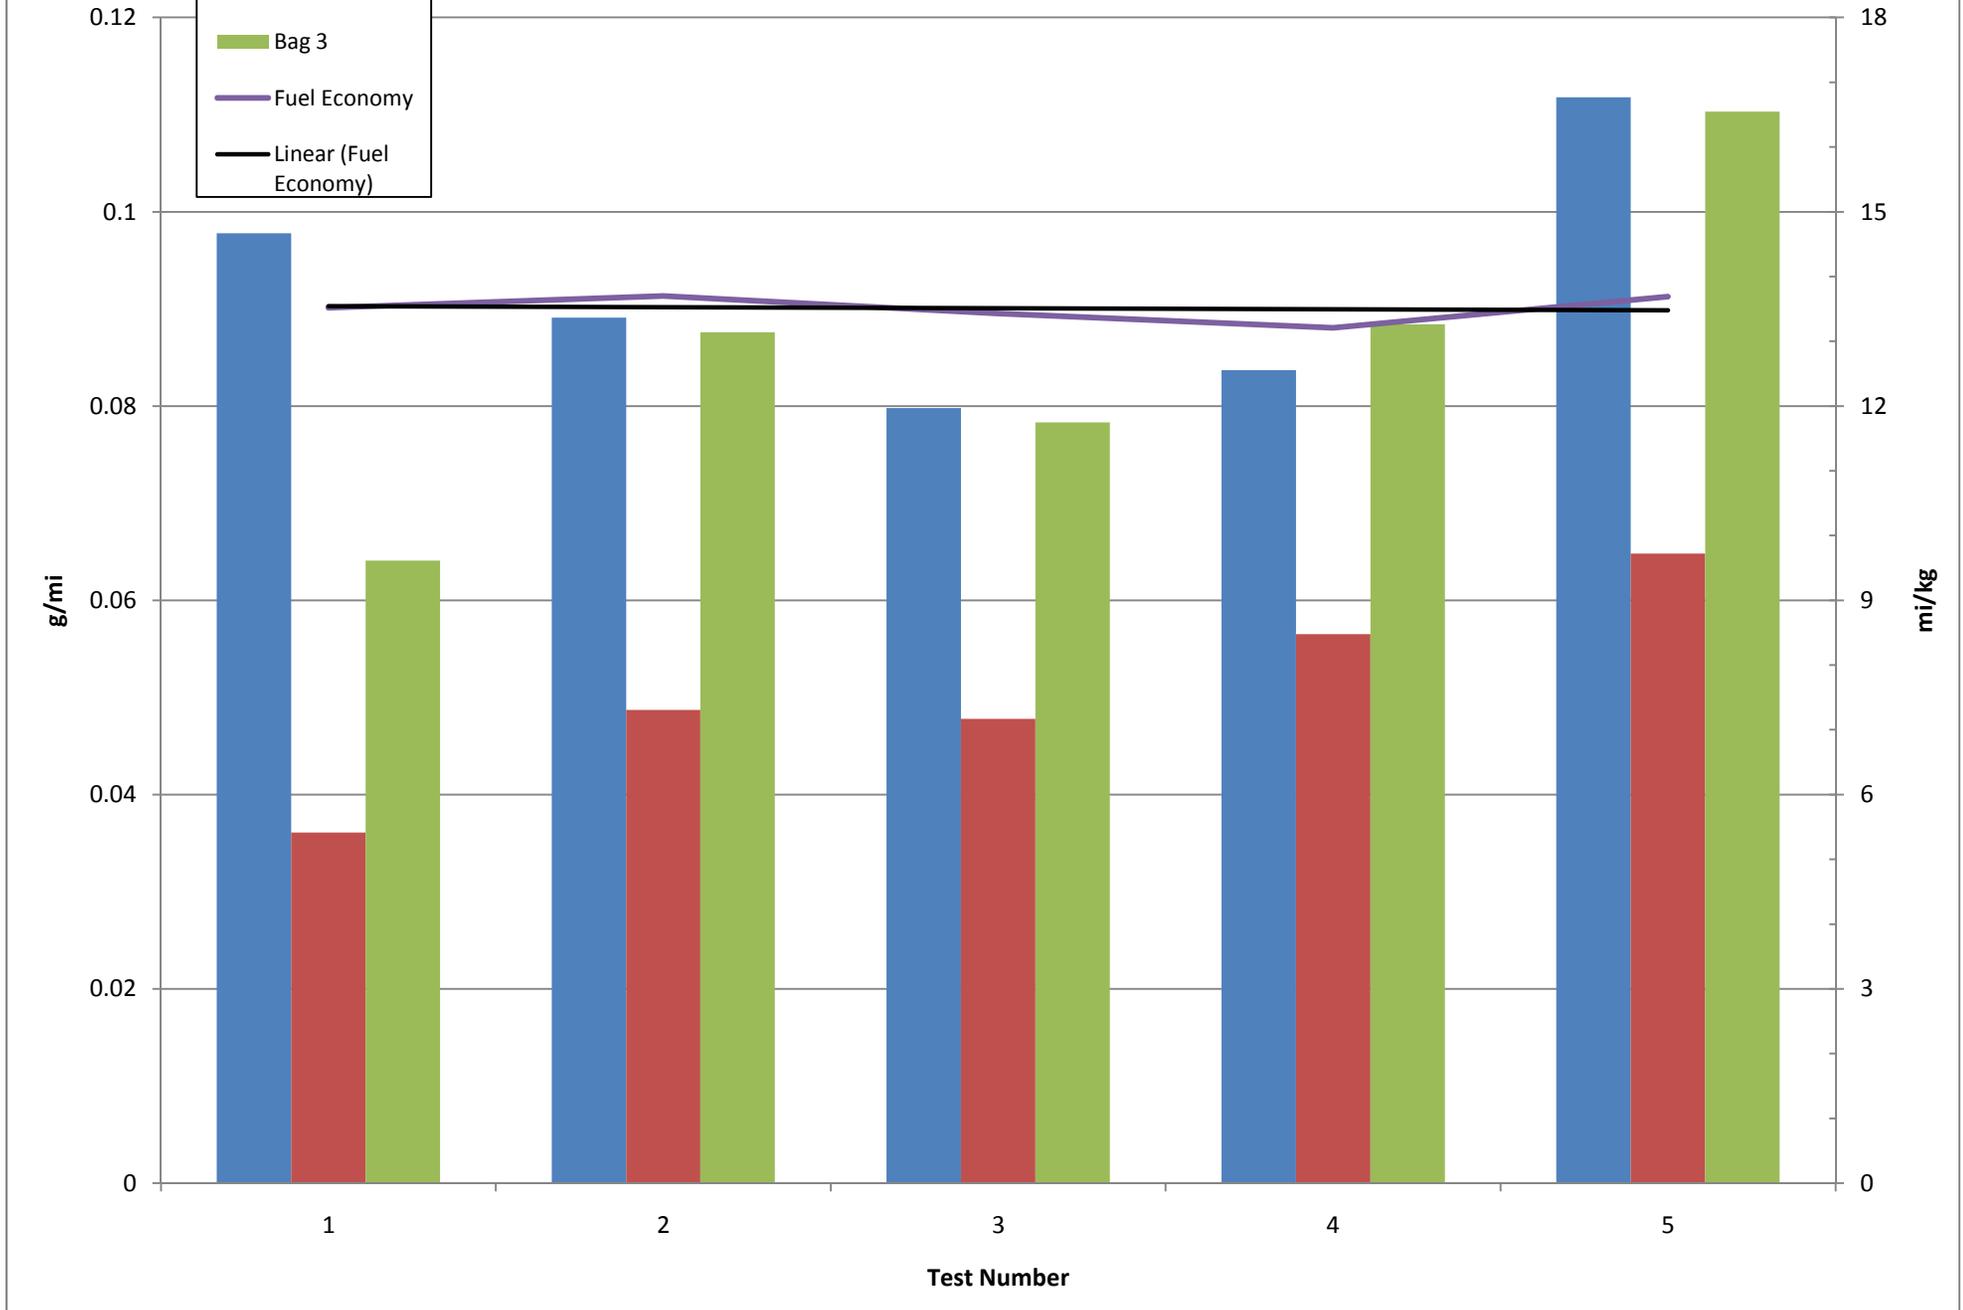
EPA75 2nd Cold Start NOx Vehicle 5000

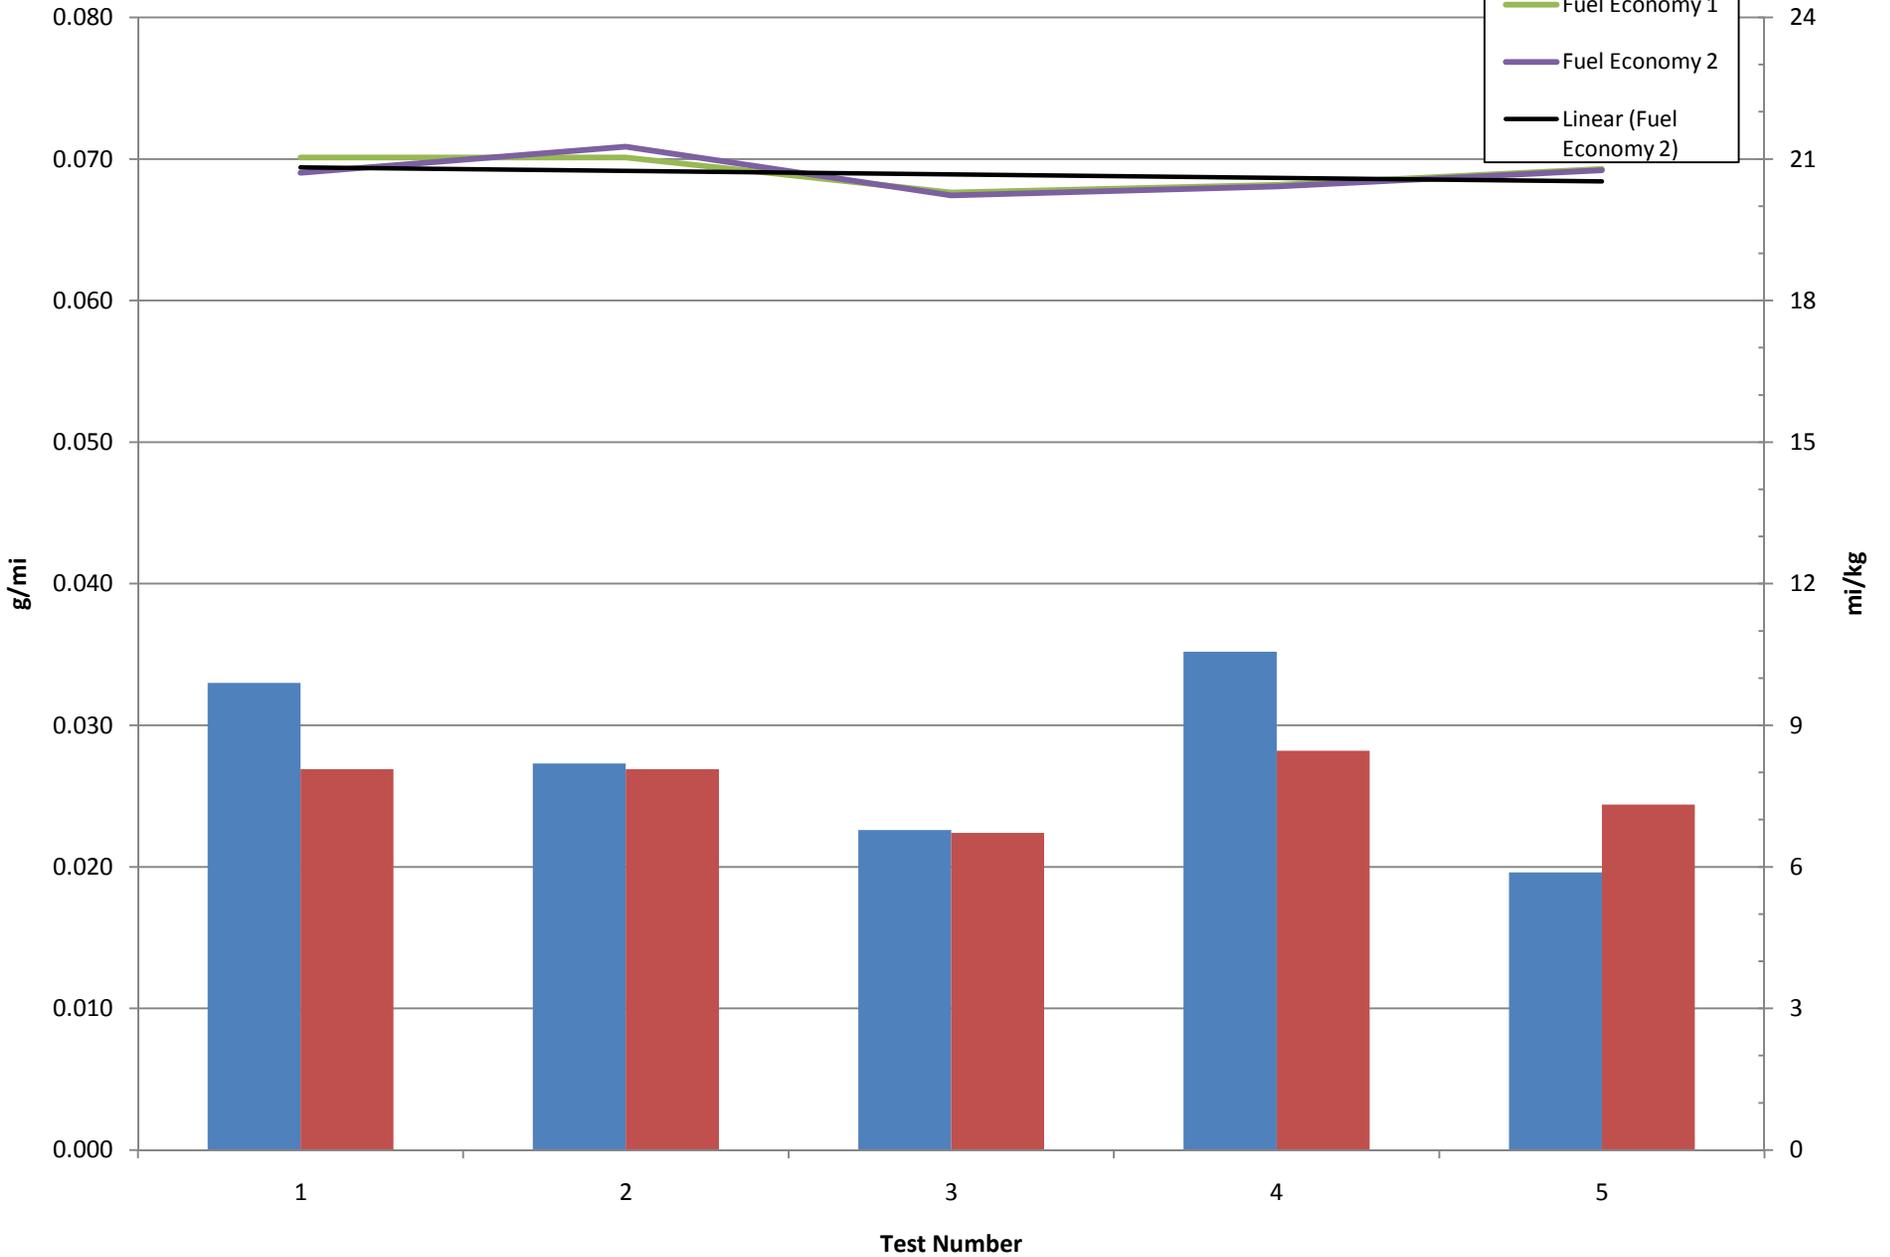
HWYFET NOx Vehicle 5000

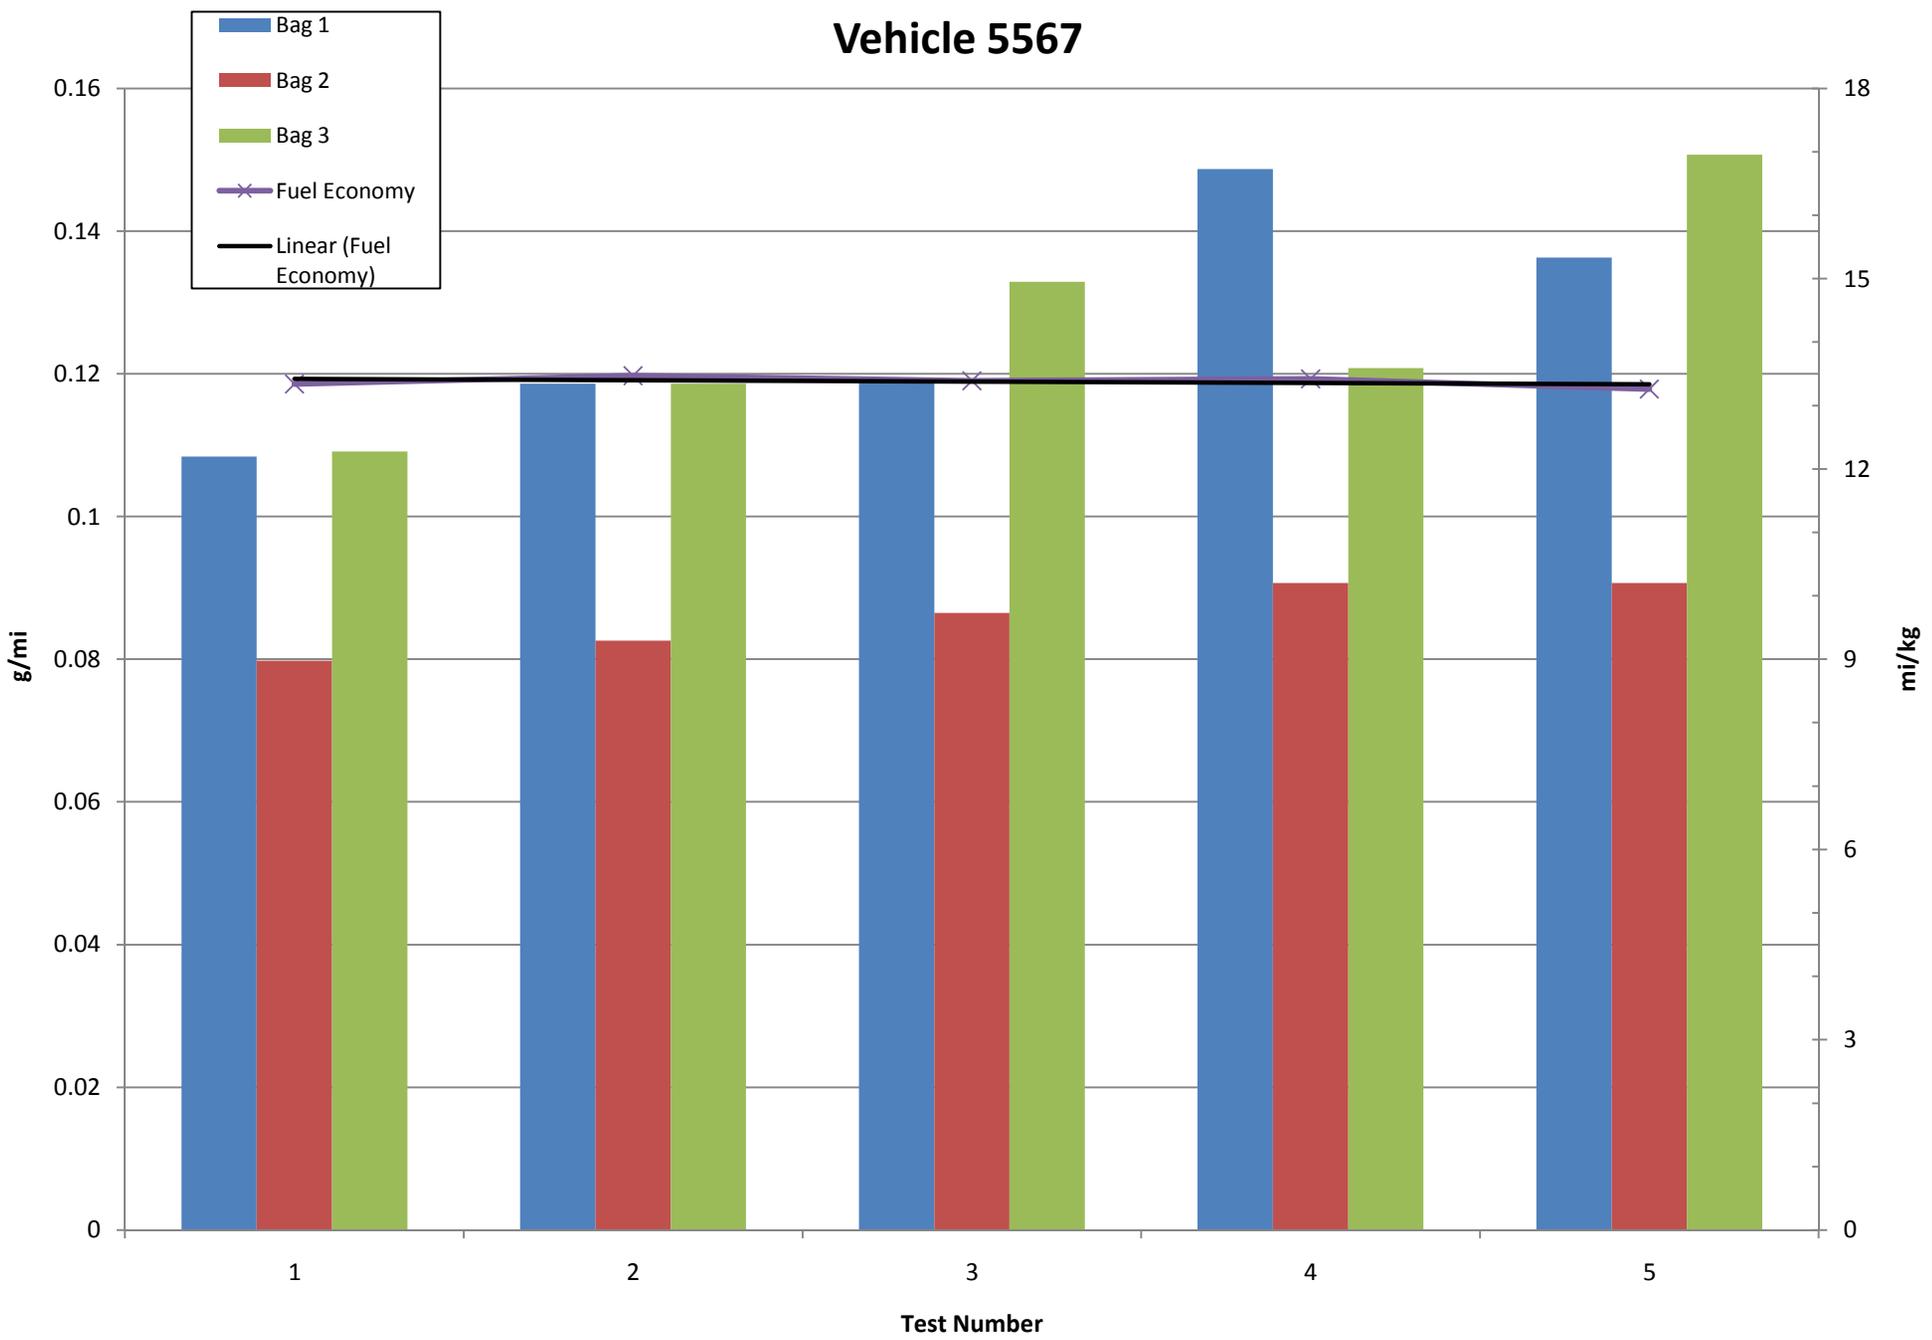
EPA75 Cold Start NOx Vehicle 5567

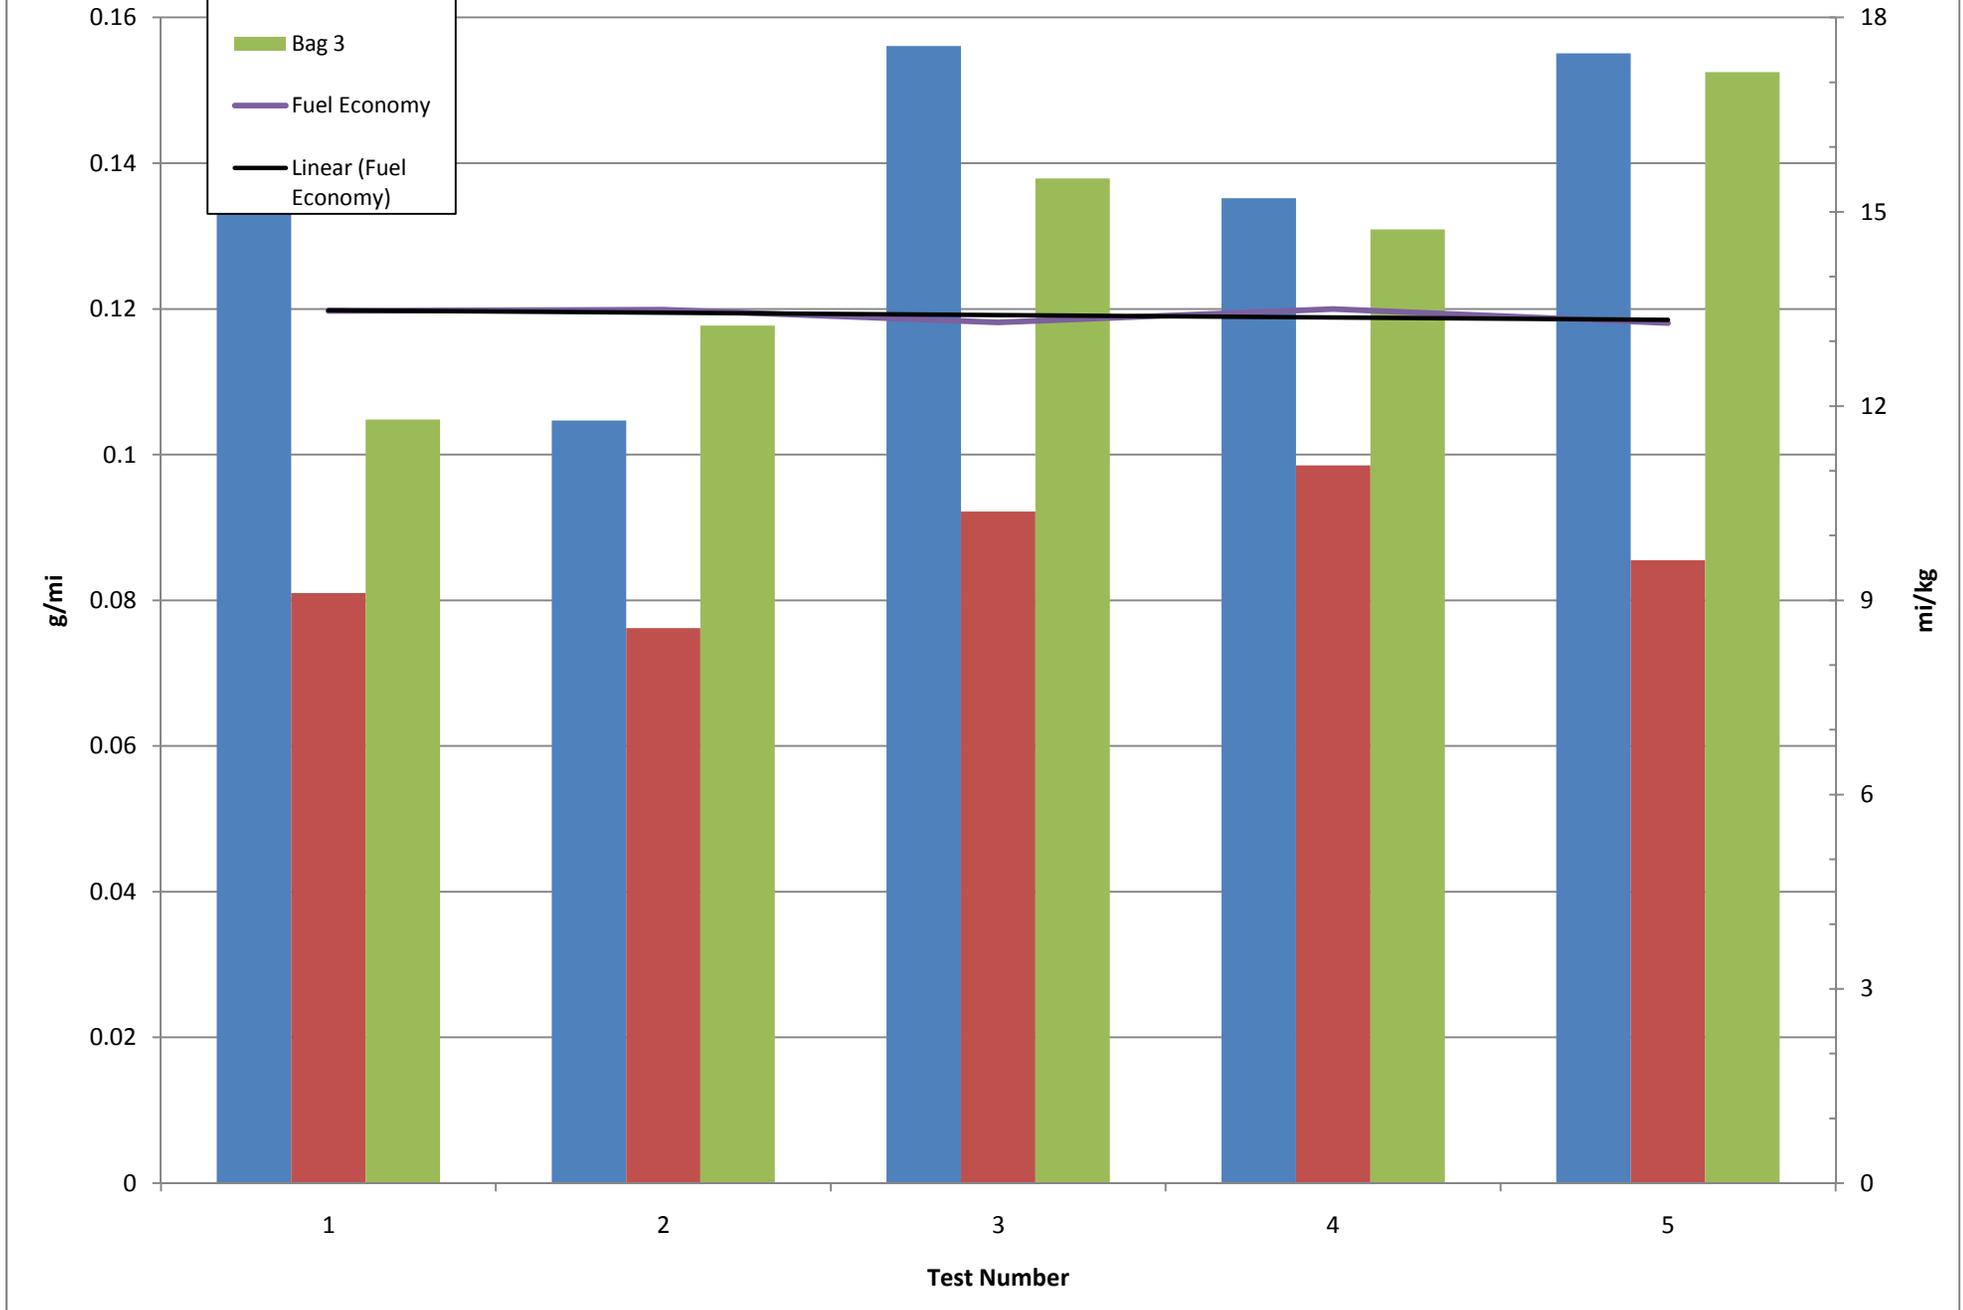
EPA75 2nd Cold Start NOx Vehicle 5567

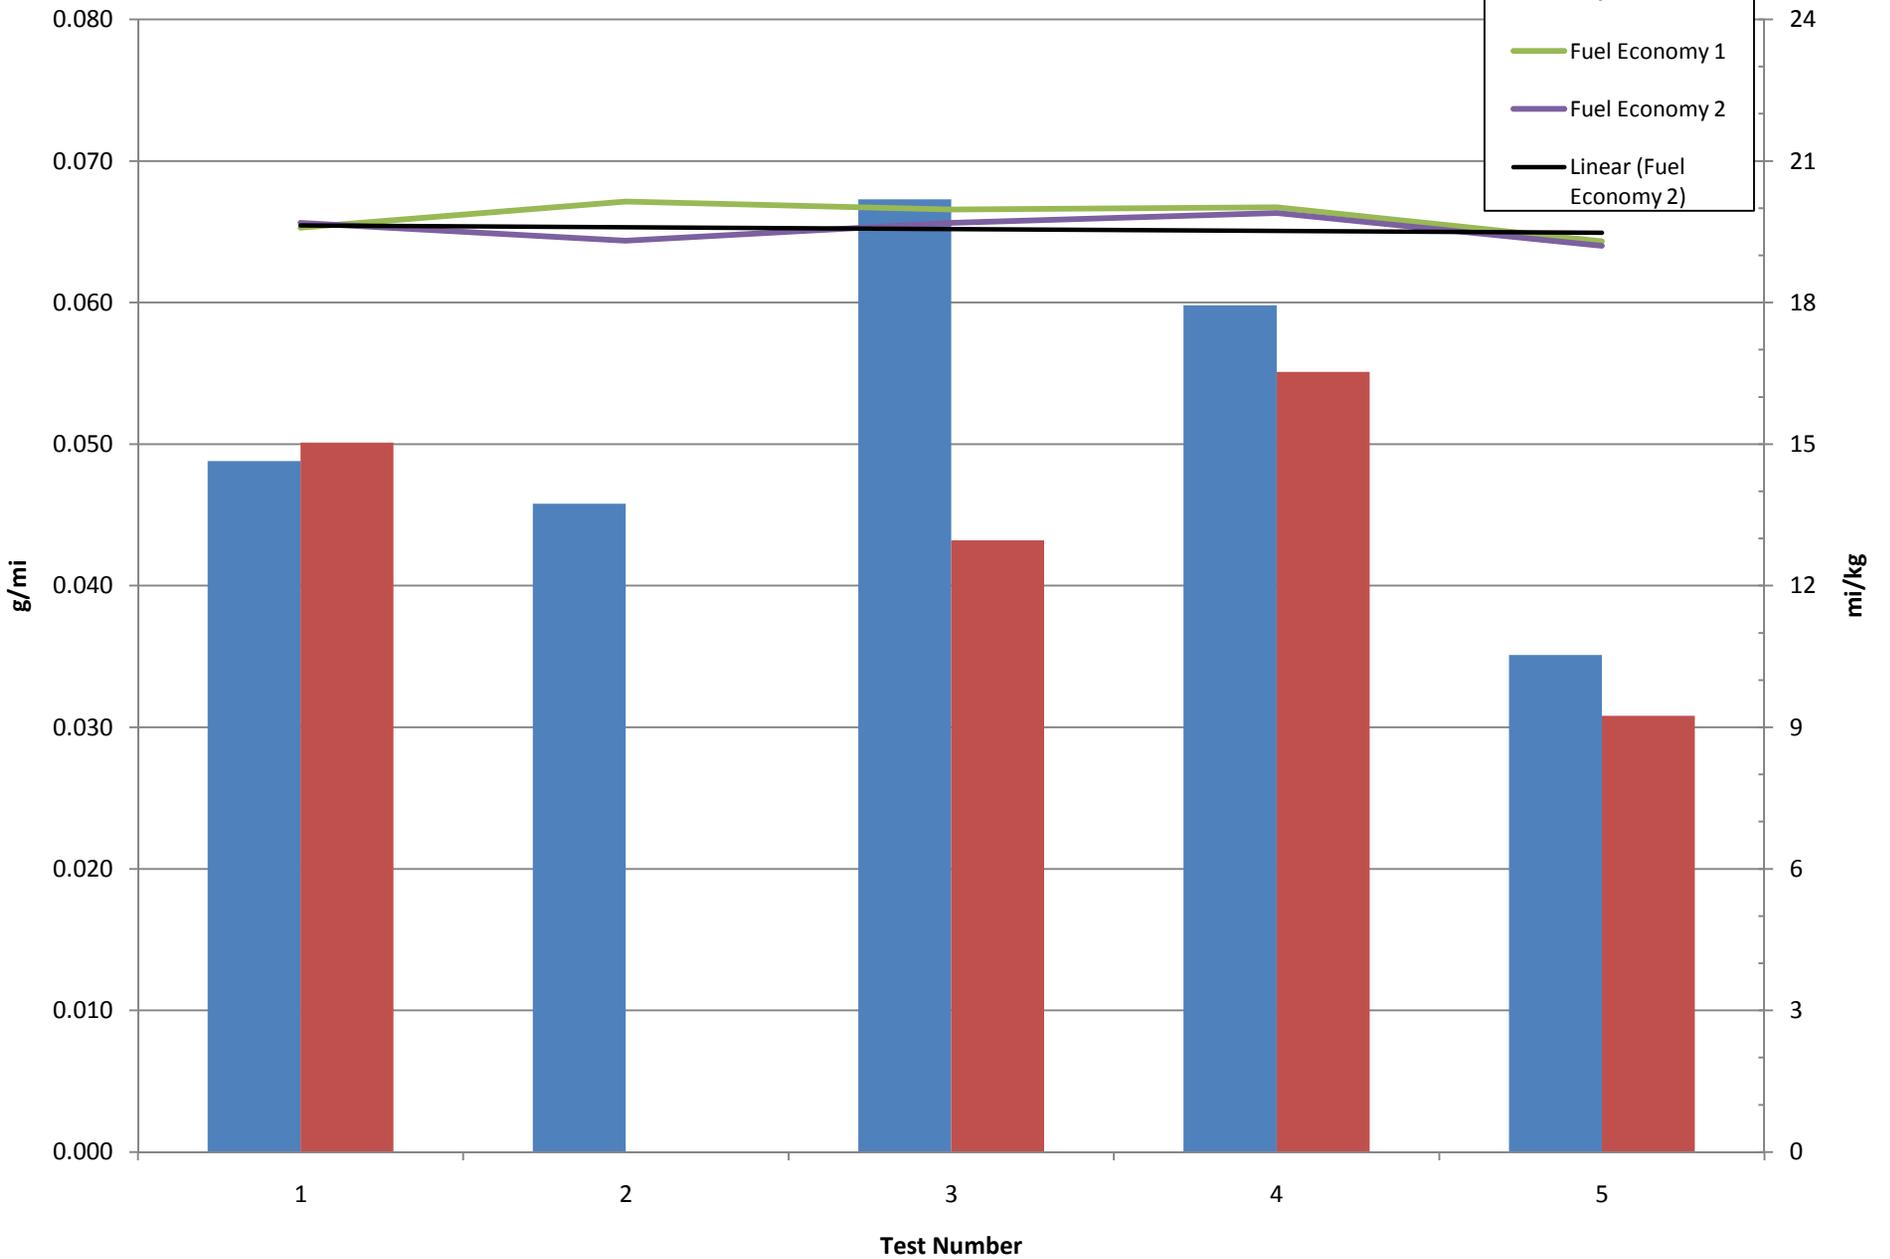
HWYFET NOx Vehicle 5567

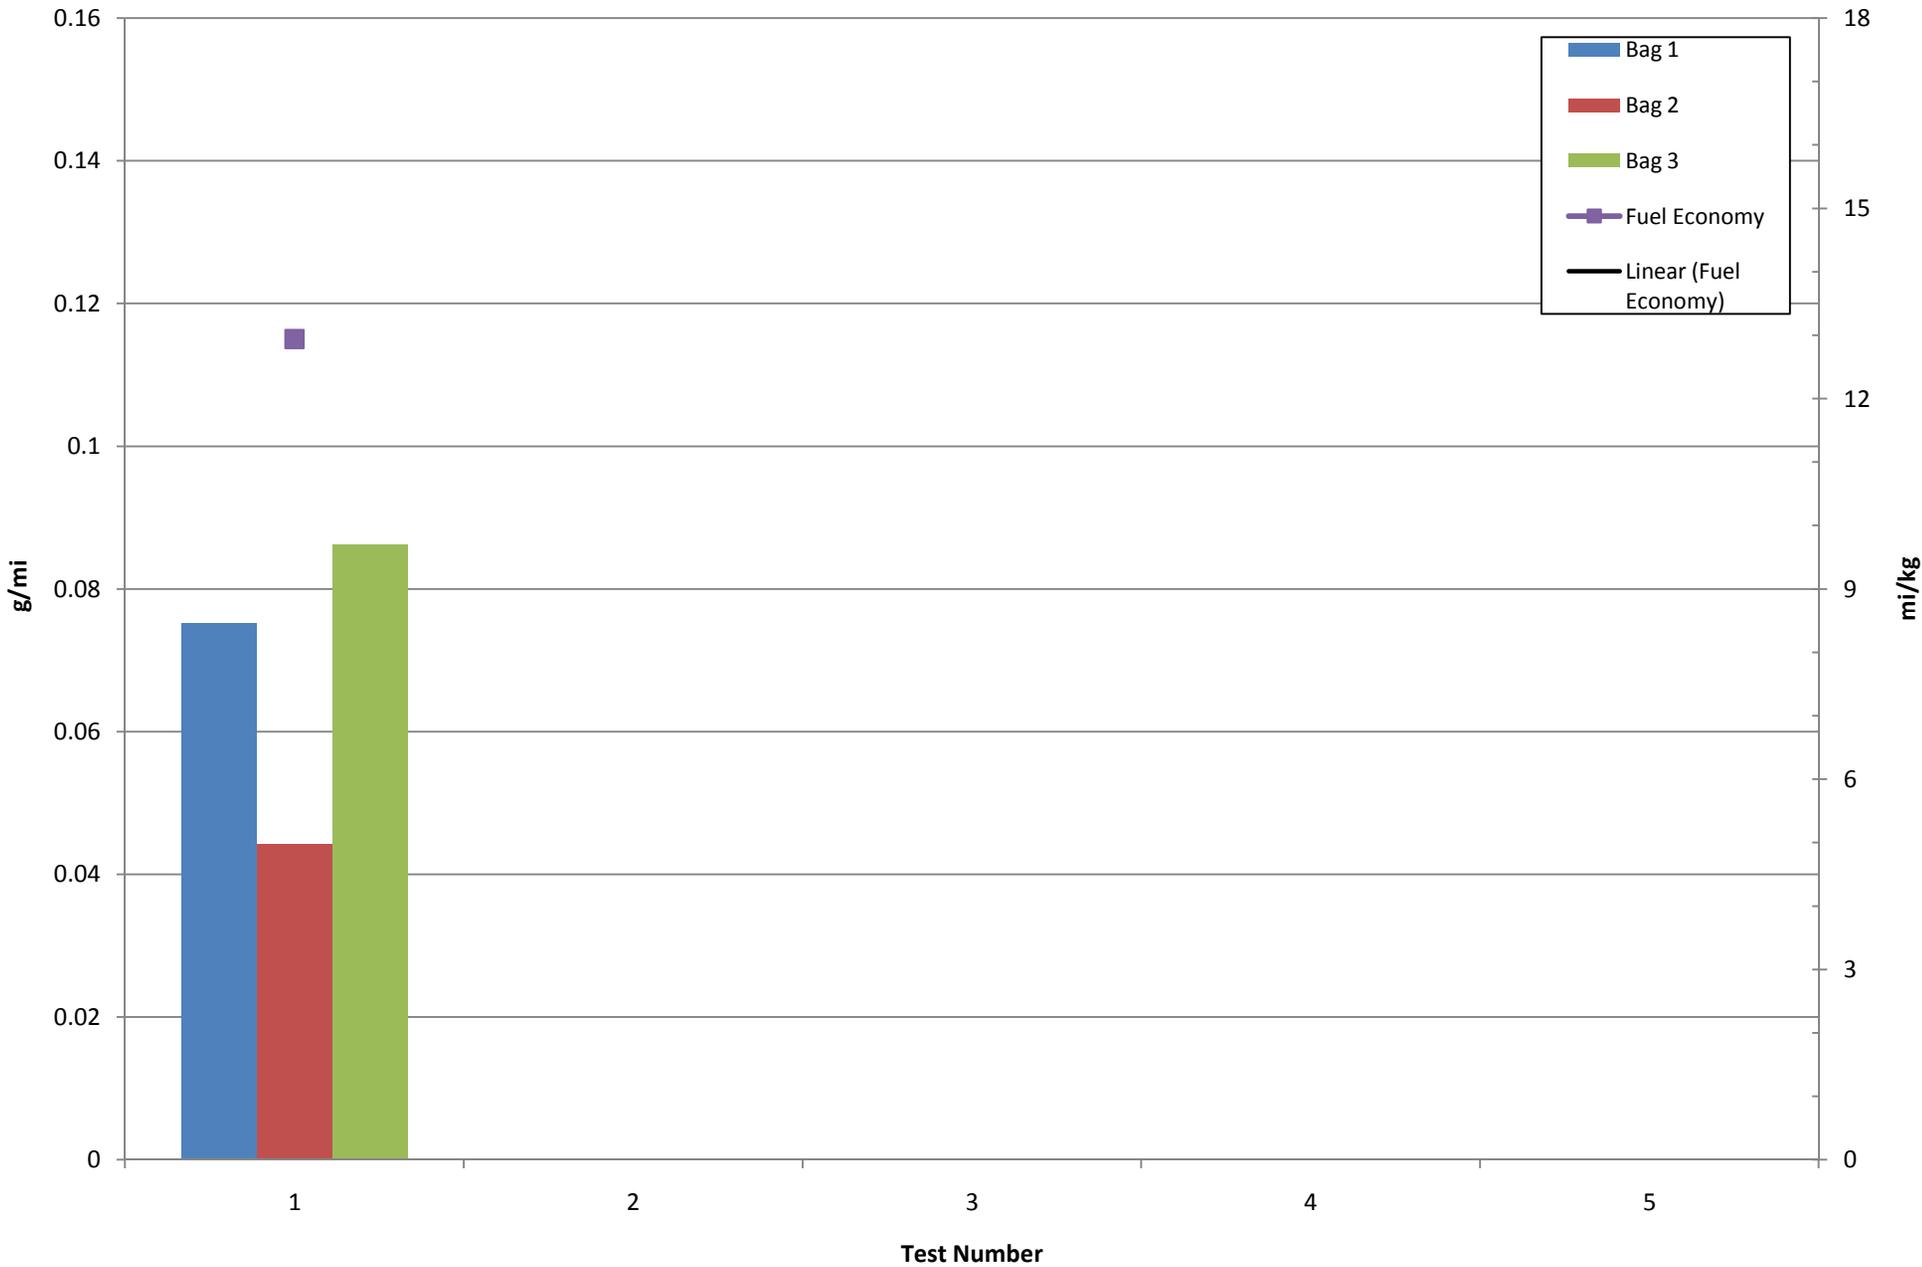
EPA75 Cold Start NOx Vehicle 5567

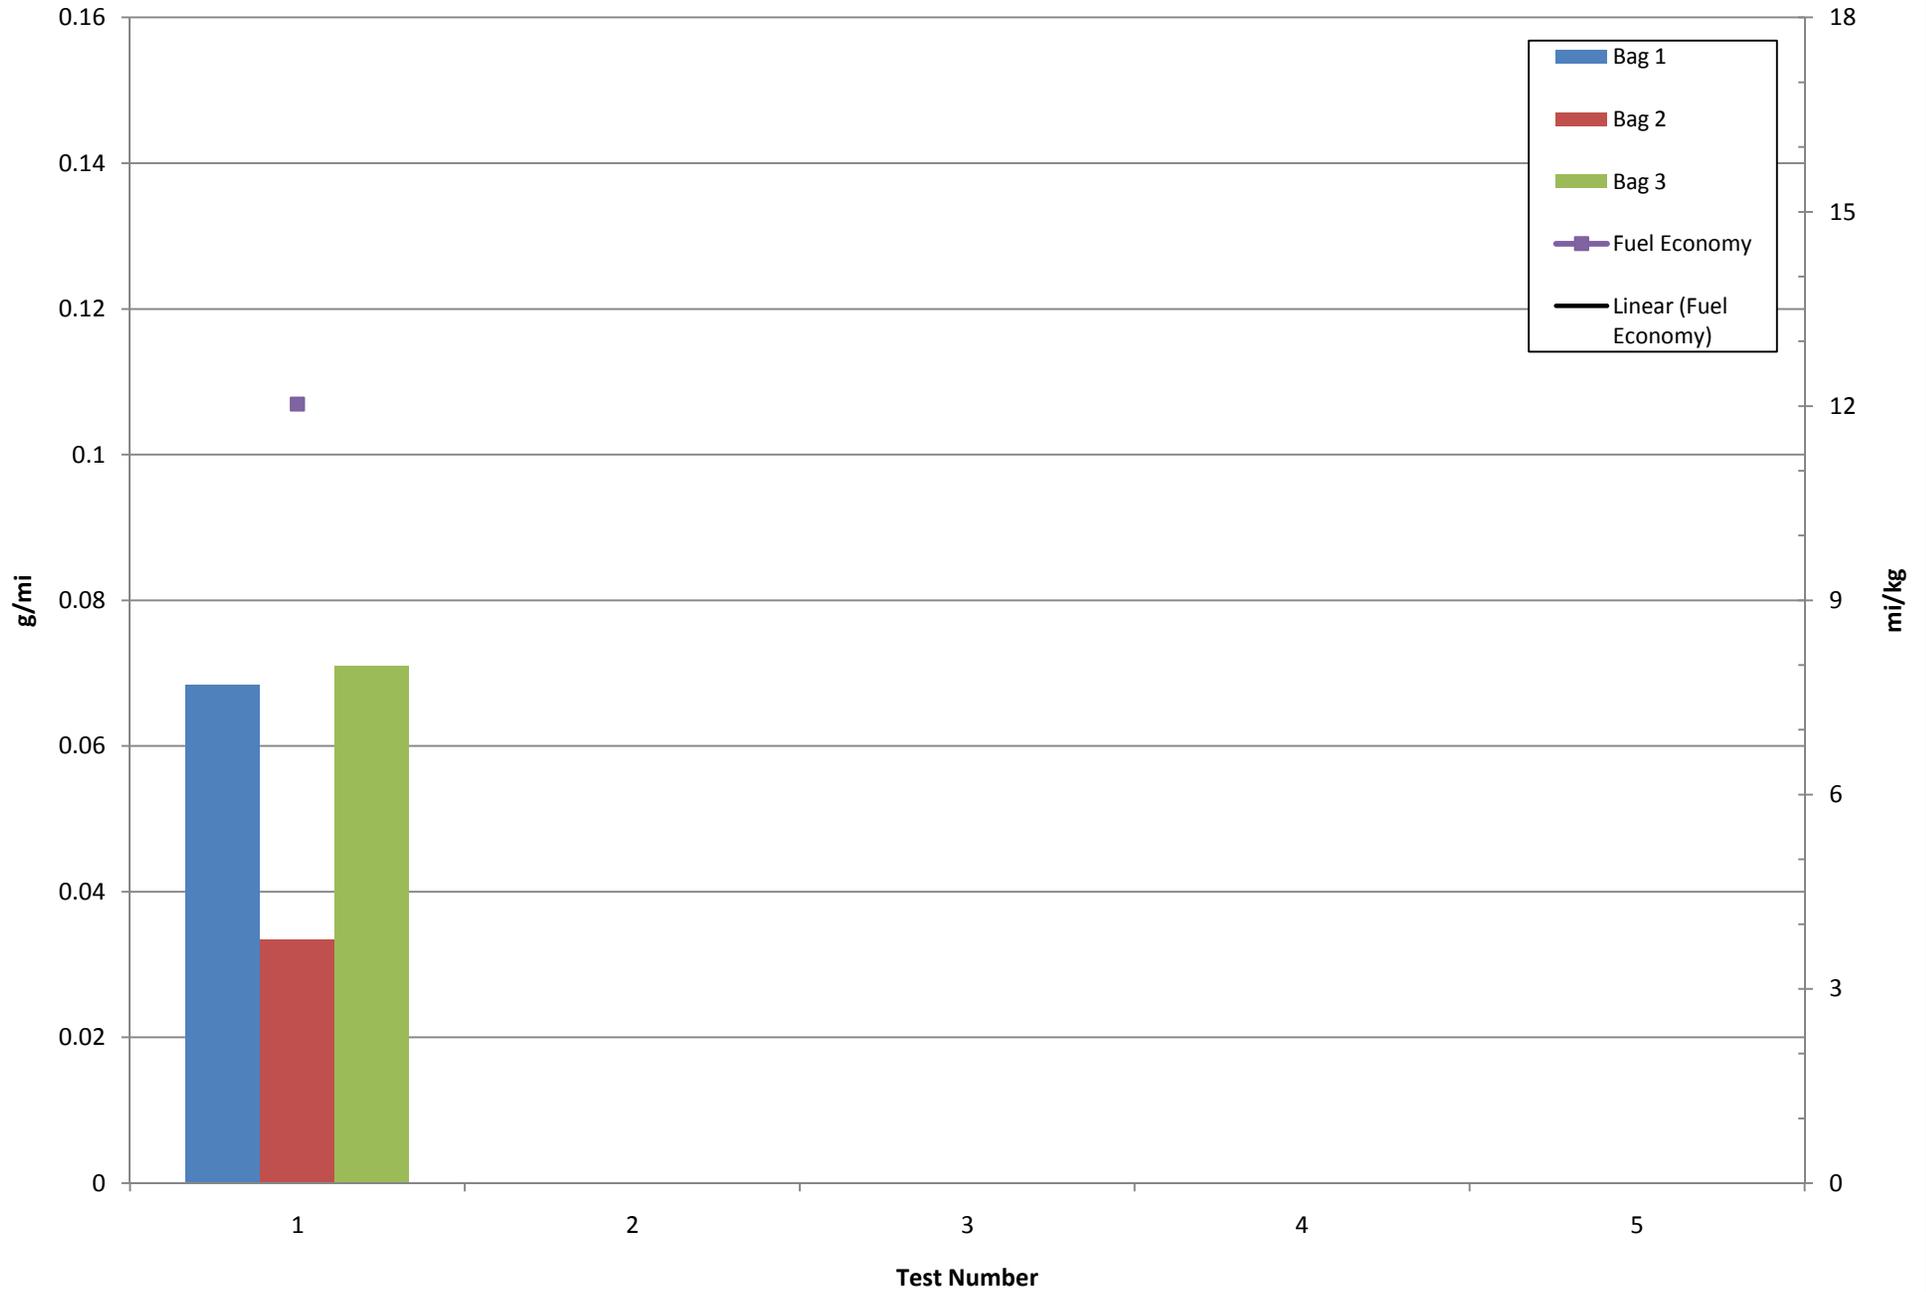
EPA75 2nd Cold Start NOx Vehicle 5567

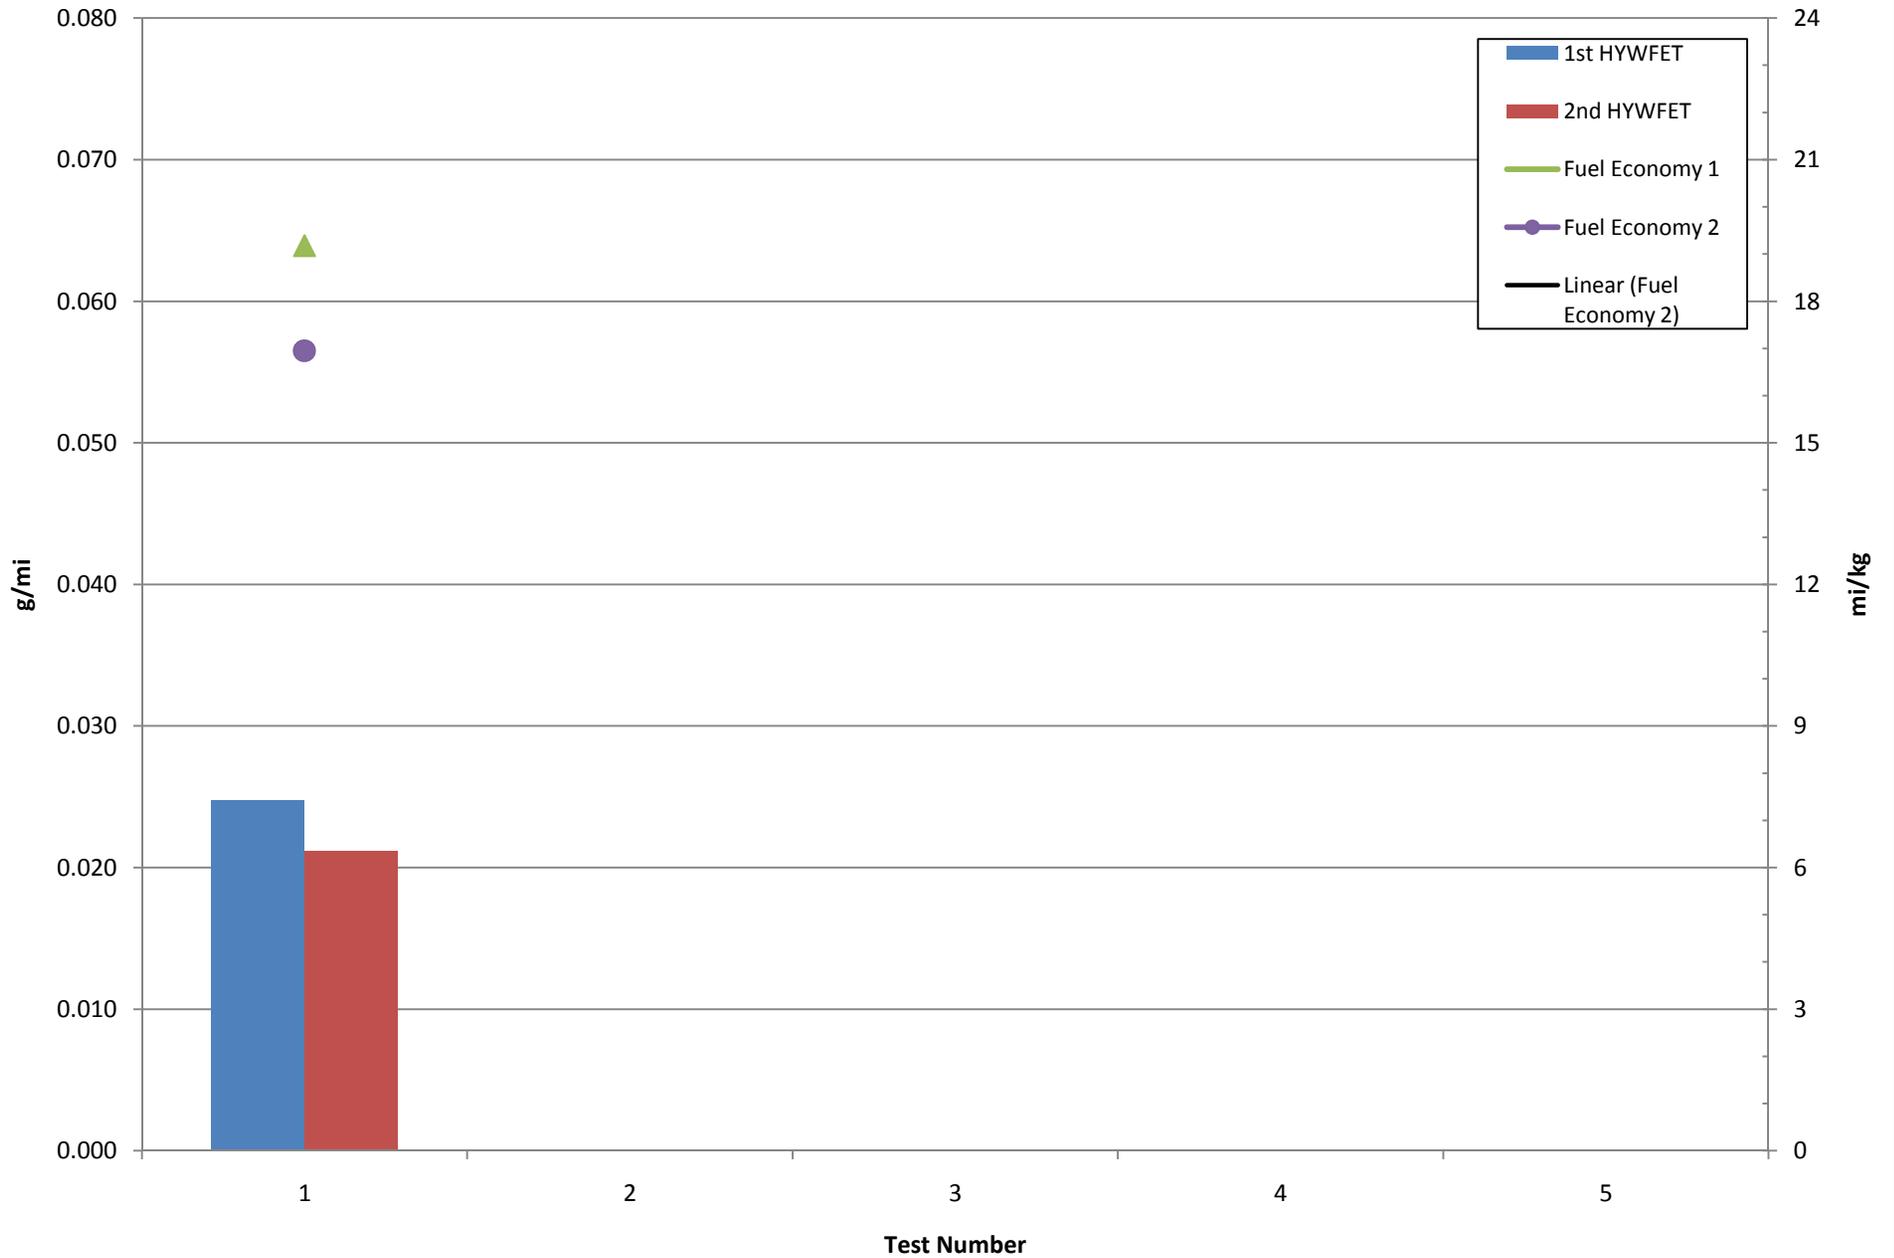
HWYFET NOx Vehicle 5567
