CORROSION EFFECTS OF CALCIUM CHLORIDE INJECTION FOR MERCURY CONTROL ON THE POLLUTION CONTROL EQUIPMENT

Topical Report

Western Research Institute

U.S. Department of Energy

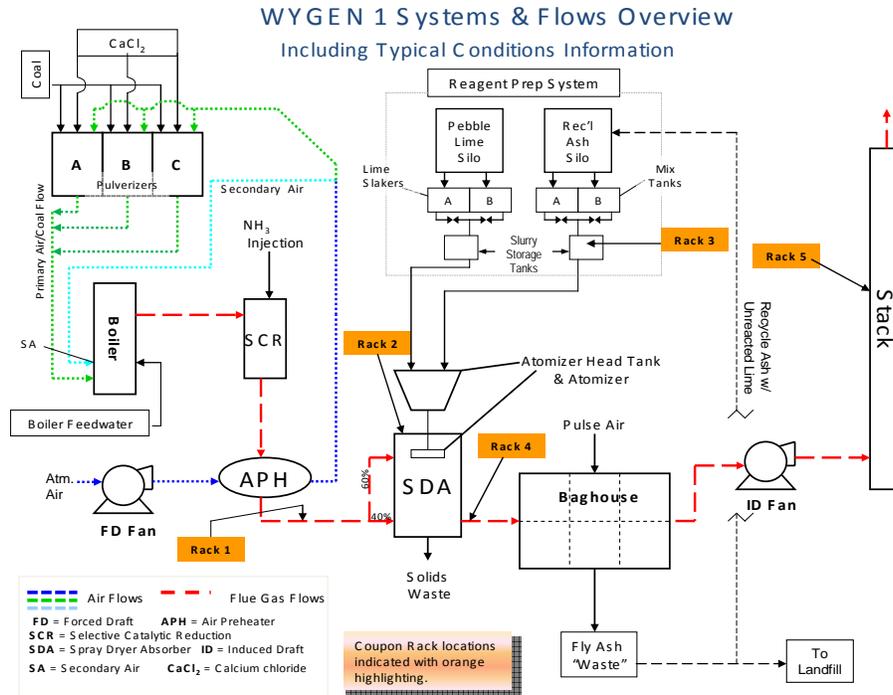
Chlorides are added to the coal by injecting aqueous calcium chloride solution onto the pre-pulverized coal as it enters each of the pulverizers (Figure 1). The CaCl₂ is mixed evenly with the coal via the pulverization process and carried with primary combustion air to the boiler's firebox burners. Mercury, found naturally in the coal, reacts with the abundance of chloride in the flue gas and is captured by the existing flue gas cleaning equipment (Pan *et al.*, 2003). This increase in chloride concentrations in the flue gas may possibly affect the corrosion rates within the plant, but may also affect the performance of the air pollution control equipment.

Corrosion coupons were placed in strategic locations during periods with and without CaCl_2 injection in the back-pass section of the plant downstream of the air preheater (Figure 1). Corrosion coupon racks were specifically designed for each location to accommodate installations into various types of ports and conditions. Six locations were originally planned. The baghouse outlet head space could not be safely accessed to install a coupon rack. The locations in which corrosion racks were successfully placed include:

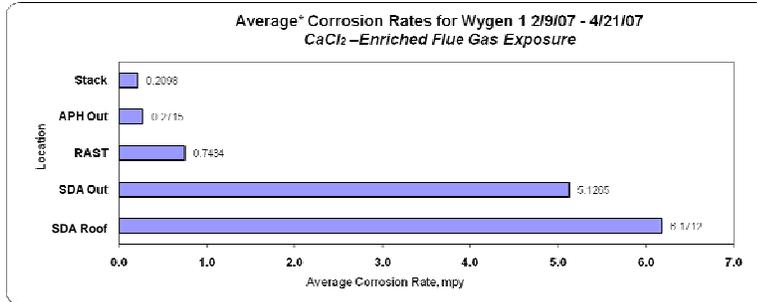
Figure 2. BHP Wygen 1 Corrosion Coupon Results From CaCl₂ Addition Period

The coupon racks' removal and their subsequent disassemblies were accomplished without any unintended damage to the corrosion coupons. The standardized corrosion coupons results from MSI showed the greatest corrosion loss in the regions of the SDA Roof and SDA OUT – averaging 6.17 and 5.13 mils per year (mpy) respectively. The terminal coupon on the SDA Roof assembly showed a loss rate of over 1 mpy greater than the other two standard coupons on the same assembly, while the three SDA OUT coupons' loss rates were fairly even between the three coupons in that set (see Figure 2). The other three coupon assembly locations showed less than 1 mpy average losses.

Fig. 1: Corrosion Rates from CaCl₂ period of Wygen 1 corrosion study, 2/9/07 - 4/21/07

Despite the likelihood of high chloride concentrations in the recycle ash slurry during periods of CaCl_2 injection, the coupons removed from the RAST showed an average of only 0.7434 mpy (see Figure 2). Because of the vigorous turbulence and velocity in this environment, it is unclear just how much material loss was due to erosive effects from the entrained fly ash as opposed to actual corrosion caused by immersion in the slurry. Although the high velocities and turbulence may cause erosive losses, they may actually help protect against corrosion, especially pitting attack, despite the likelihood of elevated chloride levels (Fontana, 1986). In either case, the coupons appeared to be protected, at least in part, by a heavy layer of fly ash deposits that encased each coupon. This heavy layer of material was also noticed on the walls of the recycle ash slurry tanks as they were being drained during a planned outage, which may offer the same protection against corrosion.

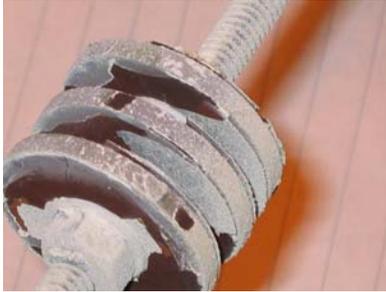
The SDA Roof coupons' material accumulation over their surfaces was thin and generally even with no directional patterns evident. The material coating appeared to be lifted from the metal face of the coupon. (see Picture 1). After they were cleaned, raised edges could be seen in the center of the coupons on both sides where the 0.625" Teflon spacer covered the metal surface, thus protecting it from corrosion (see Pictures 2&3). There were no other notable features present on these coupons.

Picture 1: SDA Roof coupons after removal from CaCl₂-enriched Flue Gas Exposure

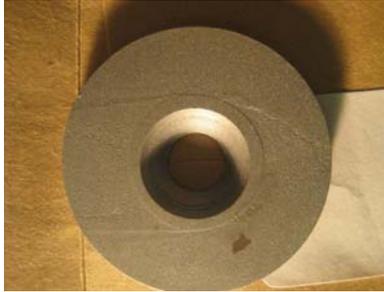
Picture 2: Cleaned coupon from SDA-OUT after exposure to CaCl₂-enriched flue gas. Notice the bullet-shaped pattern across the face. "Bullet" points downstream of flow. Dark spot is a stain on the metal surface – cause yet unknown.

The SDA OUT coupons had a similar coating of material on their surfaces as the SDA Roof specimens, but had accumulated a directionally oriented, bullet-shaped build-up of fly ash across the faces and spanning between each coupon. This build-up effectively shielded the area of the coupons covered by it from the corrosive effects of the flue gas and left distinct corrosion patterns noticeable after cleaning by MSI (see Picture 2). There were no other notable features present on these coupons.

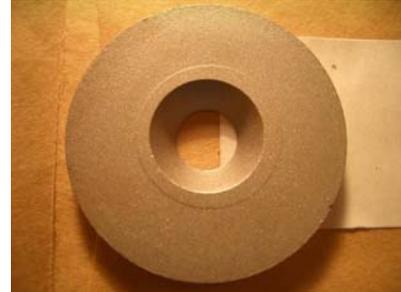
Picture 3: Cleaned coupon from SDA Roof after exposure to CaCl₂-enriched flue gas. Notice the raised area around the center chamfer caused by exposure protection from the 0.25" Teflon spacer.

As mentioned earlier in this report, the 0.625" spacers protected the centers of the coupons from corrosion. A spacer of this diameter was needed due to the 0.5" chamfered center hole. It helped ensure consistent spacing between each coupon. The coupons were selected without realizing that the center hole was chamfered. Since this portion of the surface area was not exposed and the corrosion calculation does not take this into account, the reported corrosion rates are lower than the true corrosion rates. Future corrosion experiments should minimize this covered area and expose as much surface area as possible. Despite this oversight in coupon rack design, the corrosion surveillance still yields valid information as to what areas of the flue system will be prone to elevated corrosion rates during periods of CaCl_2 injection.

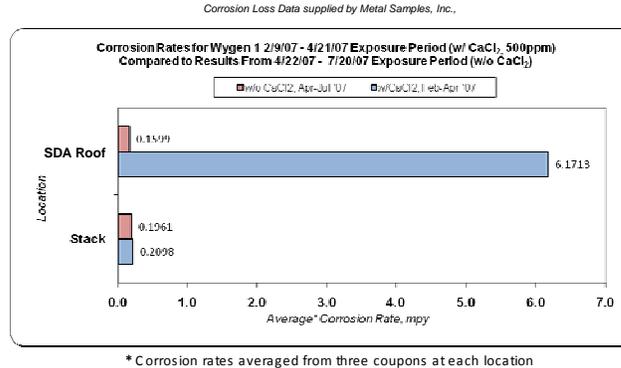
Figure 3 Comparison of Phases 1 & 2 Corrosion Results from BHP's WYGEN 1

The SDA Roof coupons showed a drastic decrease in corrosion loss during this exposure period, yielding a 0.1599mpy loss (see Figure 3). There were no discernable corrosion scars left on the coupons this time.

stay with the fly ash and not the flue gas as the coupons in the stack showed negligible corrosion (~0.2 mpy) during both injection and non-injection periods (see Figure 3).

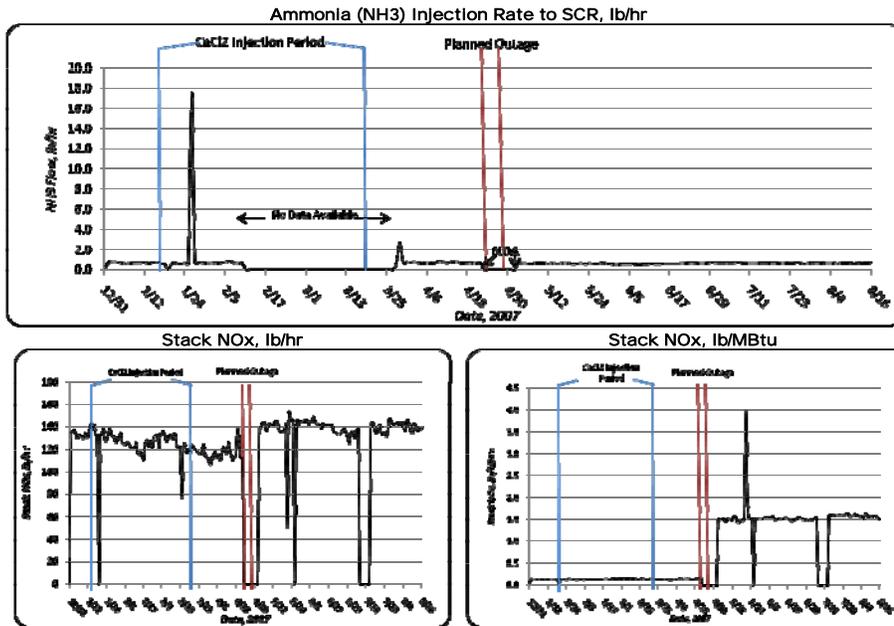
Figure 4. Black Hills Power (Wygen 1) NO_x Stack Emissions Graphs

The data collected in 2007 for stack NO_x emissions were inconclusive. Data plots for NO_x emissions measured in two different units of rate did not appear to be consistent with each other. Stack NO_x emissions reported in lb/MBtu were steadily lower before a planned April 2007 outage and suddenly increased to a much higher steady level after the outage. The NO_x emissions in pounds per hour also increased after the outage, but not to the same magnitude (see Figure 5). The NO_x-controlling chemical (ammonia) showed essentially no injection during either period, despite a large portion of the data was missing for the CaCl₂ injection period (See Figure 4). No conclusive data or reports have been provided to account for this discrepancy.

Figure 4: Black Hills Power (Wygen 1) NO_x Stack Emissions Graphs :
Comparing Ammonia Injection to Stack NO_x Emissions in Pounds per Hour (lb/hr) & Pounds per Million Btus (lb/MBtu)

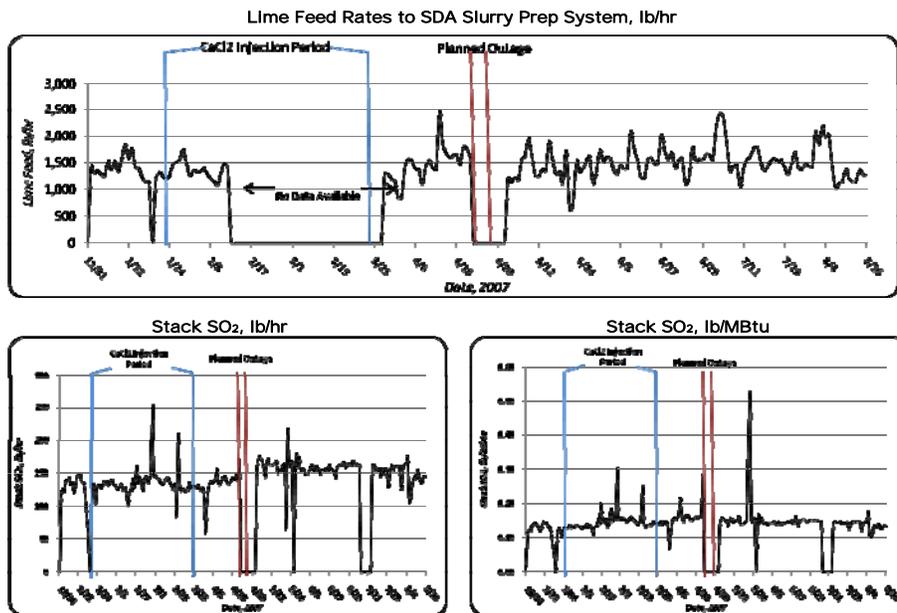
Figure 5. Black Hills Power (Wygen 1) SO₂ Stack Emissions Graph

The 2007 SO₂ emissions at the stack showed little difference in the averages between the two condition periods (see Figure 5). While there was slightly more lime fed on average during the period without CaCl₂ injection, it mirrored the trend in SO₂ (lb/hr) at the stack, which was also higher by approximately the same magnitude. Average sulfur emissions on a lb/MBtu basis were kept the same between the injection and non-injection periods (0.15 lb SO₂/MBtu per period). As with the ammonia injection data, a large portion of lime feed data was missing during the CaCl₂ injection period, which lowers confidence in the results from that period.

Figure 5: Black Hills Power (Wygen 1) SO₂ Stack Emissions Graphs :
 Comparing Lime Feed Rates to Stack Emissions in Pounds per Hour (lb/hr) & Pounds per Million Btus (lb/MBtu)

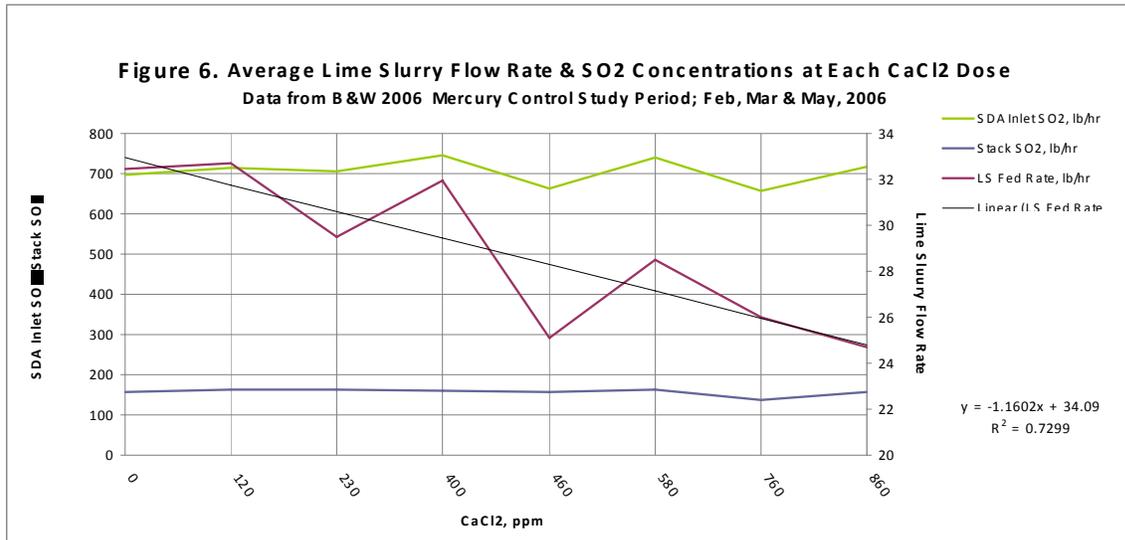
Data were available from the 2006 B&W mercury test period that allowed for an analysis of the effects of CaCl₂ on SO₂ emissions. The data show a fairly strong correlation between CaCl₂ dose and lime slurry usage. SDA inlet SO₂ concentrations averaged a steady trend around 712 lb/hr and the stack saw a steady average of 157 lb/hr (see Figure 6).

Figure 6. Average Lime Slurry Flow Rate and SO₂ Concentrations at Each CaCl₂ Dose

trend patterns and magnitudes of change for the same NO_x emissions between different emission rate units. The only sufficient data for analysis were regarding SO₂ emissions. Lime slurry is the SO₂ controlling reagent and a cost to the power plant. Sufficient lime slurry will be used to maintain the stack SO₂ emissions just under permit limits, according to operational practices. Thus, as the data show, the stack SO₂ emission rate will remain fairly constant. Lime slurry demand becomes the indicator as to how the CaCl₂ performs with the SO₂ emissions. As the data show, lime usage during the 2006 B&W CaCl₂ tended to decrease with increasing CaCl₂ doses (see Figure 6), while it made no significant changes in 2007 (Figure 7).

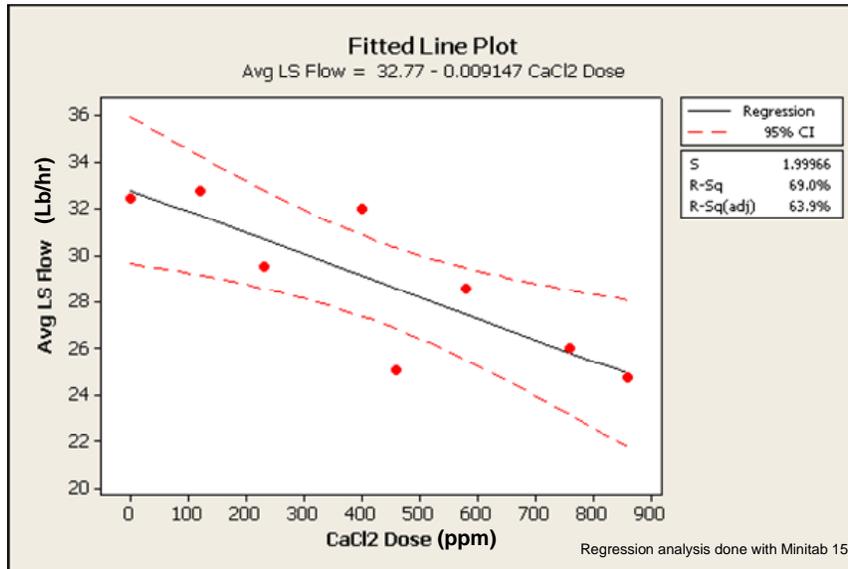
Over this same time period, lime slurry usage tended to decrease as CaCl₂ doses increased. A statistical analysis of the average lime slurry usage during each level of CaCl₂ dosage was performed. The student's t-distribution was used and yielded an α of 0.005. Also, regression analysis gave an R^2 value of 0.7299 (Figure 6&7). This shows that it is highly probable that, given the way in which the data were collected, the CaCl₂ had a beneficial effect on SO₂ reduction. Insufficient data did not allow the same analysis to be performed on NO_x emissions for the 2006 B&W study.

Figure 7. Lime Slurry Regression Analysis During Various CaCl₂ Doses from 2006 Babcock and Wilcox Mercury Control Study
