Environmental impacts of forest road construction on mountainous terrain

Erhan Caliskan

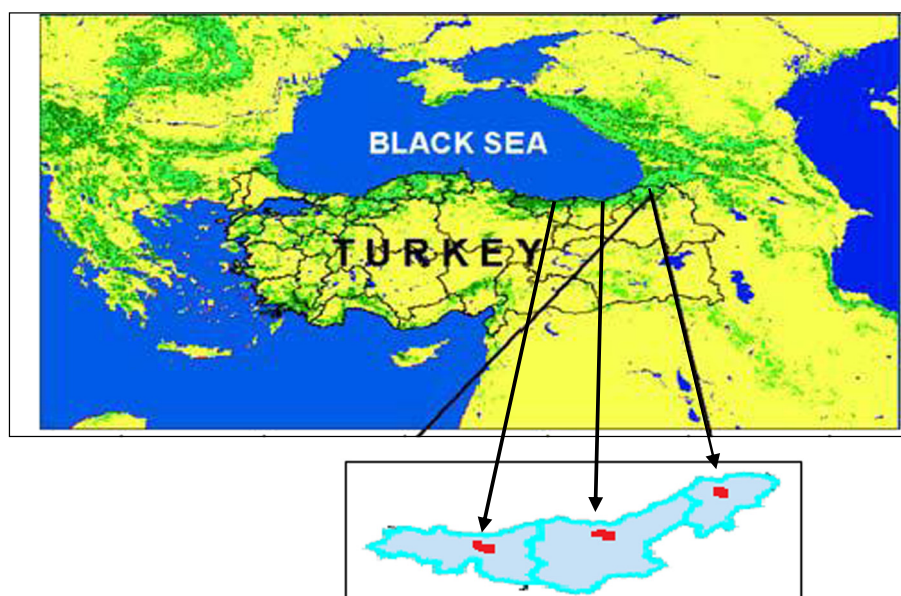
Figure 1 The study area.

Four areas in which forest road construction work is done and which have similar characteristics were within the Giresun, Trabzon and Artvin mountain areas, chosen for the area of study (Figure 1). In the Şalpazarı Forest Enterprise area (Trabzon), commercial tree species include *Picea orientalis*. The elevation ranges from 700 to 800 meters with ground slopes of 30 to 50%. Total length of the sample road examined in this study was about 1,550 meters with an average road width of 4 meters. In the Düzköy Forest Enterprise area (Trabzon), commercial tree species include *Fagus orientalis* and

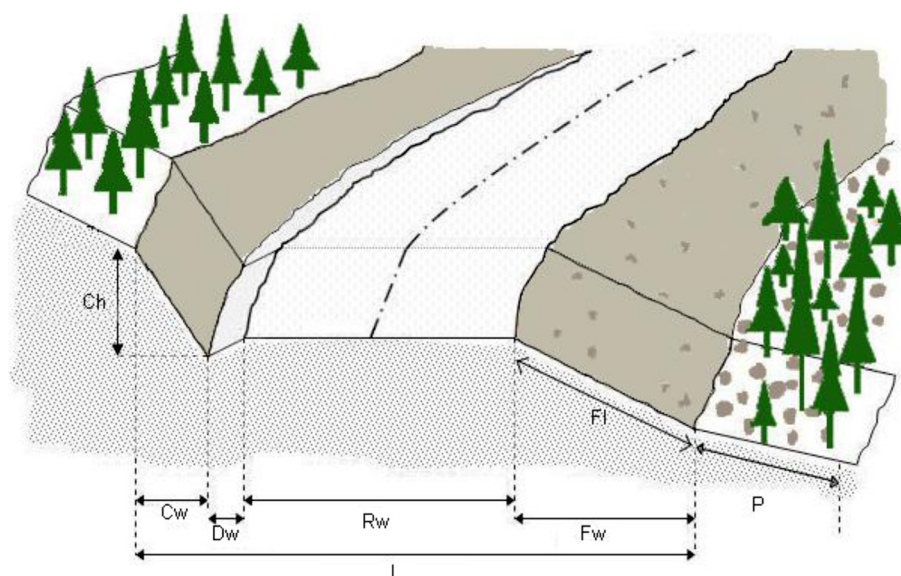
Figure 2 The decision variables measured from each cross section along the sample road.

The entire construction process in the areas of the study was observed in the field, and data was collected during and after construction. To characterize road sections, nine decision variables were measured from each cross section. These variables include cut-slope height (Ch), cut-slope width (Cw), ditch width (Dw), road width (Rw), fill-slope width (Fw), fill-slope length (Fl), road construction zone width (L), effect distance length (P),

and ground slope (S) (Figure 2). Surveying instruments such as clinometers, steel tape, laser range-finders, miras, poles and altimeters were used in the field studies.

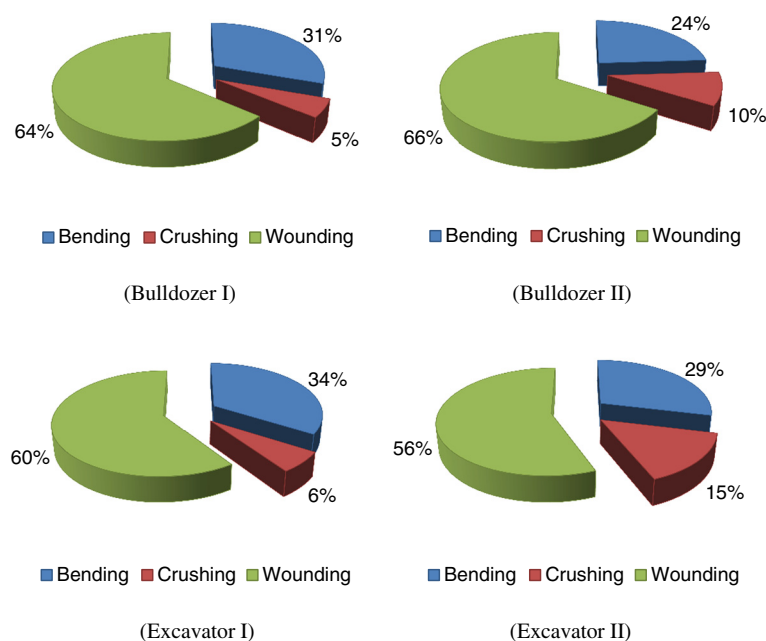
Figure 3 The percent of damage as bending, crushing and wounding.

The percent of damage in terms of wounding, bending and crushing of trees are 64%, 31% and 5% repectively (for BulldozerI), 66%, 24% and 10% repectively (for BulldozerII), 60%, 34% and 6% repectively (for ExcavatorI) and 56%, 29% and 15% repectively (for Excavator II). The percent of damage in terms of wounding, bending and crushing is shown in Figure 3. The number

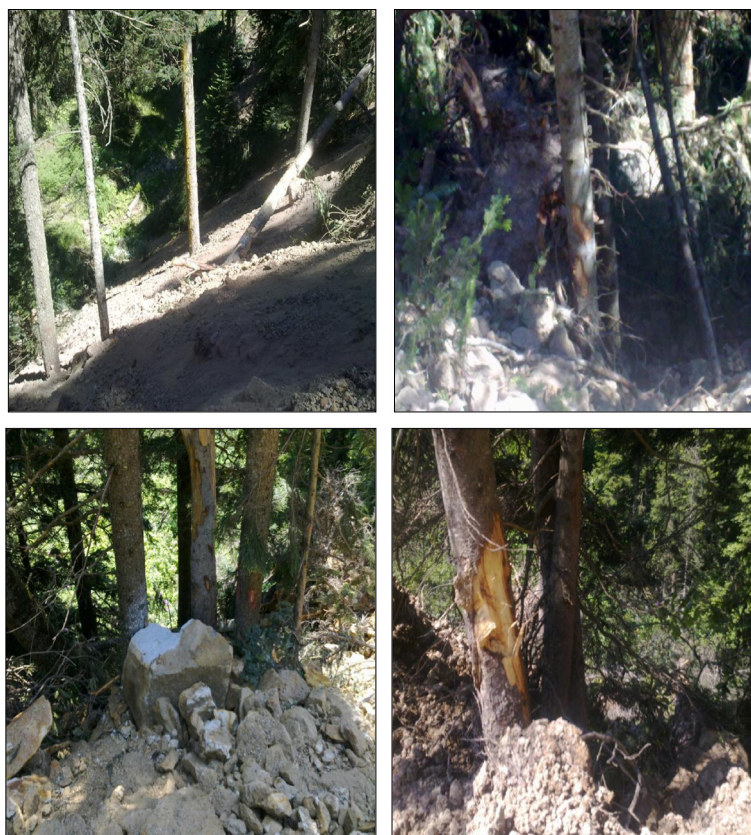
Figure 4 Tree damages during forest road construction.

damage in these regions. Also, direct economic loss occurred due to poor timber quality. The damage caused by road construction are shown in Figure 4.

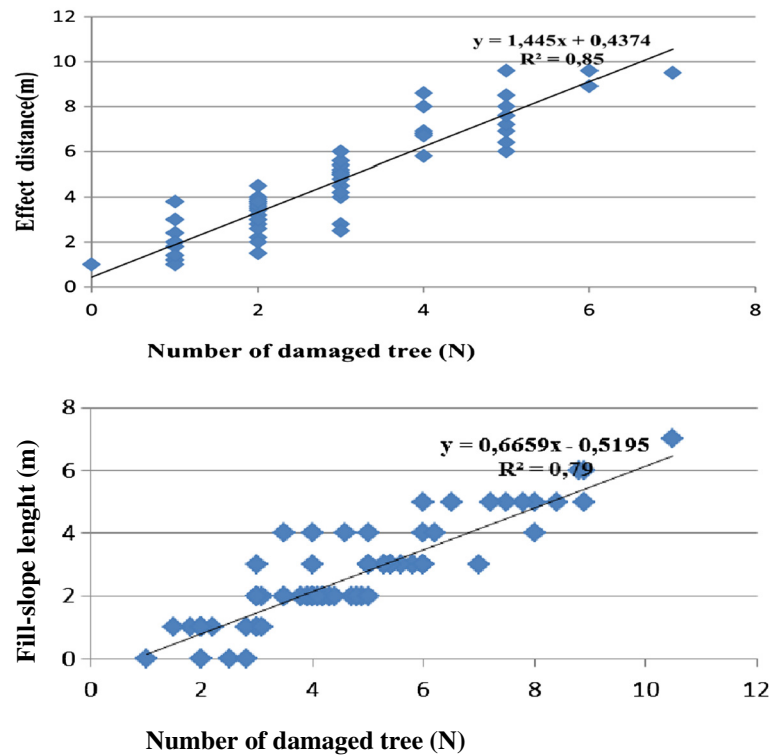
Figure 5 Relationship between the number of damaged trees, the length of effect distance and the length of fill slope.

analysis, it was determined that there was a significant relationship at a 99% confidence level between the number of damaged trees and independent variables such as gradient of the terrain, cut area, length of the fill slope, length of the effect distance, number of trees and type of machine. The graphics of the relationships that are considered to be important in the correlation matrix are given below. In the graphics, it can be seen that as the length of effect distance increases, the number of damaged trees also increases. In the same way, as the length of the fill slope increases, the number of damaged trees again increases (Figure 5).

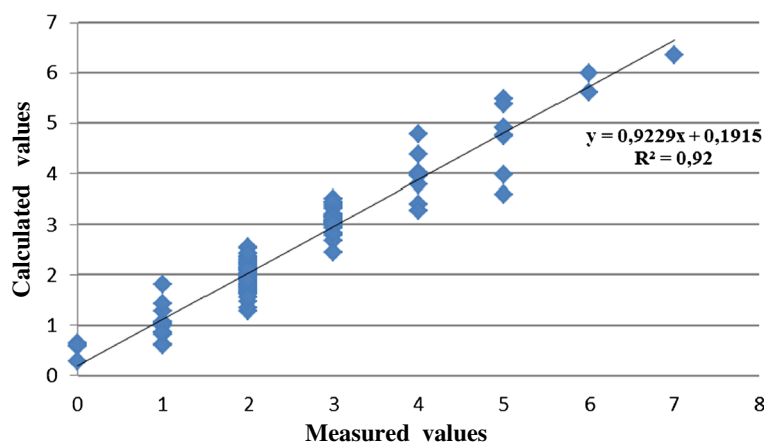
Figure 6 A comparison between the calculated and measured values of number of damaged trees.

of excavators. The graphics of the measured values and the calculated values belonging to the regression model are seen in Figure 6.
