A. TUROWSKA<sup>\*,#</sup>, J. ADAMIEC<sup>\*</sup>

## MECHANICAL PROPERTIES OF WE43 MAGNESIUM ALLOY JOINT AT ELEVATED TEMPERATURE

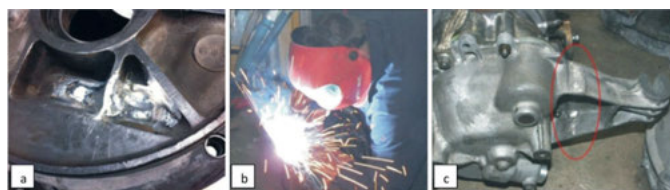
Fig. 2. Application of welding techniques in cast magnesium alloys: a) repairing castings, b) joining castings, c) repairing cast after wear and tear [8,9]
