CORROSION DAMAGE INVESTIGATION OF SILVER-SOLDERED STAINLESS STEEL ORTHODONTIC APPLIANCES USED IN VIVO

The aim of the conducted study was to evaluate corrosion damage in silver-soldered stainless steel rapid palatal expansion Hyrax appliances.

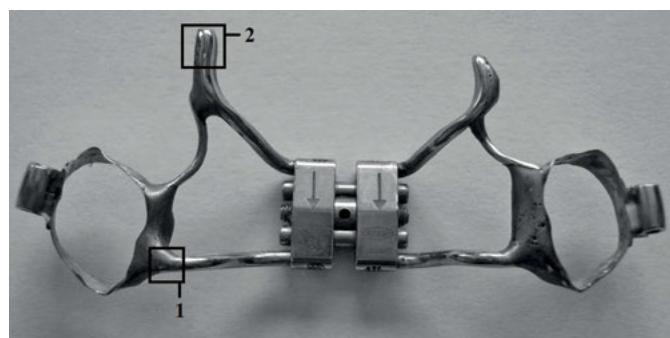
Fig. 1. The Hyrax device used for 2 months; 1, 2 – described in the text solders

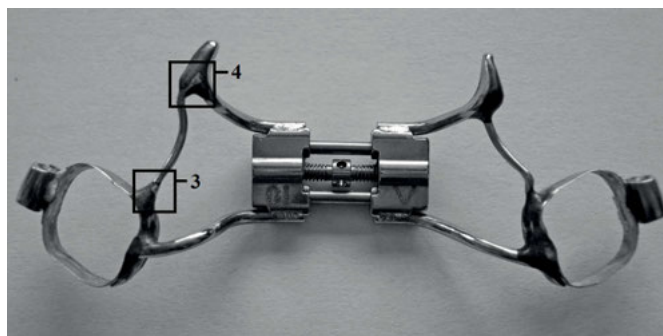
Fig. 2. The RPE appliance used intraorally for 6 months; 3, 4 – mentioned in the text solders

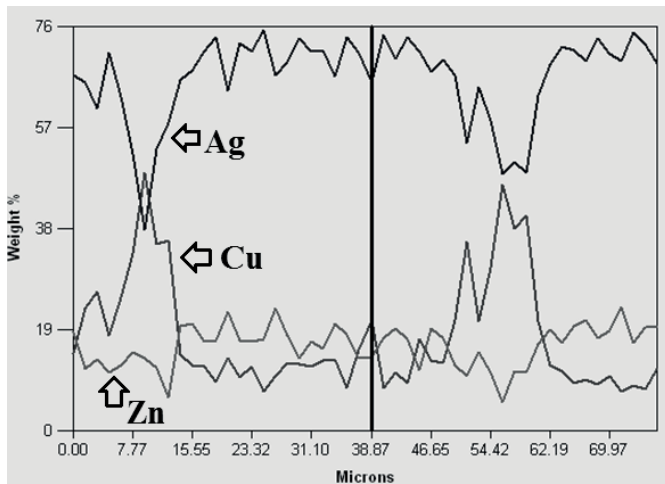
It is worth noting that solders of the RPE appliance after 6 months in service reveal lower Cu and Zn mass content than samples used intraorally for 2 months (Table 2). What is more, linear EDS analysis (Fig. 4) of solder 1 showed differential elements composition in the material interface. Corrosion pits were singled out as Cu-rich areas, whereas their zinc amount was remarkably reduced. The Ag content remained at an almost even level.

Fig. 3. Linear EDS analysis of solder 1

In linear EDS analysis (Fig. 3), the examined corrosion pitted solders showed local variations of chemical composition. A similar preferential dissolution of silver solder, containing 22% Cu, 17% Zn, 56% Ag and 5% Sn, has been observed by Vahed et al. [10]. It is known that one-element rich particles result in a micro-galvanic effect, which leads to selective corrosive damage development. Vahed et al. [2] suggest that corrosion processes nucleation is expected to occur first at the stainless steel interface due to the heat-sink effect of the stainless steel and the heterogeneous sites provided by the pre-existing surface, as shown in Fig. 5b.

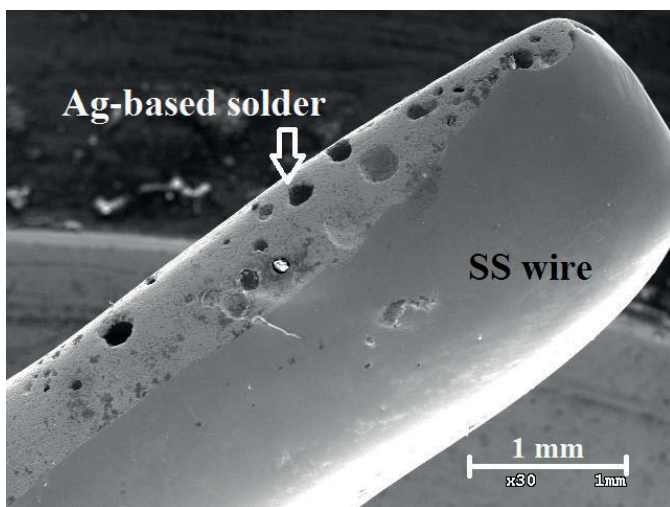
It was observed that corrosion damage was considerably greater in appliances used for 6 months rather than 2 months (Fig. 4, Fig. 5, Fig. 6). Unlike appliances used for a shorter amount of time, solders of the Hyrax expansion device after 6 months in service showed a predisposition to come away from the steel (Fig. 6). This might cause immediate failure of the appliance and a premature need to repair the device.

Fig. 4. RPE appliance after 2 months in service, solder 2, magnification 30 \times , SEM photograph. Visible severe corrosion pits in the solder material and non-corroded wire

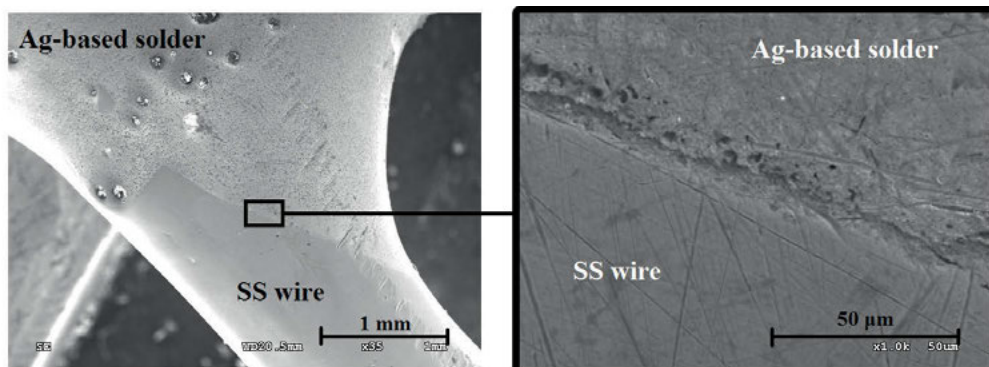
Fig. 5. Hyrax expansion device after 2 months of use, solder 1, magnification 30 \times (a) and 1000 \times (b), SEM photographs. Solder shows no tendency to coming away from the steel, although at the magnification of 1000 \times there is a noticeable characteristic for galvanic corrosion pitted boundary between the materials

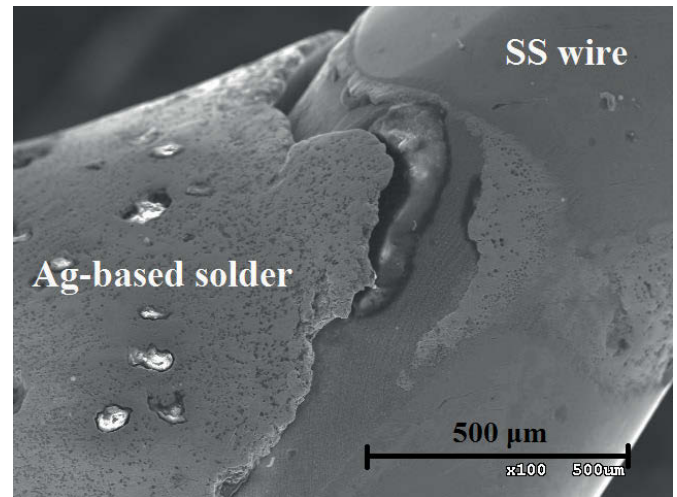
Fig. 6. Hyrax device after 6 months of intraoral use, solder 3, magnification 100 \times , SEM photograph. Observable tendency to loosening up the bimetallic junction caused by solder corrosion

Health implications are not the only aspects which should be investigated when discussing material corrosion. The mechanical properties of the whole construction advance in degradation, even if one of the parts fails. Insecure, non-springy processes, or coming away from the steel solders, may be unable to provide a reliable interlink between the elements, even for as short an amount of time as 6 months. Nowadays, as an alternative to thermal conjoining procedures, ultrasound laser welding procedures have been introduced [19].

processes are intense and lead to severe damage, like loosening of soldered joints in a short amount of time. Due to the observed damage, the authors suggest further studies into ultrasound laser welding in orthodontic applications.
