SOME ASPECTS OF CONTINUOUS CASTING OF LOW CARBON MICROALLOYED STEELS WITH NIOBIUM AND TITANIUM

An analysis of the causes of transverse corner and surface crack formation during continuous casting of low carbon niobium and titanium-containing steel into square billets is presented in this paper. Using X – ray analysis method, the chemical composition of non- metallic phases inside corner cracks was determined. The temperature ranges of the occurrence of nitrides and carbonitrides of Nb, Ti and Al were established using FactSage 6.2., a commercial computer program. The need for the precise selection of cooling conditions during casting of billets both in the mould and in spray cooling regions was pointed out with the aim of obtaining the optimum surface, and particularly corner temperature of the billet before its entrance to the straightening stand.

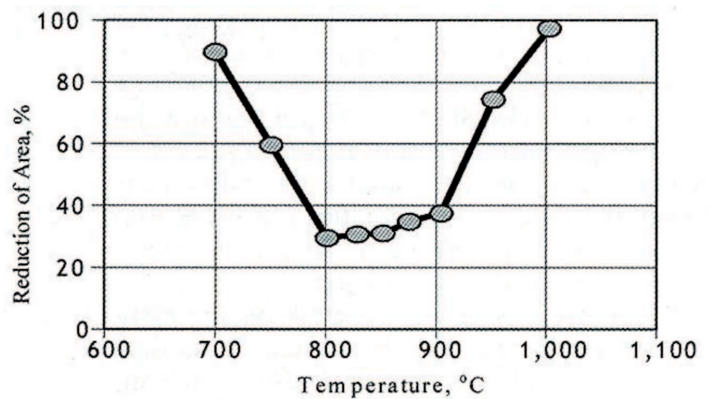
Figure 1 represents the relationship of the value of the reduction of area of steel containing 0.09% C; 1.41% Mn; 0.032% Al; 0.028% Nb and 52 ppm N as a function of temperature, as determined experimentally in study [3]. As indicated by the presented relationship, the minimum values of the reduction of area, which can be assumed in this case as the measure of plasticity, are attained by the steel of the specified chemical composition in the temperature range of 800÷870°C (1073÷1143 K). If the temperature at the billet corners reaches values from the determined temperature range during straightening, the stresses that form as a result of stretching undergone by the top surface of the billet (on the side of the smaller radius of CC machine) will cause transverse cracks to occur. The results of numerous research works [5-7] indicate clearly that the concentration of those stresses occurs in hollows on the continuous cast billet surface, which are caused by the oscillatory movement of the mould (the so called oscillation marks). When analyzing the causes of transverse cracks occurring on the surface of low-carbon HSLA steels, it should also be taken into account that, due to their carbon content, they are classified into the group

Fig. 1. Variation in the value of the reduction of area as a function of temperature for steel containing 0.028% Nb [3,4]

The performed measurements of continuous cast billet surface temperature immediately after the straightener, using an optical pyrometer, showed that the temperature in the upper corner zone reached values in the range of 785÷890°C. According to the results of a literature review, in the temperature range of 800÷900°C steels with 0.028% of niobium are characterized the lowest values of the reduction of area. It was found that billet

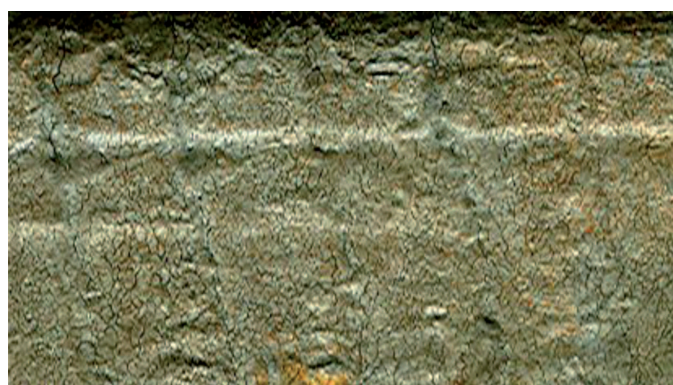
Fig. 2. Cracks on the surface of an S355J2-NbTi steel continuous cast billet

Figure 2 clearly indicates that the cracks located at the billet corners and extending into the material have their origin in the locations of oscillation marks.

It should also be noted that the oscillation marks deflect distinctly with increasing distance from the edge, assuming a curvilinear shape. Such a shape of these traces is indicative of clear disturbances of the steel level position in the mould. Metal turbulences at the meniscus level and a variable metal level in the mould, which cause the state as seen in Fig. 2, are an impermissible irregularity in the continuous casting technology. Some of the cracks visible in Fig. 3 are up to 5 millimetres deep, so their removal by grinding of the billet surface is not fully possible.

The location of transverse cracks at the billet corners, as shown in Figs. 2 and 3 clearly indicates that they lie along the oscillation marks. The depth of those marks and the distance between them resulting from the mould travel, as well as the position relative to the billet surface, will therefore indirectly influence the mechanism of formation and the size and frequency of occurrence of corner cracks. This finding is confirmed by the results of numerous studies [11-14]. On these grounds, it was fully justifiable to adjust the continuous casting parameters being in use, which determine the formation oscillation marks. The main parameters characterizing the mould operation include: instantaneous mould speed, average mould speed, complete cycle time, oscillation frequency, stroke length, and negative strip time, t_{NS} . For the sinusoidal form of oscillatory mould movement, t_{NS} is defined as the time, in which, as the mould moves down, its displacement velocity is higher than the casting speed, and is defined from the relationship:

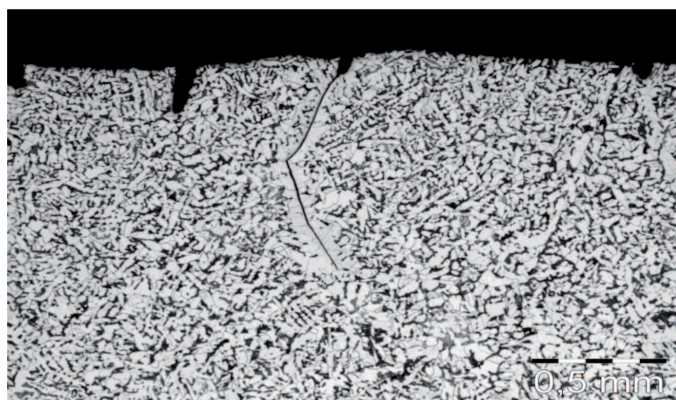
Fig. 3. Arrangement of cracks in the corner area; the sample after etching (with Nital)

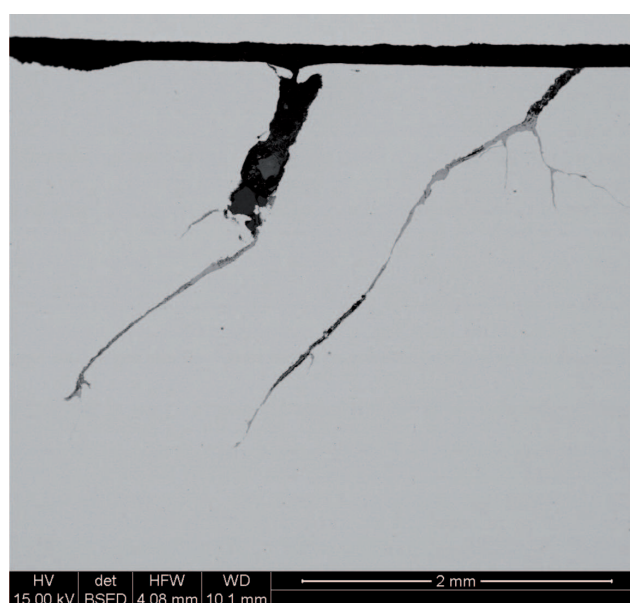
To identify the phase composition immediately around and inside the cracks, observations of metallographic sections were made using a light microscope and a scanning electron microscope. The contents of elements in selected micro-areas were determined by the X-ray microanalysis method using an energy dispersion spectrometer (EDS) on an Inspekt F scanning electron microscope with an EDAX microanalysis attachment. Examinations of the scanning microscope were made at an accelerating voltage of 15kV. The position of a randomly selected cracks at the billet edge is shown in Fig. 4, while Fig. 5 shows the magnification of the lower crack part, with the locations, for which the determinations of chemical composition of the phases present there were made, being marked with numerals.

Fig. 4. Corner position of the transverse crack chosen for analysis

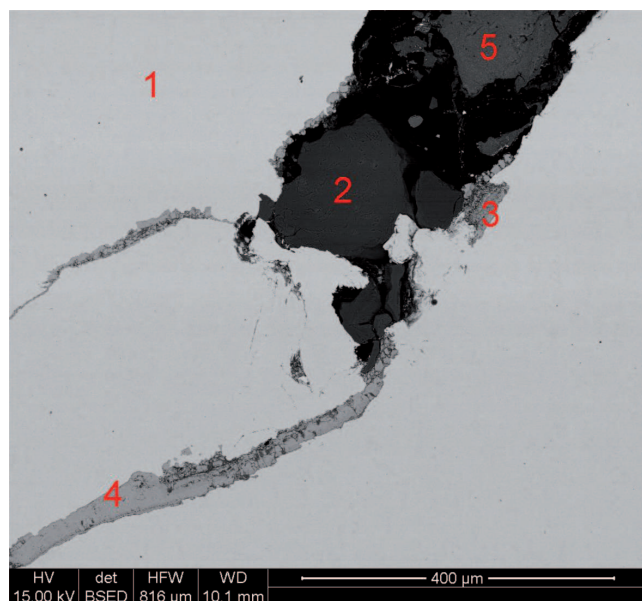
Fig. 5. Positions of the areas (marked with Arabic numerals) selected for analysis, in which chemical composition determination was made

When analyzing the chemical composition of the material filling the crack and its neighbourhood it can be noticed that at point "2" there is an agglomeration of aluminium oxide, which can either be the product of steel deoxidation with aluminium or be a component of the protective flux added to the mould. Point "3" corresponds to the mixture of the oxides of iron, silicon and manganese, whereas point "4", the oxides of manganese and iron. At points "3", "4" and "5", considerable

concentrations of oxygen and iron occur, which suggests the oxidation of the inner surface of the cracks. It can also state with a high probability that, in this region of the crack, the oxides filling it up come to some extent from the flux material, which contained among other 1.0÷2.5% Fe_2O_3 , 2.5÷4.0% MnO and up to 5.5% Al_2O_3 . Since it is hard to explain their origin by the incomplete modification of the composition of oxide non-metallic inclusions in the liquid steel at the ladle furnace process stage, considering the 0.017% Al content of the steel and its modification with a Ca-Si alloy (with a finished steel Ca content of 26 ppm). The confirmation of this observation is the chemical composition of the non-metallic phase represented by point "5". The presence of carbon, sodium and chlorine in this zone indicates that the source of these elements are chemical compounds being components of the granular flux added to the mould. The relatively high concentrations of chromium and nickel, found in the region where point "5" lies, also require explanation. These elements come from the protective coat applied on the inner plane of the mould's copper tube walls. This coat consists of chromium and nickel, among others. This means that this coat might have been partially damaged as the continuous cast billet skin moved along the mould walls.

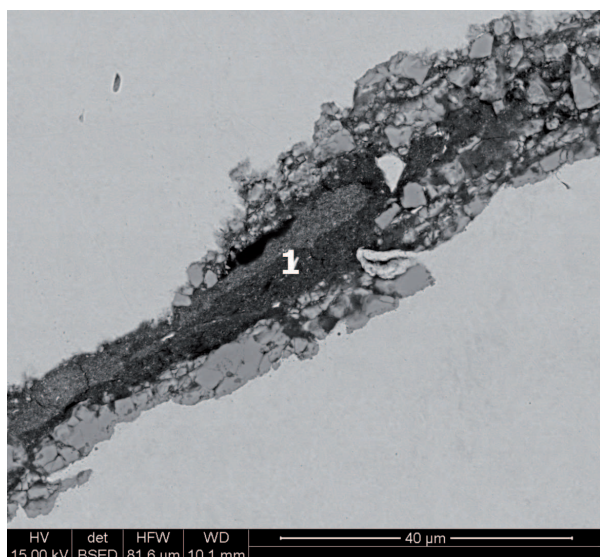
To make sure that the composition of the non-metallic phases present inside transverse cracks, as determined by X-ray microanalysis, has not the nature of an isolated case, a crack situated in another area (Fig. 6) was randomly chosen and subjected to similar analysis, whose results are given in Table 3.

Fig. 6. Distribution of non-metallic phases inside the transverse crack situated near the corners of a 160×160 mm billet

By comparing the chemical composition of non-metallic phases, determined at point "1" (Fig. 6), with the composition determined for cracks in another area (Table 2), great similarity can be found to exist between them. The differences between the contents of particular elements not being large enough to allow the observation that their source is the mould protective flux, what it was earlier affirmed. It is also characteristic that, in the case analyzed, chromium and nickel also occur inside the crack, whose source is an internal Cr+Ni alloy protective coat that is applied on the mould's copper surface. On the basis of the obtained analysis results, a decision was made on the need for changing the chemical composition of the mould flux so as to achieve its lower viscosity in the temperature range of 1200÷1500°C.

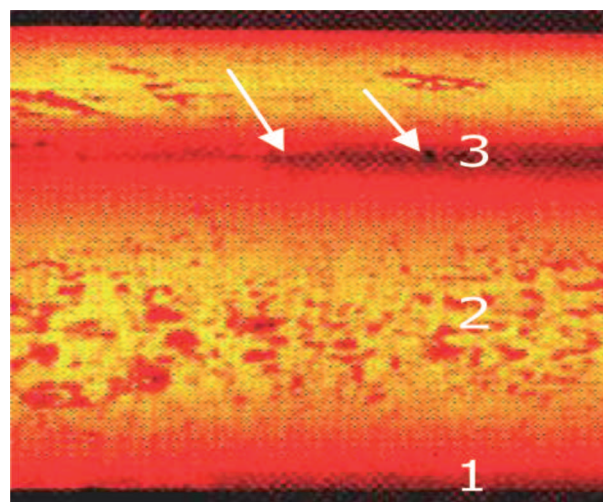
To obtain additional information on the location of occurring transverse cracks, using an optical pyrometer, a measurement of the temperature of their surface and corners was taken immediately after the material had exited the straightener (about 0.6 m beyond the stand). The areas in the billet surface, where the temperature

was measured, are denoted with the numerals 1÷3 and shown in Fig. 7.

Fig. 7. Locations of temperature measurements on the surface of a continuous cast slab (1÷3) of steel S355J2 – NbTi (cracks at the corners are marked with the arrows)

Points 1 and 3 correspond to the temperatures of the upper and lower corners, whereas point 2 was situated approximately in the middle of the lateral plane. The cracks at the billet corners, visible to the naked eye, situated on the upper plane side (smaller radius of CC machine), are marked with the arrows. The obtained temperature values are given in Table 4. As the temperature measurement was also taken at the exit from the straightening stand, it can be assumed that the measured temperature of the surface and the corners corresponds to the temperature, at which the cast billet deformation caused by straightening took place. As indicated by the values shown in Table 4, the temperature of the upper corner (3) assumed values from the range, in which steels with a niobium content of 0.028% exhibit a distinct loss of plastic properties, as follows from Fig. 1. The clearly lower temperature of corner (3) compared to corner (1) was indicative of a higher intensity of cooling this area of the continuous cast billet. As turned out, the cause of this situation was an excess of water, which, in an uncontrolled manner, dripped down one of the spray cooling zone segments onto that fragment of the billet surface. The material deformation (tensile stresses on the upper billet plane) caused by straightening of the material at too low a temperature was probably one of the causes of transverse cracks occurring at the corners.

straightening was conducted at too low temperatures. It should also be noted that distinct differences in temperature between individual corners were found. With the aim of correcting this irregularity, efforts were undertaken to eliminate the uncontrolled water streams in the spray cooling zone.

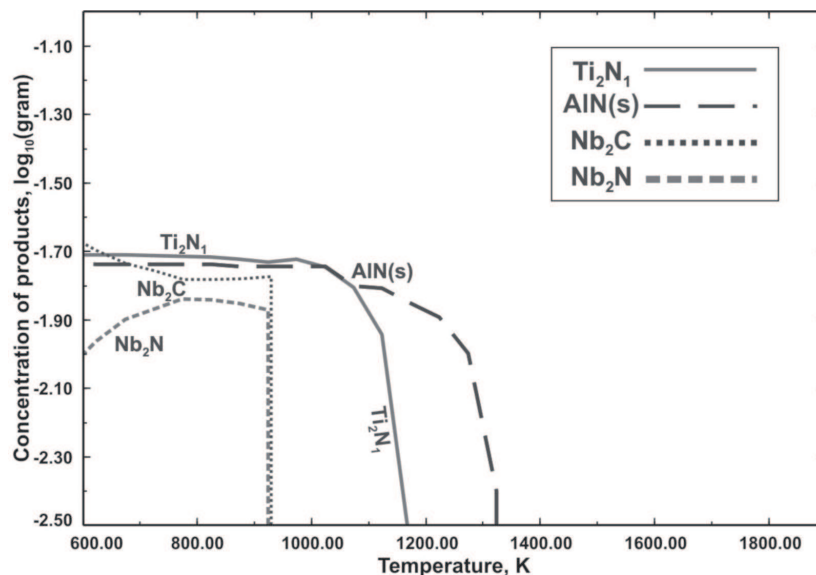
As has been demonstrated by computations made using the FactSageTM software program (Fig. 8), for the set chemical composition of the steel investigated (Table 1), the formation and occurrence of nitrides and carbides in a broad temperature range is possible. From the point of view of the influence of those precipitates on the plastic

Fig. 8. Relationship of nitride and carbide formation reaction product mass as a function of temperature in steel S355J2 – NbTi of chemical composition, as given in Table 1, computed using the FactSageTM program

The possibility of precipitation of nitrides, carbides and carbonitrides of alloying elements (Nb, Ti) and Al in the steel of the analyzed chemical composition, as confirmed by calculations, while considering the potential for their precipitation at grain boundaries, indicates that the proposition to limit the concentration of nitrogen in steel melted in an electric arc furnace is legitimate. The amount of precipitated nitrides will be in that case proportionally smaller.
