Z. STANIK*

TYPICAL FAILURES IN THE DAMAGED ROLLING ELEMENTS MADE OF DIFFERENT MATERIALS IN THE MOST IMPORTANT VEHICLE UNITS

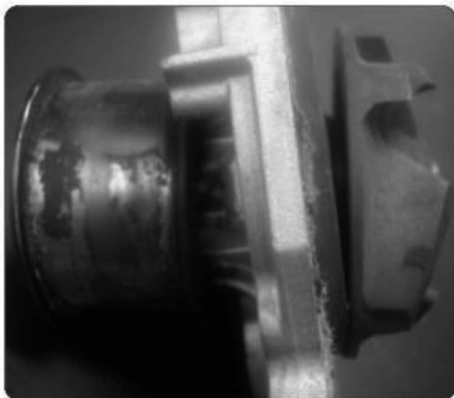
Figures 1 and 2 show seriously damaged water pump in effect of blocking the rotor shaft. This situation was caused by lack of collinear as a result of connecting rotor to frame. This failure results from damage to bearing race way which was excessively radial loaded by shaft. The fitting errors, for example too high tension of timing belt or wrong reparation may cause such a failure. For example, according to repair technology there is need to replace the water pump and timing belt. The new belt may cause more tension in timing system and thus the pump bearing (which is not in good condition) is not able to carry the increased radial loads.

Fig. 1. Damaged water pump

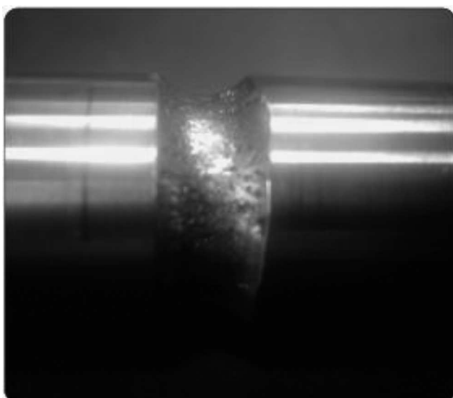
Fig. 2. Damaged roller of water pump

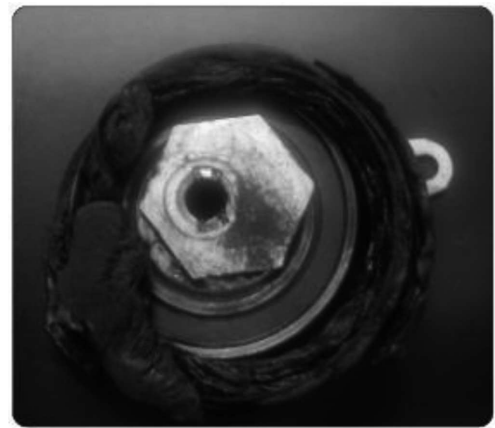
The next example is damage to tension shaft, which tighten the belt timing. A belt pulley of tension shaft was fused because of too high temperature (Fig. 3). A high temperature as a result of increasing the friction coefficient causes fusion of plastic on belt pulley. Defect of bearing seal and the same decrease in lubricant of tension shaft may causes fusion of shaft. It is because the higher coefficient of friction, the higher temperature. The cumulative effect of that situation is a seized up shaft, broken V-belt (wedge belt) and finally lack of power transmission of the basic auxiliary devices.

Fig. 3. Fused belt pulley of tension shaft

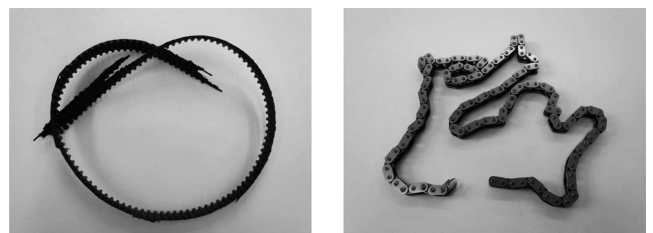
The examples of failures shown in figures above (1-3) consequently lead to serious damages to the elements of timing system. The kind of damages is presented in figures 4-6 below.

Fig. 4. Damage to belt and chain of timing system

In case of blocking any of timing system elements, some stresses may appear, which are unpredictable even by the constructors. In effect, a timing belt or chain is slid or broken. It may causes (especially if the engine is earlier damaged a serious and expensive damage to transmission unit, such as distortion of valves, damage to pistons (as a result of their collision) or damage to timing shaft, which may then leads to damage to car head. At present, after this kind of failure is impossible to repair the damaged engine, especially because of a distinct lack of repair technology (made professionally by

Author proposes a possible solution to this situation. According to the author, a continuous monitoring of the technical condition or diagnosis those elements of which damage could lead to failure units as well as sub-units of vehicle.

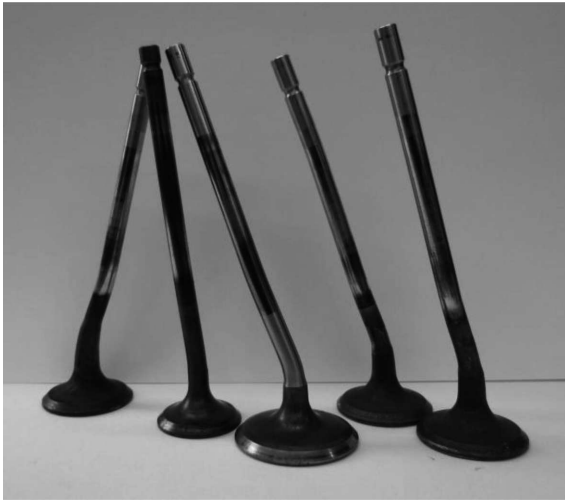
Fig. 5. Distortion of valves

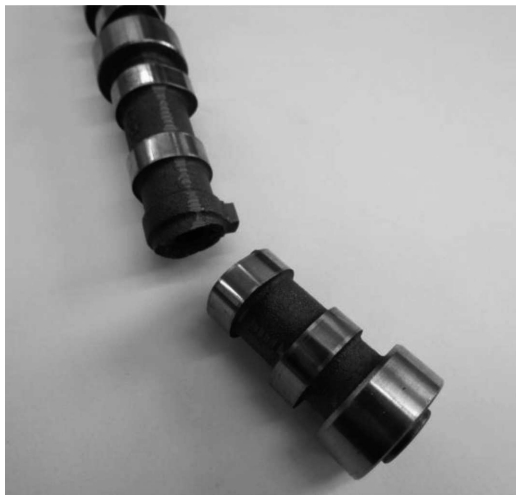
Fig. 6. Camshaft broken

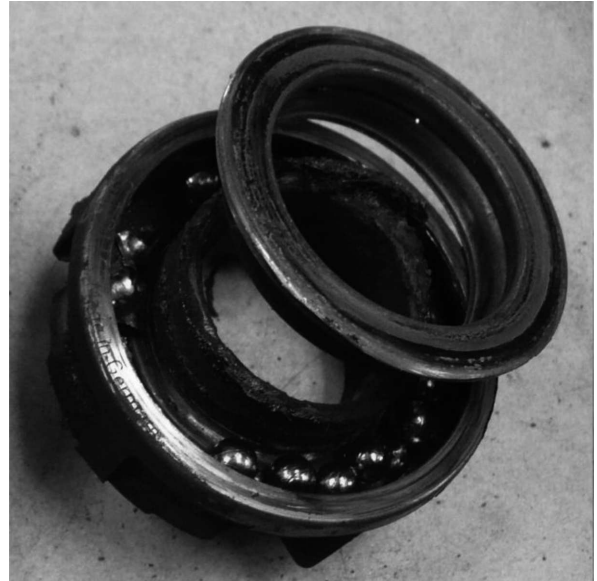
The next example (Fig. 7, 8) shows the damaged thrust bearing of clutch set. This kind of failure causes the noise when pressing on the accelerator pedal, for example in order to change gear. After pressing on pedal, thrust bearing works under pressure only when it is pushed axially to pressure disk. Bearing, which is damaged is able to generate the noise after pressing on pedal.

Fig. 7. Worn thrust bearing

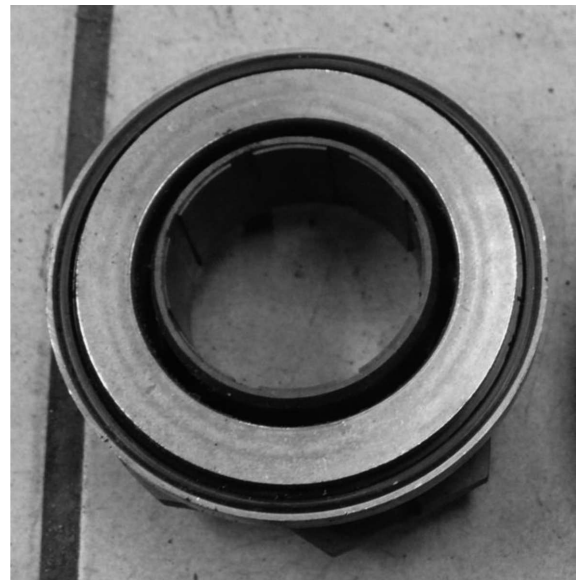
Fig. 8. New bearing

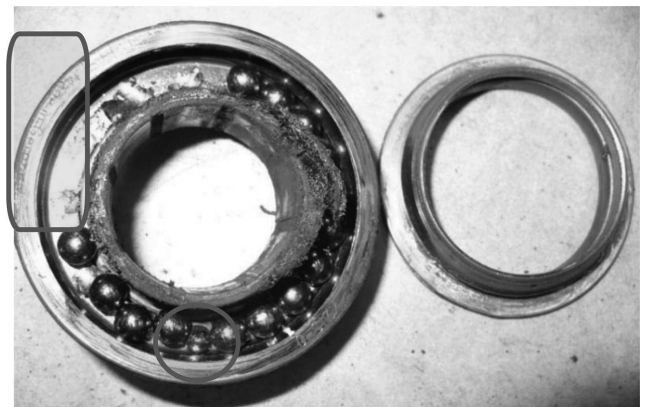
In Figure 9, the compressed material is marked by red rectangle. This material originate from damaged both elements

Fig. 9. Degradation of rolling elements of thrust bearing

and race way of bearing. This kind of failure is caused by inappropriate hardness of individual rolling elements. This leads to total degradation of the bearing elements. Rolling element

marked by circle in the same picture changed completely its dimension by being worn. It is seen by comparison its diameter to the other rolling elements of bearing. Such a damage may cause appearance of the radial and axial clearances which significantly exceed design guidelines.

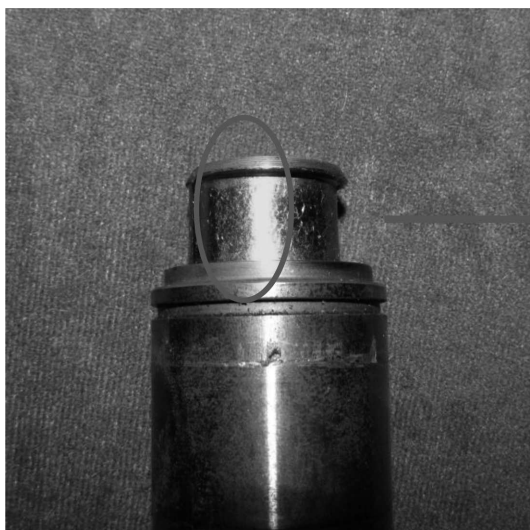
Figures 12 and 13 shown examples of worn main shaft of gearbox. In this case a pin, which is an integral part of the main shaft is destroyed. Destruction relates to the surface of rolling elements and the pin surface. This example points to the conclusion that it is rather a manufacturing defect, because a vehicle had respectively low mileage. The reason for it could result from for example faulty heat treatment both the rolling elements and the pin itself. In effect, the bearing race way was defected, i.e. a nominal pin diameter decreased significantly as a result of loss of the material (wearing of surface).

Fig. 12. Damage to main shaft bearing pin of gearbox

This kind of defect is manifested as an increased noise as a result of clearance on the shaft. In effect, the toothed wheels of gearbox don't mesh properly. This failure can't be repaired because there is no possibility of changing the rolling bearing because it's inside track is on shaft. It may be resolved only by buying new shaft which is very expensive in comparison to the price of the single rolling bearing. Also, regeneration padding is rather a short-term solution. A structural solution described above is very often apply by the many manufactures of different vehicles brand.

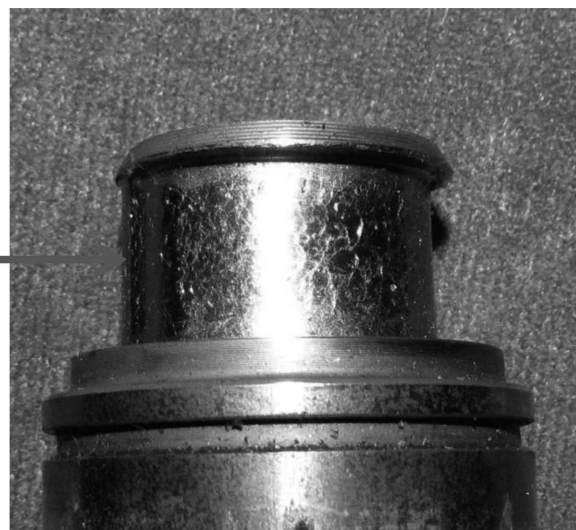
Fig. 13. Material wearing and change in diameter of pin

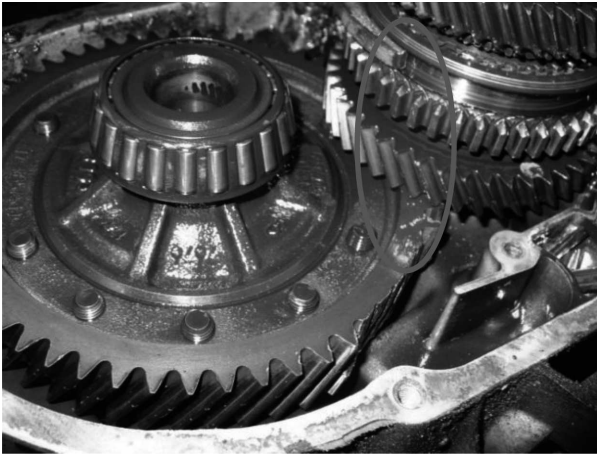
The examples of defects in main transmission gear are presented in figures 14 and 15. The totally damaged tooth of toothed wheel in main transmission gear are there shown. This kind of damage is caused by the rolling bearing (of main shaft) failure. In effect, toothed wheels of main gearbox don't mesh properly.

Fig. 14. Damaged bearing of main shaft

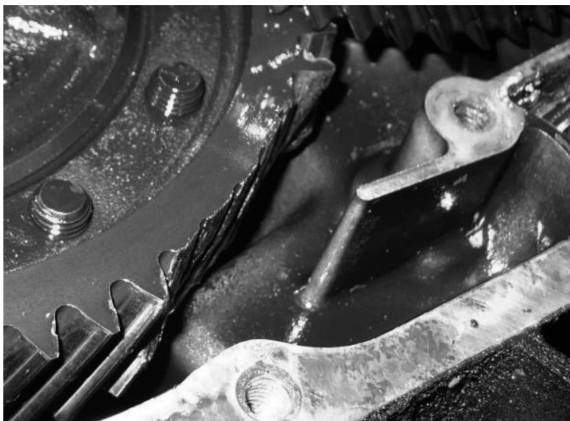
Fig. 15. Defected toothed wheels of main shaft

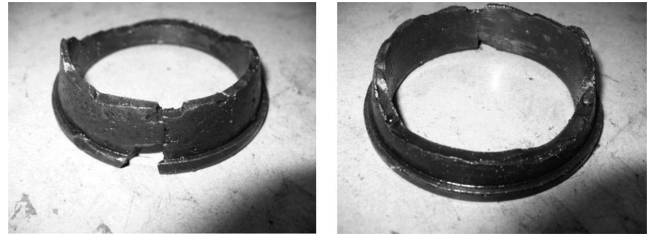
Figure 16 shows a totally damaged inside track of roller bearing that was located in driving axle of lorry. This severe structural damage indicates that a user of vehicle was not interested in the reason of specific voice that indicated improper work of main transmission gear. The scale of destruction indicates that a lorry was regularly overloaded, for example a maximum vehicle capacity was exceeded.

Fig. 16. Totally damaged inside track of roller bearing in lorry

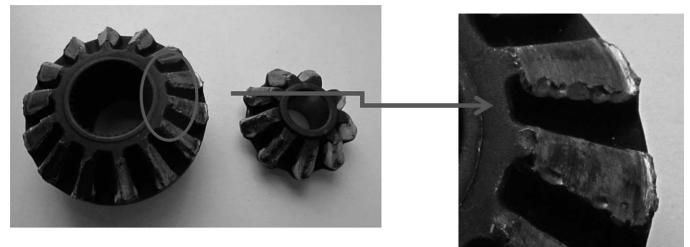
Figure 17 shows the damaged toothed wheels of differential gear. That kind of damage is caused by destruction of the bearings race-way of main transmission that is shown in figure 16. The toothed wheels are seriously damaged because of a large deviation from the nominal geometric parameters of the axis position.

Fig. 17. Damaged elements of differential gear

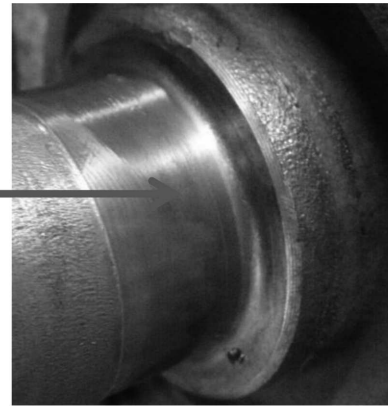
The next example (Figure 18 and 19) shows destruction of wheel bearing pin. This kind of failure is caused by a very little bearing preload. As a result of it, an inside track is displaced relative to the pin. An operation in such adverse conditions caused loss of material of co-operated elements. As a result of process of surface grinding, an operation in such adverse conditions caused loss of material of co-operated elements.

Fig. 19. Worn surface of pin in hub

All the examples of damaged elements, given above pointed to the conclusion that these elements, without doubt should be exchanged. This example of failures for sure causes irregular distribution both stresses and surface pressure in the bearing elements. Finally, because of it the wheel may be blocked. This may then lead to the dangerous situations, considering the fact that at the present time vehicles are able to achieve high speed.

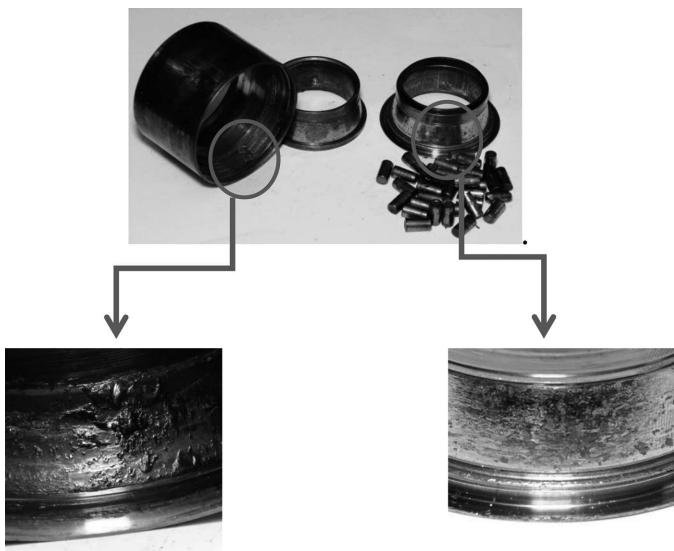
Figure 20 shows damaged wheel bearing. In that case both bearing races were destructive because of operating. The condition of race was estimated to be completely destroyed. This means that exploitation of vehicle in such bad condition would be highly dangerous for its users.

Fig. 20. Damaged race of wheel
