P. RANACHOWSKI\*<sup>#</sup>, Z. RANACHOWSKI\*, S. KUDELA JR\*\*<sup>#</sup>, A. PAWEŁEK\*\*\*, A. PIĄTKOWSKI\*\*\*

## STUDY OF FACTORS DETERMINANT OF SILICEOUS ELECTRICAL PORCELAIN RESISTANCE TO STRUCTURAL DEGRADATION

The subject of this study was investigation of the factors that have a decisive influence on the resistance of siliceous porcelain to degradation processes. There was tested material C 110 type, which is widely used for the production of low-voltage (LV) elements such as insulators and bushings. On the basis of mechanical-acoustic and microscopic research of small-sized samples, which were subjected to compression, there were distinguished successive stages of degradation of the material structure. In the authors' opinion, they have a reference to the ageing process, taking place during many years of work under operating conditions. Thus, it was possible to assess the structural factors that determine the durability and reliability of LV electroinsulating elements. The results were related to electrical aluminous porcelains.

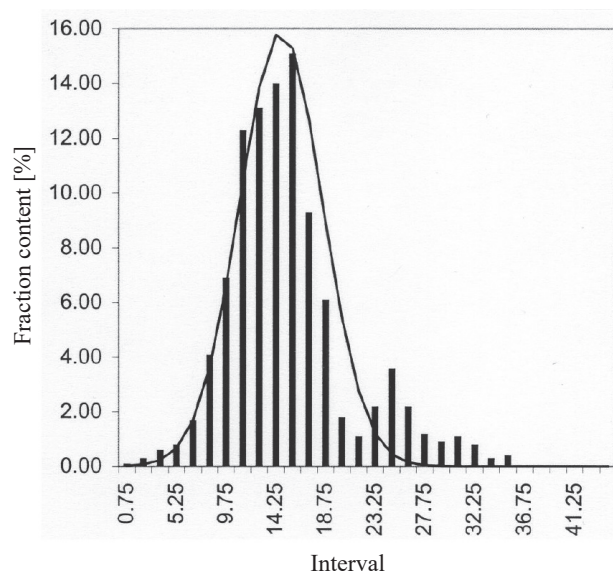
Fig. 1. The size distribution of quartz grains in the tested porcelain. The vertical axis - fraction content in percent, along the horizontal axis - an interval of particle size in microns. The distribution is dominated by two fractions - the size of a dozen or so and 20 - 30  $\mu\text{m}$ . The value of the average is 14.7  $\mu\text{m}$

The content of quartz was equal to  $20 \pm 2\%$ . Considering the size of quartz grains – explicitly dominated fraction of dozen or so micrometers, nevertheless a significant part constituted the relics in the range of  $20 \div 30$   $\mu\text{m}$ . Figure 1 presents distribution of the quartz grains diameter. Unfavorable phenomenon was the presence of agglomerations of larger quartz grains. Additionally, a significant part of the relics exhibited disadvantageous lamellar morphology. In the structure of majority of electrical porcelains, the quartz phase is mainly responsible for internal stresses and the initiation and development of cracks. This is the basic cause of increasing ageing processes with time passing. Significant part of quartz grains contained cracks and was insufficiently associated with matrix. As a result a substantial part of relics fell out during the preparation of surface of the tested samples.

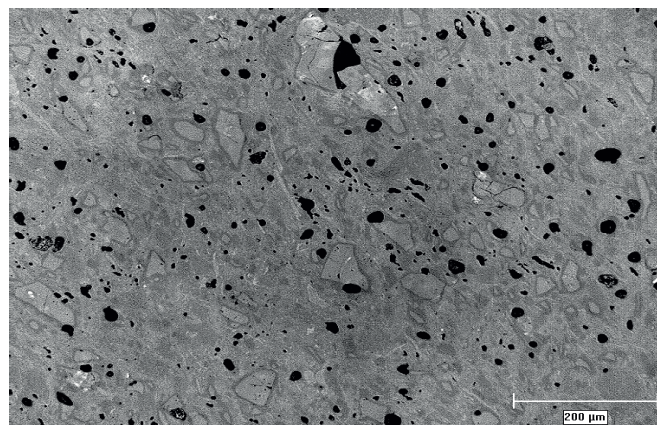
Fig. 2. Image of the microstructure of tested siliceous material, magnification 100x. There are visible brighter quartz relics and darker precipitates of mullite against the background of gray glassy matrix. Black cavities remaining after the crushed out quartz grains occupy about 6% of the surface. Pores are small - a few microns - and cover approximately 0.5%

The content of the glassy matrix was high - as compared to other electrical porcelains, even of the same class. It amounted to  $55 \pm 4\%$ . A high content of the glassy phase has advantageous influence on the cohesion and bonding of all porcelain phases. The material contained small amount of cullet, originating from grinding media. Electrical siliceous porcelains are characterized by significant diversity, but the structure of the tested material can be regarded as homogeneous and representative. The phase composition was in general typical. In Fig. 2 is presented image of the material microstructure.

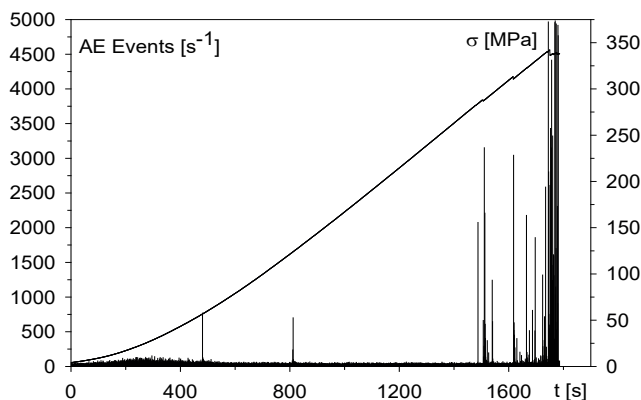
Fig. 3. Mechanoacoustic characteristics of the weakest specimen - compressive strength equal to 342 MPa. Linear scale of AE events

The mechanical-acoustic characteristics of the individual samples demonstrated considerable diversity. Nonetheless, there were recognized characteristic, successive stages of degradation - the preliminary, the subcritical and the last - critical stadium. Figure 3 presents the course of the rate of AE events versus the increase of compressive stress for the weakest sample. Figure 4 represents the rate of events energy of the other specimen.

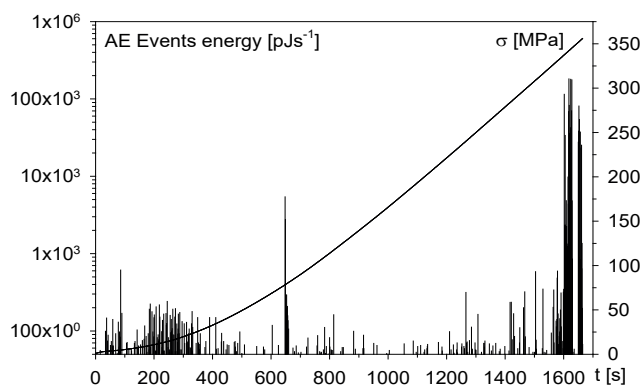
Fig. 4. The rate of events energy in one-second intervals as a function of the stress increase for the sample destroyed at 351 MPa. Logarithmic scale is used for the EA descriptor

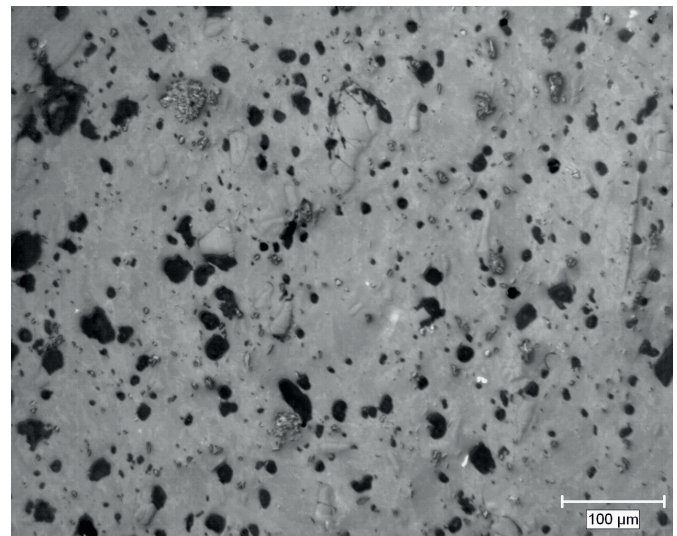
Fig. 5. The structure of siliceous material loaded up to the preliminary stage of degradation, magnification 200x. Numerous damages and crushed out grains of quartz are visible. Dark cavities cover about 10% of the surface

and crushing out of quartz grains was the source of AE signals. This effect referred particularly to the small grains - of the size of several microns. Susceptible to degradation were the grains with a lamellar morphology. The most resistant to failure and separation from the matrix were the grains of a middling size between 20 and 30 mm, distinguished by the regular shape and typical morphology. Besides quartz, there occurred crushing out of almost all particles of cullet. Mullite precipitates were not affected by degradation. They had a coherent structure and were well combined with the glass matrix. Damaged and crushed out elements of the structure covered over 10% of the area of tested surfaces of the stressed samples. In figure 5 is presented material of the sample loaded up to 60 MPa.

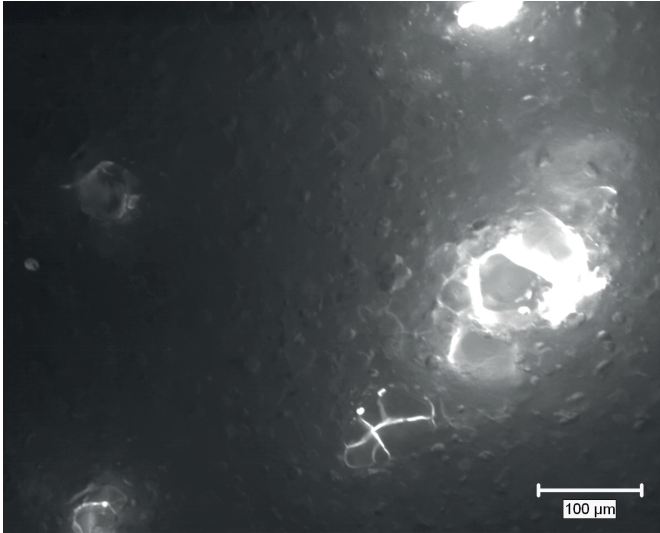
Fig. 6. Microscopic image of the material of the sample loaded up to 387 MPa, in UV light, at a magnification of 200 times. There is visible the area of loose structure - a cluster of large grains of quartz and distinctive grain cracking. Resin with addition of a UV fluorescent was used

Image analysis of the samples loaded up to 285 MPa and 387 MPa showed that further, relatively small degradation - in a wide range of stress - undergoes only the quartz phase. Circumferential and internal cracks are generated and increase in the grains. Thorough examination, using UV light, proved that in the material structure occur centres of cracks. These are the regions of loosened structure - the agglomerations of the larger grains of quartz, which crack with increasing stress and are being separated from the glassy phase. The cracks that can propagate into the matrix are initiated in these regions. These cracks, growing gradually in the matrix, are one of the most important factors in the process of degradation. Their rapid rise takes place during the critical stadium and leads to the sample destruction. Figure 6 presents the area of loose structure - the center of large cracks in the material of the sample, loaded up to 387 MPa.

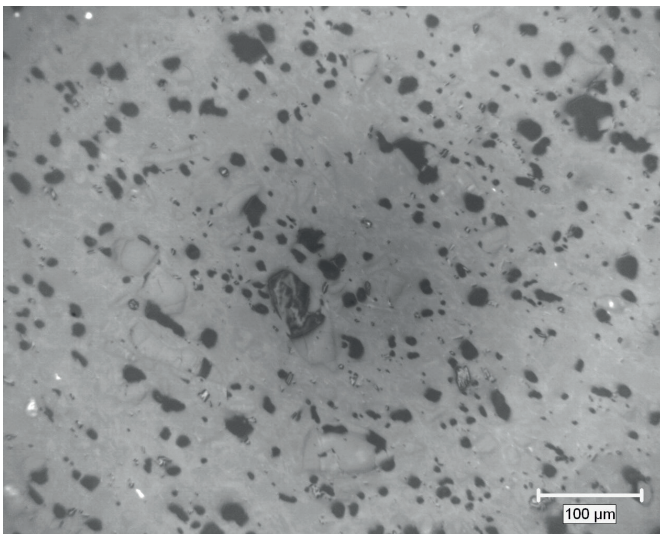
Fig. 7. Microstructure of the sample stressed up to 285 MPa, at a magnification of 200 times. Dark areas representing cracked and crushed out grains of quartz and their fragments as well as cullet fragments comprise above 11%. The mullite phase and the glassy matrix remain unaffected

The preliminary stadium of degradation was connected mostly with the effect of small quartz grains damage. During the next - subcritical stage was visible harmful influence of the clusters of bigger quartz grains - of several tens of microns. Destroyed and crushed out components of the structure in the advanced subcritical stage comprised about a dozen percent. The strongest constituent - the mullite phase remained without any damage. Figure 7 presents central part of the sample that was stressed up to 285 MPa. Advancement of degradation processes in its structure can be specified as average. There should be emphasized that these effects are limited only to the quartz phase and not numerous particles of cullet.

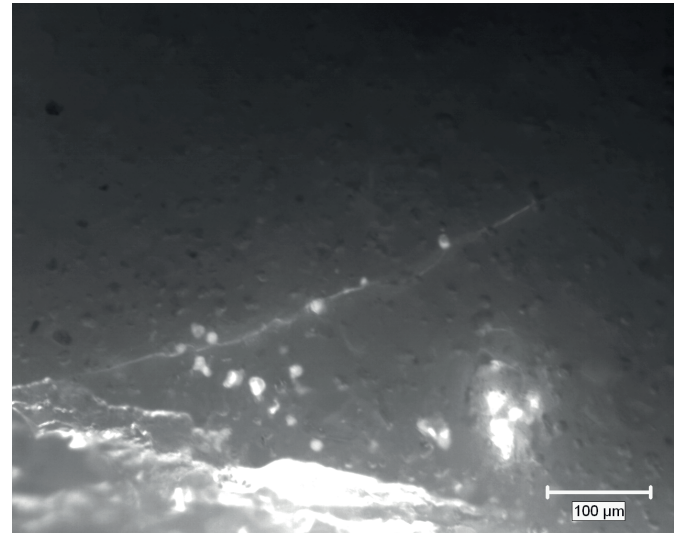
Fig. 8. Microscopic UV light picture of the material of the sample loaded up to 285 MPa, at a magnification of 200 times. The area in the immediate vicinity of the broken off fragment is visible. In addition to cracking, takes notice characteristic area of loose structure at the bottom right of the image. It is clearly visible due to applied resin with added fluorescent agent, visible under UV light

Sometimes, during the subcritical stage, a local fracture and splitting off the corners or even the whole wall of the stressed sample can occur. This effect is followed by strong AE signals, and is visible on the stress increase curves as a characteristic faults (leaps) – Fig. 3. In the vicinity of the broken off portion are then shaped large cracks. However they are typical for the critical stadium of degradation. Figure 8 shows a marginal area of the sample, loaded up to 285 MPa, in the area adjacent to the separated portion of the wall. Visible large cracks are not characteristic effect of the subcritical stage. There is also evident the typical area of loose structure.

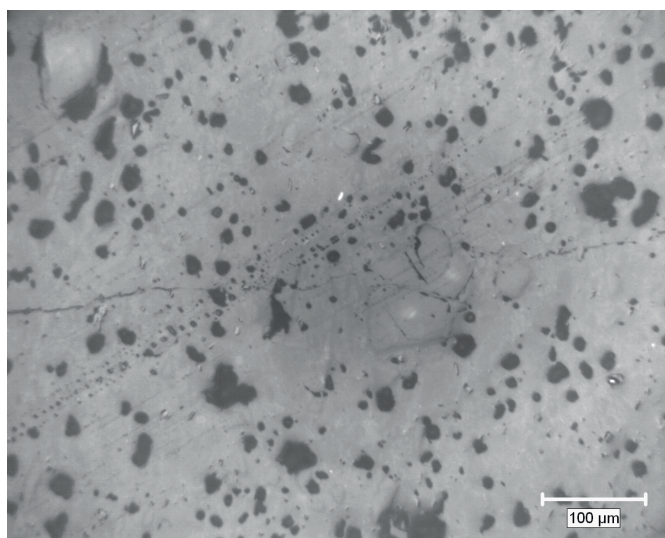
Fig. 9. Heavily fractured microstructure of the strongest sample fraction, at a magnification of 200 times. Separated and crushed out elements of the structure comprise about dozen percent of the surface

In the case of the sample with the highest strength (469 MPa), the agglomerations of the larger grains of quartz, forming a loose structure centers, occurred very rarely. The homogeneity of the material, observed in micro and semi-macro scales, was high. Therefore, the mullite phase distribution was the most advantageous, although very small number of individual crystals of mullite in the glassy matrix – typical for such type materials. This structure showed high resistance to compressive stress, even higher than in the case of the typical strength of aluminous C 120 kind material of the traditional, older type - generally about 400 MPa (in the case of modern material - over 500 MPa) [4]. Figure 9 shows the highly cracked microstructure of the fraction of the strongest sample. Beside the distinctive macro-cracks, plurality of the parallel cracks of the matrix are visible. Characteristic course of the cracking is a reflection of the loading direction.

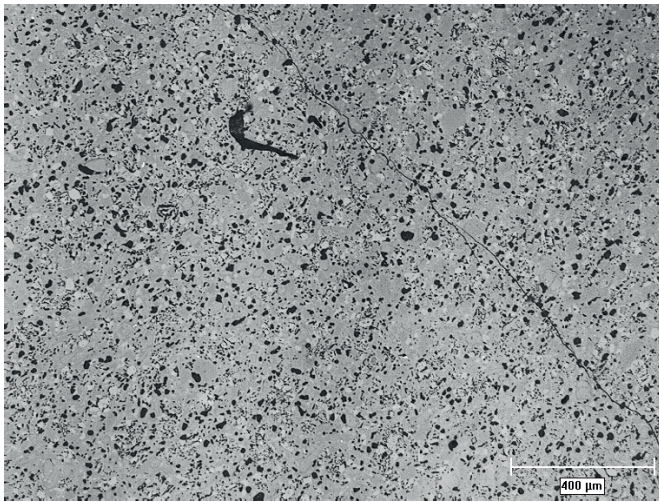
Fig. 10. The image of siliceous porcelain of LV stand-insulator after over 20 years operation period, at a magnification of 50x. Extended crack as well as black slit, elongated in a direction parallel to the axis of the insulator, are visible. There are a lot of micro-cracks within and at the boundaries of the quartz grains. Black areas that remained after crushed out grains of quartz and cullet fragments cover about 10%

Figure 10 presents advanced ageing processes in domestic siliceous material of the LV stand-insulator after over twenty years of exploitation. About 1/3 of initial amount of quartz phase (29 – 32%) were damaged and underwent crushing out during surface preparation. Remaining grains contained microcracks, especially peripheral. Structural integrity were much weakened and there were found elongated, nearly critical cracks propagating throughout all phases of the material and only deviated by precipitates of mullite.

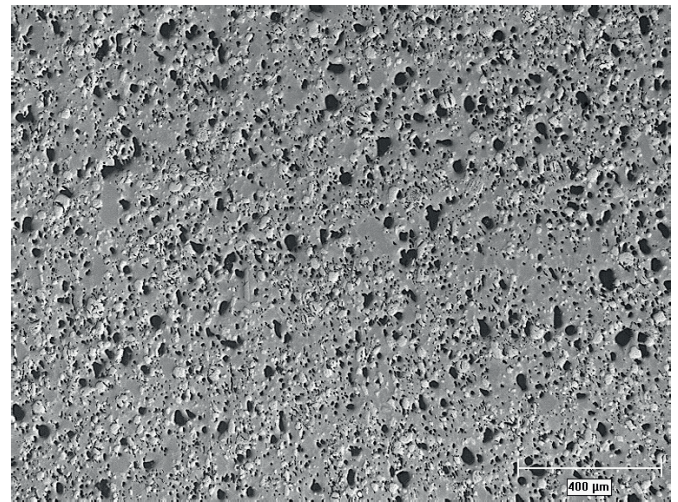
Fig. 11. The image of C 120 type porcelain of HV line insulator after about 30 years operation period, at a magnification of 50x. The effects of the degradation of the structure appropriate to the subcritical stage, with a high degree of advancement. Over 1/3 of the quartz grains (nearly 9%) was separated and crushed out from the structure. In the vicinity of the relics of quartz are present numerous micro-cracks in the glassy matrix

disintegration. In figure 11 is presented typical image of aged aluminous material of domestic line insulator after about 30 years operation period. Advanced degradation processes are visible. They are a consequence of high and diversified amount of the quartz phase in the material structure - initial average content 24%. This phase was the main source of internal stresses, initiation and growth of micro-cracks.
