PROPERTIES AND MICROSTRUCTURE OF LASER WELDED VM12-SHC STEEL PIPES JOINTS

Paper presents results of microstructure and tests of welded joints of new generation VM12-SHC martensitic steel using high power CO₂ laser (LBW method) with bifocal welding head. VM12-SHC is dedicated to energetic installation material, designed to replace currently used. High content of chromium and others alloying elements improve its resistance and strength characteristic. Use of VM12-SHC steel for production of the superheaters, heating chambers and walls in steam boilers resulted in various weldability researches. In article are presented results of destructive and non-destructive tests. For destructive: static bending and Vickers hardness tests, and for non-destructive: VT, RT, UT, micro and macroscopic tests were performed.

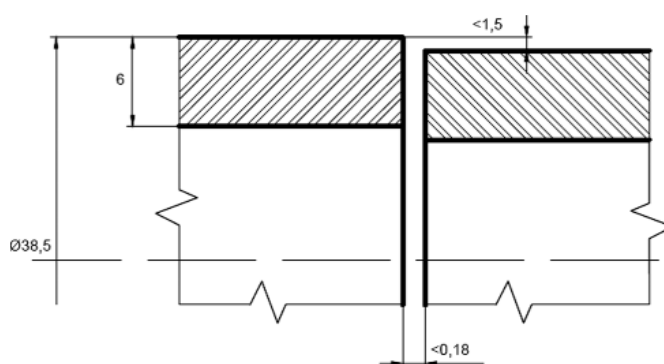
Fig. 1. Preparation of pipe stub edges for laser welding

in laser welding preheating can be perform by defocusing laser beam [7]. Conventional methods of welding require proper prepare of joining edges by chamfering. Due to narrow width of the fusion zone proper fitting of joining edges is require (Fig. 1), by using bifocal welding system this requirement can be reduce. Paper presents results of LBW joining method of VM12-SHC new generation martensitic steel by using bifocal welding head and obtained tests of welded joints results.

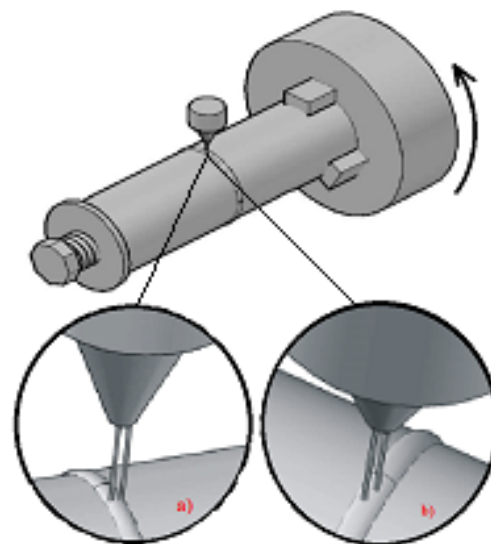
Fig. 2. Schematic of circumferential laser welding pipe stand, foci orientation of bifocal welding head a) option 1, b) option 2

of weld root shielding gas was conveyed. For welding bifocal welding head with bisected mirror was used [5]. Welding was performed with two foci orientation: perpendicular(option 1) and parallel (option 2) to weld in order to verify bifocal welding head orientation on quality of the obtained joints (Fig. 2). In table 2 based laser parameters of welded pipe stub was presented.

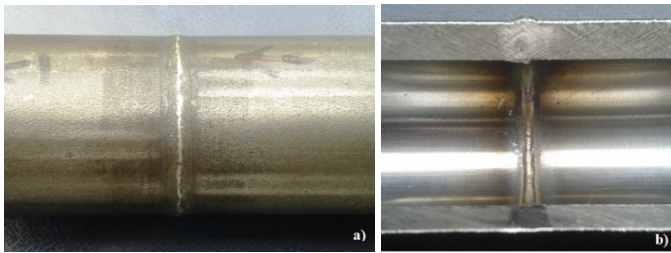
Fig. 3. Face of weld (a) and root of weld (b) after cutting of part of joint

Visual testing was conducted according to PN-EN ISO 17637 [13]. Acceptable quality level identified according to PN-EN ISO 13919-1 [14]. Welds made at B quality level (stringent requirements) subjected to further testing. Fig. 3 shown weld made in option 2 welding head manipulator orientation, qualified to B quality level.

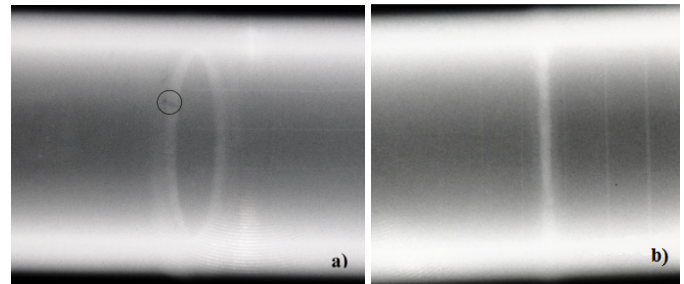
Fig. 4. Radiographic testing a) – option 1, b) – option 2 of weld

Source of radiation was ERESKO 42F X-ray tube with effective focal point of 3×3 mm. To visualize Kodak Industrex MX 125 class C3 photographic film was used. Distance between X-ray manipulator and pipe was 500 mm. Exposition parameters: 140 kV, 4 mA, $t = 1$ mm. Fig. 4 shown radiograms for correct welds. No outer defects were identified, slight gas pore inside of weld was detected.

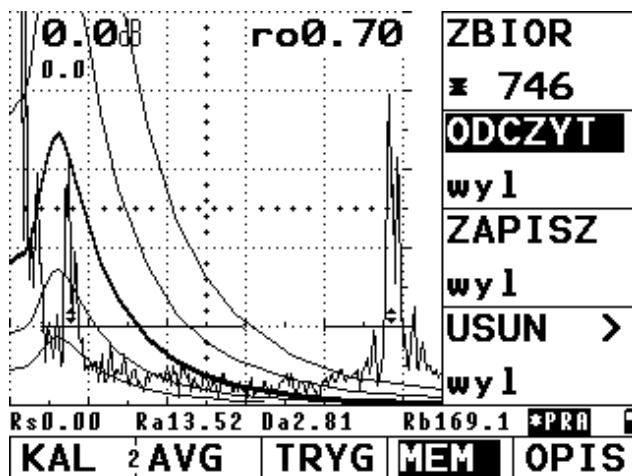
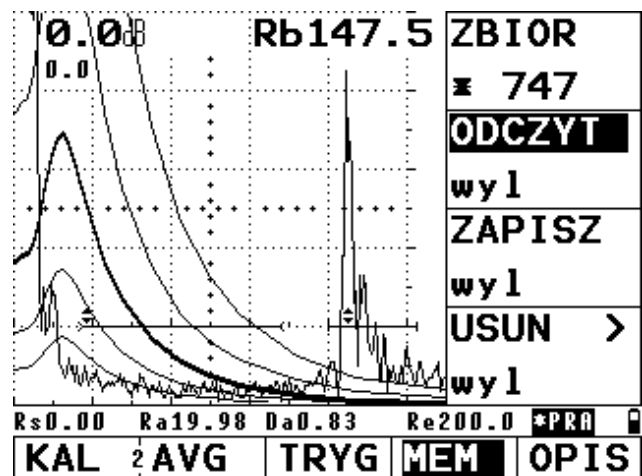
Fig. 5. Ultrasonic tests result

Due to perform testing ultrasonic flaw detector USM 35S of GE (Krautkramer) industry was used. Echo-sounding technique by (MSEB-4) front and (MWB 70–4) side measuring head using DGS ($D_{DSR} = 0.7$ mm) scale. Fig. 5 shown typical detection of gas pore (Fig. 5a) and lack of defects (Fig. 5b).

High compliance of radiographic and ultrasonic tests results were achieved.

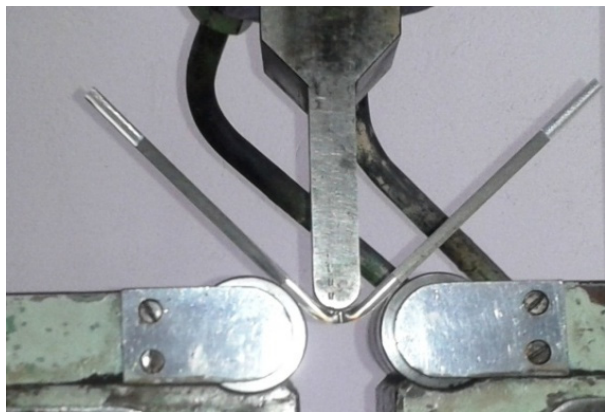
Fig. 6. Side bend test

Technological bending test of weld ductility was conducted according to PN-EN ISO 5173 [12]. Due to weld zone and HAZ in laser welding are very narrow tests were performed on non standard samples size. Static bending test was performed on INSTRON 8501 testing machine (Fig. 6). Diameter of bending die was 40 mm. For both technological option of welding close bend test was received.

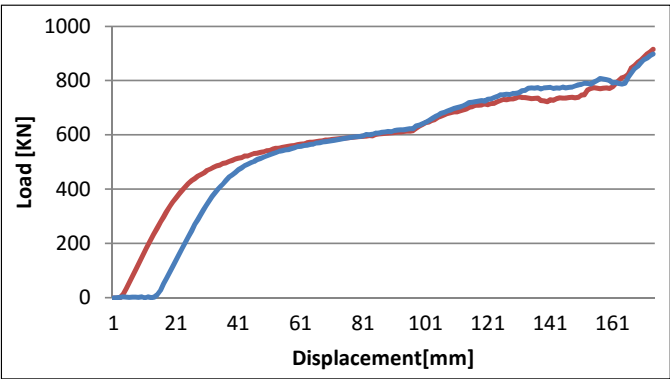
Fig. 7. Static close bend test diagram

Fig. 7 shown very similar results for both welding head orientation options. Lower banding forces in option 1 shown slightly lower properties of receiving weld joints.

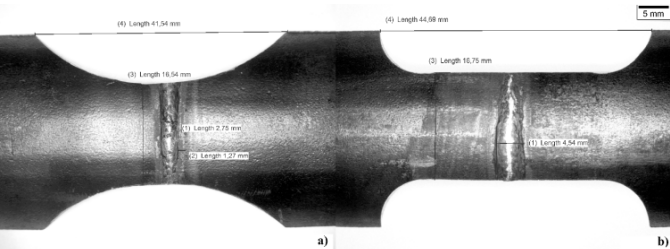
Fig. 8. Samples for tensile test, a) weld, b) welded joints

Technological tensile tests was performed for weld and welding joints (Figs. 8, 9). Results for both options shown good strength properties. Failure of welded joints occurred outside HAZ, failure of weld occurred in interfacial layer of HAZ and weld. Results of static stretching test was shown in table 4.

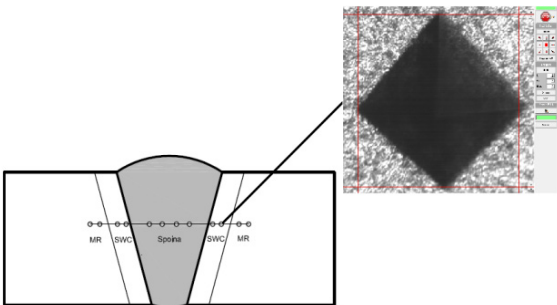
Fig. 10. Hardness test point distribution

Hardness test was carried out for both options according to PN-EN ISO 6507-1 [17]. Fig. 10 shown distribution of test points, Figs. 11 and 12 shown results of hardness.

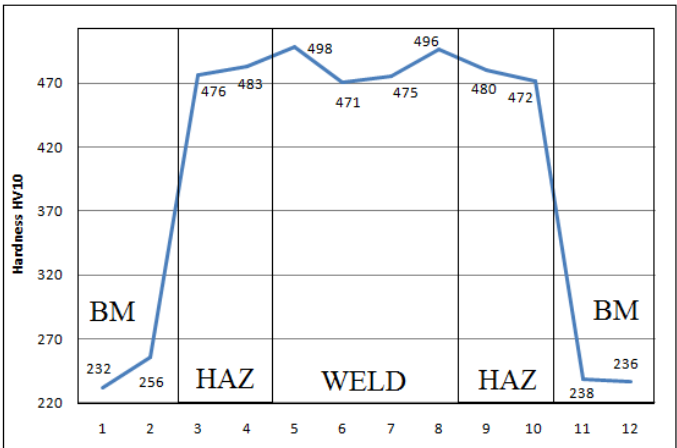
Fig. 11. Hardness distribution in weld cross-section for option 1

Hardness test results shown strengthening in weld and HAZ. Due to both options of welding head orientation hardness distribution is slightly different. For option 1 hardness of weld and HAZ is more uniform than in option 2, however option 2 shown inconsiderable smaller value of hardness in weld than in HAZ towards for option 1, that may indicate of smaller temperature gradients for technological option 1. According to PN-EN ISO 15614-11 maximum allowable limit of Vickers hardness HV10 after heat treatment is 380 [18], however results shown values approximating for 495 HV10. According to standard of PN-EN ISO 15614-11 exceed maximum value of hardness for B quality level and post welded heat treatment are required.

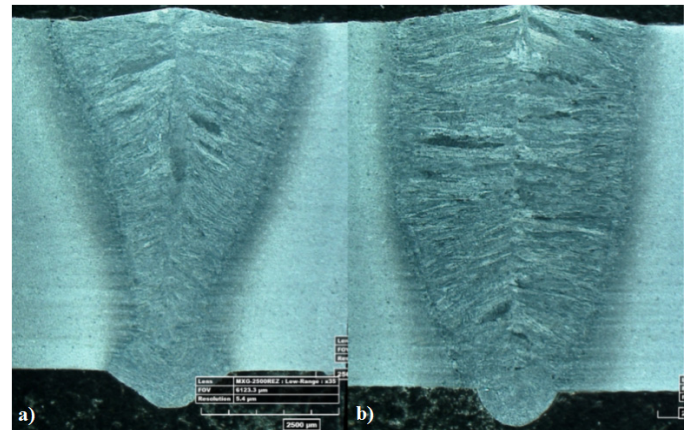
Fig. 13. Macrostructure of weld joints a) option 1, b) option 2 – Hirox confocal digital microscope, magnification 35 \times

Fig. 13 presents macrostructure results of both technological option of welded joints. Macroscopic image shown properly formed of welded joints in cross-section. Welds profiles shown dissimilarity in crystallization process for both technological welding head orientation options.

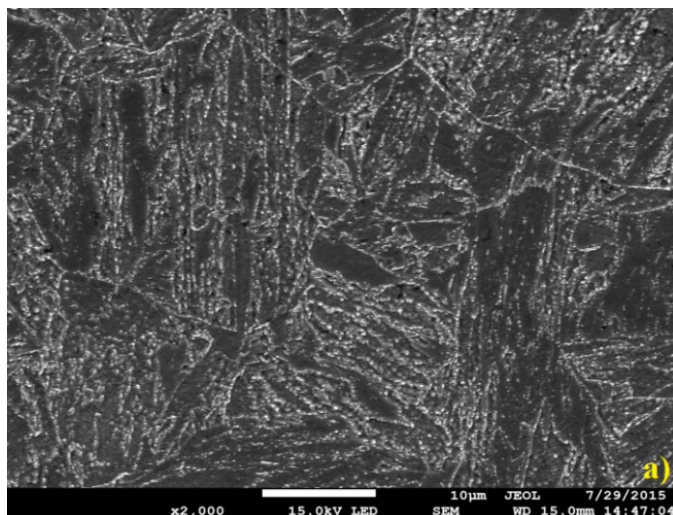
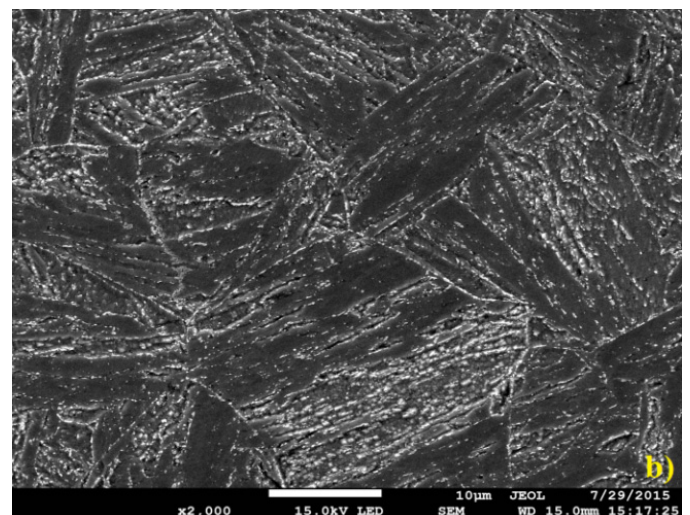
Fig. 14. Microstructure of BM – a) option 1, b) option 2 – JEOL electron microscopy, magnification of 2000 \times

Typical images of BM, HAZ and weld microstructures for laser welded VM12-SHC martensitic steel was presented. Fig. 14 shown microstructure of joint welded in option 1 of bifocal welding head configuration, Fig. 15 shown microstructure for option 2. Obtained weld joints characterized by the occurrence of no welding defects. Typical structure of VM12-SHC welding joints is martensite with carbides precipitates.
