## **Backpressure Testing of Rotary Microfilter Disks**

Mark D. Fowley  
David T. Herman

April 2011

Savannah River National Laboratory  
Savannah River Nuclear Solutions  
Aiken, SC 29808

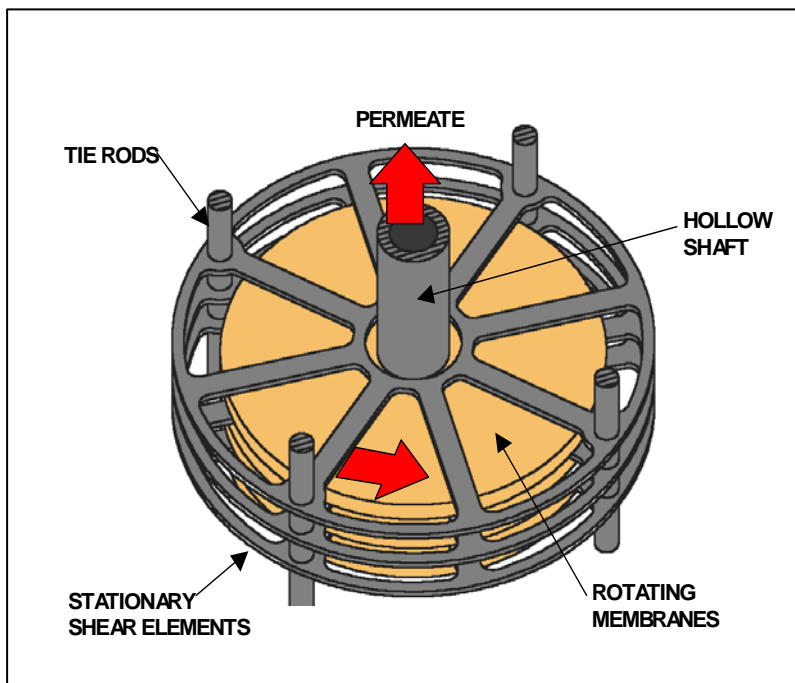
**Figure 1-1: Rotary MicroFilter Configuration, 3 Disks Shown**

The EDL disk assembly had two turbulence promoters (or stationary shear elements, reference Figure 1-1 and Figure 2-6) on either side of the rotary disk. The disk and two promoters were held together by four bolts at the periphery of the turbulence promoters. A pair of Teflon spacers (0.125 inches thick), located on each bolt, maintained a 0.125 inch spacing between the surfaces of the disk and the promoters. The disk was radially centered in the promoters by the hub fitting, which fit snugly in the inner diameter (ID) of each promoter. The hub fitting itself was centered on the disk during assembly and centrality was verified by measurement from the hub outer diameter (OD) to the disk OD at four places. The clearance between the filter membranes and the turbulence promoters from the hub to the OD was approximately 0.125 inches.

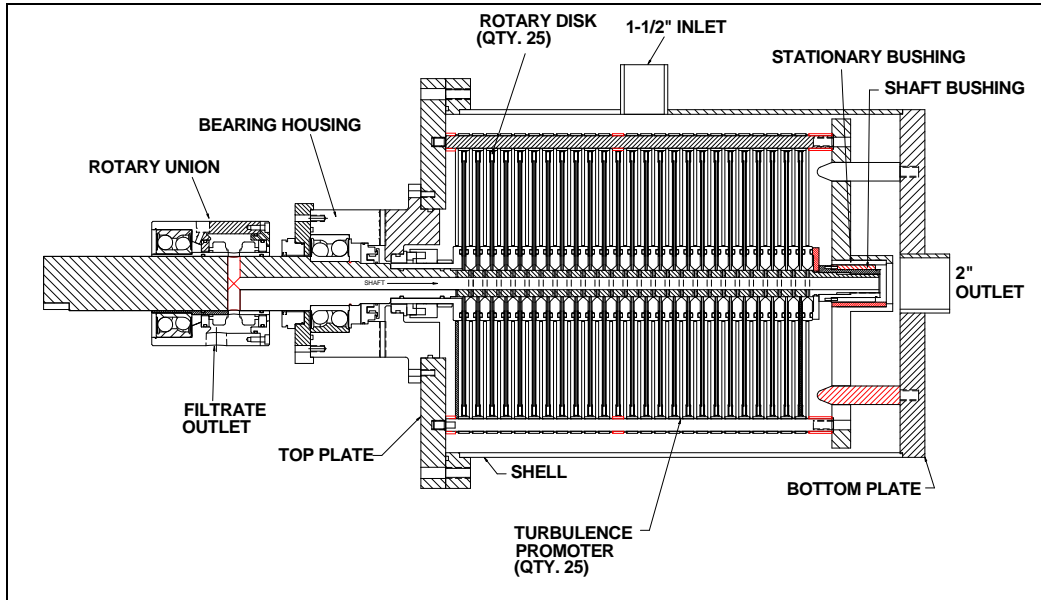
**Figure 1-2: 25 Disk Rotary MicroFilter Assembly**

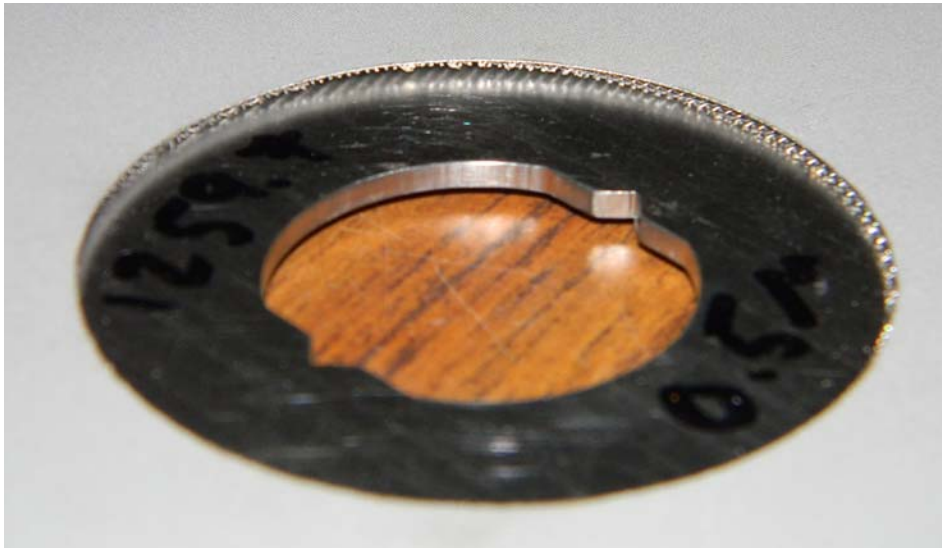
The rotary disks were constructed from stainless steel, and formed in a sandwich-like configuration (Figure 2-1). The center was a solid core, approximately 10-3/4 inches in diameter and 0.125 inches thick, with a notched hole in the middle to accommodate the hollow shaft. On both sides of the core was a large-mesh screen that provided the flow path for the filtrate to the

hollow shaft, and on top of each screen was the Pall Corporation PMM050 0.5 micron nominal pore size filter, which was only 0.007 inches thick. The stainless steel membranes were made by adhering powdered stainless steel to a woven wire mesh. The effective filter area of each disk was 0.98 ft<sup>2</sup> (value includes both sides of the disk). The membrane was seal-welded to the solid core at the outer perimeter but was not welded or similarly affixed to the core at the hub. The membrane was sealed at the hub by o-rings. In the 25-disk RMF the o-rings are in the shaft assembly; in the EDL disk assembly the o-rings were in a special hub fitting (reference section 2.2.2).

**Figure 2-1: Hub of SpinTek Stainless Steel Rotary MicroFilter Disk**

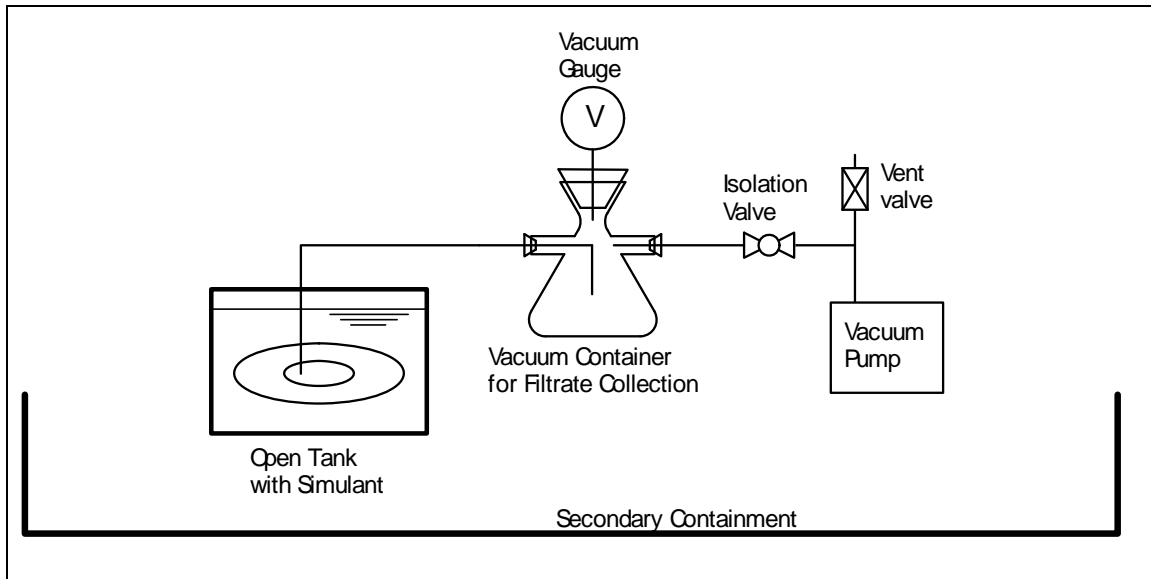
For the forward-pressure test the disk was submerged in simulated sludge to extract filtrate through the filter membranes. The turbidity of the filtrate was measured to quantify the efficiency of the RMF. A standard laboratory vacuum pump was used to pull filtrate through the membranes in the forward direction. A container in between the pump and the disk collected the filtrate for turbidity measurement. A vent valve at the vacuum pump was used to regulate the vacuum on the disk and an isolation valve in between the pump and the vacuum container provided isolation for the container and the disk, if desired. The simulated sludge was contained in a shallow tub where the disk was placed in the horizontal position. The position of the disk was deemed inconsequential for extracting filtrate; therefore, the horizontal position was chosen to minimize the amount of simulated sludge required.

**Figure 2-3: Sketch of the Forward-Pressure Test Equipment**

The two test configurations for the backpressure and forward-pressure tests are depicted in Figure 2-2 and Figure 2-3.

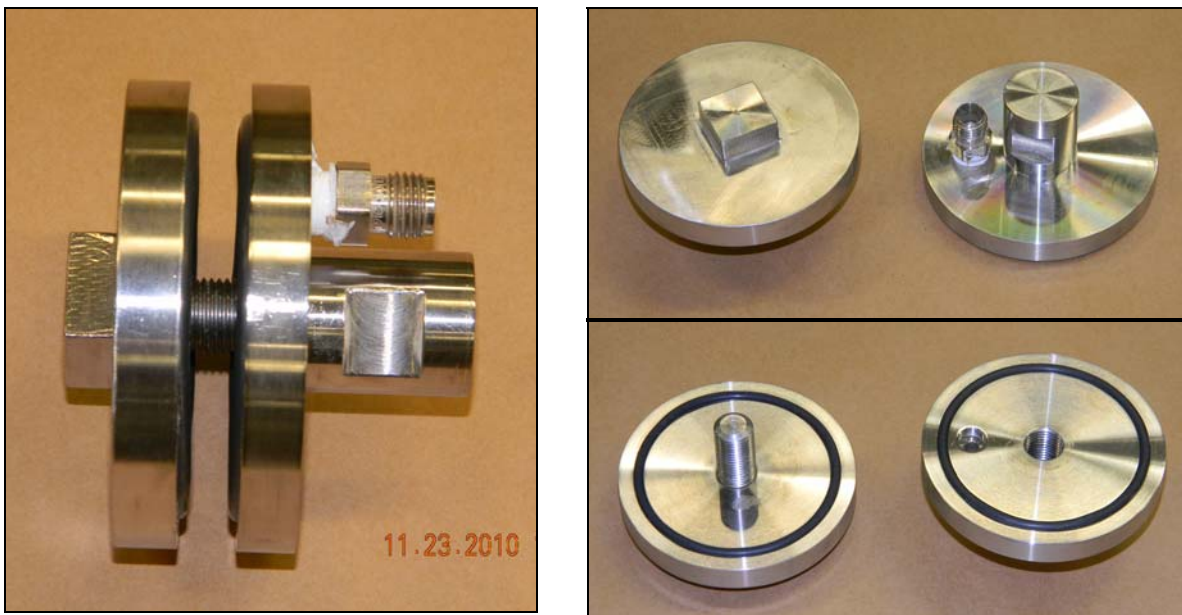
In both the backpressure and forward-pressure test a special hub fitting was used to apply pressure and vacuum to the RMF (see Figure 2-4). The hub fitting was constructed of two separate pieces that were mechanically joined by a threaded stub in the center. Each piece contained an o-ring on the inner surface to provide a seal on the membrane surface. One side of the fitting contained a Swagelok® connector for the pressure or vacuum line.

**Figure 2-4: Hub Fitting for Pressure Tests. Assembly View, Outer View & Inner View (with O-rings).**

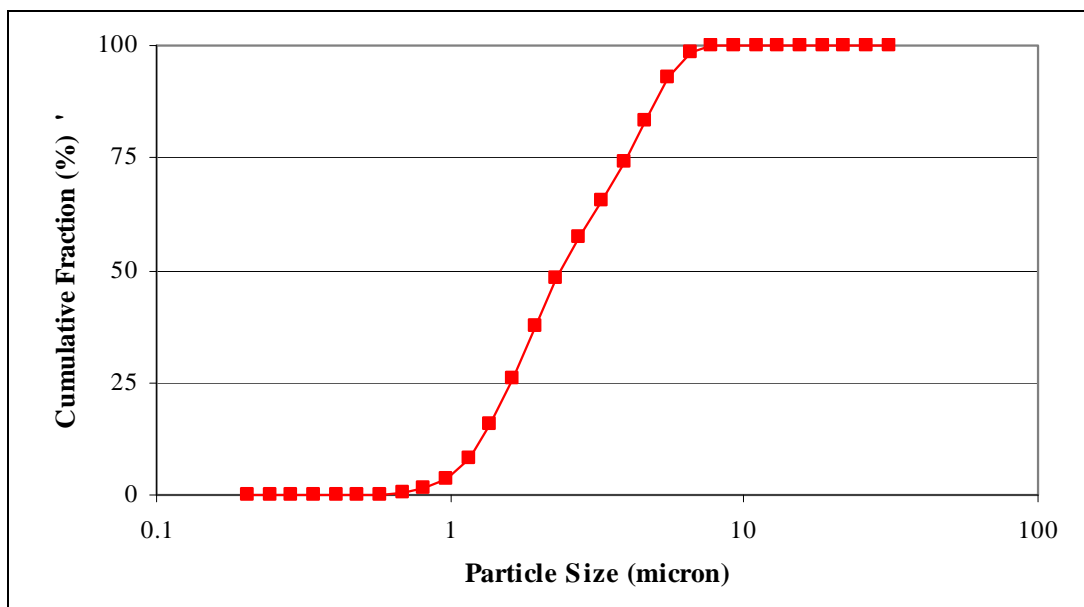
The particle size distribution (PSD) for the simulated sludge is shown in Figure 2-5. The mean particle size was approximately 2.3 microns and approximately 3.8% of the particles were less than 1 micron [5].

**Figure 2-5: PSD of SRS Tank 8F Simulated Sludge**

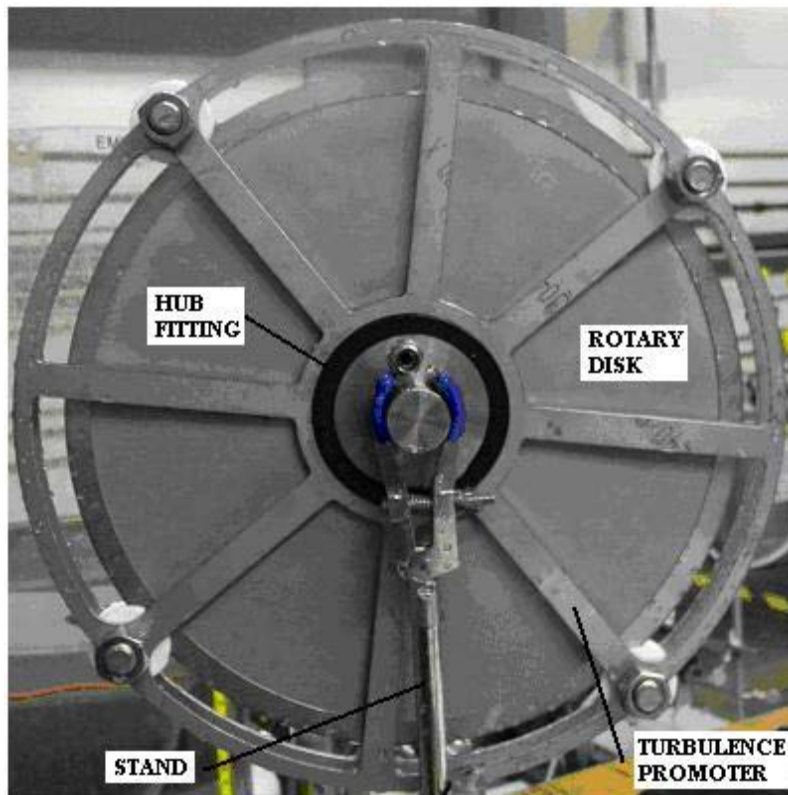
The first disk was assembled with two turbulence promoters on either side and attached to the disk stand. The pressure line was attached and then the assembly was submerged in a 40 gallon clear acrylic tank. The disk assembly, with the stand, is shown in Figure 2-6.

Note in Figure 2-6 a black band around the OD of the hub fitting. This was electrical tape that (along with the Teflon spacers) electrically isolated the disk from the promoters. The intent was

to measure the resistance between the disk and a promoter while submerged in the clear tank. The resistance was expected to notably change when the filter membrane expanded to contact the promoter. The resistance was measured by a hand-held multimeter. Unfortunately, the resistance measurement was unstable and did not provide reliable data.

**Figure 2-6: Disk Assembly for Backpressure Test**

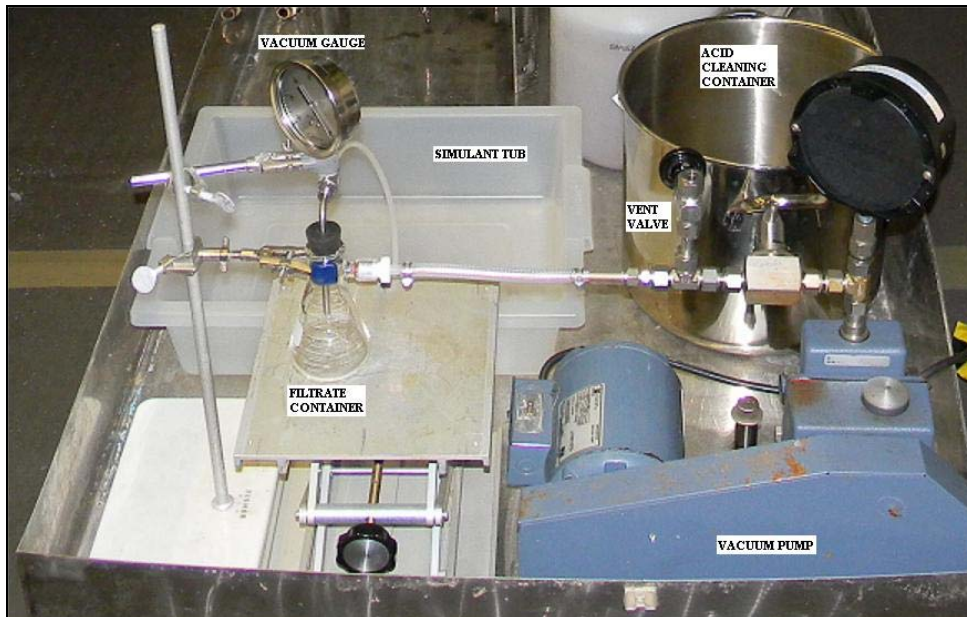
The disk assembly was removed from the tank and a forward-pressure test was conducted on the disk. A picture of the forward-pressure test equipment is shown in Figure 2-7. The same hub fitting was used for the forward-pressure test but the turbulence promoters were removed. The

filtrate collection container was cleaned, the vacuum line was attached to the hub fitting and the disk was submerged in the tub of simulated sludge. Filtrate was first extracted to rinse the collection beaker then drawn for turbidity measurement. The filtrate was extracted by applying a slight vacuum to the disk (approximately 4 in Hg), the magnitude of which was controlled by the vent valve. Approximately 100 ml of filtrate was collected for the turbidity measurement.

**Figure 2-7: Forward-Pressure Test Equipment**

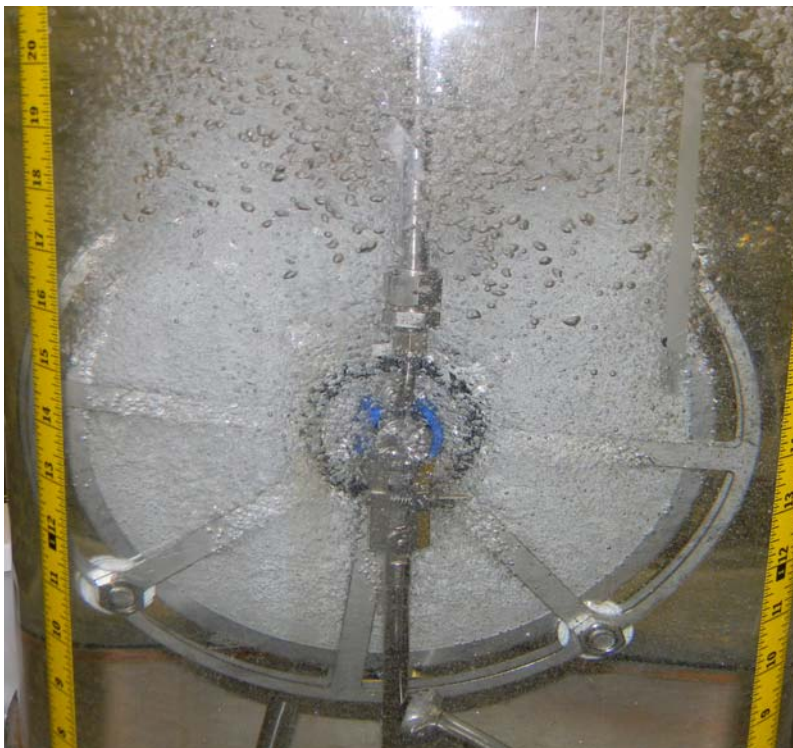
Figure 3-1 shows a typical bubble pattern for Disk 1 during the backpressure test. The bubble flow pattern throughout each day of testing appeared uniform across both sides of the disk, however, at the higher pressures (above ~30 psig) the features of the disk above the hub were obscured by the intense bubble flow. Regardless, any physical damage to the filter membrane was expected to be readily detected at both the lower and higher backpressures. Physical damage was not detected during the entire backpressure test of the first disk regardless of the bubble flow.

**Figure 3-1: Disk 1 during the Backpressure Test**

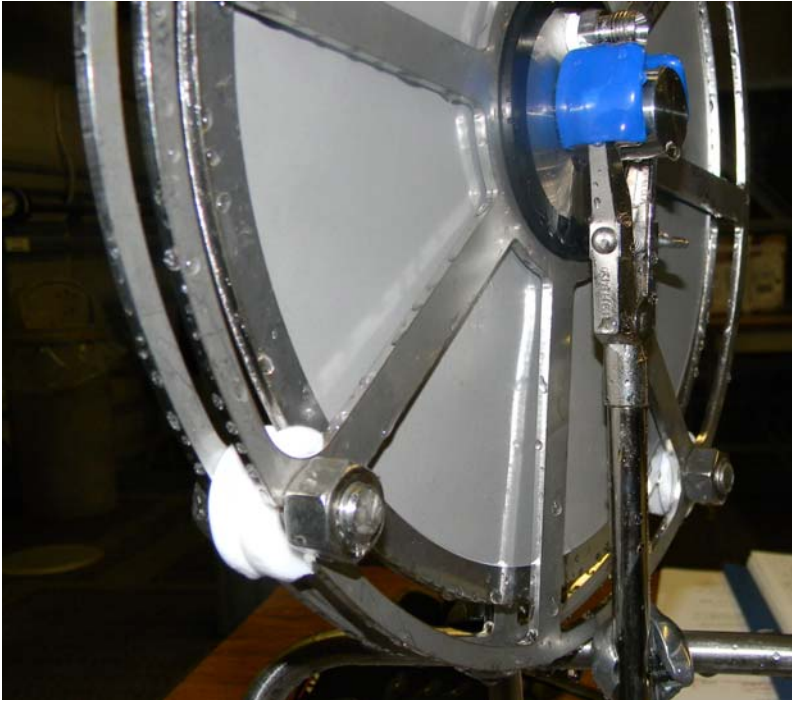
The inspection at the end of the first day revealed some deformation of the filter membranes of both sides in the form of a permanent bulge near the hub fitting. Figure 3-2 shows the disk assembly in the stand. Note the diminishing gap between the side of the promoter spoke and its

reflection at the 6 o'clock position. The gap was 0.05 inches at the closest point and 0.125 inches at the OD of the membrane.

**Figure 3-2: Disk 1 After 40 psig Backpressure**

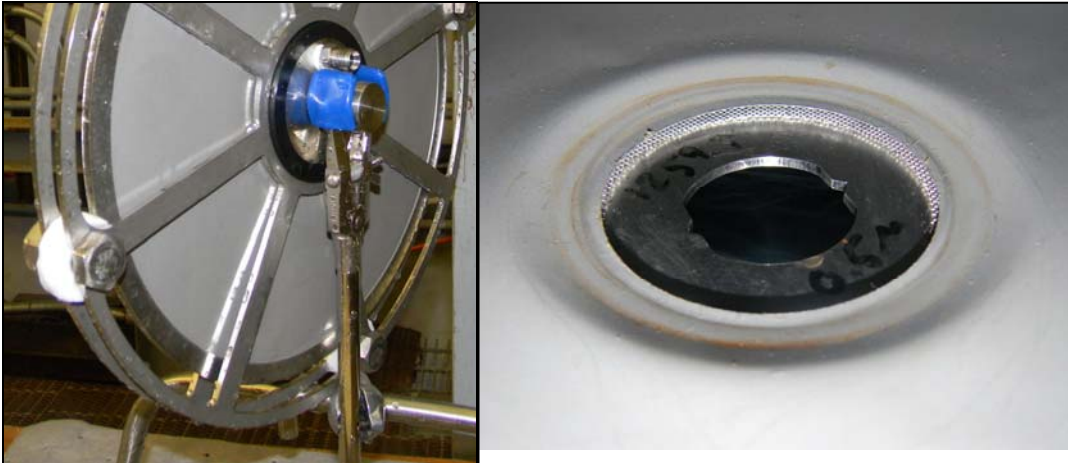
The inspection at the end of the second day revealed deformation, however, the amount of deformation did not appear to have increased. The gaps between the promoter spokes and the membrane measured at the end of the second day were comparable to the gaps at the end of the first day. Figure 3-3 shows the deformation of the first disk at the end of the second day. The first photo is the assembly, highlighting the diminishing gap from the OD to the hub between the membrane and promoter spoke. The second photo is the hub of the disk showing the extent of deformation around the hub fitting. When a flat-edge was laid across the bulges the maximum height of the flat-edge from the core surface was 0.160 inches (measured on both sides of disk).

**Figure 3-3: Disk 1 After 75 psig Backpressure**

The extent of the membrane deformation is shown in Figure 3-3 (Disk 1) and Figure 3-4 (Disk 2). The shape and location of the deformation was similar between the two disks but the pressure at which the deformation occurred and the extent of the deformation was not. Wrinkles or slack in the membrane may have contributed to the differing amounts of deformation.

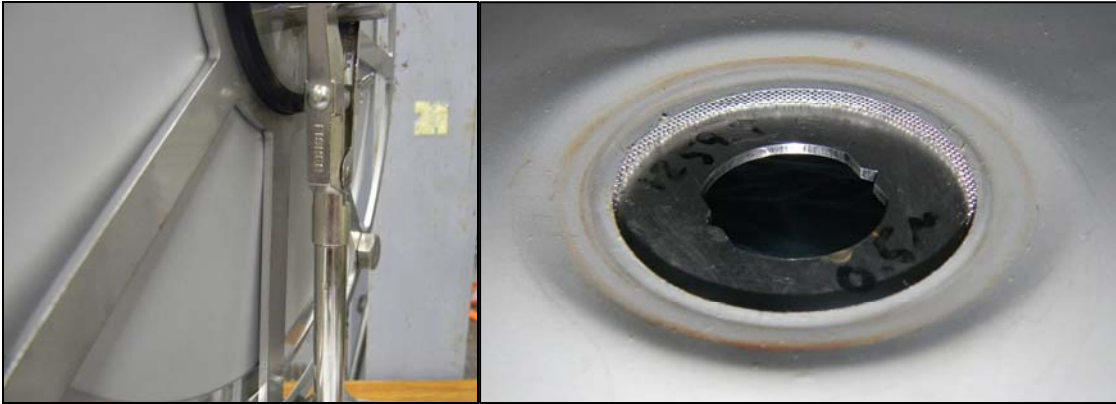
The Disk 2 was backpressured to 5 psig for 10 minutes then removed from the tank for inspection. The bubble flow pattern appeared uniform throughout the test. Upon inspection it was seen that the filter membranes on both sides had permanently deformed to the extent where one appeared to contact a spoke of the turbulence promoters. Figure 3-4 shows the deformation of the second disk after the initial backpressure test of 5 psig. The first photo is the disk assembly showing the gap between the membrane and promoter spoke. The second photo shows the extent of deformation near the hub fitting. The smallest gap between the membrane and spoke was 0.008 inches. The gap at the OD of the membrane was 0.125 inches. The backpressure testing of the second disk was not continued since it appeared that one membrane had deformed to the turbulence promoter in the 5 psig test, implying membrane failure during rotational operation. When a flat-edge was laid across the bulges the maximum height of the flat-edge from the core surface was 0.230 inches (measured on both sides of disk).

**Figure 3-4: Deformation of Disk 2 Membrane**

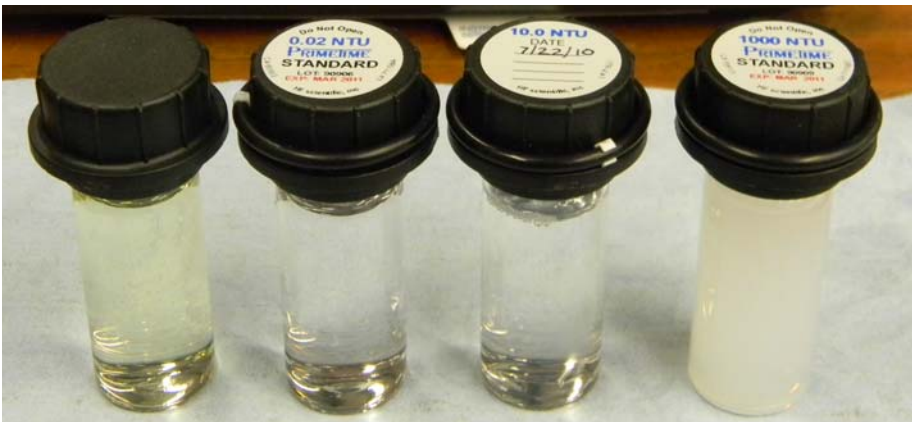
Figure 3-5 shows the filtrate from the second disk along with vials of the turbidity standards used to calibrate the turbidity meter. The turbidity values of the standards, from left to right, are 0.02, 10.0 and 1000 NTU. The filtrate appears clear with some yellowish coloring. Referencing the PSD chart in Figure 2-5, there is a negligible amount of particles below the nominal pore size of the RMF (0.5 micron) and only 3.8 % of the particles less than 1 micron. The slight coloration of the filtrate can be attributed to dissolved solids and conceivably the small percentage of particles less than 0.5 micron in the simulated sludge that may have passed through the filter (reference Figure 3-5).

**Figure 3-5: Vials of Filtrate (left) and Turbidity Standards (0.02, 10.0 & 1000 NTU)**

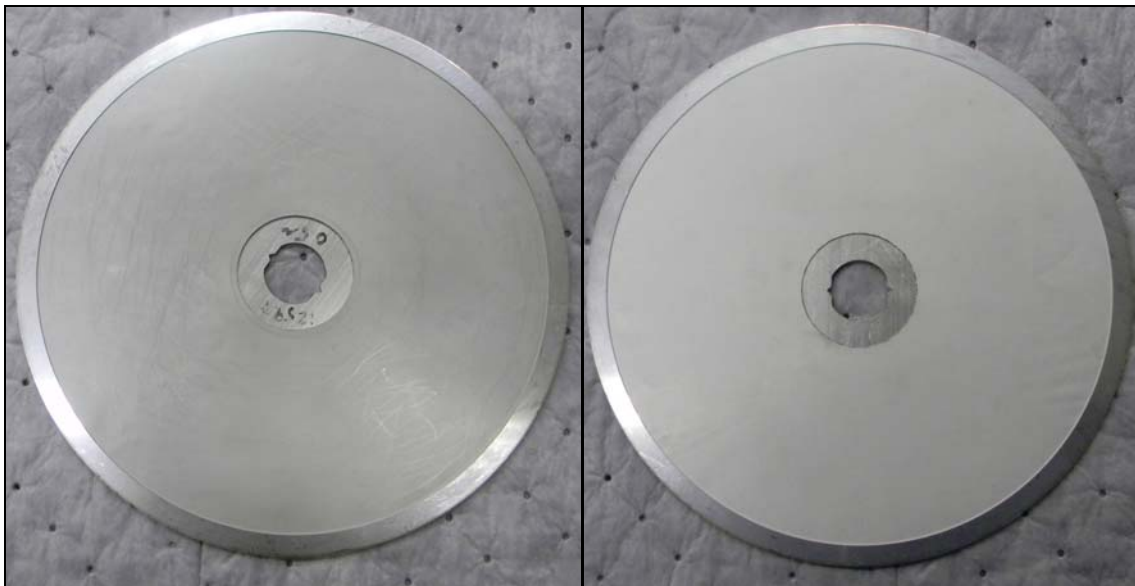
Each side of the RMF is constructed by first laying the pre-cut doughnut of membrane material on top of a pre-cut doughnut of large-mesh screen on top of the solid core. A thin stainless steel ring, approximately 0.4 inches wide and slightly larger than the OD of the disk, is seal welded around the OD circumference, which bonds the membrane and core together. The membrane is bonded to the core at the OD only. The membrane lies loosely on the screen and is not stretched prior to welding. The membrane is typically flat but, in some assemblies, wrinkles or other contour irregularities have been noted. The presence of wrinkles, or slack in the membrane, may provide more “give” during deformation. Figure 3-6 shows both sides of the second disk prior to the backpressure test. Wrinkles and other irregularities can be seen on both sides of the disk; more so in the second photo, at about the 4 o’clock position at the OD. Pre-test pictures of the Disk 1 are not available for comparison.

**Figure 3-6: Wrinkles in the Front and Back Membranes of Disk 2**

There may be other contributing factors for the greater deformation such as the torque applied to the hub fitting during assembly. The torque was not measured but may have been less for the disk that had more deformation. A reduced torque might allow material to slide under the o-ring during deformation providing more material for the deformation.
