Department of Energy FOA Award DE-FC36-08GO18036

Development of Advanced Polymeric Reflector for CSP Applications

Final Report
March 28, 2013

<i>Lead Organization:</i>	Abengoa Solar Inc (ASI)
<i>Other Team Members:</i>	Deposition Technology Innovations Inc (DTI)
	Science Applications International Corp. (SAIC)
	Swisher and Associates

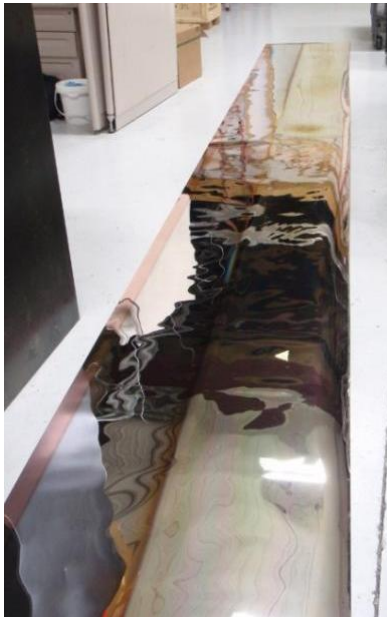
Initial film samples showed brown and yellow discoloration, as was expected for uncalibrated runs in the new chamber. Clarity increased incrementally with adjustments to the process parameters. During long process runs in September highly transparent alumina coatings were achieved. On-site measurements via UV-Vis spectroscopy, showed very high reflectance of approximately 96%.

Figure 7. Reflective film. Left side is bare silver film and right side is Alumina coated film

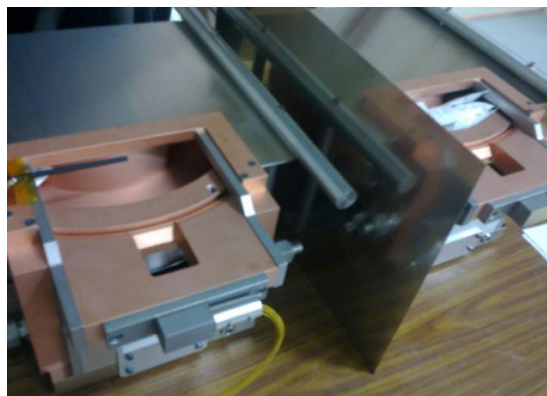
This made it necessary for the team to determine whether a “head-to-head” e-beam gun orientation could be used, or whether the magnetic cross-talk issues would be too great in this configuration. To make the determination, bench-top magnetics tests were performed. Two e-beam guns were placed side by side in both “head-to-head” and “head-to-tail” orientations, with varying numbers of μ -metal sheets placed between them, Figure 9. The electromagnetic sweeps were turned up in steps to maximum power. Magnetic measurements were taken with a gauss-meter at each interval, to determine the electromagnetic effects of each gun on the other.

Figure 9. E-beam magnetic field test with a piece of μ -metal placed in between the sources

The tests revealed a number of surprising results. The effect of the μ -metal sheets, which are supposed to act as magnetic shields between the guns, was found to be nearly negligible. Data collected from the magnetic measurements in the “head-to-head” orientation indicated that very little interference existed between the two e-beam sources, just as the team had hoped. An additional break-through was made when consultant Richard Swisher suggested that placing a mild steel plate beneath the guns would carry the magnetic field lines away from the guns, thus reducing the inherent interaction between them. Designs were updated to reflect the “head-to-head” e-beam orientation and a mild steel baseplate was specified in place of a stainless steel one.

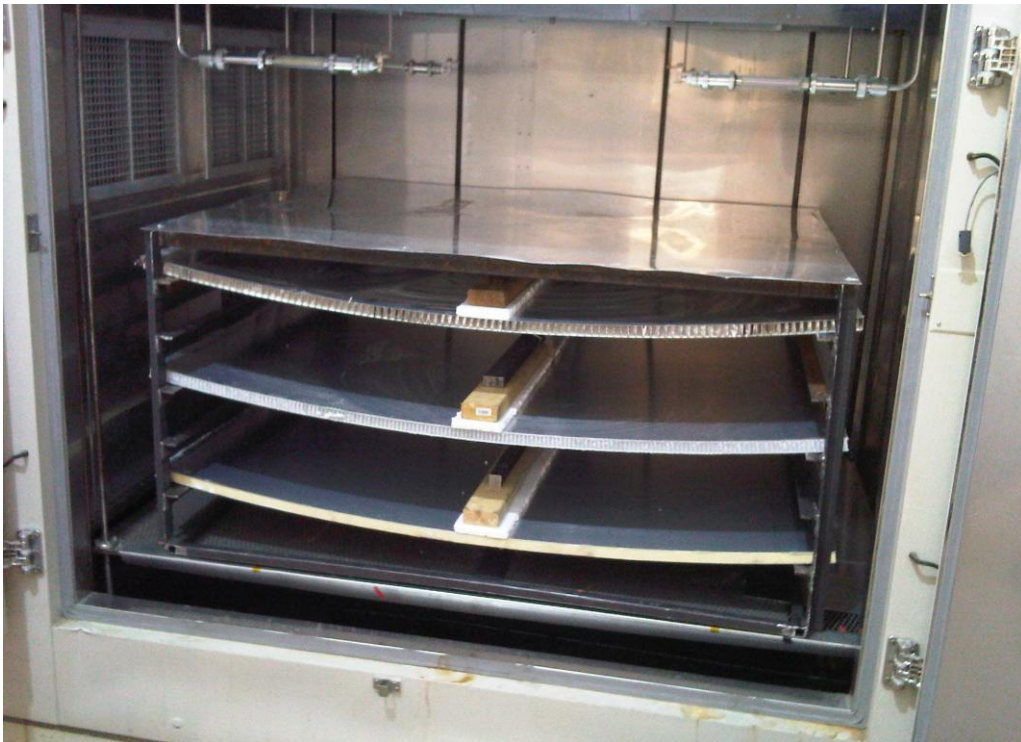
Following initial optical analysis, the NREL environmental chamber was used for accelerated weathering testing. The panels were supported and loaded in the test chamber to mimic the shear and bending loads experienced in the field. During environmental testing, samples were cycled daily on weekdays between ambient and 60°C temperatures.

Figure 14. Panels in Elevated Temperature Chamber

Panels underwent a total of 964-975 hours of environmental testing. Of the three different panels optically tested, only one passed the elevated temperature test with a change in slope of 0.33 mrad. The other two core materials showed measurable deformation following exposure, 1.02 mrad and 0.96 mrad respectively. However, the adhesive used by the manufacturer to laminate both of these panels was found to have had a T_g below 60°C. Therefore the increase in creep could have been due

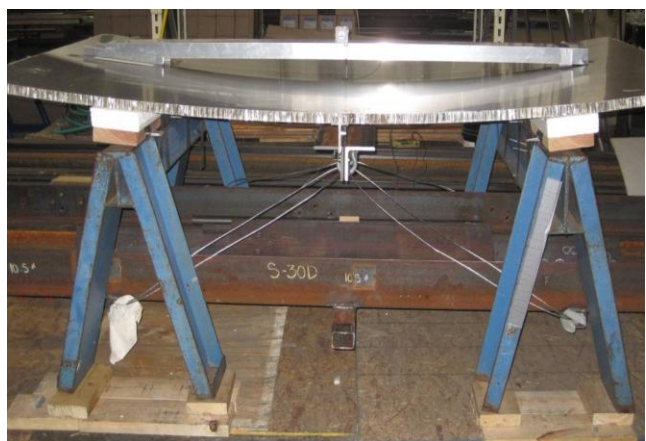
Structural testing was performed on the panels. Panels were subjected to a 3-point bending test, with a test panel section spanning 39 or 54 inches across two sawhorses, suspending a weight bucket from a stringer bonded to the panel (Figure 15). The deflection of the panel was measured and the panel was unloaded and inspected for signs of permanent deflection using the laser radar.

Figure 15. Structural Test Setup

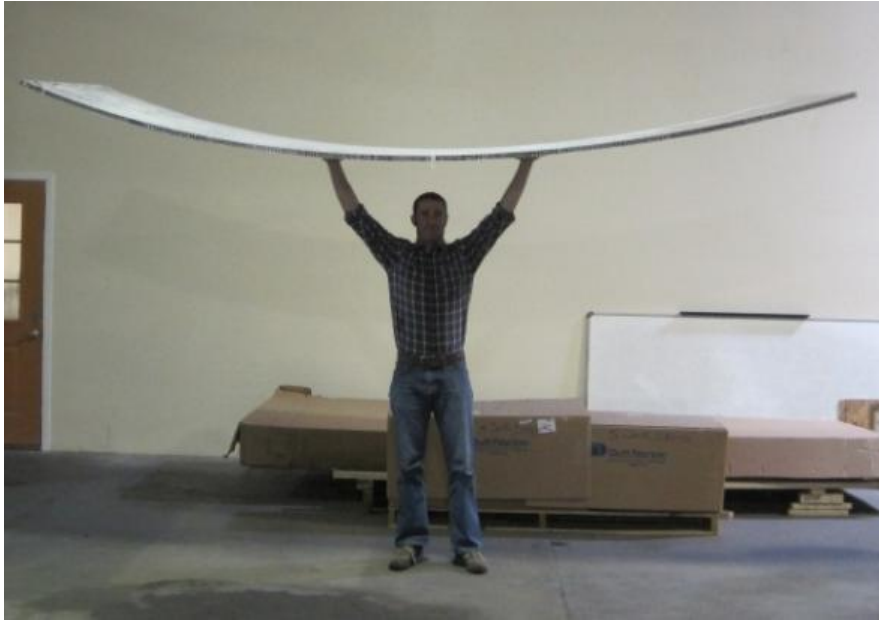
The strength and light weight of the ASRM and composite panel is expected to allow more than 33% reduction in the collector structure, with attendant LCOE reductions. This light-weight characteristic is clearly demonstrated in Figure 16.

Figure 16. The incredible light weight of the full size prototype panel

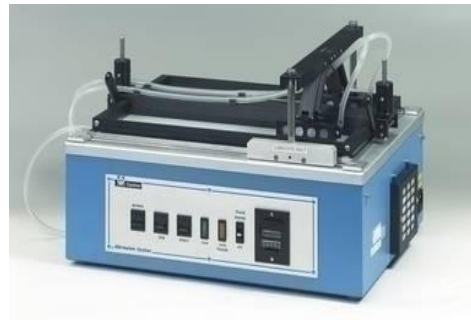
The scrub test system shown in Figure 22 is used to test the durability of the alumina coating over a 30 year period with periodic scrub cleaning. By looking at the reflectance measured via UV-Vis before and after the scrub test degradation in film properties should be visible. A shift in the maxima and minima will indicate degradation in the barrier layer.

Figure 22. ASTM D2486 Two-Channel Wet Abrasion Scrub Tester
