Advancing Residential Retrofits in Atlanta

March 2012

Prepared by
OAK RIDGE NATIONAL LABORATORY
Oak Ridge, Tennessee 37831-6283
managed by
UT-BATTELLE, LLC
for the
U.S. DEPARTMENT OF ENERGY
under contract DE-AC05-00OR22725

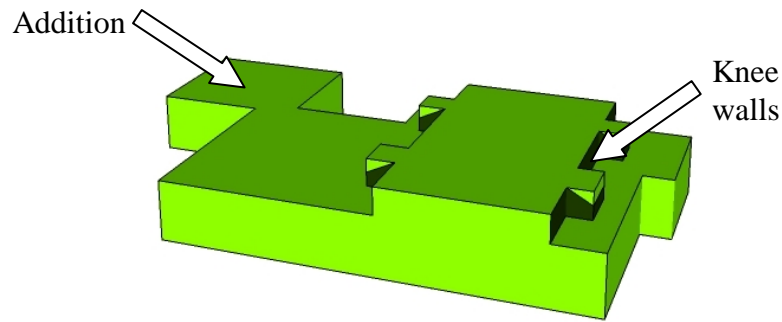
Figure 3. New York initial envelope profile

An illustration of the building envelope is shown in Figure 3. The building envelope is bounded by a framed floor above the vented crawlspace and an insulated ceiling plane above the first and second floors. The interior ceiling height for the first floor is 9 feet, while the average height of the second floor is 7 feet. The dark green colors in the figure represent the attic knee walls. As seen in the figure, there is significant attic exposure through knee walls, which had no insulation.

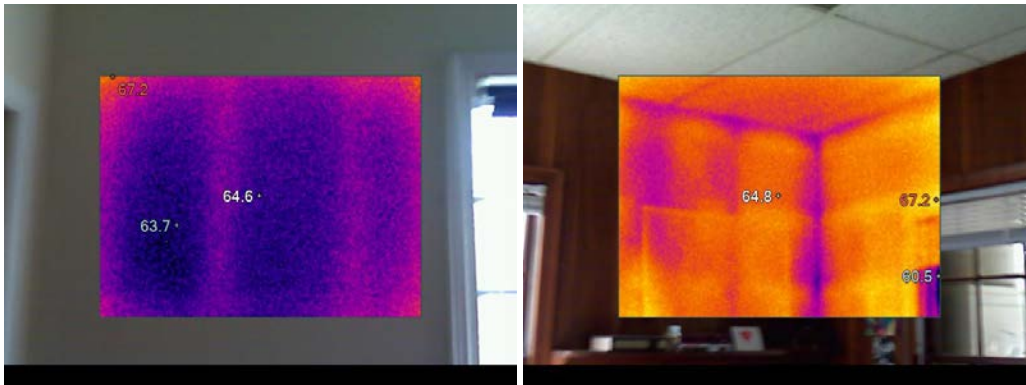
Figure 4. Thermal image of the exterior walls in the main section of the home (left image) and the addition (right image).

To aid in the building assessment, thermal infrared imaging was done. After an initial thermal scan and visual inspection by probing into a wall outlet of the main house, no presence of exterior wall cavity insulation was found. A thermal image of the main section of the home is shown in Figure 4. In contrast, the addition to the home, which was added in later years, was determined to have wall cavity insulation, as seen in the figure. R-11 fiberglass batts were assumed to be in the wall cavities.

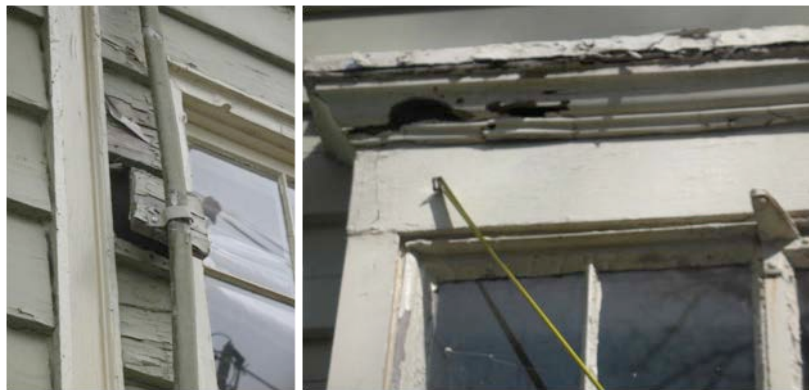
Figure 5. Photographs show examples of places in the exterior siding where rotting has occurred.

The windows in the home are all single pane, with a mixture of metal and wood frames. The exterior cladding on the building was all wood siding. In many places, the siding needed to be replaced or repaired where evidence of rotting could be seen (Figure 5)

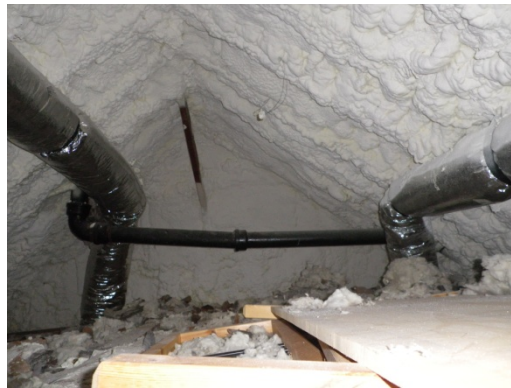
Figure 7. Open-cell spray foam on the roofline and gables.

The attic was encapsulated by applying open-cell spray foam between the 2" x 6" rafters. The final layer of spray foam was applied in a manner that both filled the cavity between the rafters and left a continuous layer over the rafters eliminate thermal bridging, achieving an assembly insulation value of approximately R-21. A picture of the roofline after open-cell spray foam application is shown in Figure 7. The gable walls were insulated with 3.5" of open-cell spray foam (R-13). All vents in the attic were covered and subsequently sealed and insulated with an overlay of open-cell spray foam.

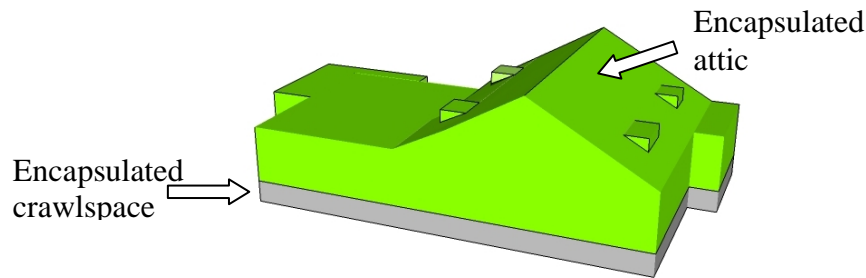
Figure 8. Illustration of building envelope after encapsulating the attic and crawlspace.

The new building envelope is illustrated in Figure 8. As shown in the figure, the attic and crawlspace are now considered part of the building envelope.

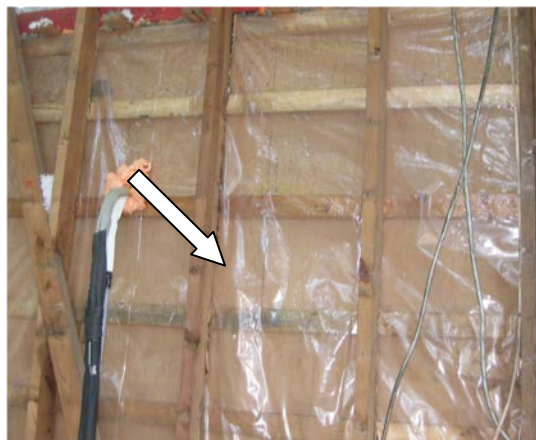
Figure 9. Wall cavity in New York where an interior vapor barrier is present.

After the siding was removed, the existence of exterior sheathing, or lack thereof, was evident. The original part of New York which was built in the 1920s (“main section”) had diagonal plank sheathing, while the addition had no exterior sheathing. Even though the addition originally had R-13 batt insulation in the cavities, there were many voids in the cavities. Therefore, the batts were removed so that fiberglass insulation (Spider® by Johns Manville) could be blown in the cavities of both the main section of New York as well as the addition. However, after the batts were removed in the addition, a plastic vapor barrier was found attached to the inside of the walls. In Climate Zone 3, a vapor barrier should not be applied on the interior of the wall cavity because condensation can develop behind the walls, which could result in compromised durability and wood rot. Fortunately, one of the researchers on this project was on site to remove the plastic film prior to the insulation being blown in the cavity.

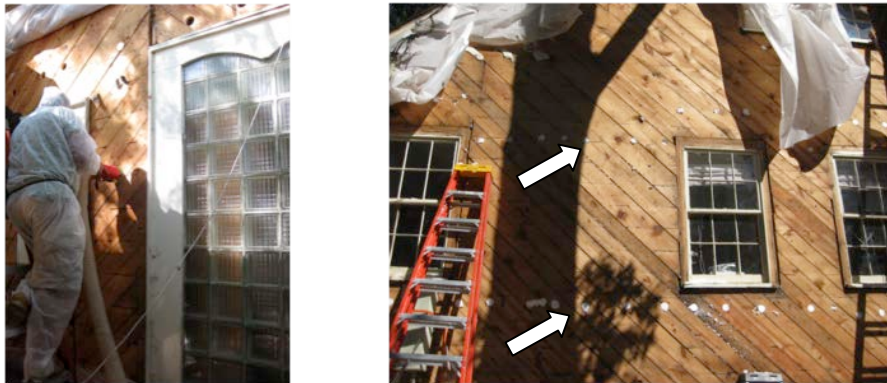
Figure 11. Photographs of the "drill-and-fill" installation of fiberglass insulation into the cavity walls. Image on the left shows the installer blowing fiberglass into the cavity. Two holes in each cavity can be seen in the image on the right.

In the main section of the home, the insulation was blown into the cavities through two holes drilled in each cavity – one at the top, and one at the bottom. The installer blew the fiberglass in from the top to let the insulation sink to the bottom. The installer then “dense packed” the insulation in the wall by blowing fiberglass into the bottom hole in the cavity.

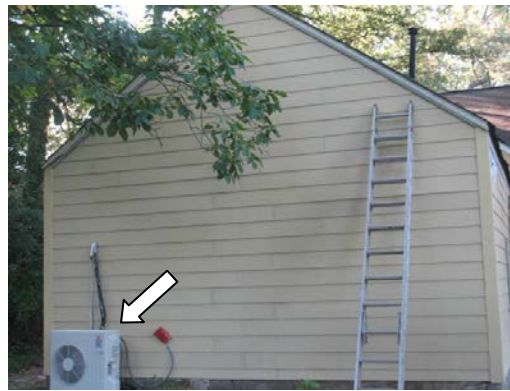
Figure 12. Photograph of the rear view of the addition. The mini-split outdoor unit is highlighted in the image by the arrow.

To replace the resistance heaters and the through-the-wall air conditioner in the addition, a ductless mini-split heat pump system with an indoor unit capacity of 1 ton and an efficiency rating of 19.2 SEER and 10.1 HSPF was added. The outdoor unit has a rated capacity of 1.5 ton unit. The refrigerant line comes from the outside into the back of the addition as shown in Figure 12.

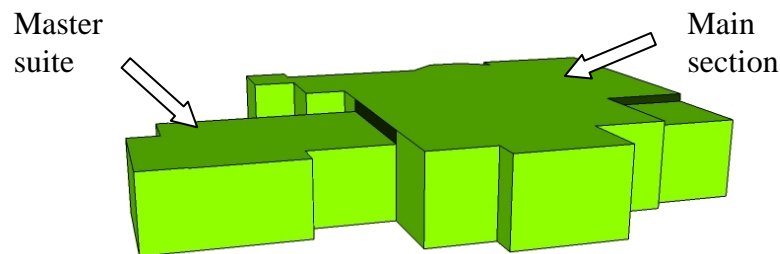
Figure 16. Illustration of Michigan's initial building envelope profile.

Shown in Figure 16 is an illustration of the initial envelope profile for Michigan. There are high ceilings throughout the main section and master suite with heights of 12 ft and 10 ft, respectively. The envelope is bounded by an insulated framed floor above the vented crawlspace and an insulated ceiling plane above the first floor. Represented in Figure 16, by the dark green colors are attic knee walls that result from the varied ceiling heights. There were R-13 batts (rock wool) in most of these knee walls, as shown in Figure 17.

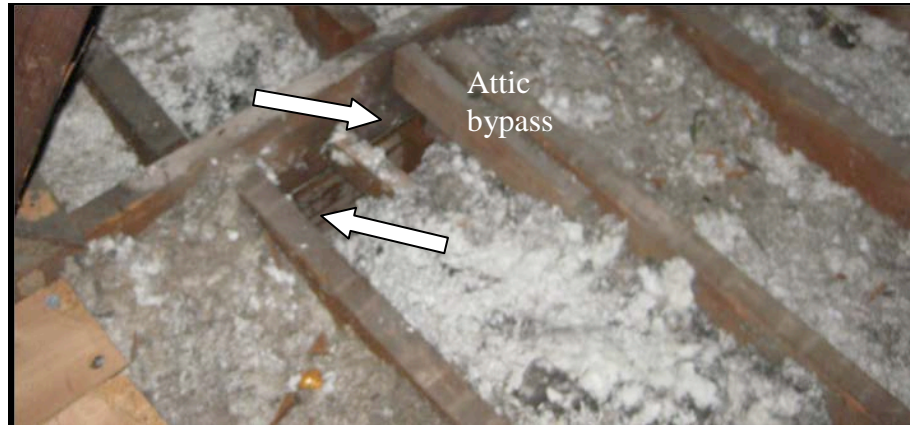
Figure 18. Photograph of attic bypass to interior walls.

As shown in Figure 18, loose fill was present in the attic ceiling with a range of coverage equivalent to insulation values that averaged R-11. However, while insulation was present, the consistency was limited. There were places in the attic ceiling that were insulated with packing peanuts (Figure 19).

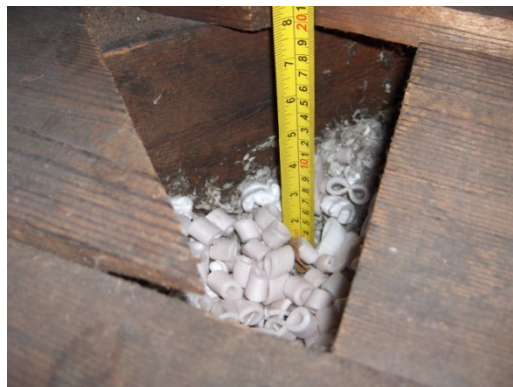
Figure 19. Packing peanuts used as insulation.

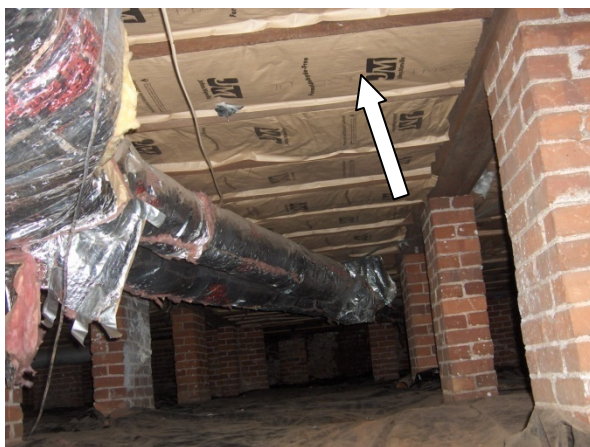
Figure 22. Photograph of the R-13 batts installed in crawlspace ceiling.

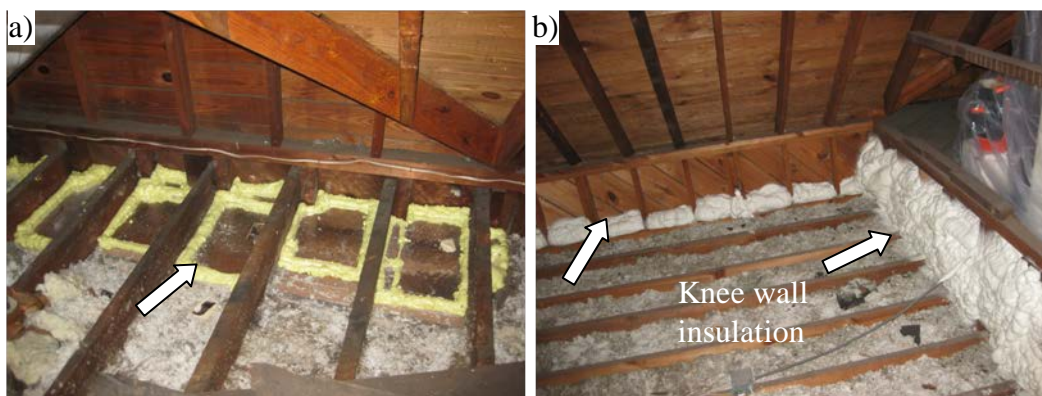
Figure 23. a) Photograph of rigid foam board applied in an attic bypass adjacent to an exterior wall. b) Photograph of open-cell spray foam applied in exterior wall bypasses. Insulation on knee walls is also shown in the picture.

The R-13 batt insulation originally in the attic knee walls was removed and replaced with a low density, open-cell foam sprayed to a thickness equal to an approximate insulation value of R-15. The spray foam provides insulation and air sealing properties to effectively align the thermal and air barriers. An example of the open-cell spray foam applied on the knee walls is shown in Figure 23. After air sealing was completed, the ceiling plane was insulated with blown fiberglass insulation for an approximate insulation value of R-38. All attic accesses were weather-stripped and insulated with R-5 Thermax boards. Since the whole-house fan was not in use. It was removed and capped with rigid foam board flashed with spray foam to create an air and thermal barrier to the living space.

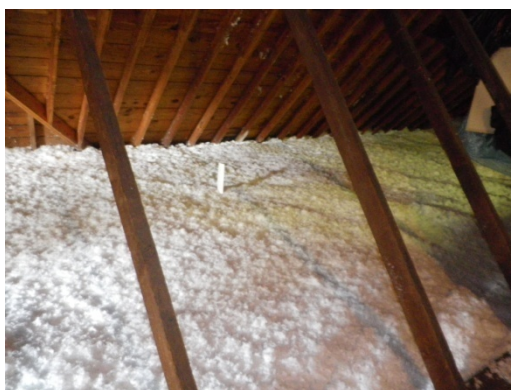
Figure 24. Blown fiberglass insulation applied in the attic ceiling (R-38).

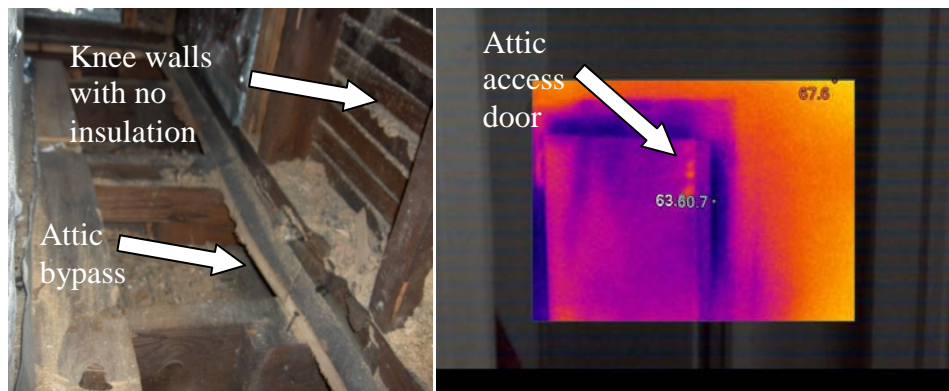
Figure 29. Attic bypasses. On the right is a thermal image of the attic access door. The blue color in the image shows attic air infiltration into the living space.

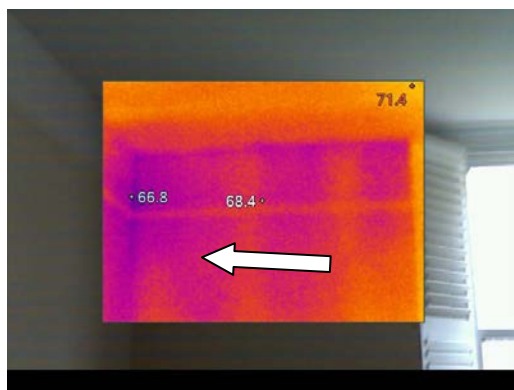
Figure 30. Thermal image of an exterior wall in North Carolina. The arrow in the figure highlights the absence of insulation in the wall cavities between the studs.

To aid in the building assessment, thermal infrared imaging was done. The assessment was performed as early in the morning as permitted by the tenant (around 7:00 a.m.) before the building gained a great amount of solar load from the rising sun. Through the thermal scan and visual inspection of the house, no insulation was evident in exterior walls of the home (Figure 30).

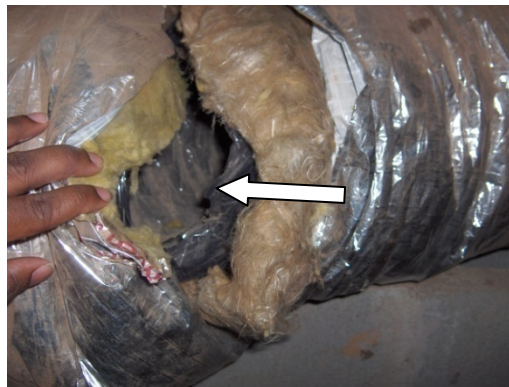
Figure 31. Disconnected ducts in the crawlspace

The ducts for first floor HVAC system were located in the crawlspace. While the ducts were insulated with R-6 insulation, they were not very effective for delivering conditioned air. There were several disconnected duct connections (Figure 31) that made pressurizing the ducts to evaluate the overall leakage not possible.

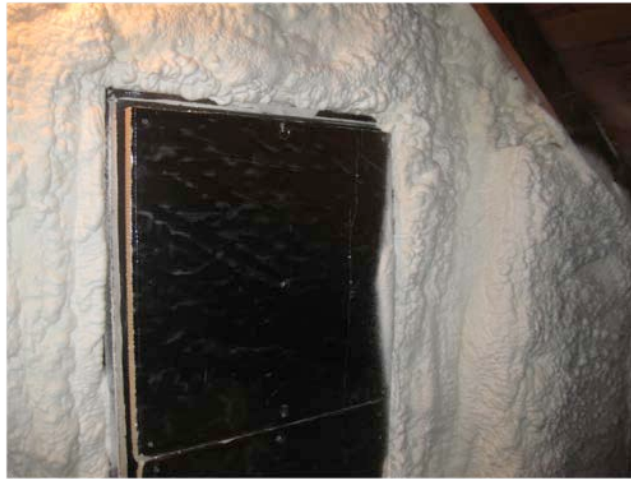
Figure 32. Insulation applied on the attic knee wall and the attic access door.

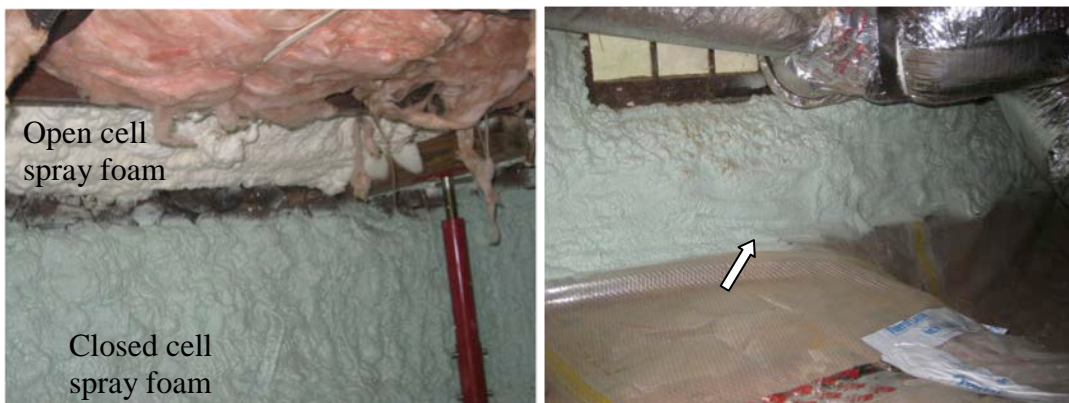
Figure 33. Crawlspace sealing and vapor barrier installation. The arrow in the picture on the right highlights the open-cell spray foam applied over the vapor barrier.

The crawlspace was encapsulated in North Carolina as a retrofit measure. In addition to the expected infiltration and moisture management improvement from sealing crawlspaces, there will also be improved HVAC performance, since the system is located in the semi-conditioned crawlspace. To encapsulate the crawlspace, the vents were covered and 2.5" of open-cell spray foam was applied over the cover along with the remainder of the band to yield an insulation level of approximately R-9. The foundation walls were also insulated and sealed with 3.5" closed-cell spray foam, yielding an insulation value of approximately R-19. Prior to the foam application, a 12-mil vapor barrier, which addresses moisture management risks from the ground, was flash-coated to the walls with foam to ensure that at least 6" of the plastic adhered to the foundation walls. The closed-cell foam was then sprayed over the plastic. Per code, a 3" termite inspection strip was created for inspection purposes. The crawlspace door was insulated with rigid foam board and weather-stripped. Photographs of the crawlspace ceiling are shown in Figure 33.

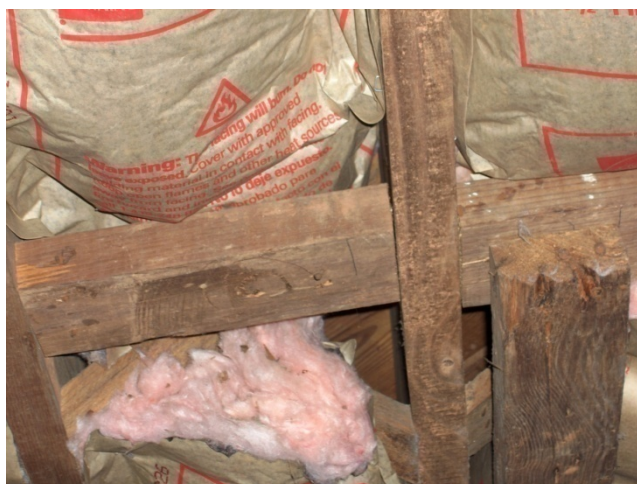
Figure 38. R-13 insulation installed in a manner inconsistent with recommended approaches.

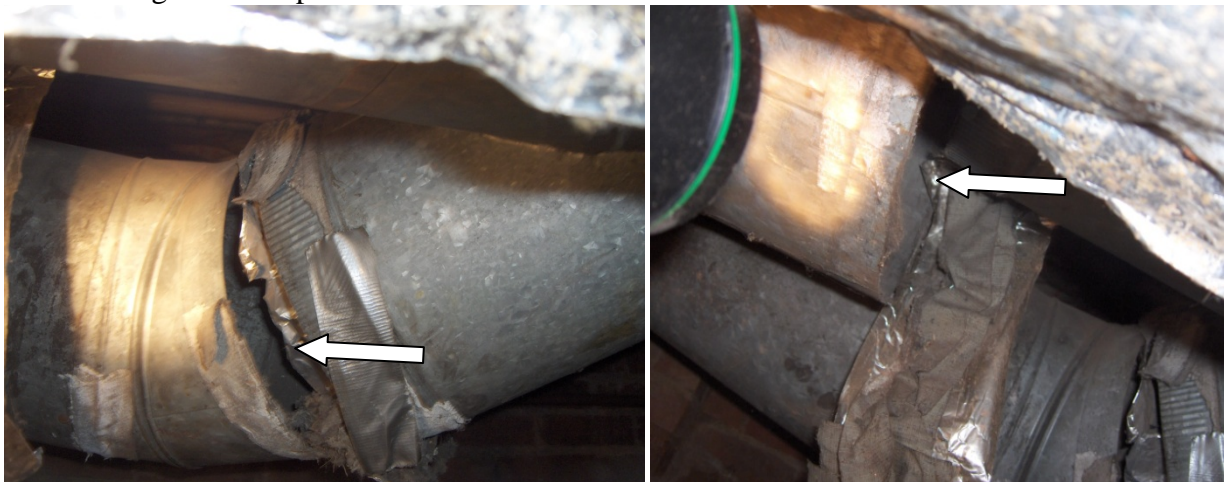
Figure 39. Disconnected ducts in the crawlspace

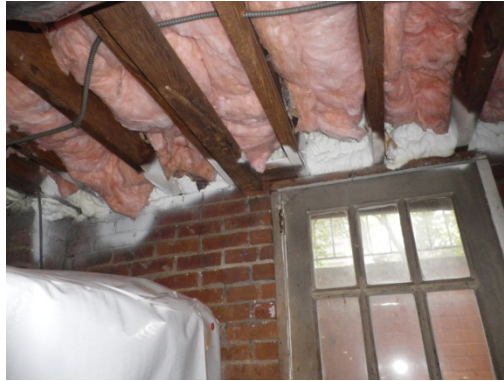
Figure 40. Fiberglass batts reinstalled in the crawlspace after air sealing

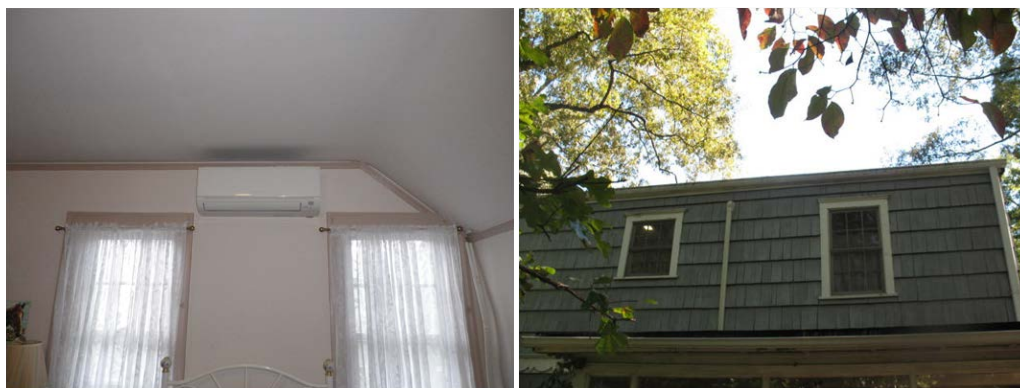
Figure 41. Photograph of the min-split system in Virginia. Indoor unit is shown in the image on the left. The outdoor refrigerant lines are shown in the image on the right.

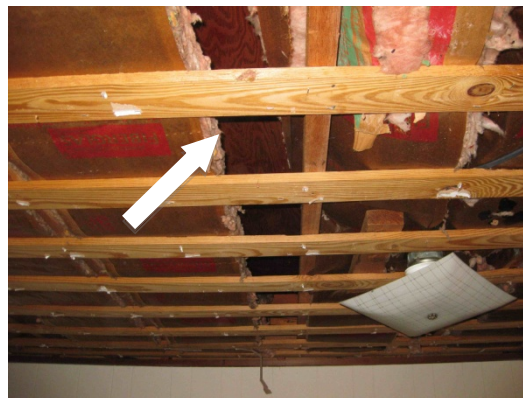
Figure 47. Ceiling insulation in the addition of South Carolina. The arrow in the figure highlights gaps in the insulation where the ceiling was not insulated from the attic air.

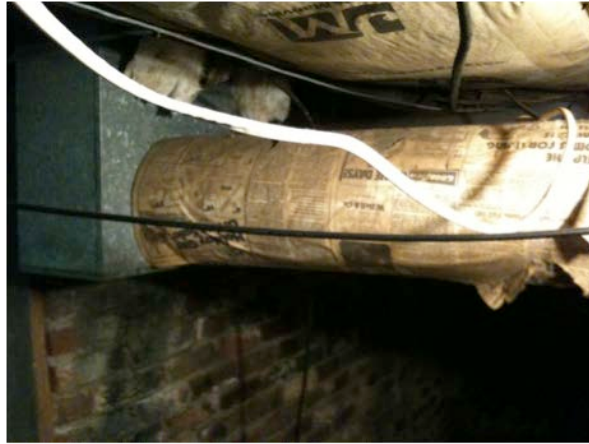
Figure 48. Ducts with newspaper used as insulation

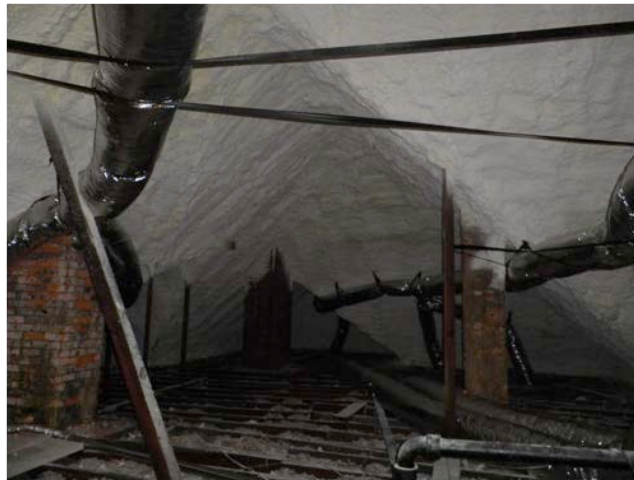
Figure 49. Photograph of attic after open-cell spray foam has been applied to the roofline

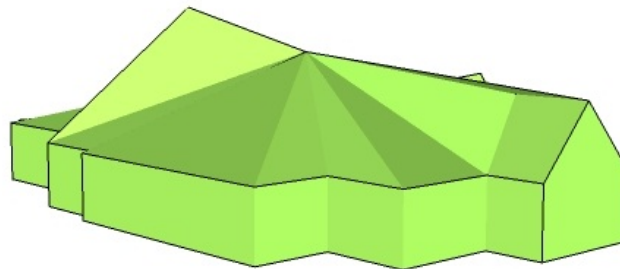
Figure 50. South Carolina post-retrofit building envelope.

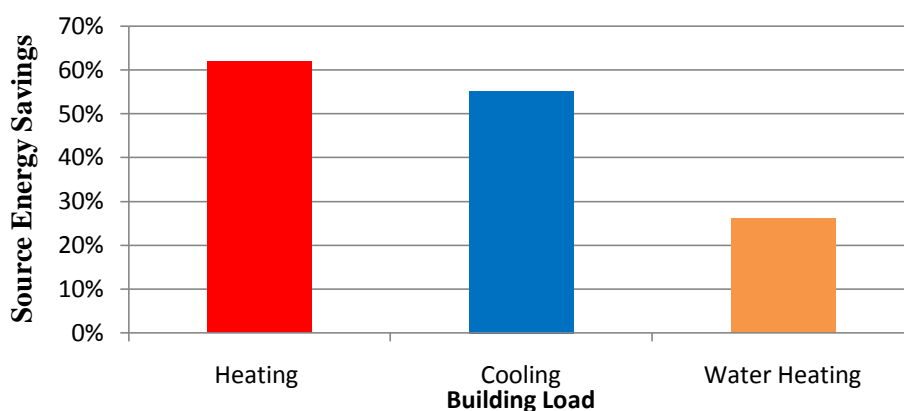
Figure 52. Simulated Energy Savings from Primary Building Loads

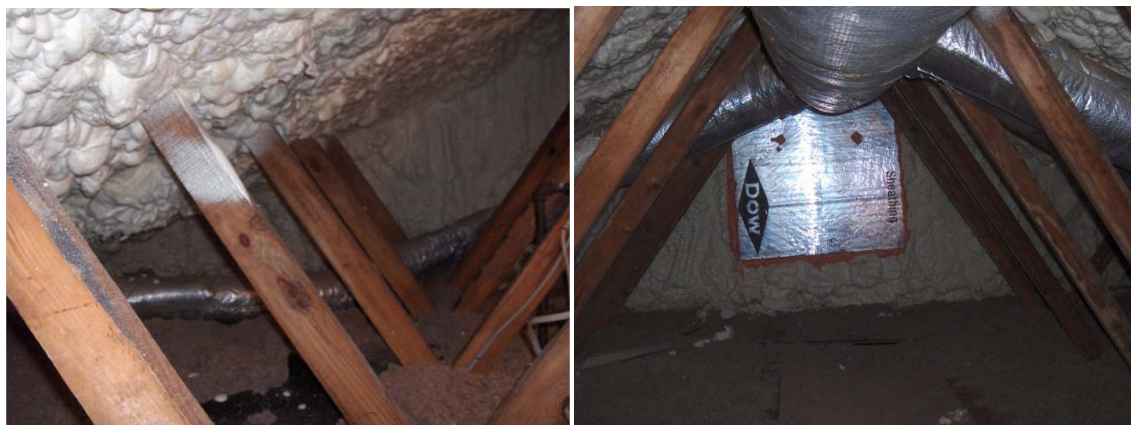
Figure 56. Open cell spray foam applied in the roofline and gables

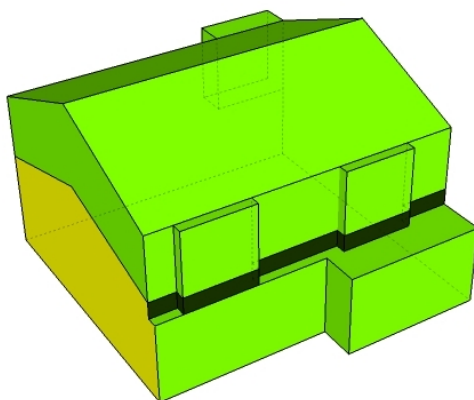
Figure 57. Illustration of the new building envelope with the attic included in the conditioned volume

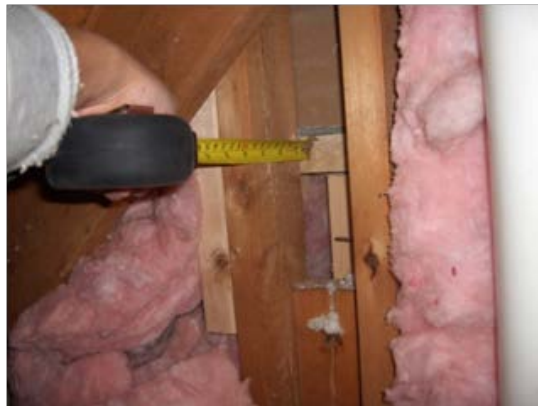
Figure 62. Void in attic knee walls

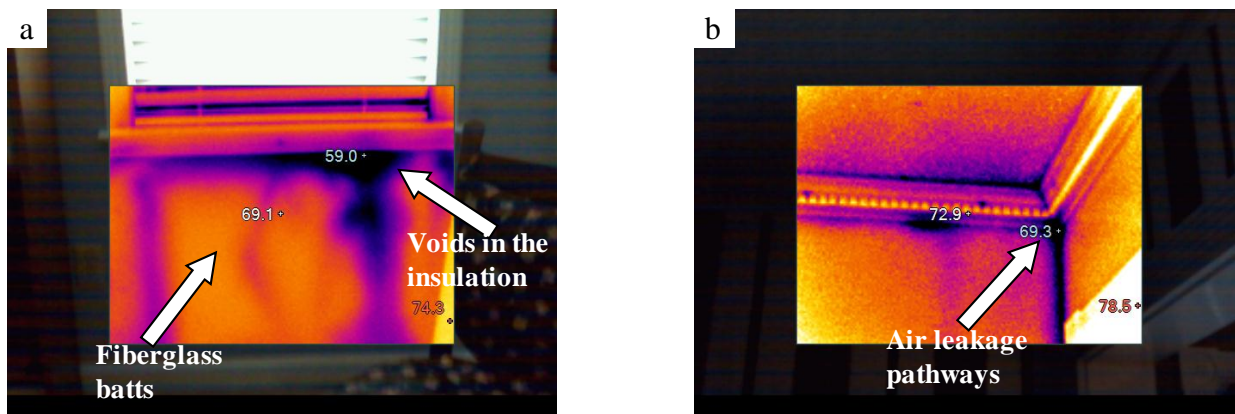
Figure 63. a) Thermal scan of an exterior wall. Voids in the insulation where the fiberglass batts have sunk over time is illustrated by the arrow. b) Thermal scan of an interior wall.

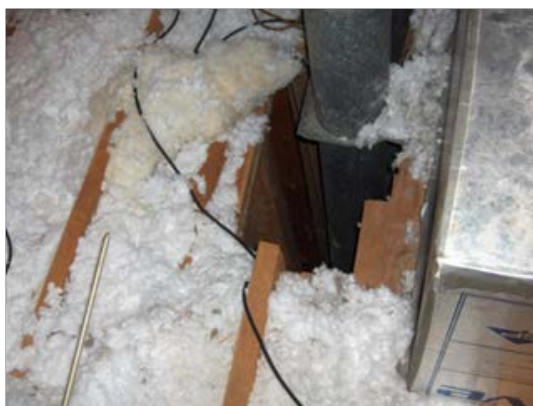
Figure 64. Open furnace chase in attic.

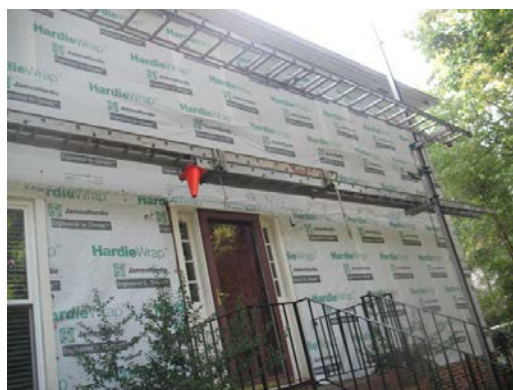
Figure 65. House wrap applied to Yellow Jackets before siding

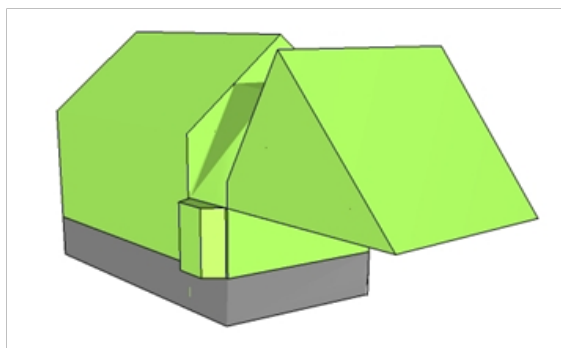
Figure 66. Yellow Jackets post-retrofit envelope profile. The gray in the photo represents the basement volume.

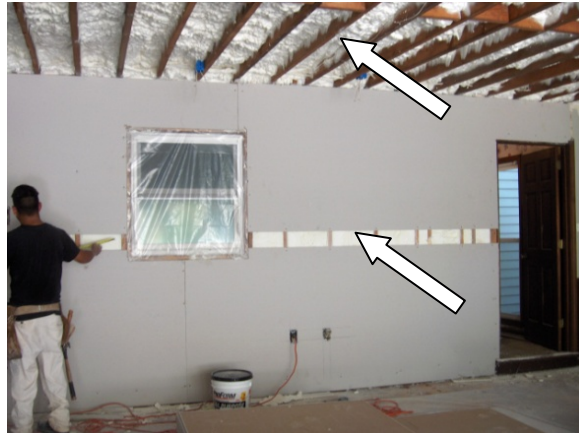
Figure 67. Insulated and sealed garage wall and ceiling. Arrows in the picture point to the spray foam in the wall cavities and in the garage ceiling.

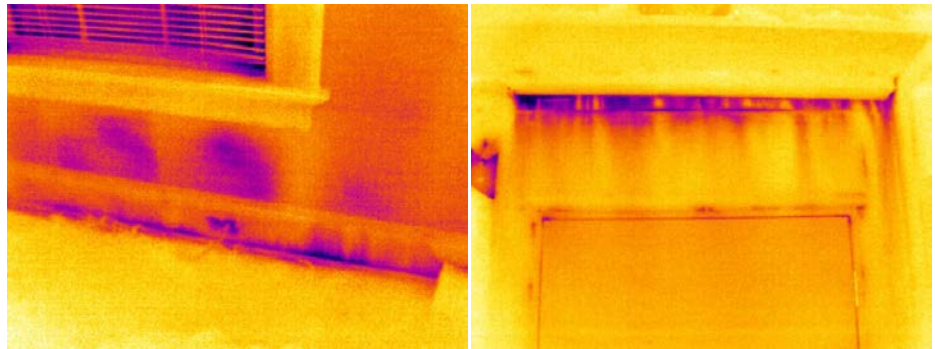
Figure 71. Thermal images that show significant air infiltration at baseboards (left) and door headers (right).

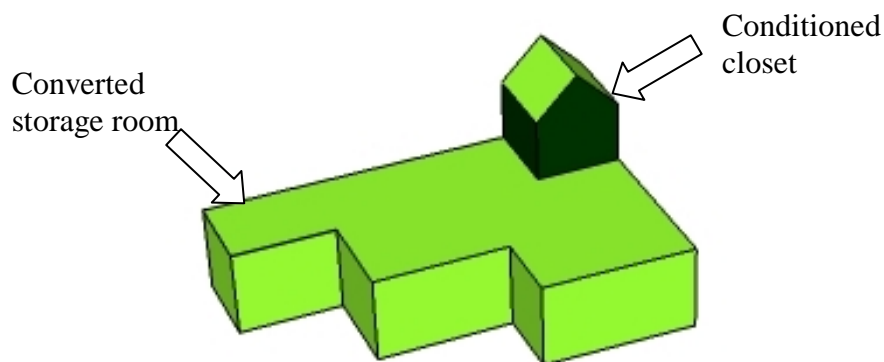
Figure 74. Illustration of the new building envelope after the addition area has been added.

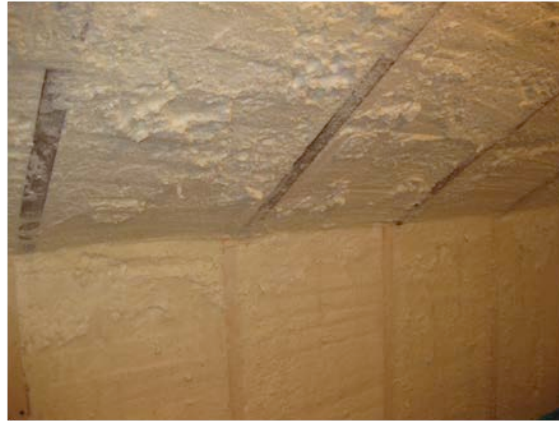
Figure 75. Photograph of open-cell spray foam in the wall cavities and ceiling rafters

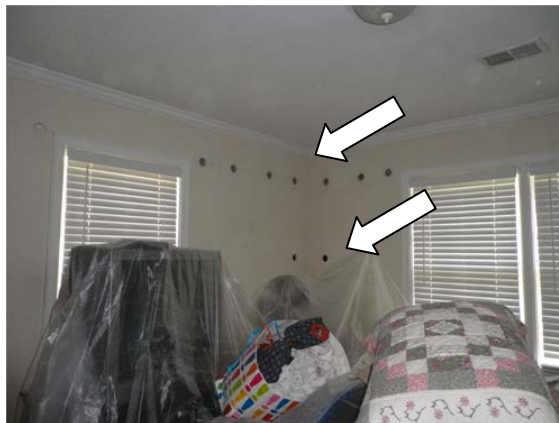
Figure 76. Holes drilled in the wall for cellulose installation

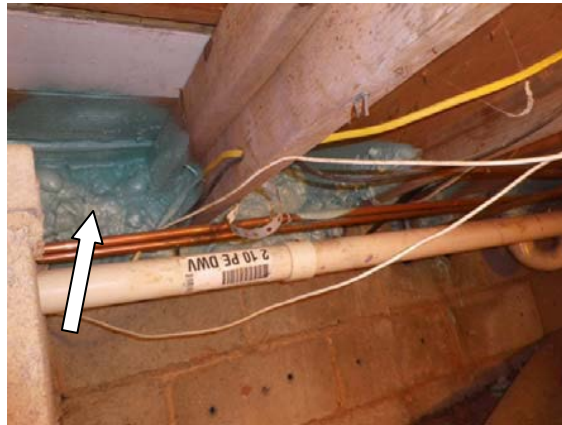
Figure 77. R-5 of closed-cell insulation sprayed on the band joist

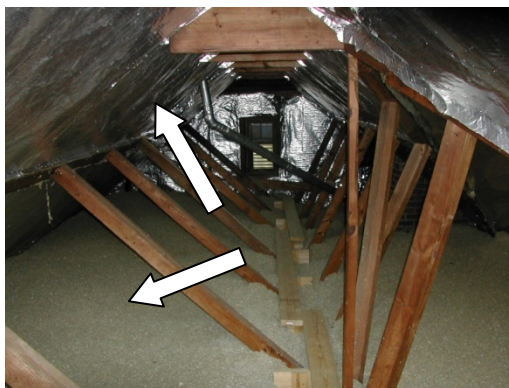
Figure 80. Photograph of the attic in Two Cities. The arrows in the figure are shown to highlight the radiant barrier on the roofline and the continuous layer of fiberglass insulation on the attic floor.

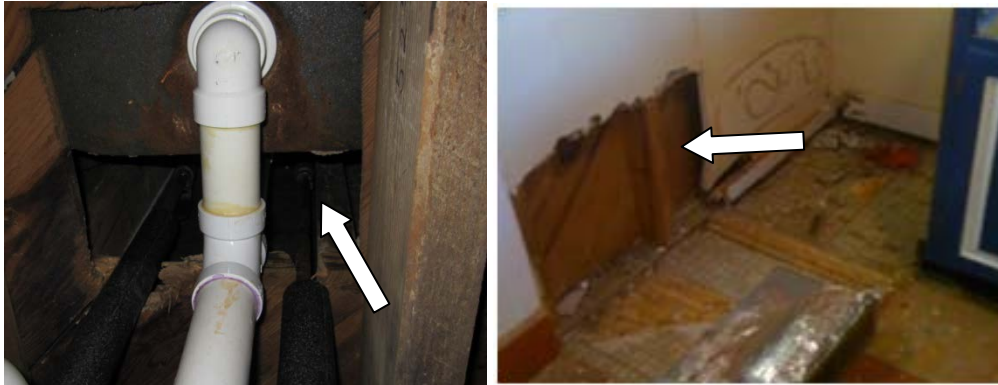
Figure 82. Infiltration pathways found in Two Cities. The photograph on the left shows an open plumbing access underneath the tub. The image on the right shows a hole in the kitchen wall behind a cabinet.

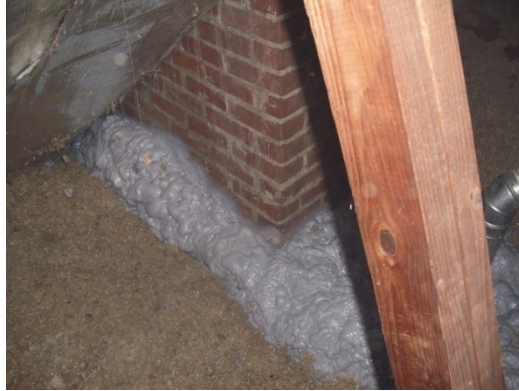
Figure 83. Spray foam insulation applied around the fireplace chase.

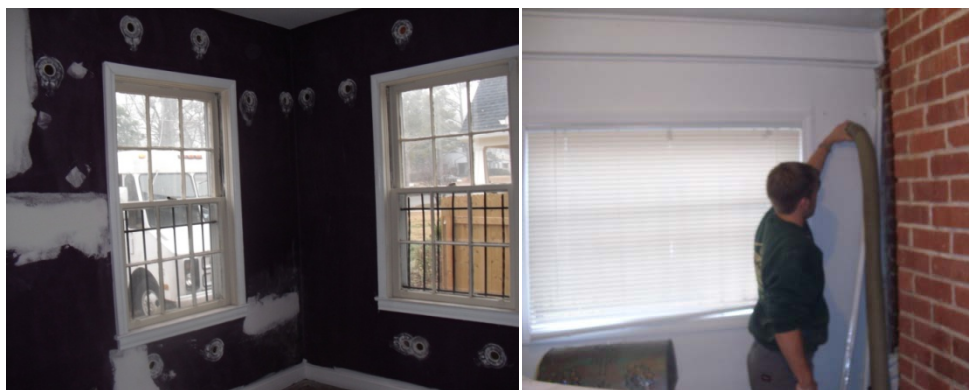
Figure 84. Drill and fill of cellulose insulation in the exterior wall cavities.

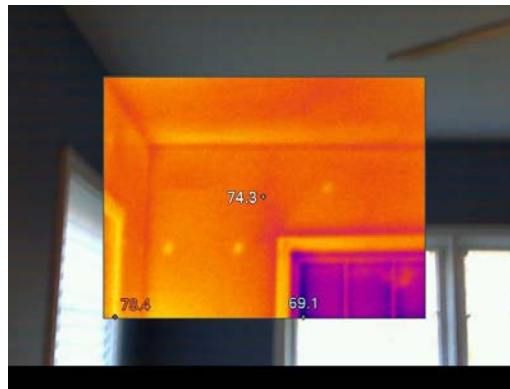
Figure 85. Thermal image of the exterior wall to show the grade of the insulation installation. The white dots in the figure are the Styrofoam plugs placed in each cavity after being filled.

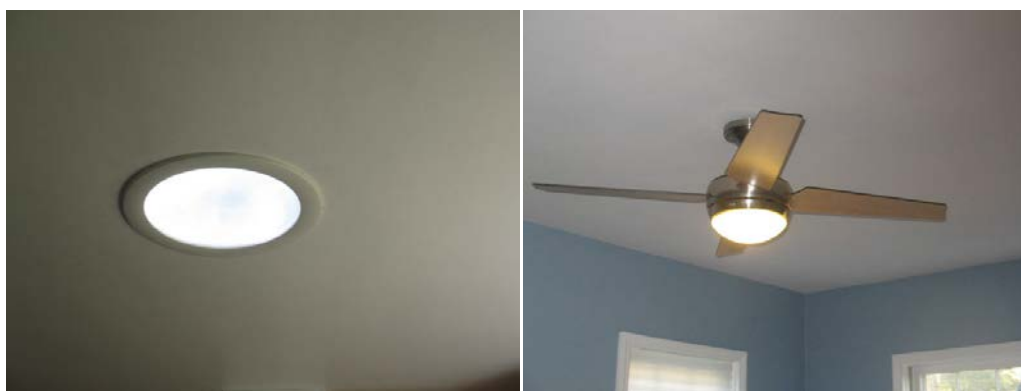
Figure 87. Sun tunnel (left) and ENERGY STAR ceiling fan (right)
