The Cleaning of 303 Stainless Steel

T. H. Shen

April 22, 2004

*Materials Science and Technology Division
Chemistry & Materials Science Directorate*

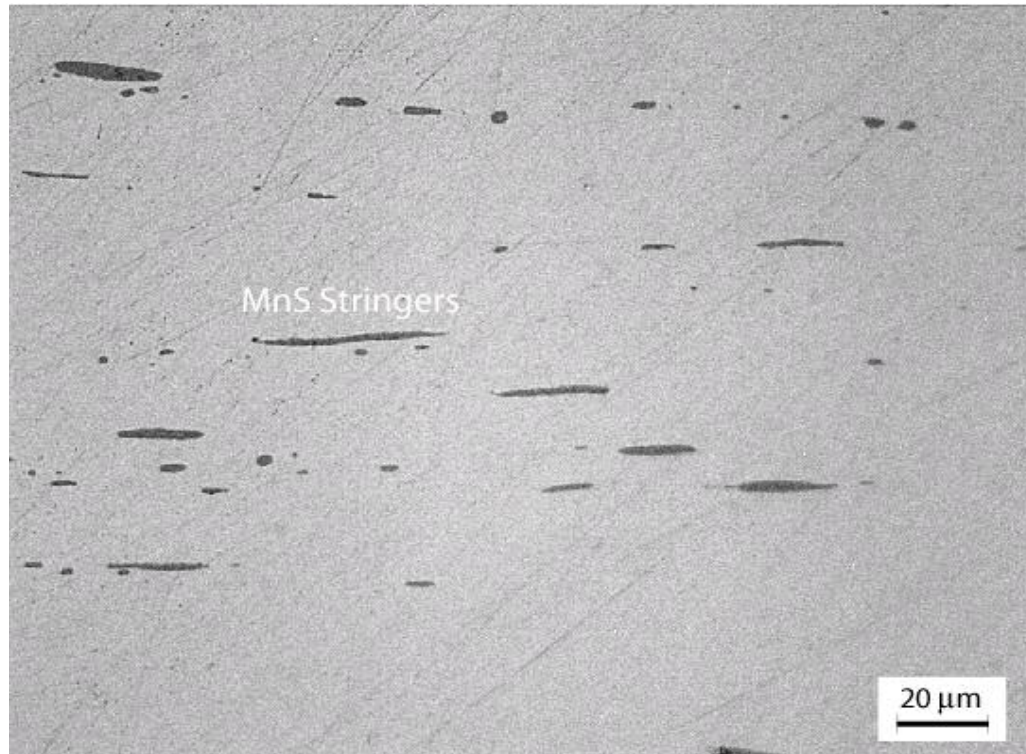
Figure 1 Typical microstructure of 303 stainless steel. The long stringers are MnS inclusions.

Figure 1 shows a typical microstructure of SS303. The MnS stringers help to promote the easy breakup of metal chips during machining.

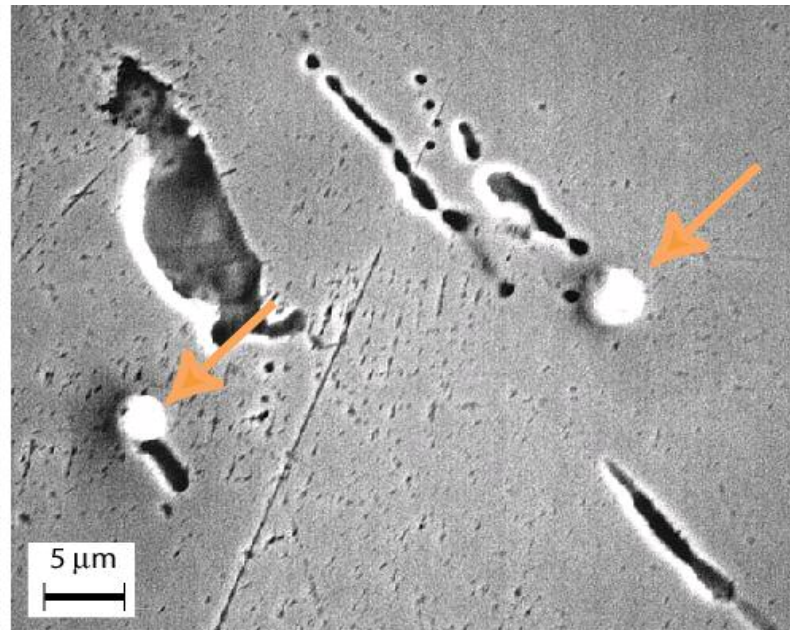
Fig 2a

Figure 2a shows that the nitric acid dissolved the MnS inclusions and left many pits behind. Micron-size elemental sulfur particles, identified by EDXS as shown in **Figure 2b**, were re-deposited back to the surface in the vicinity of these pits as indicated in **Figure 2a**. The precision cleaning that followed the nitric-acid passivation could not remove these particles.

It is likely that the sulfur found in the NVR measurements originated from the metal itself. To identify the origin of sulfur, an experiment was performed to simulate the hour-long nitric acid passivation followed by a precision cleaning with a mirror-polished SS303 sample. **Figure 2a** shows that the 35 vol%[†] nitric acid dissolved the MnS inclusions and left many pits behind. Micron-sized elemental sulfur particles, which were identified by EDXS/SEM as shown in **Figure 2b**, were re-deposited back to the surface in the vicinity of these pits as indicated by arrows in **Figure 2a**. Apparently, the precision cleaning could not remove these sulfur particles.

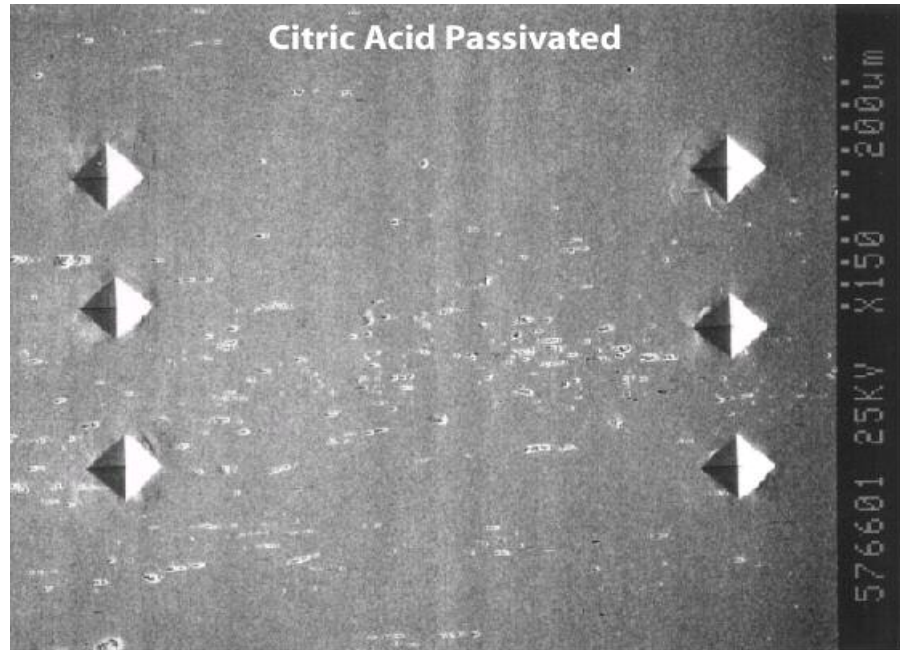
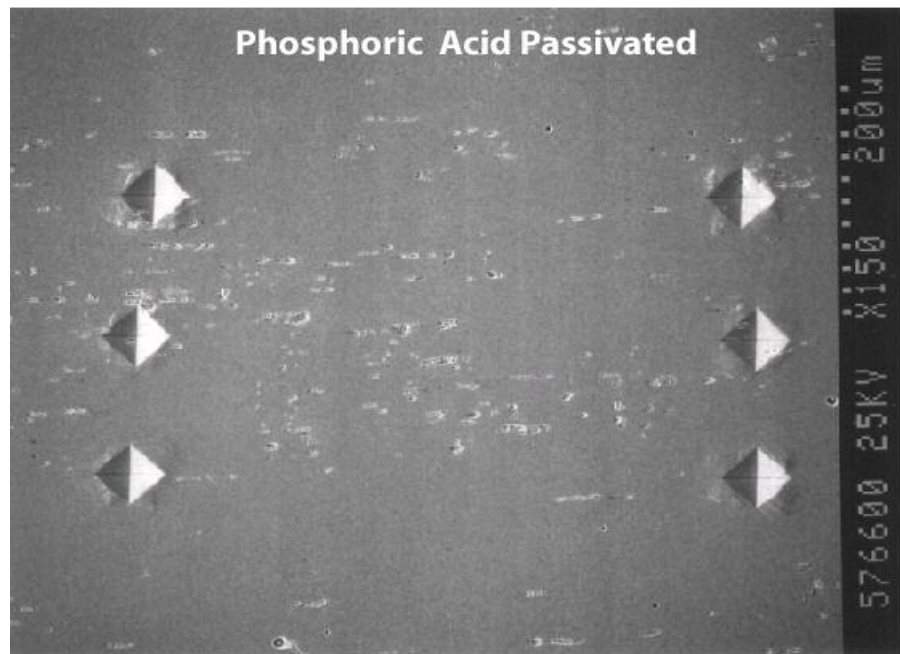
Figure 3 Both citric and phosphoric acids attacked the MnS inclusions and left pits behind. However, no elemental sulfur deposits were found in the vicinity of these pits.

Both citric acid and phosphoric acid passivations reduced the NVR and particle swipe to an acceptable level of less than $0.1 \mu\text{g}/\text{cm}^2$ and level 83, respectively. **Figure 3** shows the surface morphology of the SS303 after the citric acid and phosphoric acid passivations. Both acids attacked the MnS inclusions and left pits behind. However, the SEM investigation did not find any sulfur particles in the vicinity of these pits.

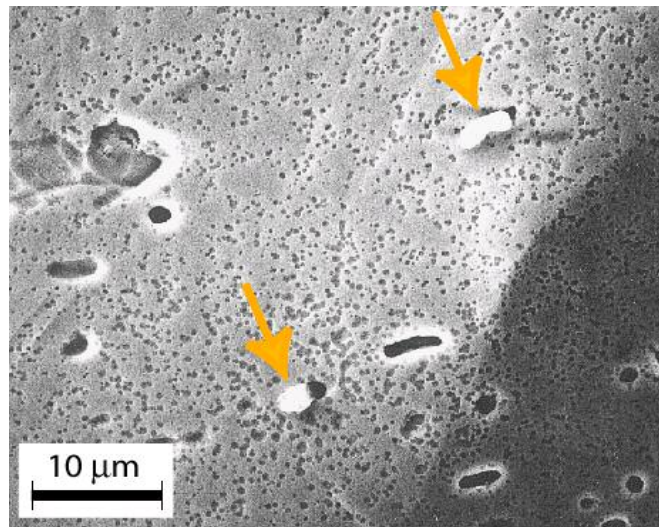
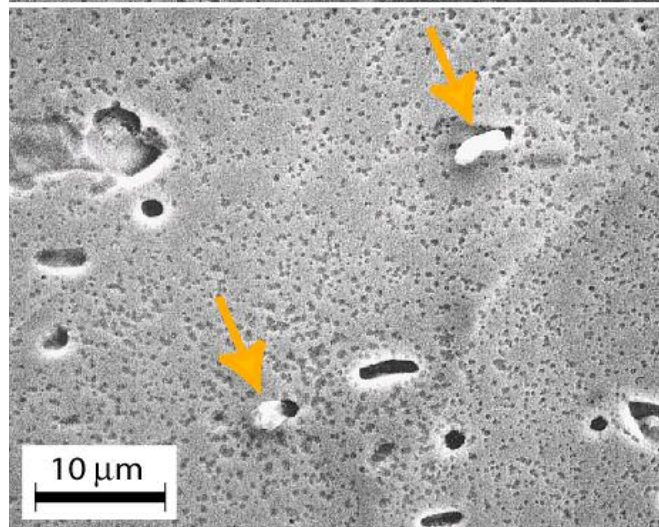
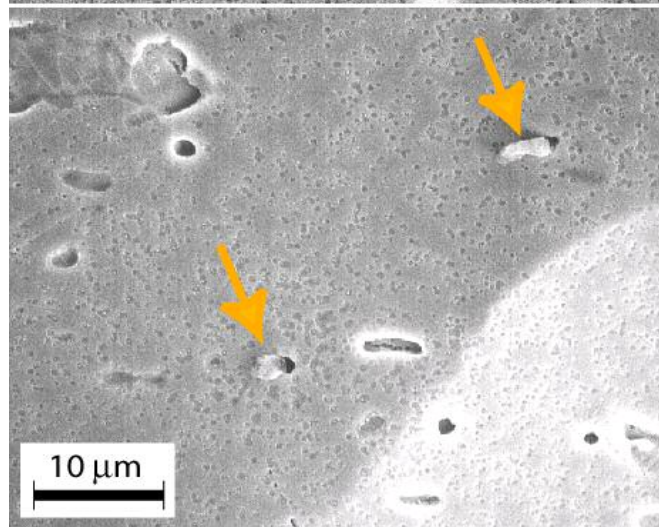
After 50 vol% nitric acid
passivation for 60 min.

Hot D.I. Water at 150°F
for 10 min.

Freon rinse

Figure 4 The sulfur particles, as indicated by arrows, didn't significantly dissolve by the hot DI water. However, Freon shows some capability in dissolving the sulfur.

The acetone soak after the nitric-acid passivation was not consistently effective in removing the sulfur from the surface. Subsequently, several solvents, *i.e.* FreonTM, isopropyl alcohol (IPA) and hot D.I. water, had also been evaluated for their effectiveness in removing the sulfur. However, the experiments showed erratic and inconsistent NVR results. **Figure 4** shows that the hot D.I. water didn't noticeably dissolve the sulfur particles, but Freon did show some effectiveness in dissolving the sulfur particles. However, sulfur particles were still present after several Freon rinses.

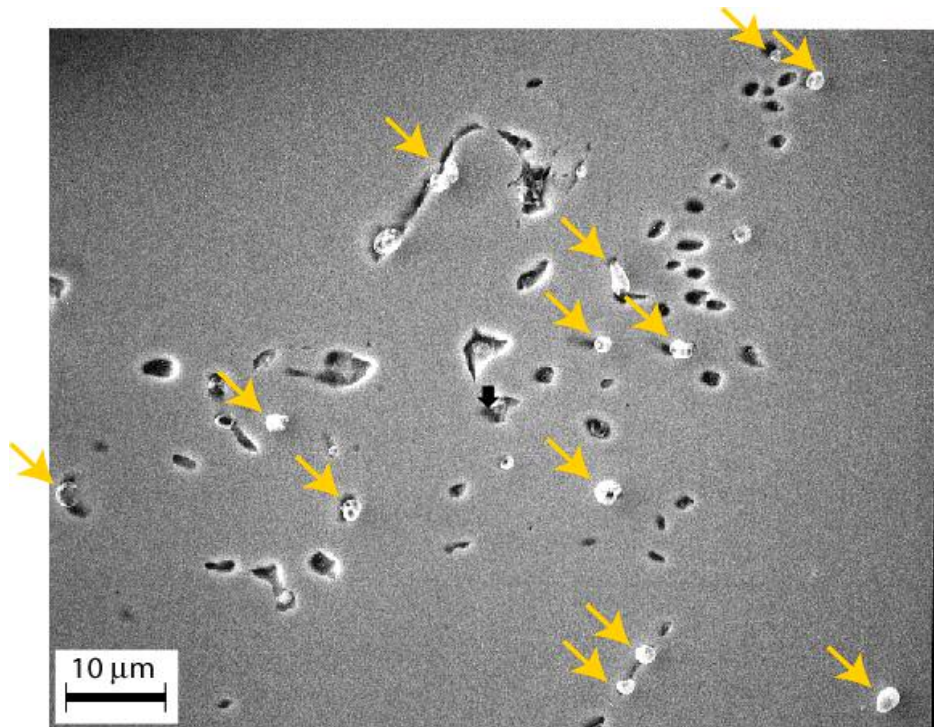
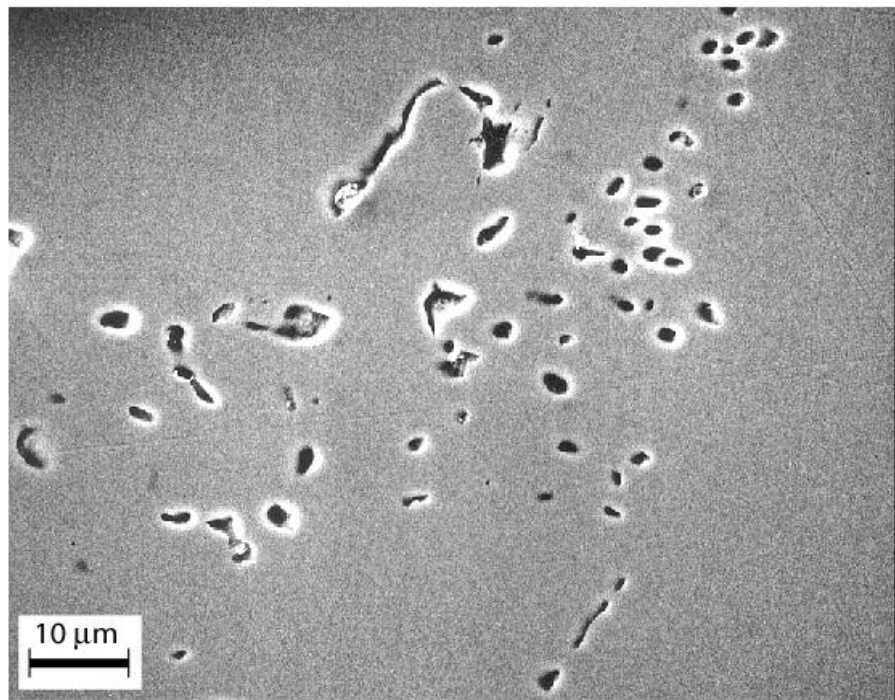
**After nitric acid
passivation**

**Nitric acid
passivation
+
NaOH
Neutralization**

Figure 5 The NaOH dissolved the sulfur particles, as indicated by arrows, and improved the pitting corrosion resistance of SS303 after the nitric-acid passivation.

corrosion performance of SS303 treated by 5 vol% NaOH at 70°C for 30 minutes after the nitric acid passivation. The results showed that the corrosion performance was indeed improved with the NaOH soak. **Figure 5** shows that the NaOH dissolved the sulfur particles, as indicated by arrows, and improved the pitting corrosion resistance of SS303 after the nitric acid passivation.
