## **Energy Design and Performance Analysis of the BigHorn Home Improvement Center**

M. Deru, P. Torcellini, and S. Pless

**National Renewable Energy Laboratory**  
1617 Cole Boulevard, Golden, Colorado 80401-3393  
303-275-3000 • [www.nrel.gov](http://www.nrel.gov)

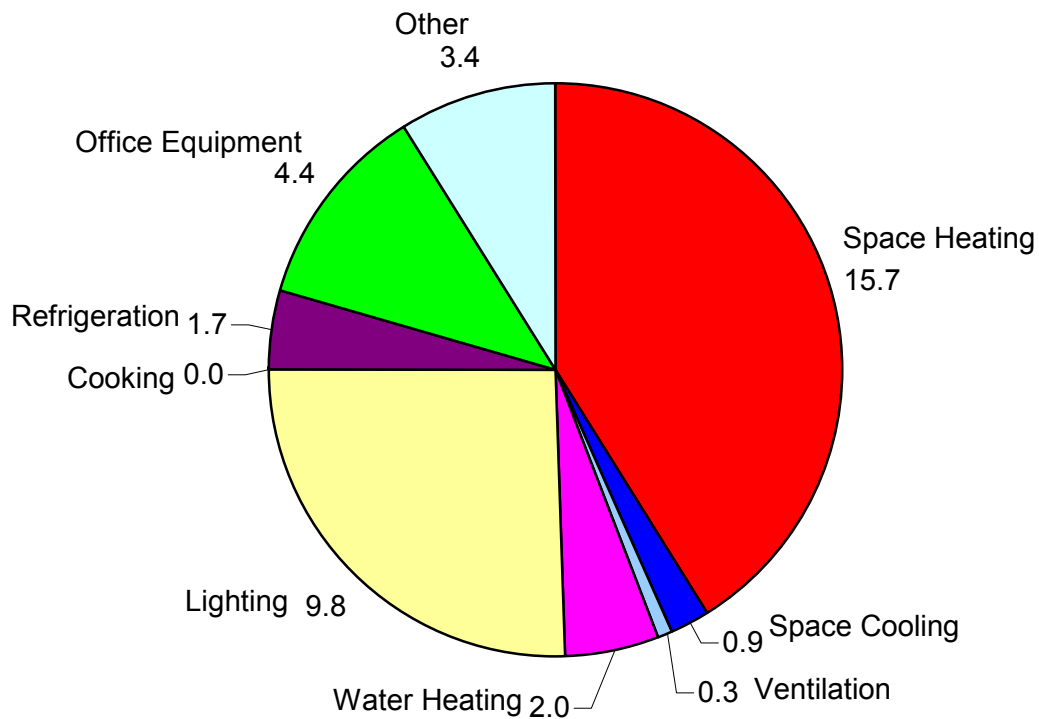
**Figure 2-2 Typical site EUIs by end use for warehouse buildings (kBtu/ft²-yr) (DOE 2003)**

Average site energy consumption by end use for mercantile and service (retail) buildings in the U.S. is shown in Figure 2-1 and for warehouse and storage buildings in Figure 2-2 (DOE 2003). The building site energy use intensity (EUI) is 76.4 kBtu/ft<sup>2</sup>·yr and 38.3 kBtu/ft<sup>2</sup>·yr for the two building types. These numbers are based on 1995 data collected by the Energy Information Administration. Most of the space heating, water heating, and cooking are by natural gas; the rest of the energy consumption is electricity. The primary energy consumed to generate and distribute the electricity is approximately three times the energy used on site. Lighting is the largest primary energy end use for both building types; therefore, reduction in the lighting of loads is a primary objective in this project.

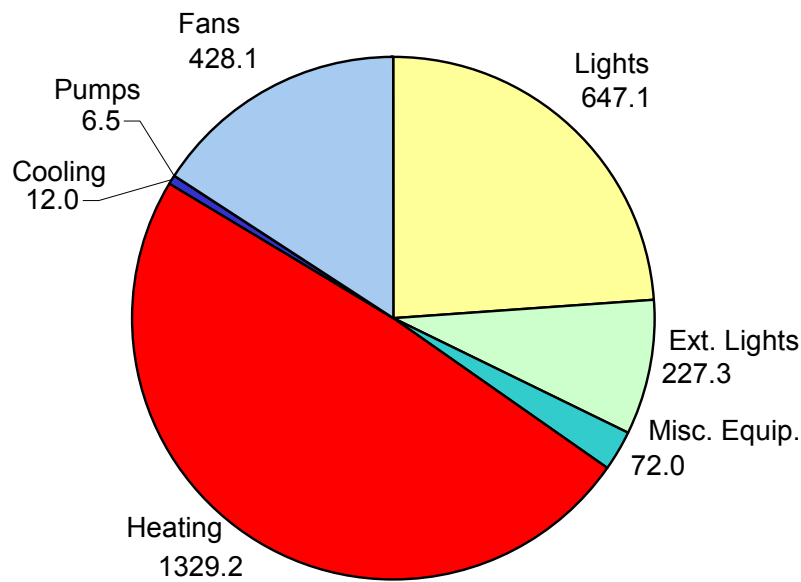
**Figure 3-1 Design Baseline Model annual site energy consumption (MMBtu)**

Figure 3-1 shows a breakdown of the Design Baseline Model annual energy consumption by category. The building is obviously dominated by the heating load, which is almost half the total building energy. The cooling load for this building can be almost entirely met by outside air economizers, which suggests that natural ventilation may meet the cooling loads. For this building with this system, the fans use a significant amount of energy to meet the ventilation needs. The high light levels in the retail area make the lighting almost one-quarter of the total. This analysis shows that reductions in the heating, fan, and lighting loads have the most energy saving potential.

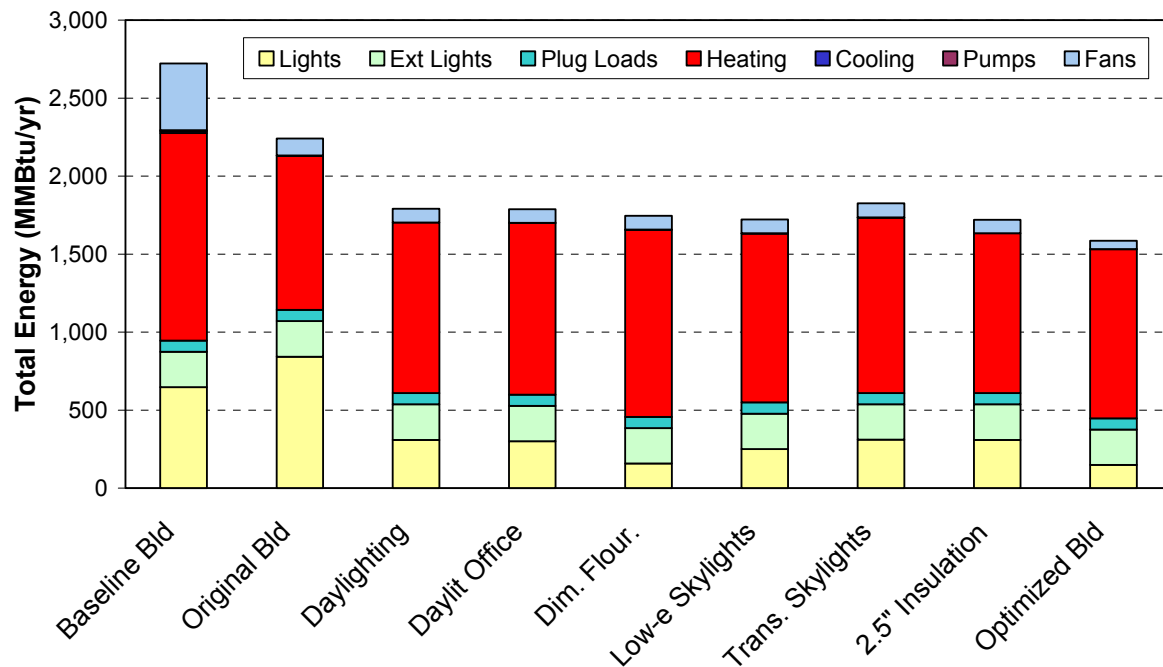
**Figure 3-5 Total energy consumption for the Design Baseline, Original, design variations, and Optimized Models**

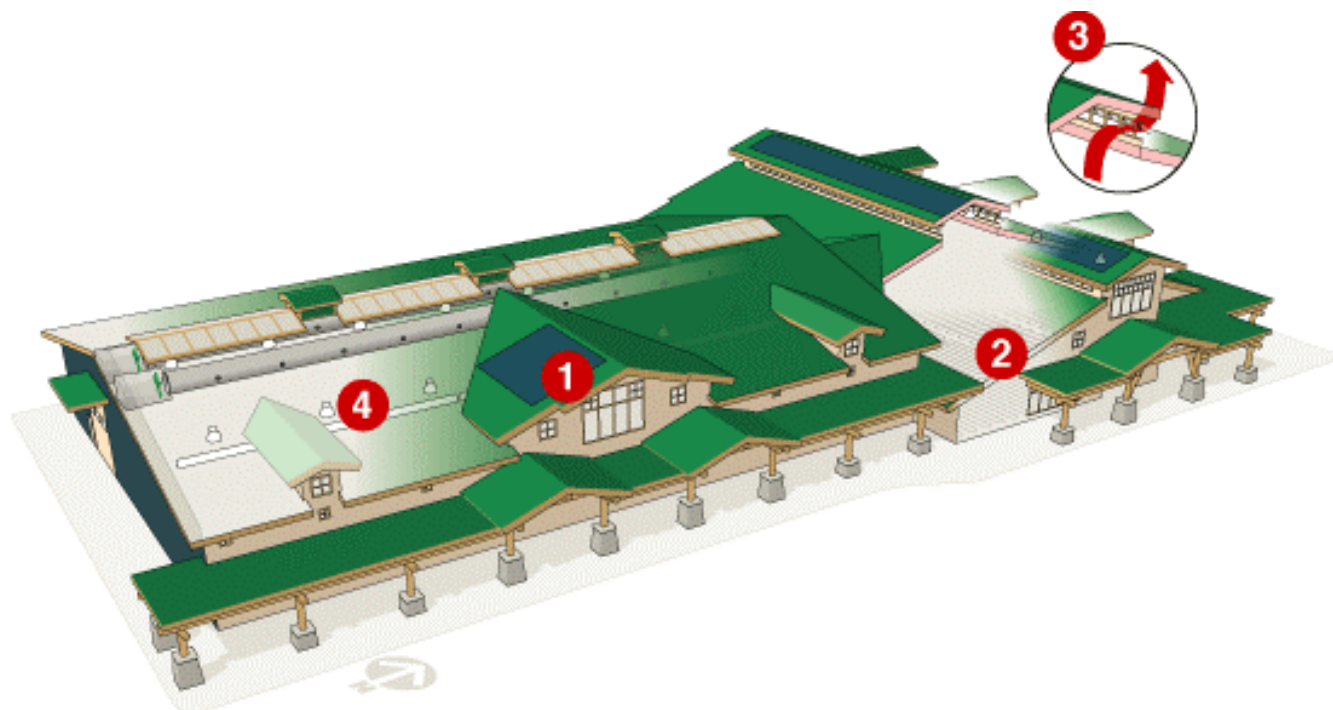
**Figure 5-1** Illustration of the layout and some of the energy features of the BigHorn Center: (1) photovoltaic panels, (2) radiant floor heating, (3) natural ventilation, and (4) daylighting

The BigHorn Center building is divided into two distinct sections: a retail/office area and a warehouse. The building layout is illustrated in Figure 5-1 with the warehouse on the left (south end) and the retail/office space on the right. The floor plans for the retail/office space and the warehouse are shown in Figures 5-2 and 5-3. The retail/office space is on an east-west axis, which allows north- and south-facing clerestory windows to be used for daylighting and natural ventilation. The warehouse area is on a north-south axis with an insulated translucent skylight along the ridge of the roof and a transpired solar collector on the south wall. Both the retail/office space and warehouse are single-story open interior floor plans, with small mezzanines and an approximately 18° sloped roof. The retail/office space mezzanine is located along the centerline of the building at the west end of the building and is used primarily as office space. The warehouse mezzanine is located along the north wall of the warehouse and is used for storage and as a pathway to the retail/office space. The Functional Areas, as defined in *Standard Definitions of Building Geometry for Energy Evaluation Purposes* (NREL 2004c), were measured from the inside surface of exterior walls and from the centerline of walls that connect adjoining spaces. These are summarized in Table 5-1. The break room and Yard Foreman's office are along the north wall of the warehouse, but they are on the same heating system as the retail/office space.

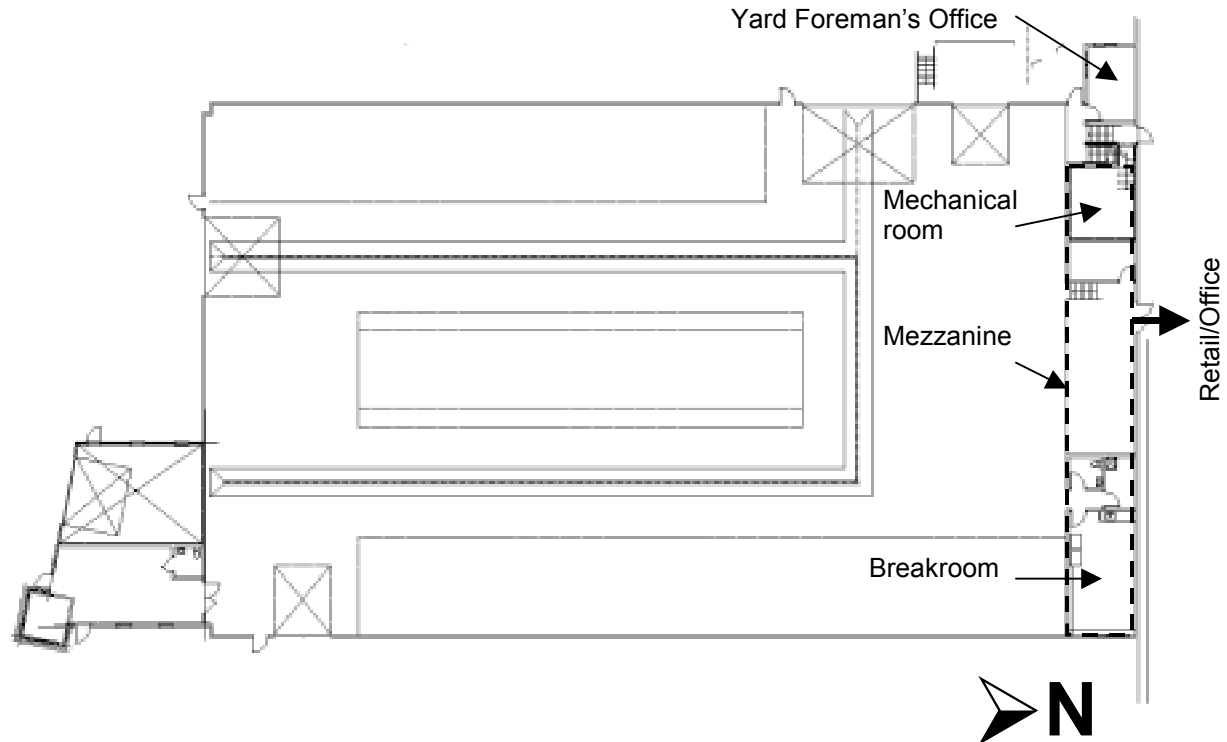
**Figure 5-3 Floor plan of the warehouse**

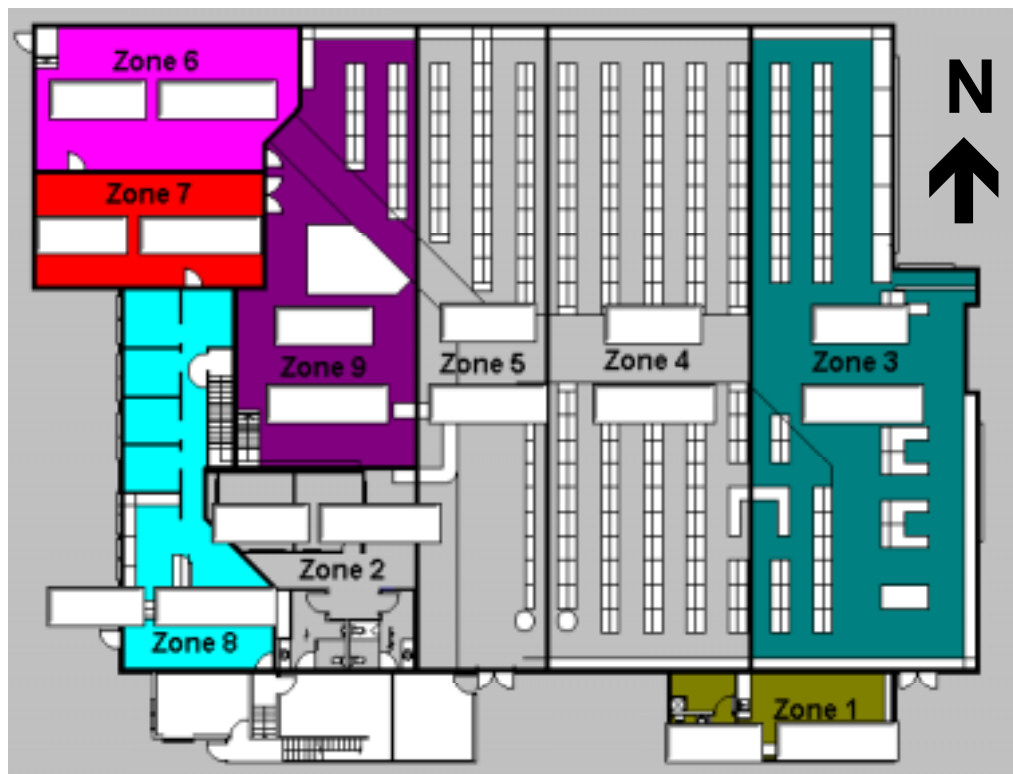
**Figure 5-4 Radiant-floor heating zones in the retail/office area**

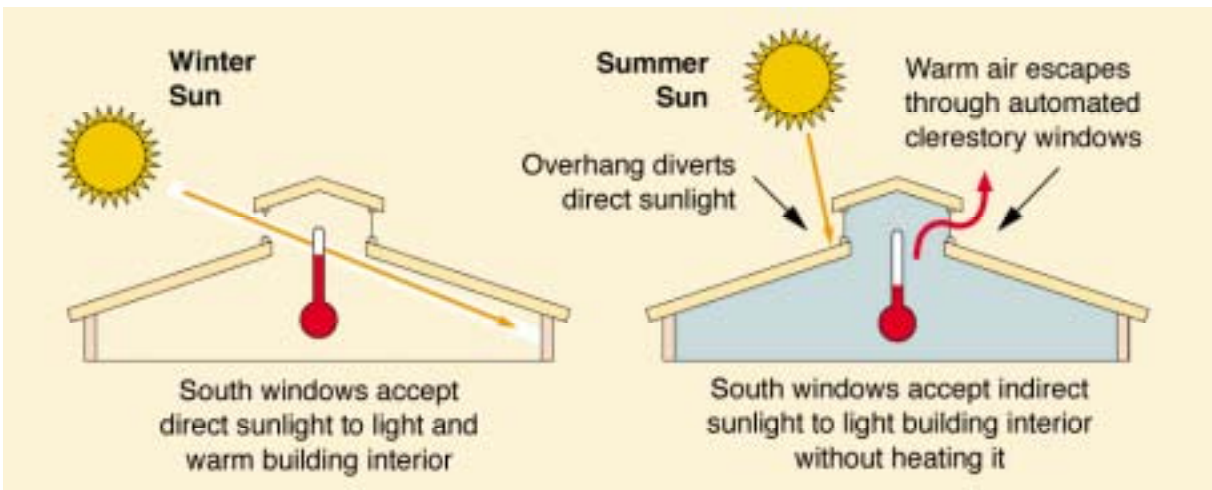
**Figure 5-6 Seasonal daylighting and natural ventilation through the clerestory windows in the retail/office space**

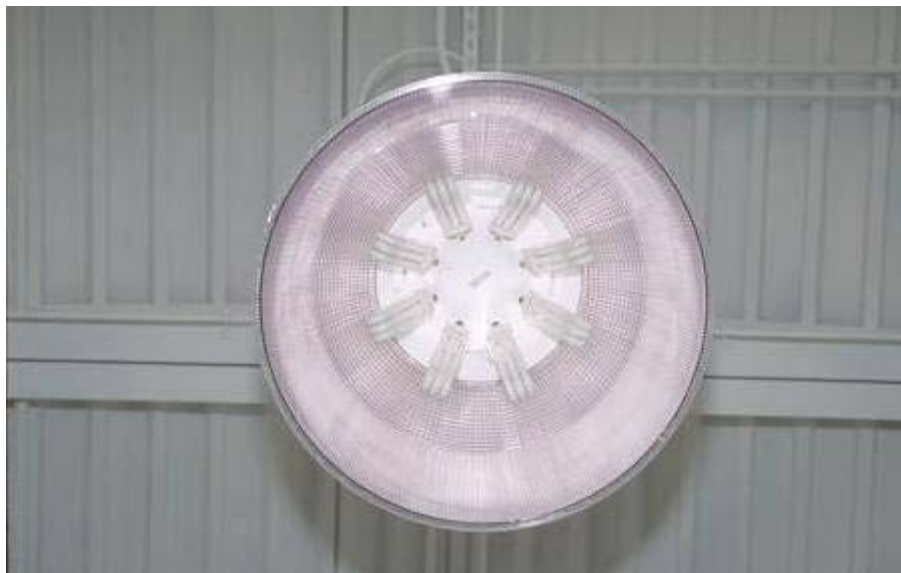
**Figure 5-7 Pendant luminaire with eight 42-Watt CFL bulbs used in the retail and warehouse areas**

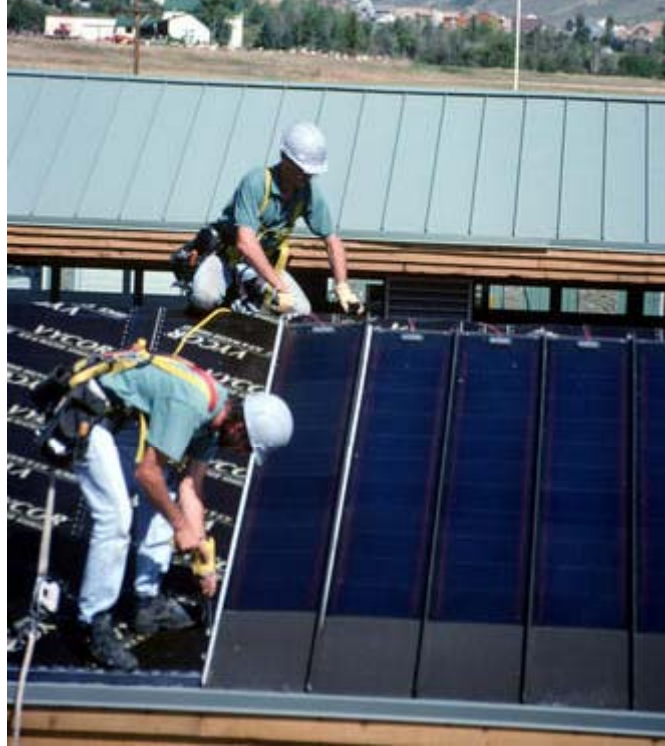
Figure 5-9 Installation of the roof-integrated PV panels

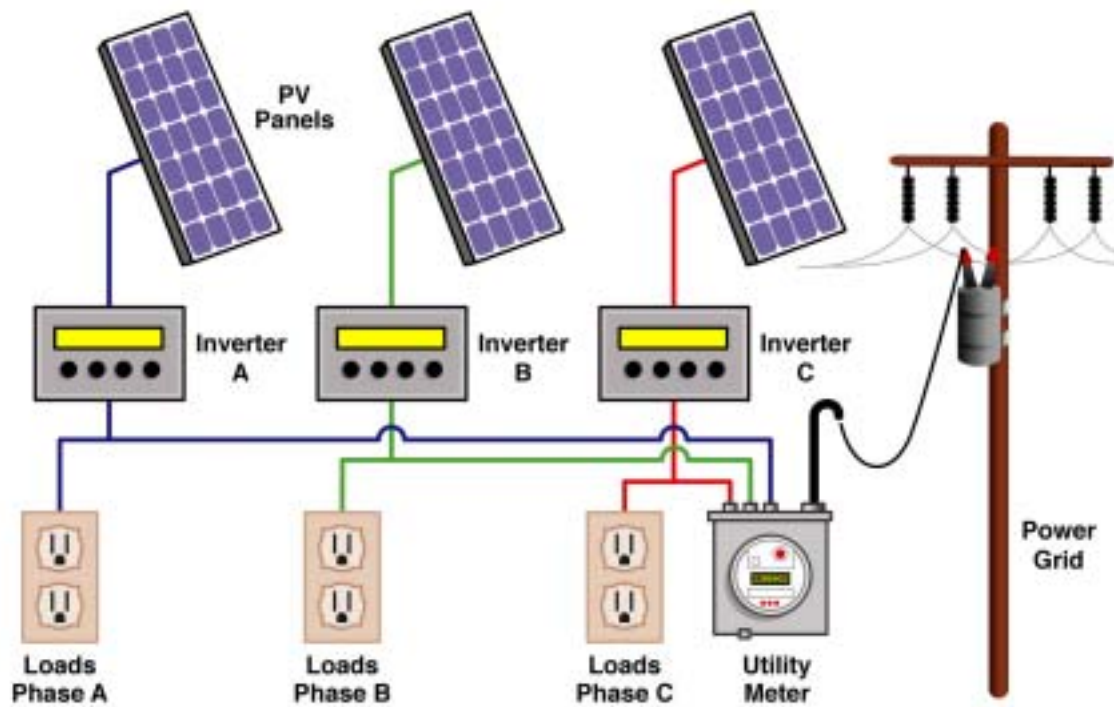
Figure 5-10 Schematic of the 3-phase PV system

Strings of three modules in series are wired in parallel to form three arrays, which were originally configured to have similar power outputs. To accomplish this, two arrays (the Phase-B and Phase-C arrays) each consisted of 48 64-W modules and the third array (the Phase-A array) was configured with 18 120-W modules and nine 64-W modules. Each array is connected to its own inverter, and each inverter is tied to a separate phase of the three-phase electrical system (see Figure 5-10). The inverters were designed to work with a standalone PV system and have no internal battery backup, so an external circuit with four 12-V batteries is used to maintain the inverter memories at night. The battery backup system is tied to the Phase-A inverter to maintain the battery charge. Problems with the PV system resulted in reconfiguring the system, which is discussed in Section 7.3.

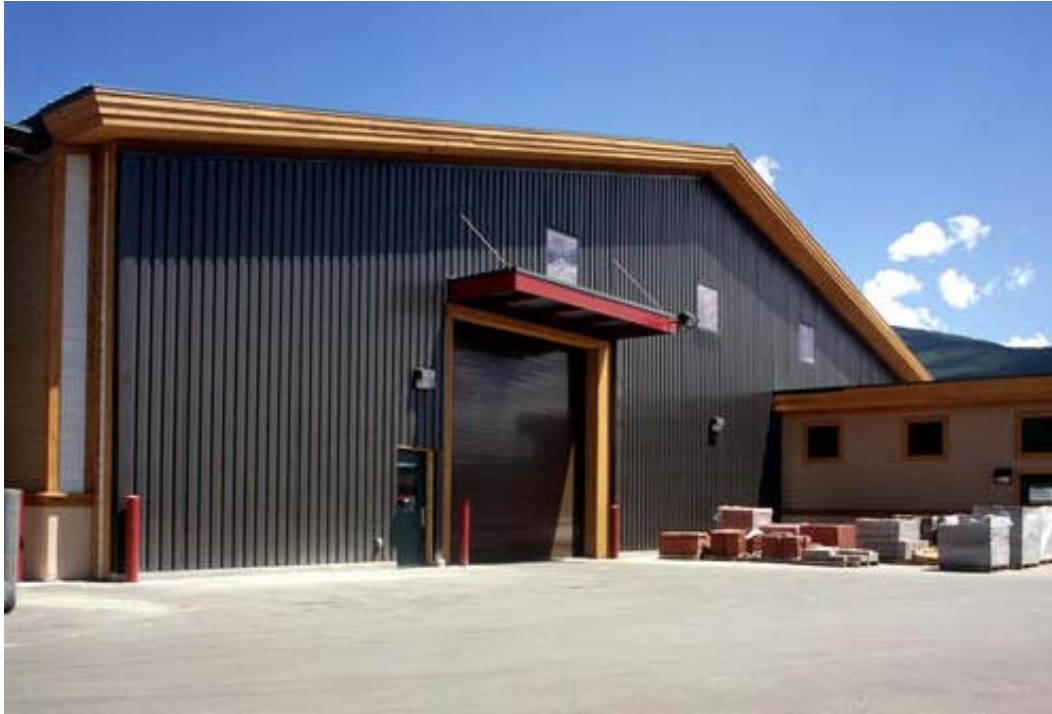
**Figure 5-12 Transpired solar collector on the south wall of the warehouse**

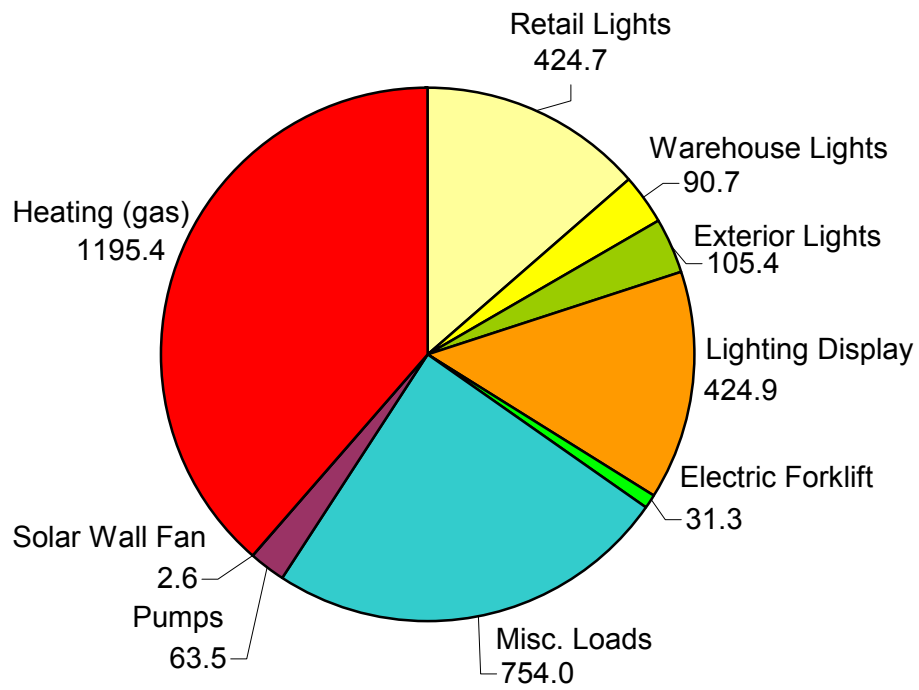
**Figure 6-2 Measured source energy use from September 1, 2002 to August 31, 2003 (MMBtu)**

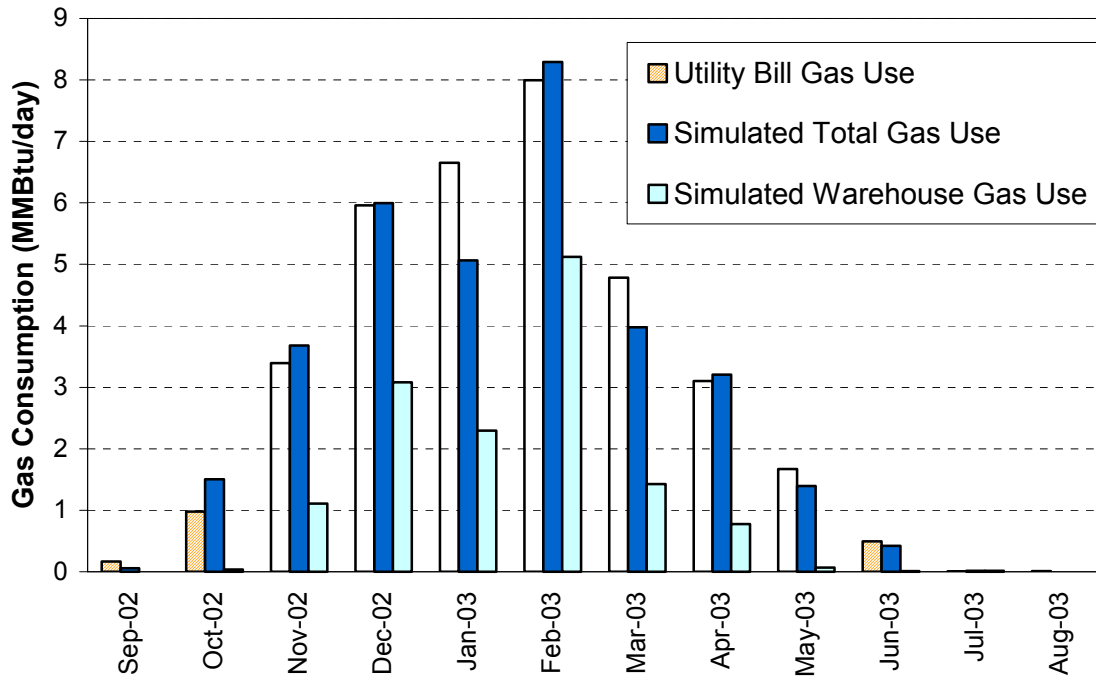
**Figure 6-9 Calibration of simulated gas consumption with utility bills**

Next, the gas consumption was calibrated with the monthly totals from the utility bills. This was difficult because only the monthly total natural gas for the building is known, and the split between the warehouse and the retail/office area is not known. In addition, the operating conditions and thermostat schedules change occasionally depending on the needs and desires of the building occupants. The warehouse is operated as a drive-in loading space, and at least one overhead door is always open during store operating hours. The radiant gas heaters are operated to keep the space warmer than 37°F (3°C). This operation is difficult to model because the air exchange with the outdoors is unknown. However, the low temperature set point in the warehouse makes it possible to find months where the heating load in the warehouse is small. The largest unknown in the model of the retail/office space heating system is the Panel Loss Ratio; therefore, this value was altered to best match the measured data. The Panel Loss Ratios that best matched the monthly data were 0.05 for the retail and office space and 0.1 for the break room. Next, the maximum infiltration for the warehouse was changed to find the best match for every month of the year. The best fit of the data was found with the maximum warehouse infiltration set to 5.25 ACH. Because of the high flow rates from open doors, it was not feasible to measure the ACH. The annual total gas use from the As-Built Model was 4.8% lower than the total from the utility bills. A look at the month-by-month comparison in Figure 6-9 shows a good match for most months. Excluding January, the simulated results are only 0.03% lower than the utility bills. January had some operational differences that were unknown and we were unable to account for them in the model.

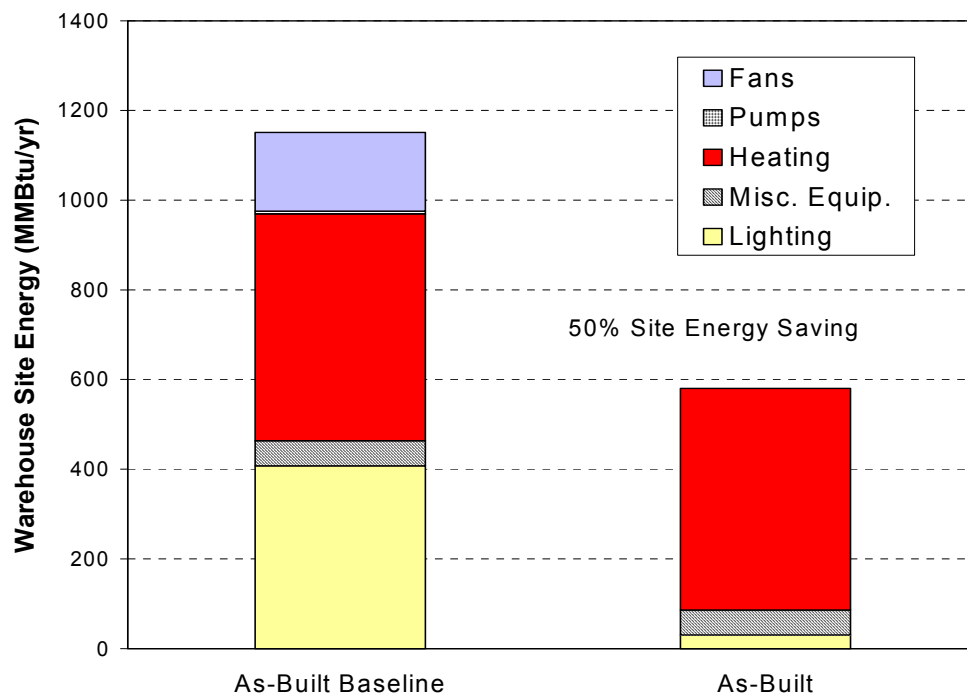
**Figure 6-12 Simulated annual site energy consumption for the warehouse using an average year weather file**

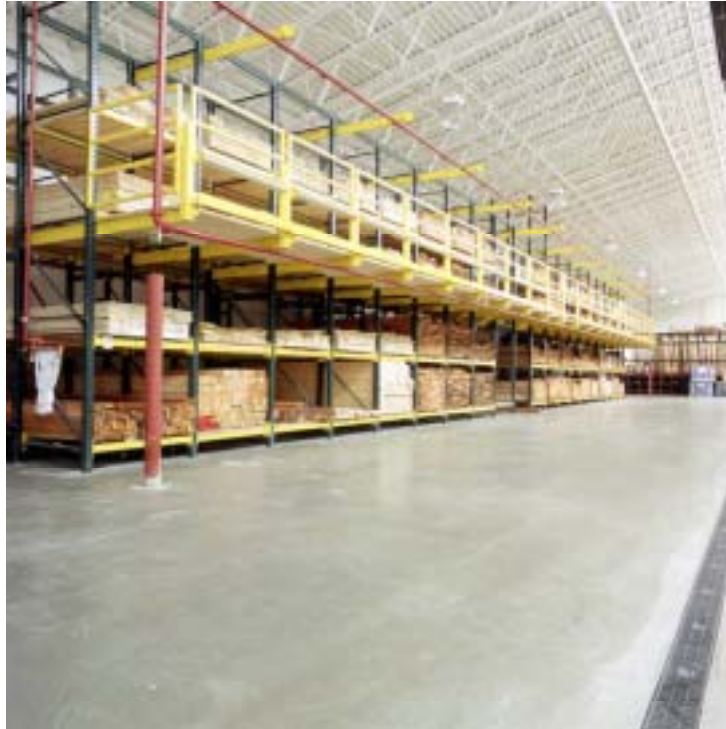
**Figure 7-1 Warehouse lighting with daylight only for clear sky conditions on June 5, 2000**

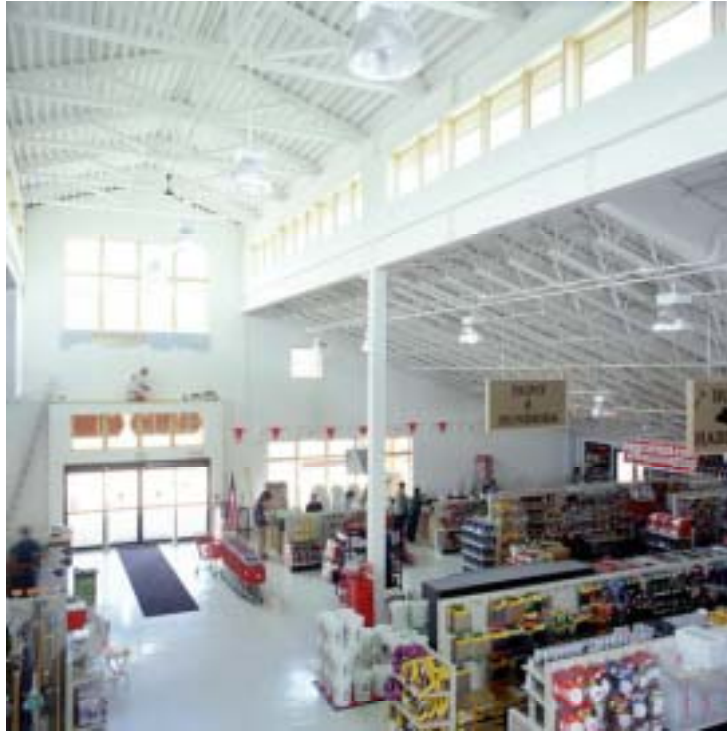
**Figure 7-2 Retail area lighting with daylight only for clear sky conditions on June 5, 2000**

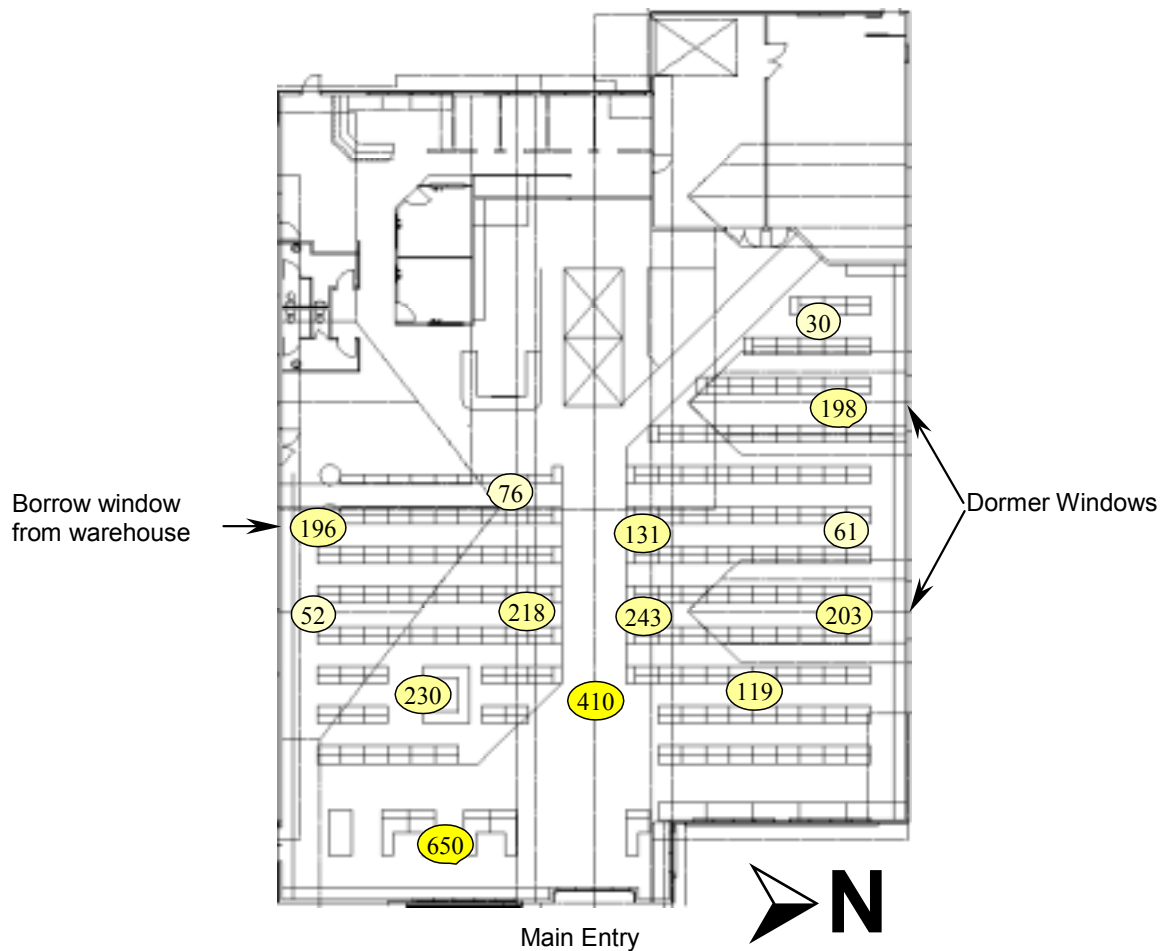
**Figure 7-3 Illuminance levels in lux from daylight only on June 5, 2000, at 11:00 MDT**

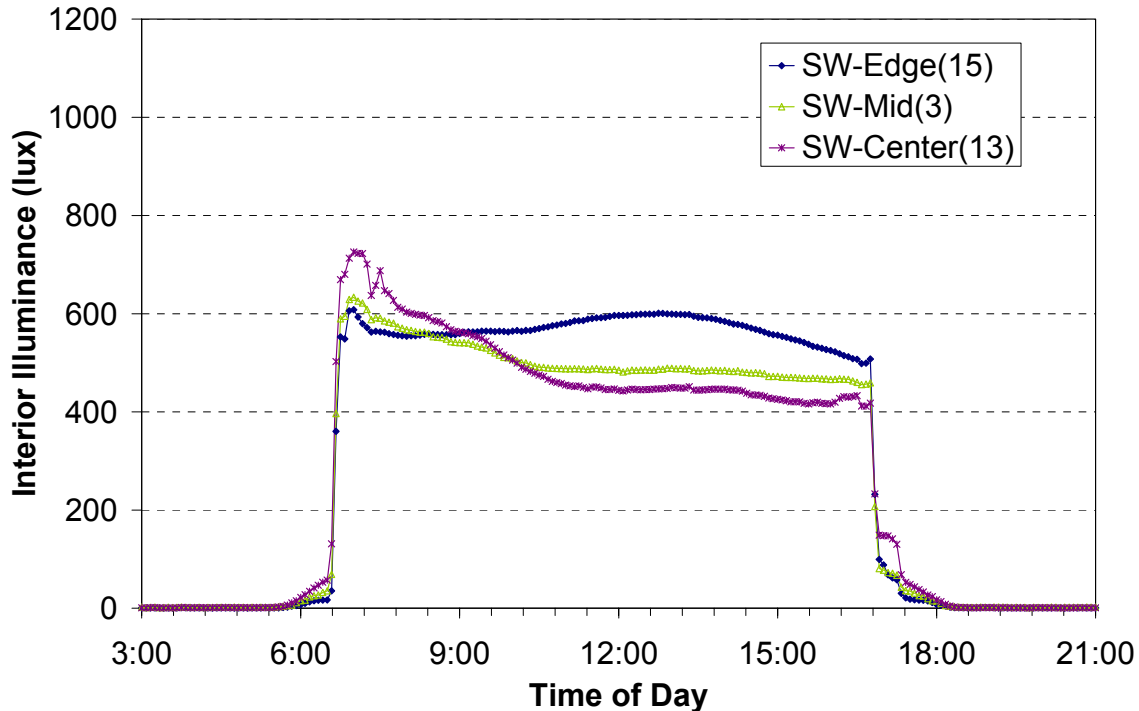
**Figure 7-14** Light levels from daylight and electric lights on the south side of the retail area on September 16, 2000

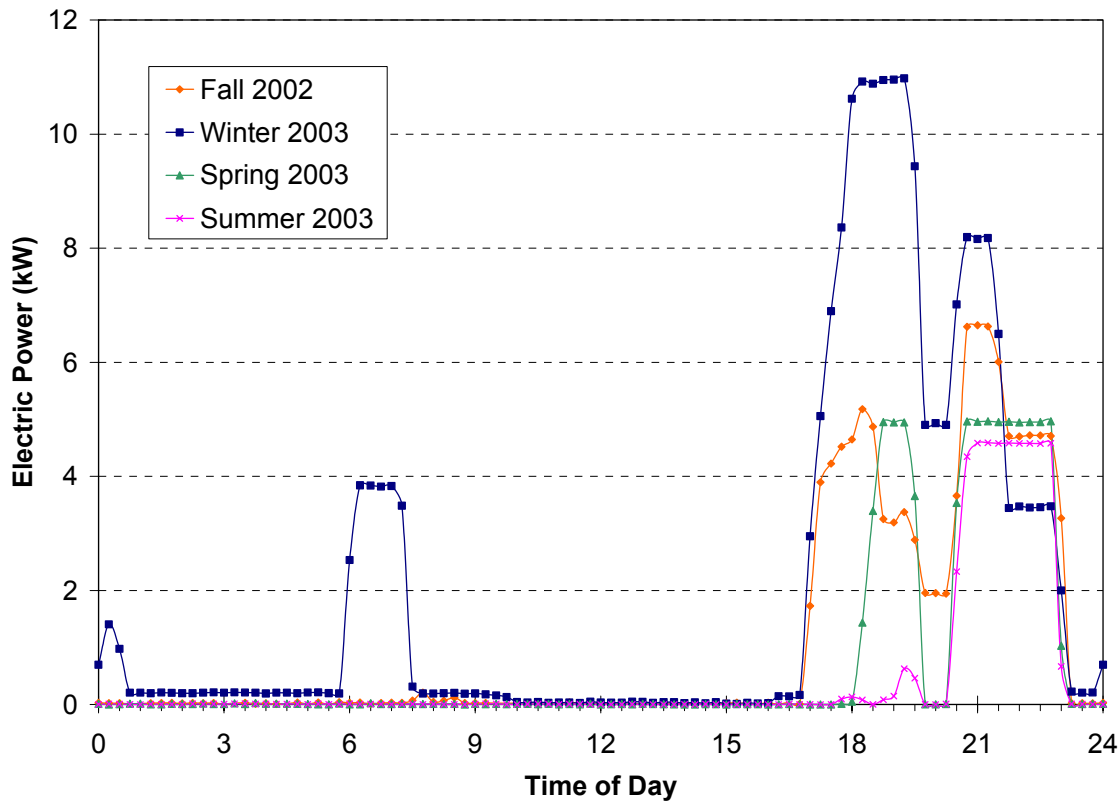
Figure 7-18 Seasonal average daily profile for the exterior lighting power

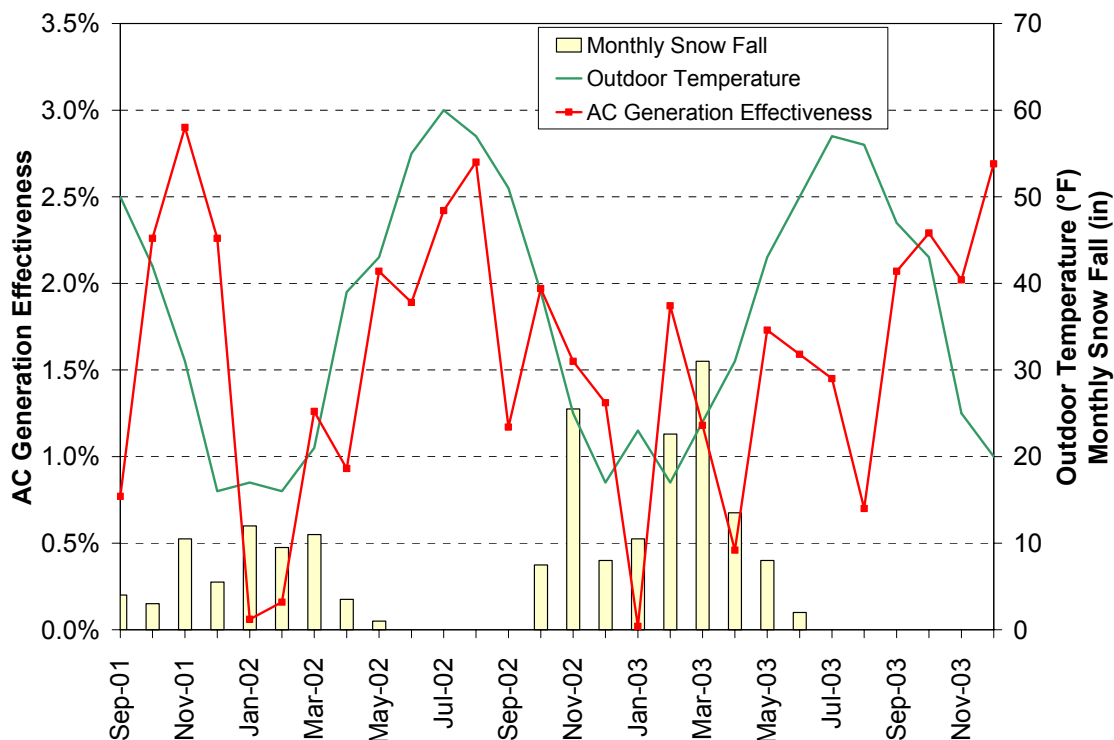
**Figure 7-21 Monthly PV system conversion efficiency with outdoor temperature and snowfall amounts**

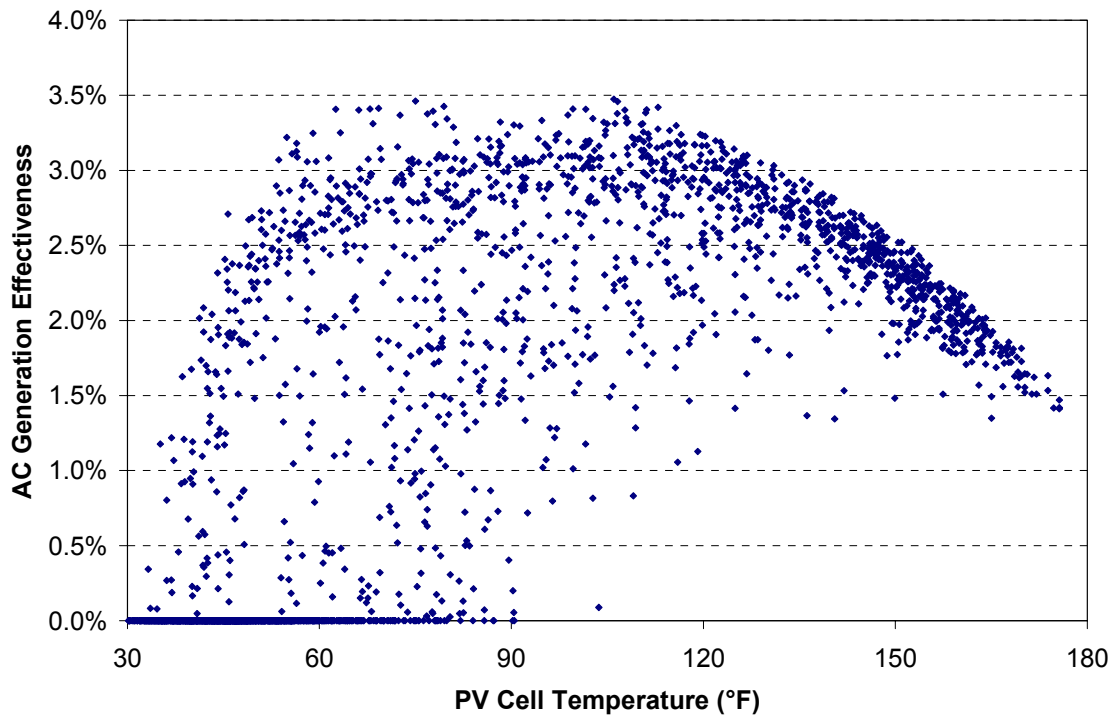
**Figure 7-23 AC Generation Effectiveness and PV cell temperature for July 2002**

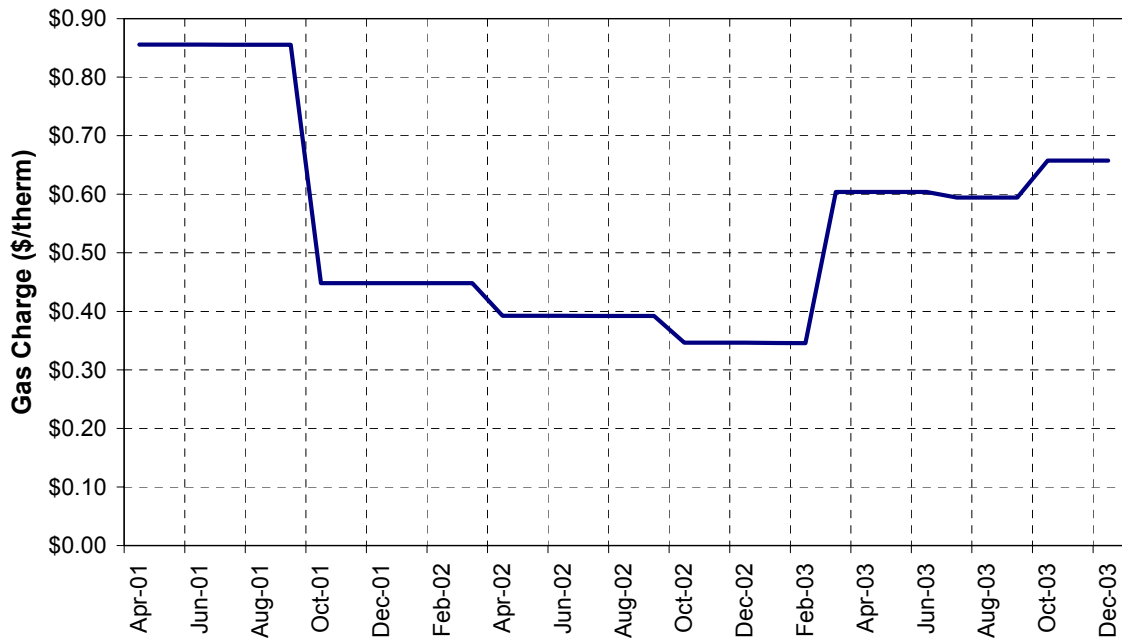
**Figure A-1 Total utility natural gas charges for the BigHorn Center**
