SAND2000-0709
Unlimited Release
Printed March 2000

Abuse Tests on Sealed Lead-Acid Batteries

D. H. Loescher, C. C. Crafts, T. M. Unkelhaeuser

Abuse tests were conducted on the lead-acid batteries used to power electrical testers used at the Department of Energy's Pantex Plant. Batteries were subjected to short circuits, crushes, penetrations, and drops. None of the observed responses would be a threat to nuclear explosive safety in a bay or cell at Pantex. Temperatures, currents, and damage were measured and recorded during the tests.

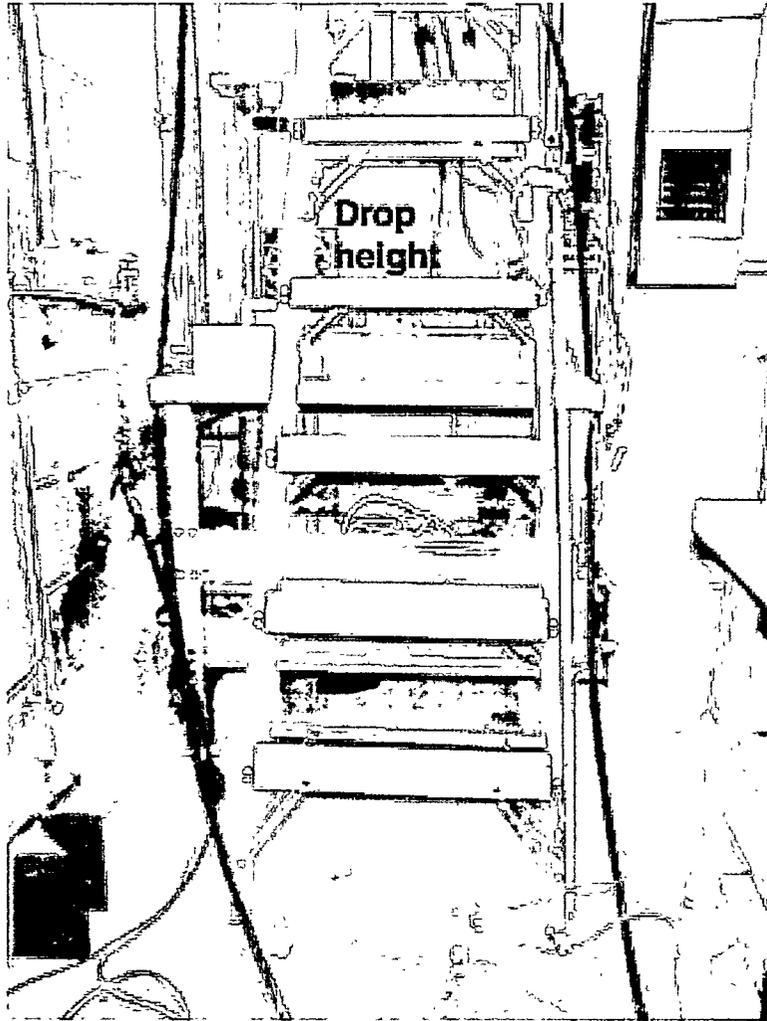
Figure 20. The setup used for drop tests is shown. The drop height was 4 feet (1.2 m).

One battery of each type was dropped from a height of 4 feet (1.2 m) onto a concrete floor. The test setup is shown in Figure 20. The battery under test was pushed off the ladder step, fell to the concrete floor, and bounced until it came to rest. The wires shown on the floor in Figure 20 were not present during the drop tests. Open circuit voltage was recorded during each test. The test records show that all open circuit voltages stayed constant throughout the drops, falls, and bounces.
